サイト状況確認調査チェック・リスト

1. Site No. 18
2. Name of School: *Rahmaterbill G.P.S.*
3. Site Location : District; *Cox's Bazar* Thana ; *Ukhia*
 Union ; *Rahmaterbill* Village; *Rahmaterbill*

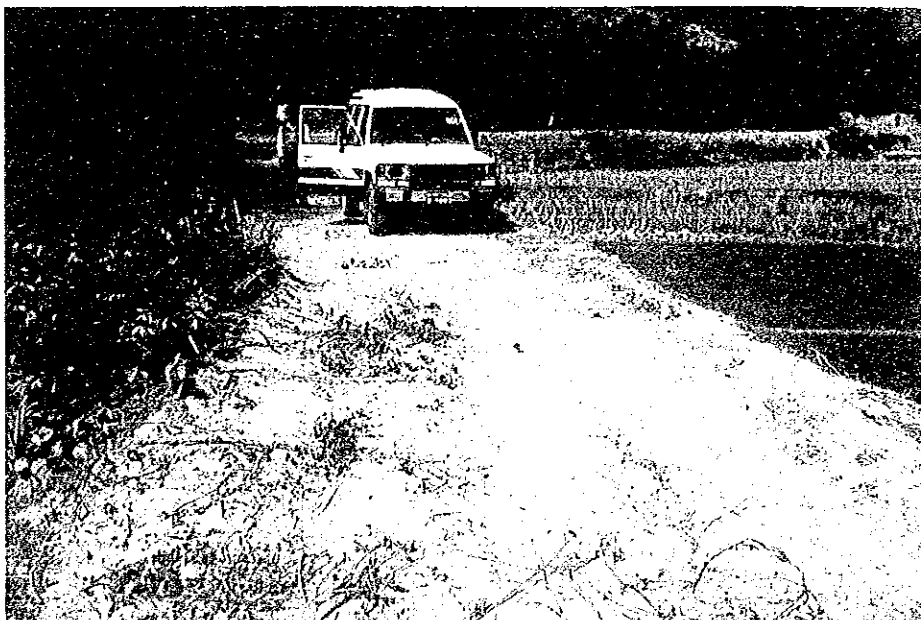
周辺の道路状況

- Necessity for Repair of Bridges or Culverts: Yes, No, *Widening is necessary.*
6. Conditions of School
 - 1) Name of Landowner : *Government*
 - 2) Area of School Site : *2164* m² (including Playground of *170* m²)
