Table 3 - 13 Analyses of Remaining Life of Runner Buckets (1/3)

FEASIBILITY STUDY ON
REHABILITATION OF DA NHIM
POWER SYSTEM

MINISTRY OF ENERGY
JAPAN INTERNATIONAL COOPERATION AGENCY

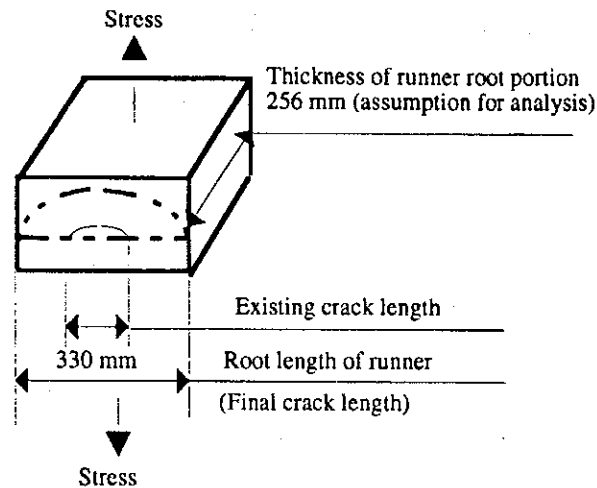
1) Analysis model formed on the basis of the existing defect condition of runner

<u>Unit No.</u>	<u>Max. length of cracks</u>	<u>Max. depth of cracks</u>
1	3 mm	5 mm
2	4 mm	4 mm
3	3 mm	2.5 mm
4	9 mm	3 mm

- Stress at root portion of runner bucket (ref. to above item 1.(2). b)) : $\sigma_A = 3.3 \text{ kgf/mm}^2$
- Stress due to centrifugal force of runner : $\sigma_r = 0.8 \text{ kgf/mm}^2$
- Residual stress of runner : $\sigma_R = 10 \text{ kgf/mm}^2$

$$\text{Average stress} = \sigma_A + \sigma_r + \sigma_R = 14.1 \text{ kgf/mm}^2$$

As a result of the above estimation, it is recommended that all the runners will be required to take proper measure within following period.

Unit No.1, 2 & 3 : Seven (7) years

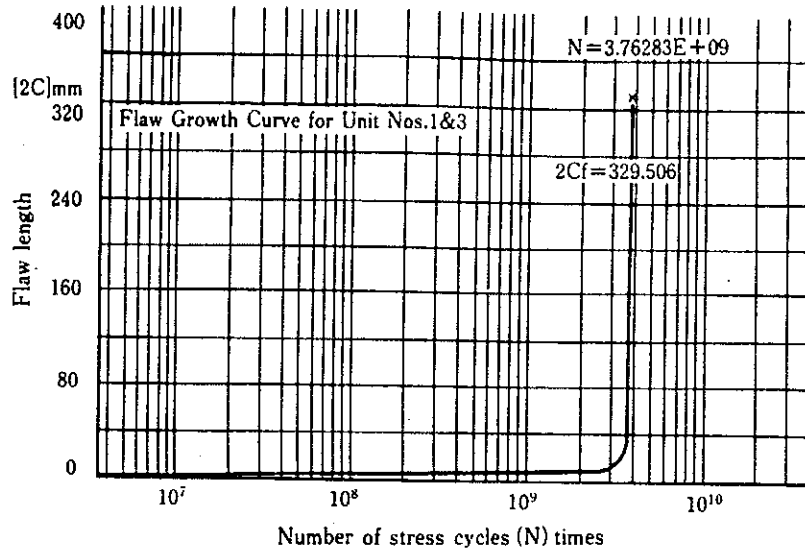
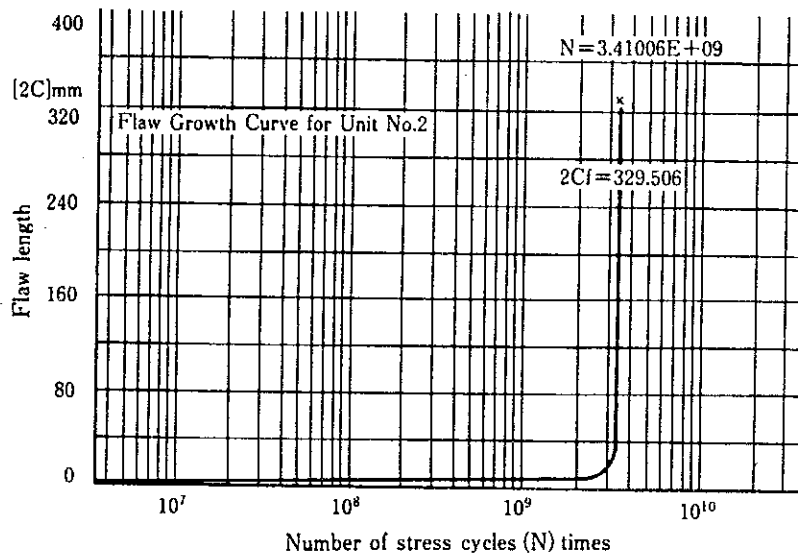
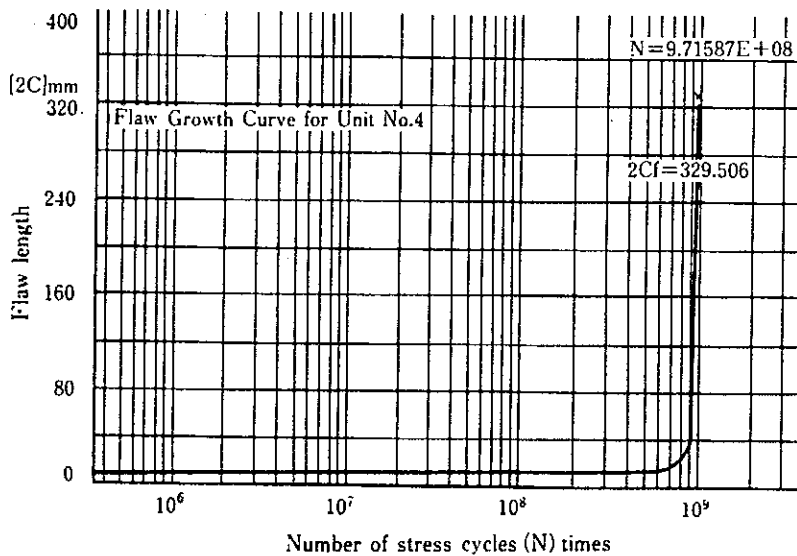
Result of Analysis on Applied Strees-Allowable Flaw Length

d) Allowable crack length : 2.7 mm

Note: From relation curve between allowable crack length and stress amplitude shown in Figure 3.6, the allowable crack length was estimated.
