DEPARTMENT OF PUBLIC WORKS AND HIGHWAYS
REPUBLIC OF THE PHILIPPINES

FEASIBILITY STUDY
ON
PAN-PHILIPPINE HIGHWAY REHABILITATION PROJECT
(MINDANAO SECTION)

FINAL REPORT
DRAWINGS

MAY 1995

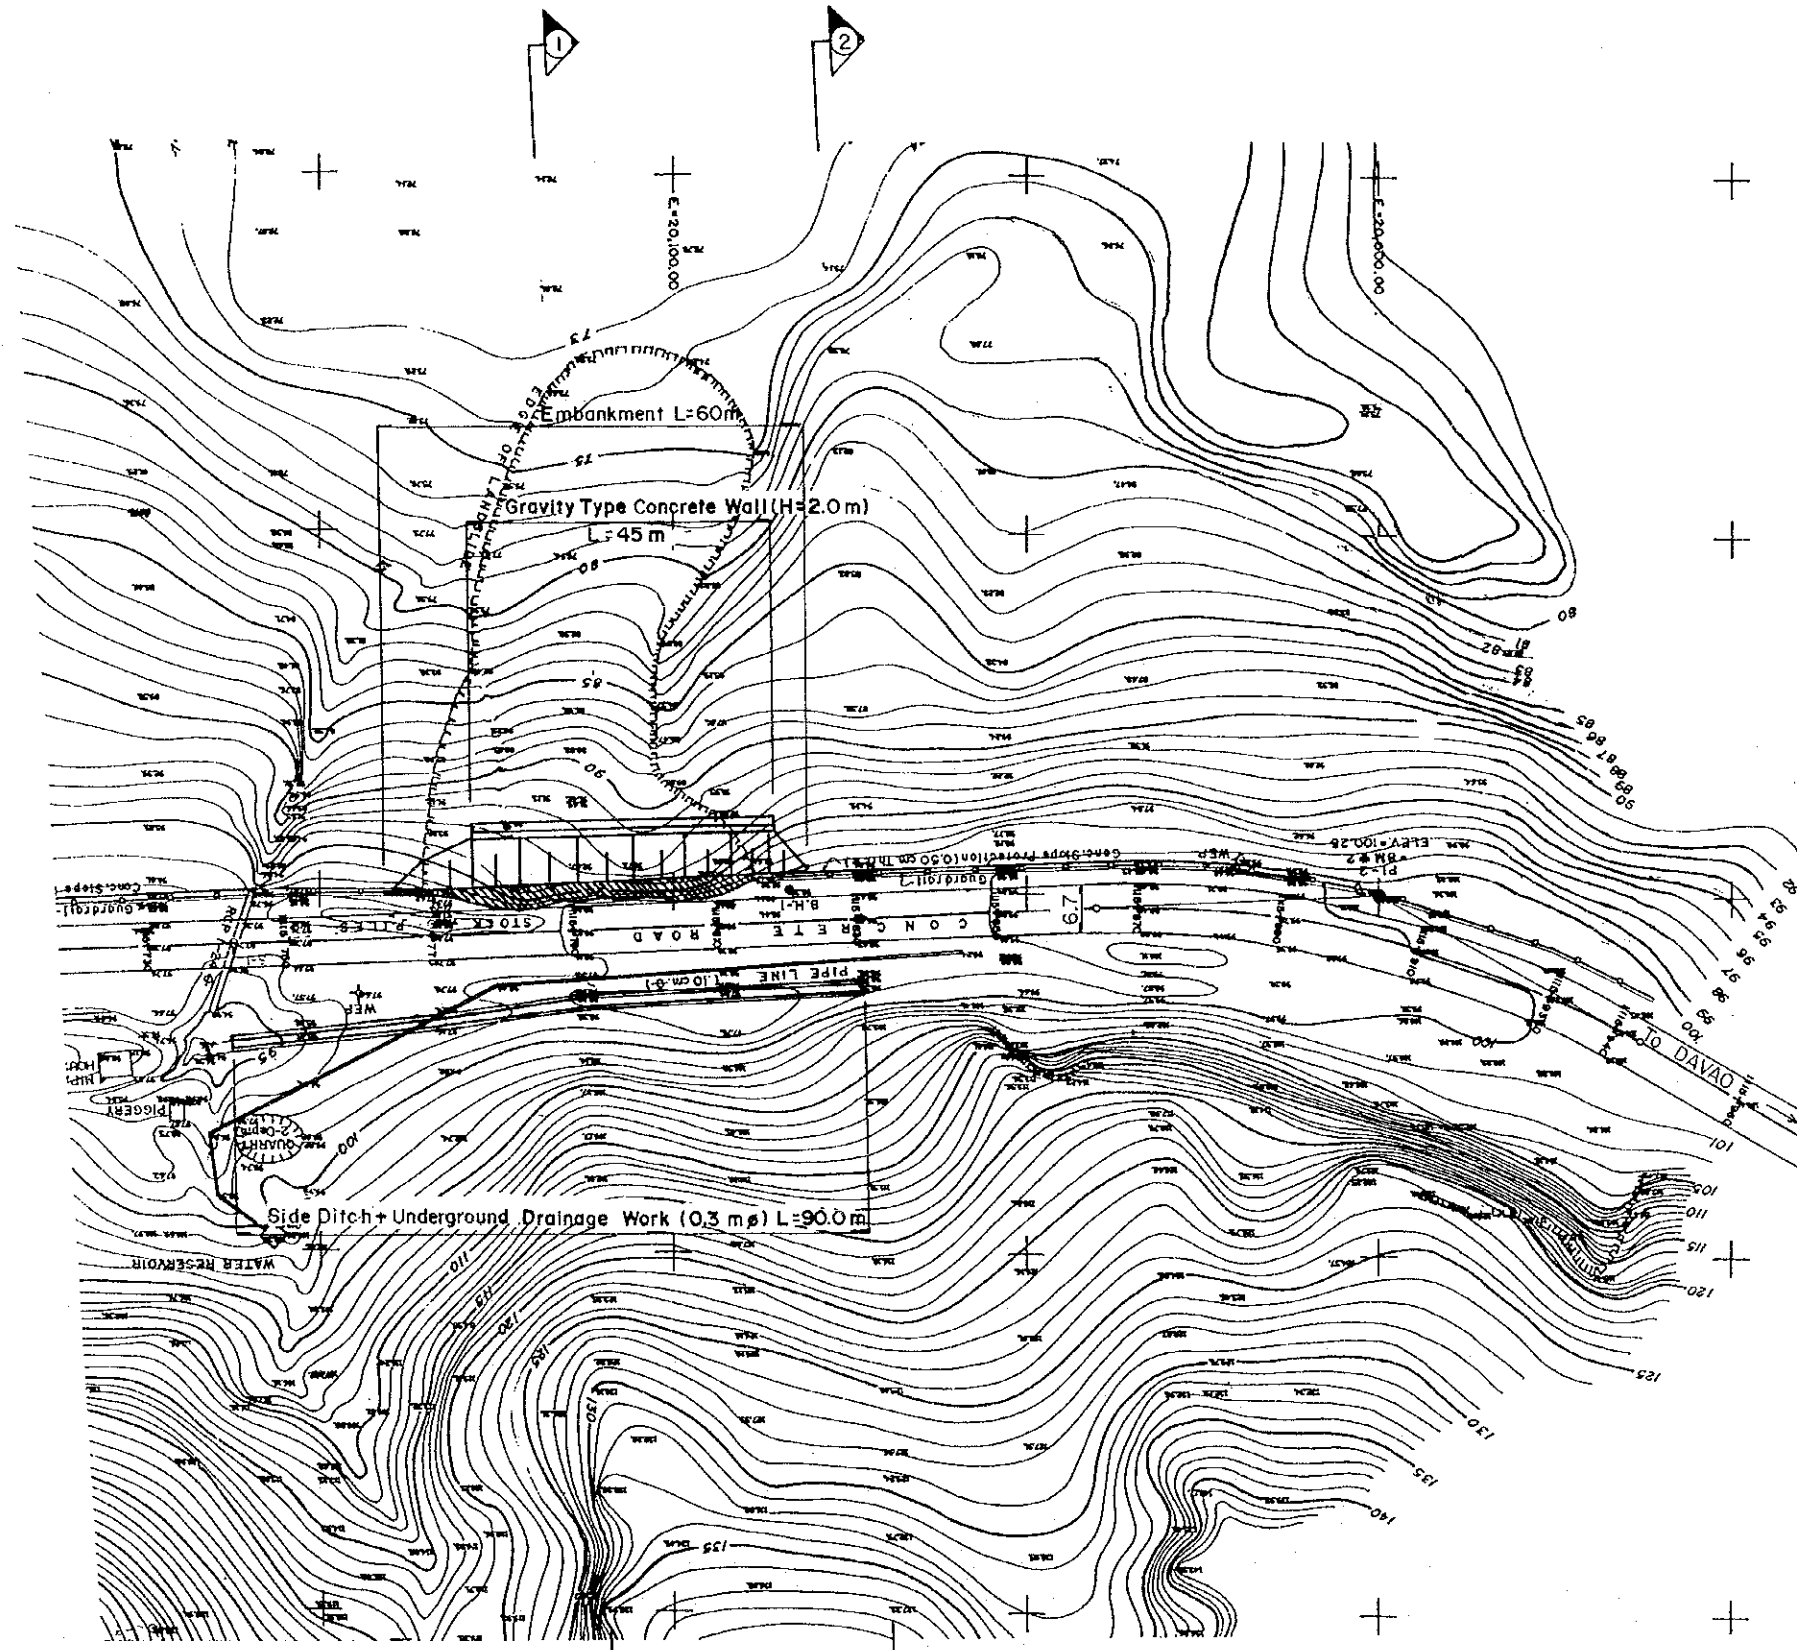
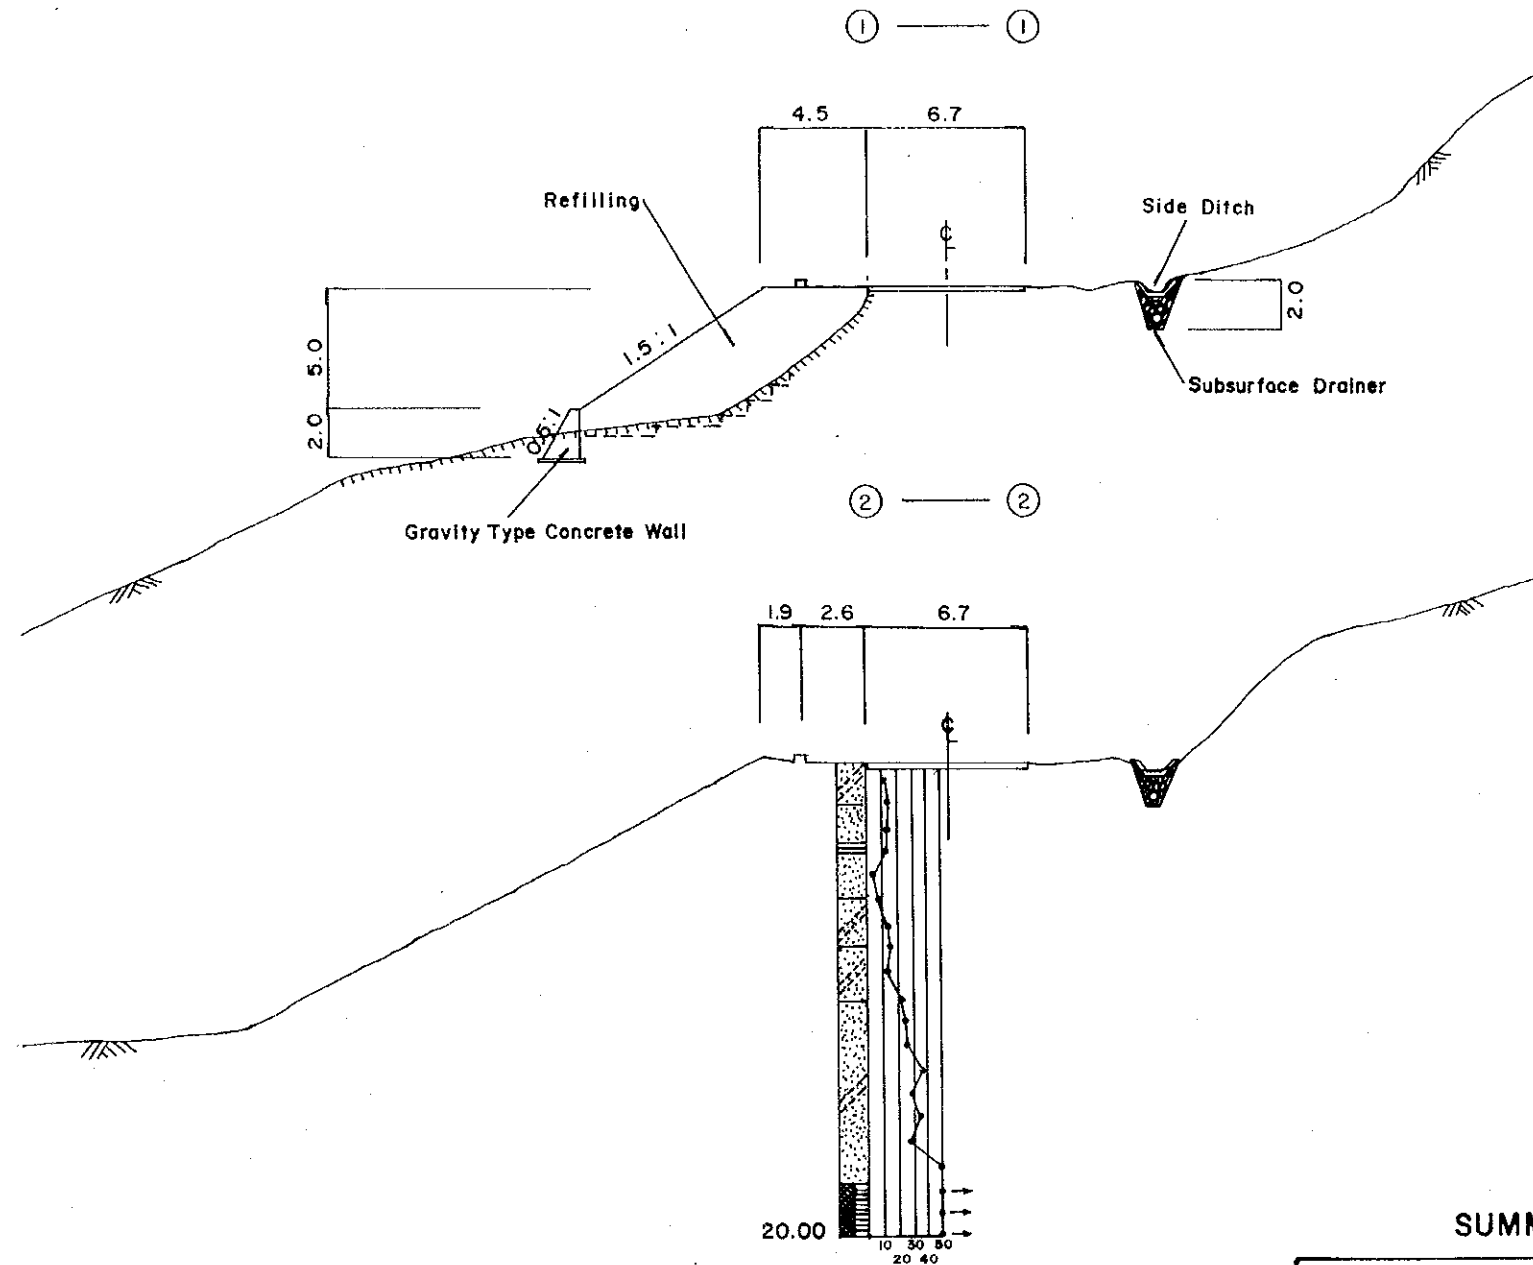
DRAWING NO.
S-3(1/2)

STATION : 1115 + 800
EMBANKMENT SLOPE FAILURE

Cause of Disaster:

- 1) Infiltration of water into boundary surface between the inclined ground and embankment.
- 2) Effect of ground water.
- 3) Embankment slope with an unstable grade.

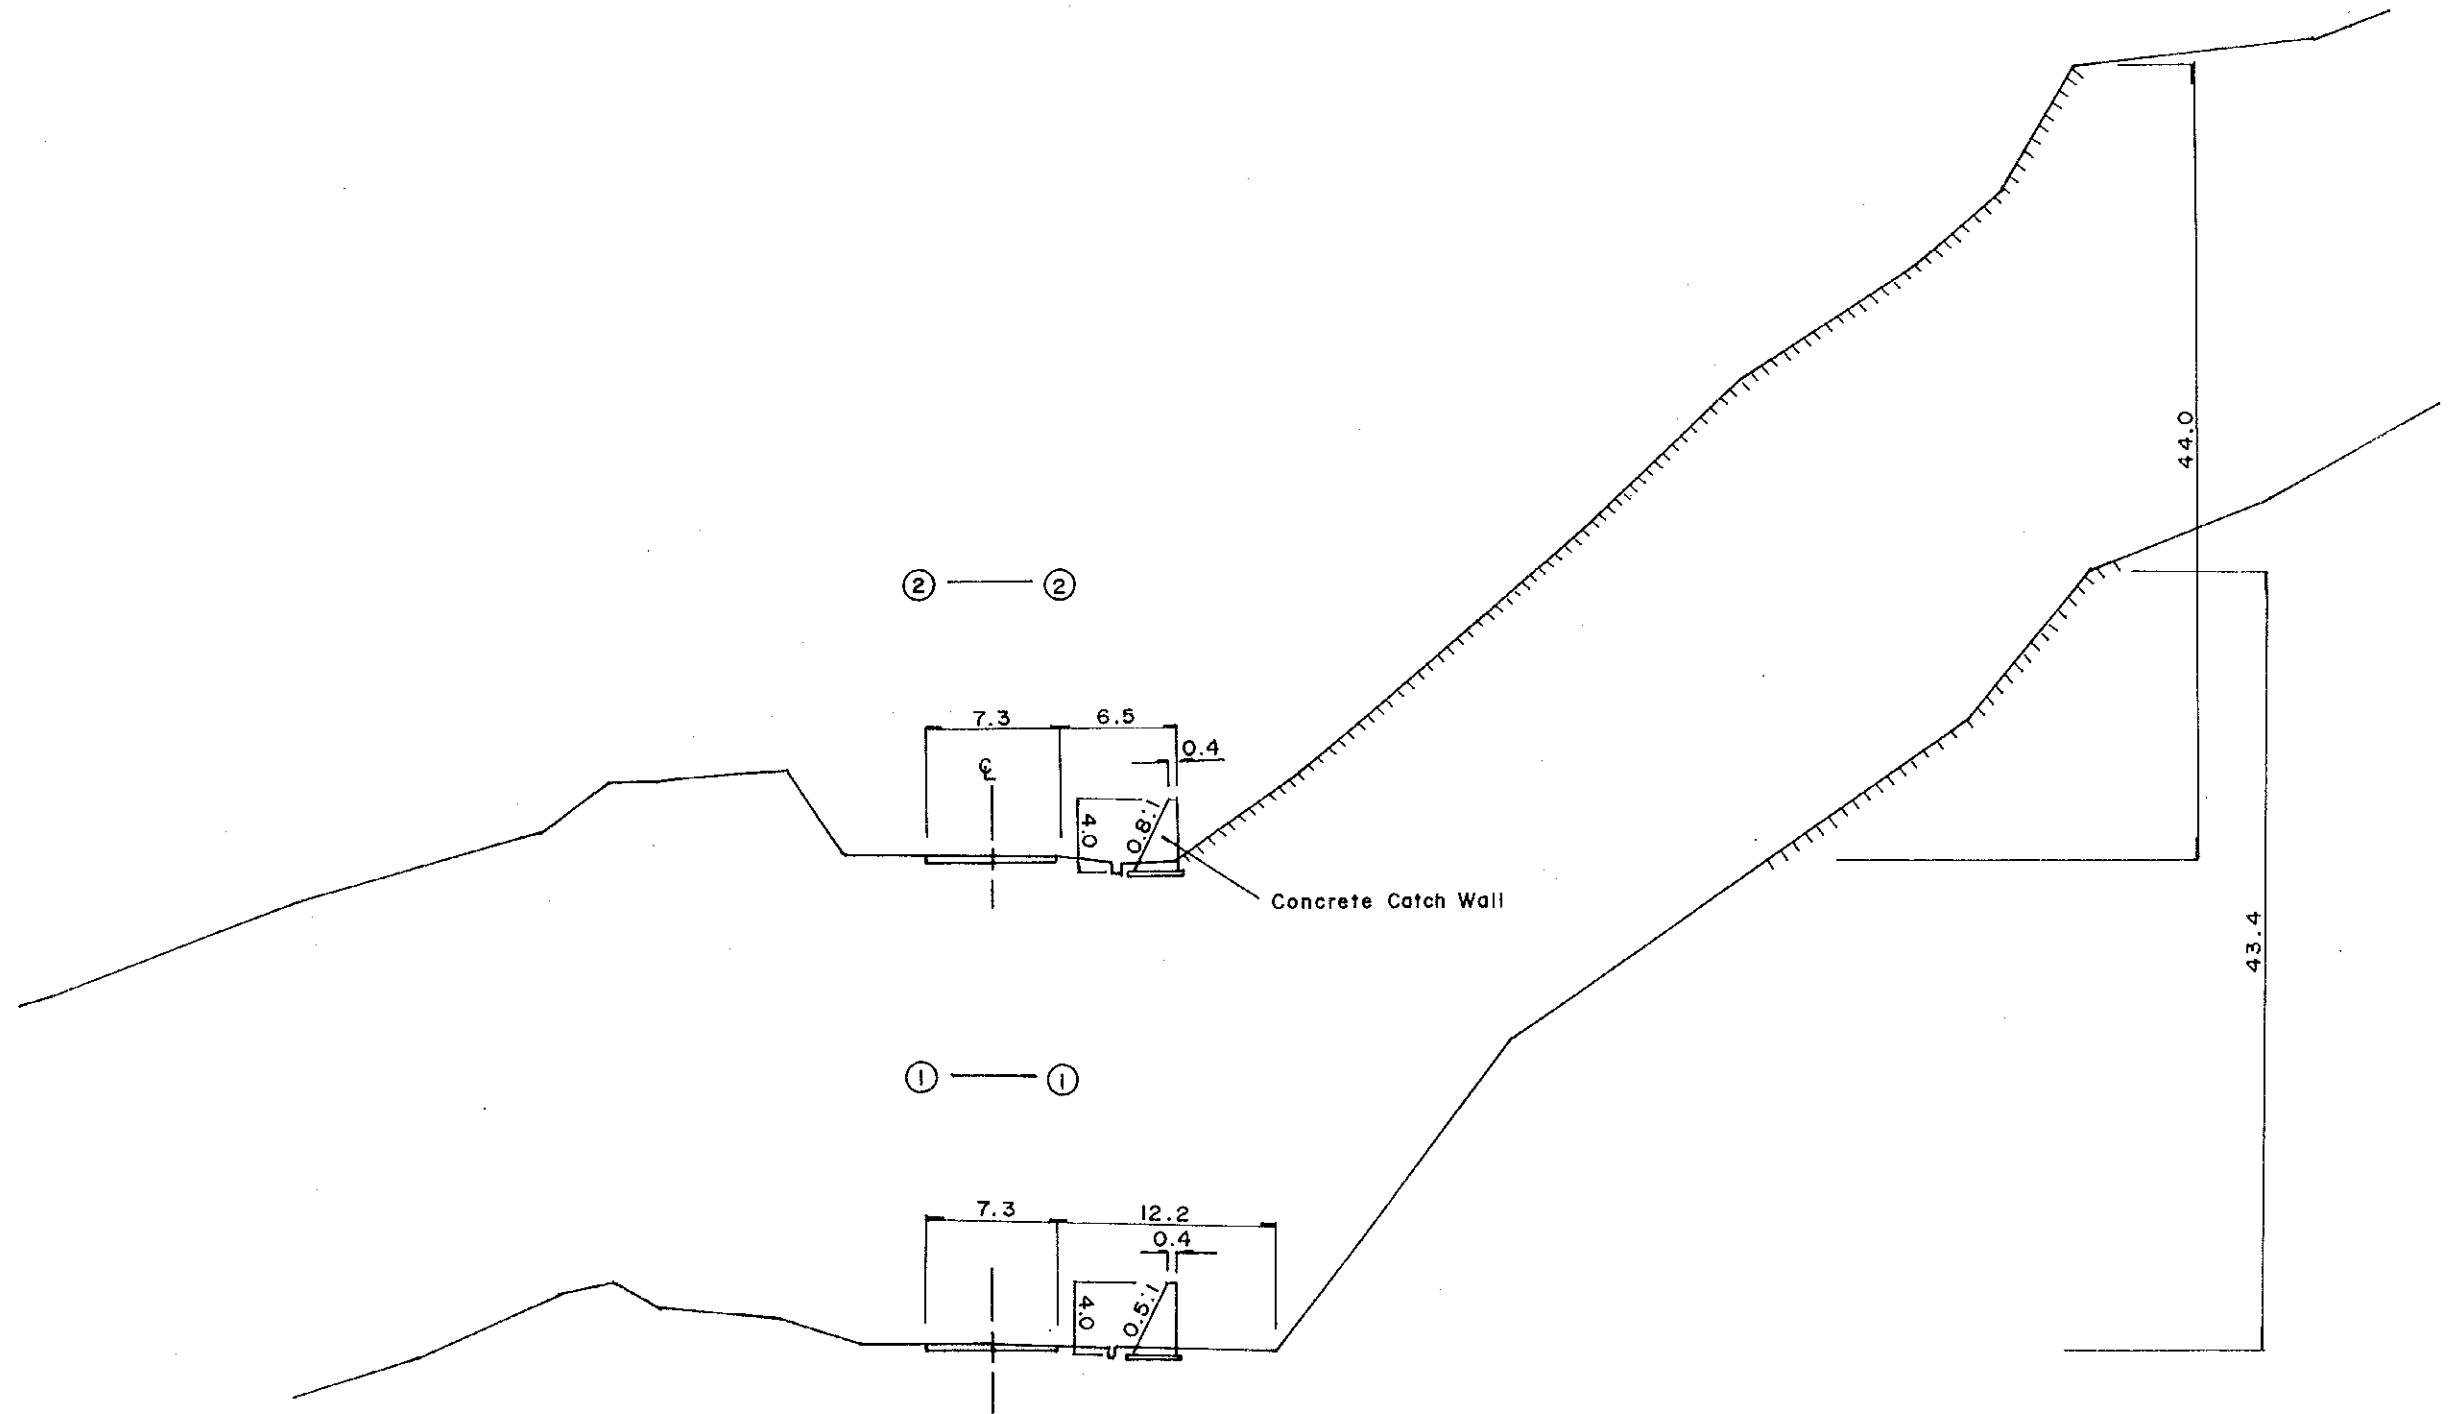
DRAWING NO.
S-4(2/2)

1116+200
CUTSLOPE FAILURE

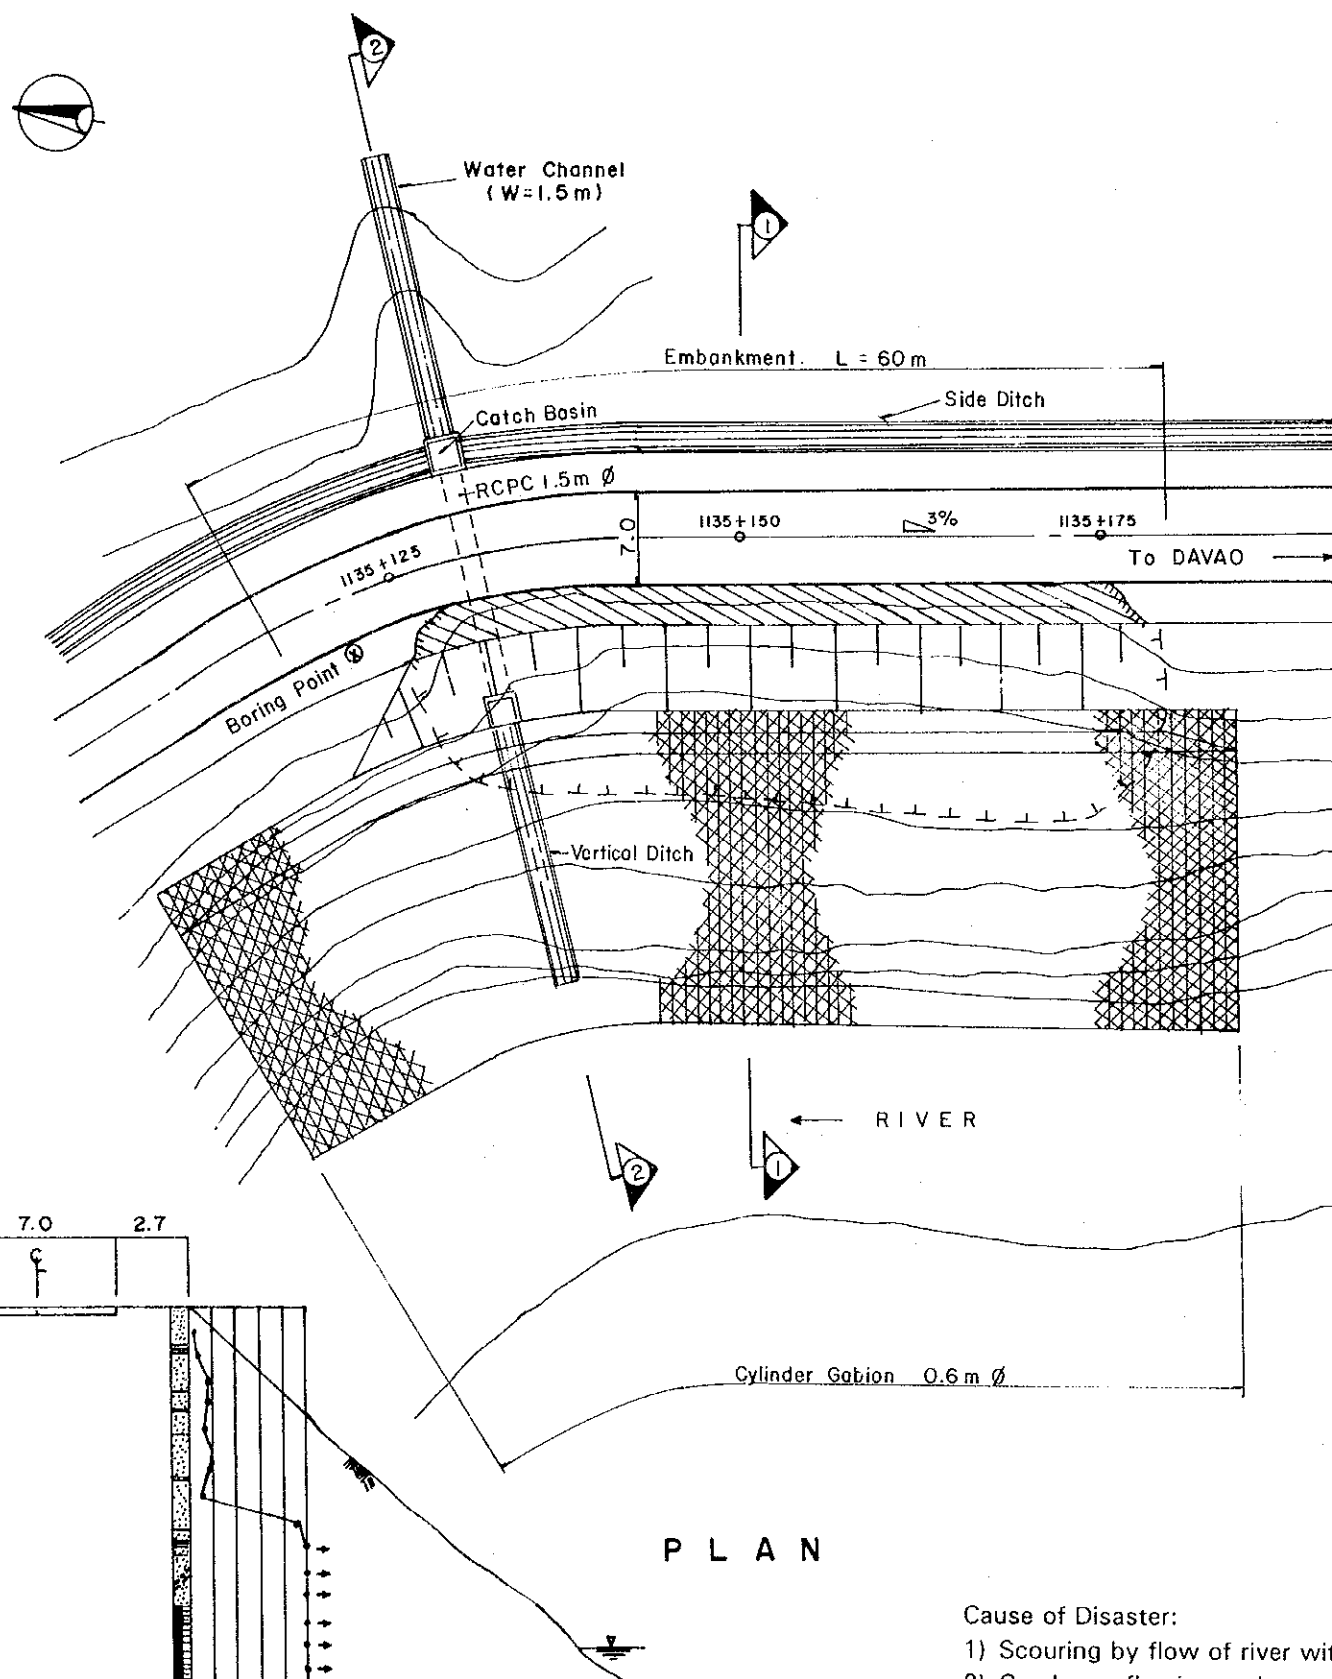
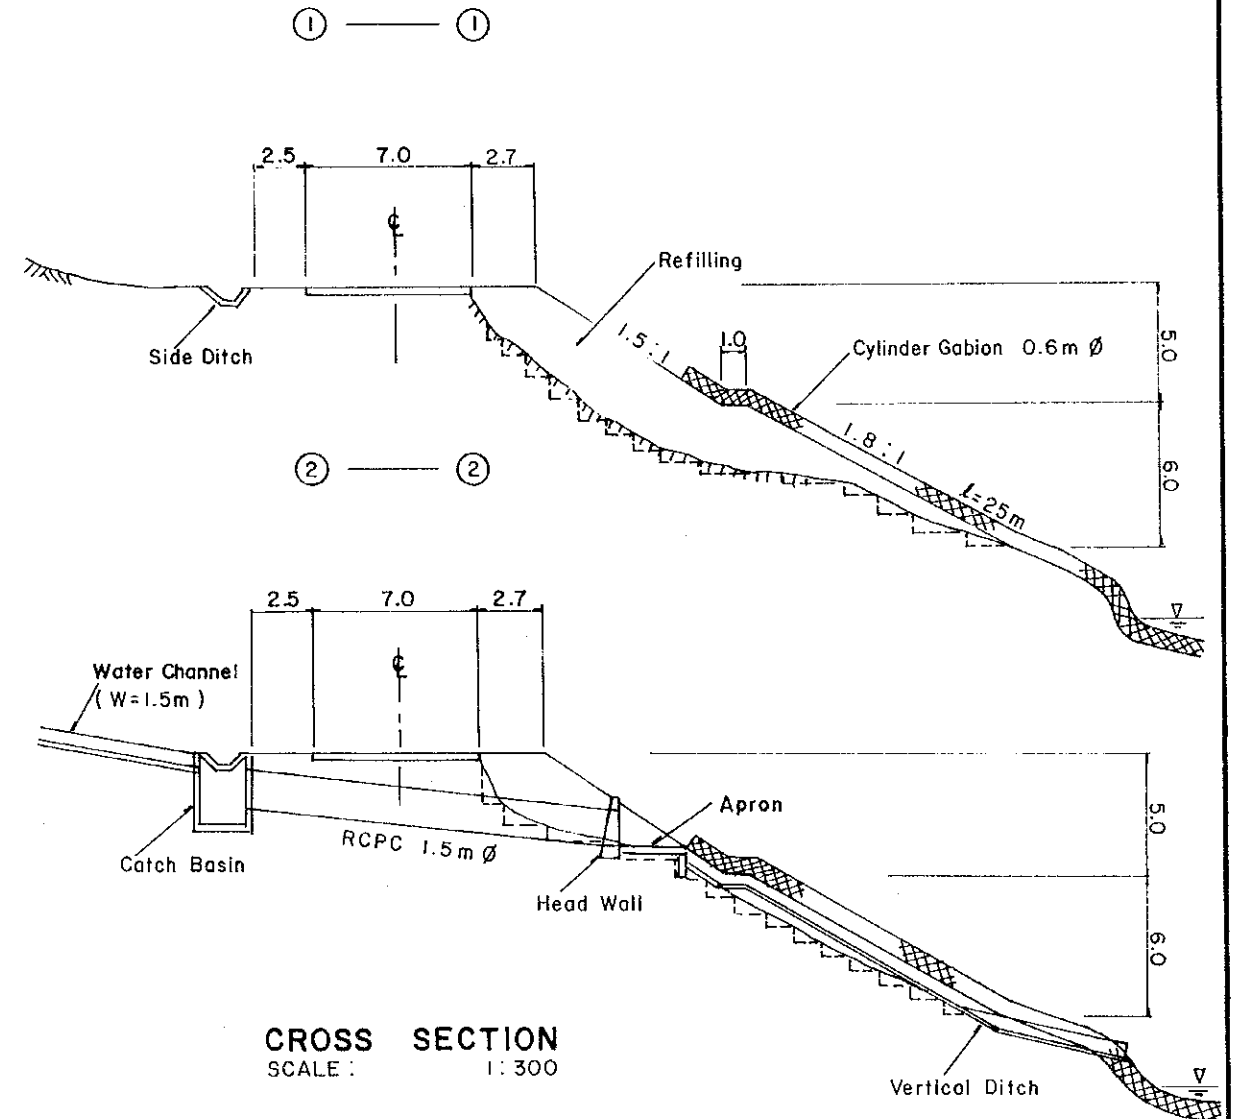
Cause of Disaster:
1) Scouring by flow of river with flood stage.
2) Creek overflowing and scouring the embankment.

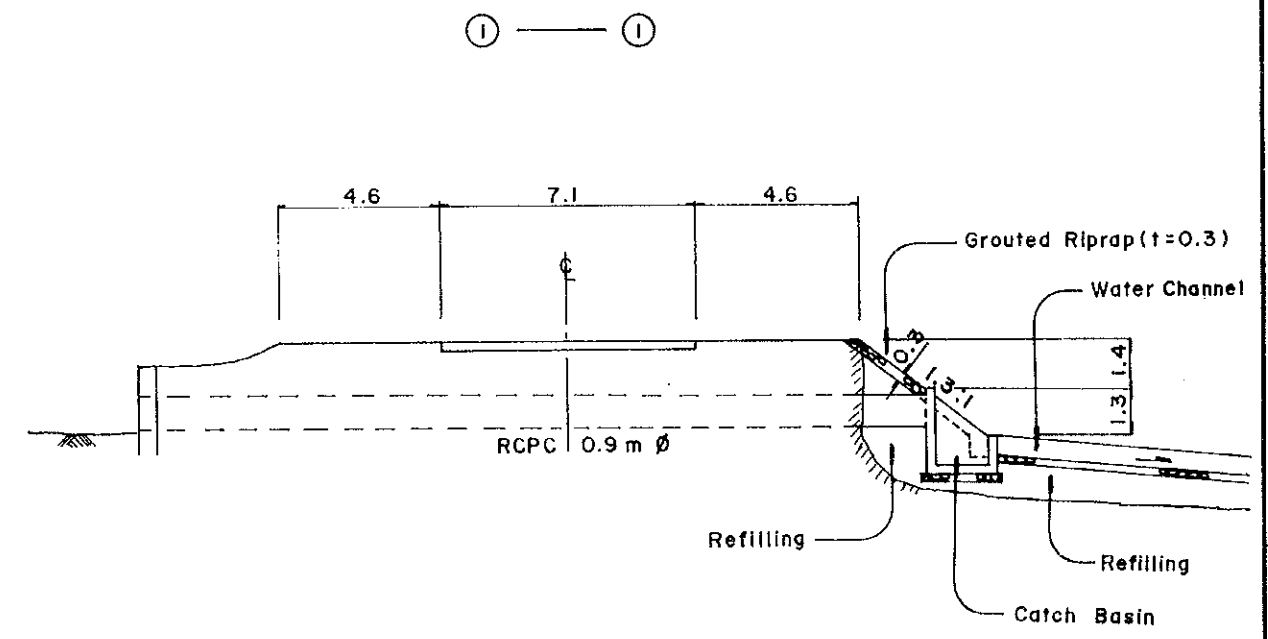
- Cause of Disaster:
- 1) Erosion at the foot of slope by pond water.
 - 2) Inadequate out-let facility of pipe culvert.
 - 3) Embankment slope with an unstable grade.

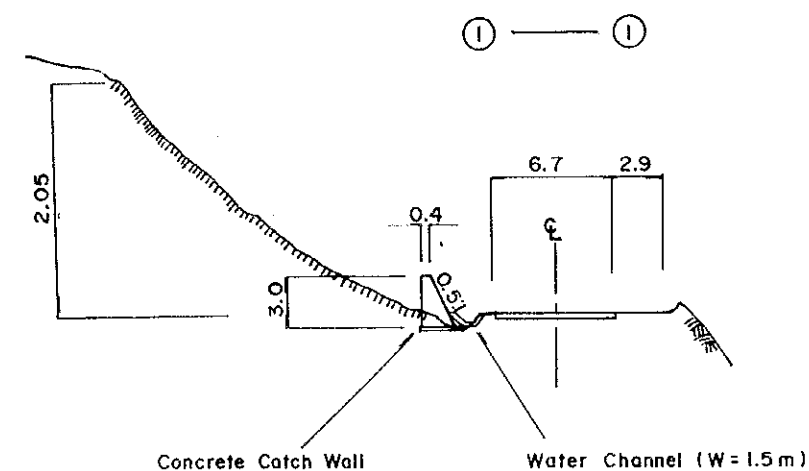
Cause of Disaster:

- 1) Failure due to lateralization: Rain wash of surface layer composed of laterite.

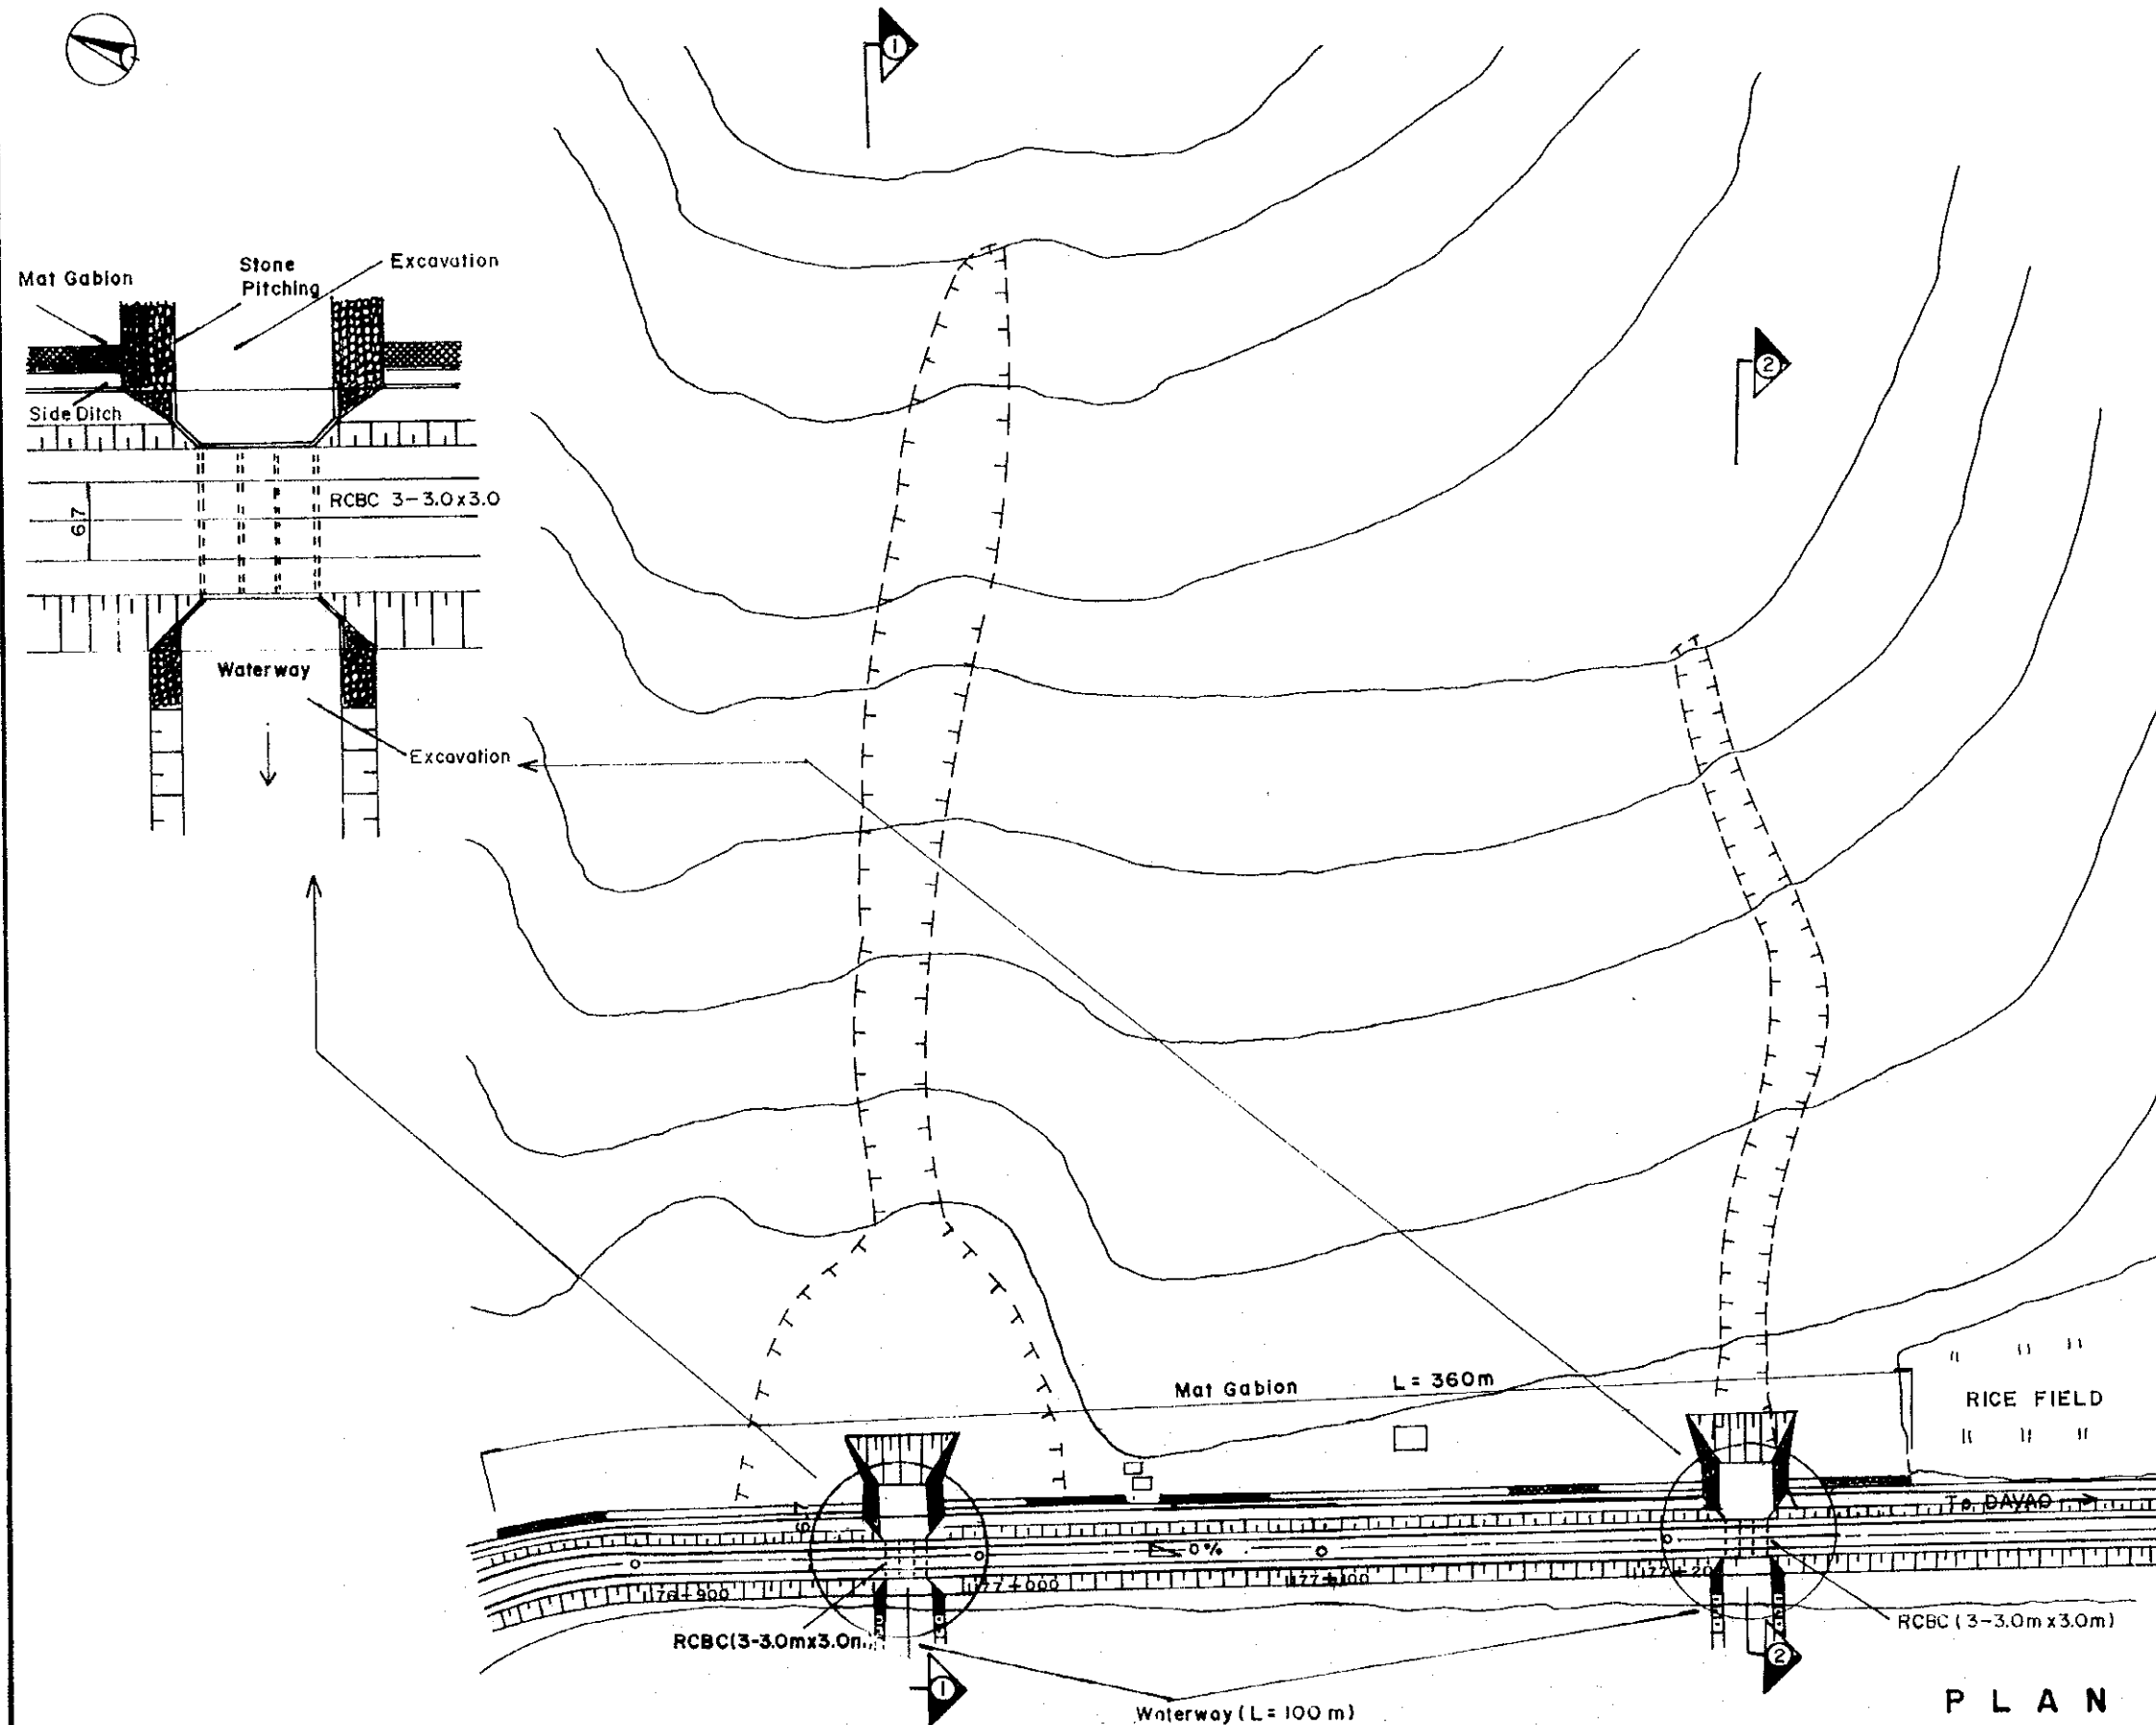
DRAWING NO.
S-12(1/2)

Cause of Disaster:

- 1) Flow of debris supplied by slope failures, deposited on the side of hill and flashed down by heavy rain.

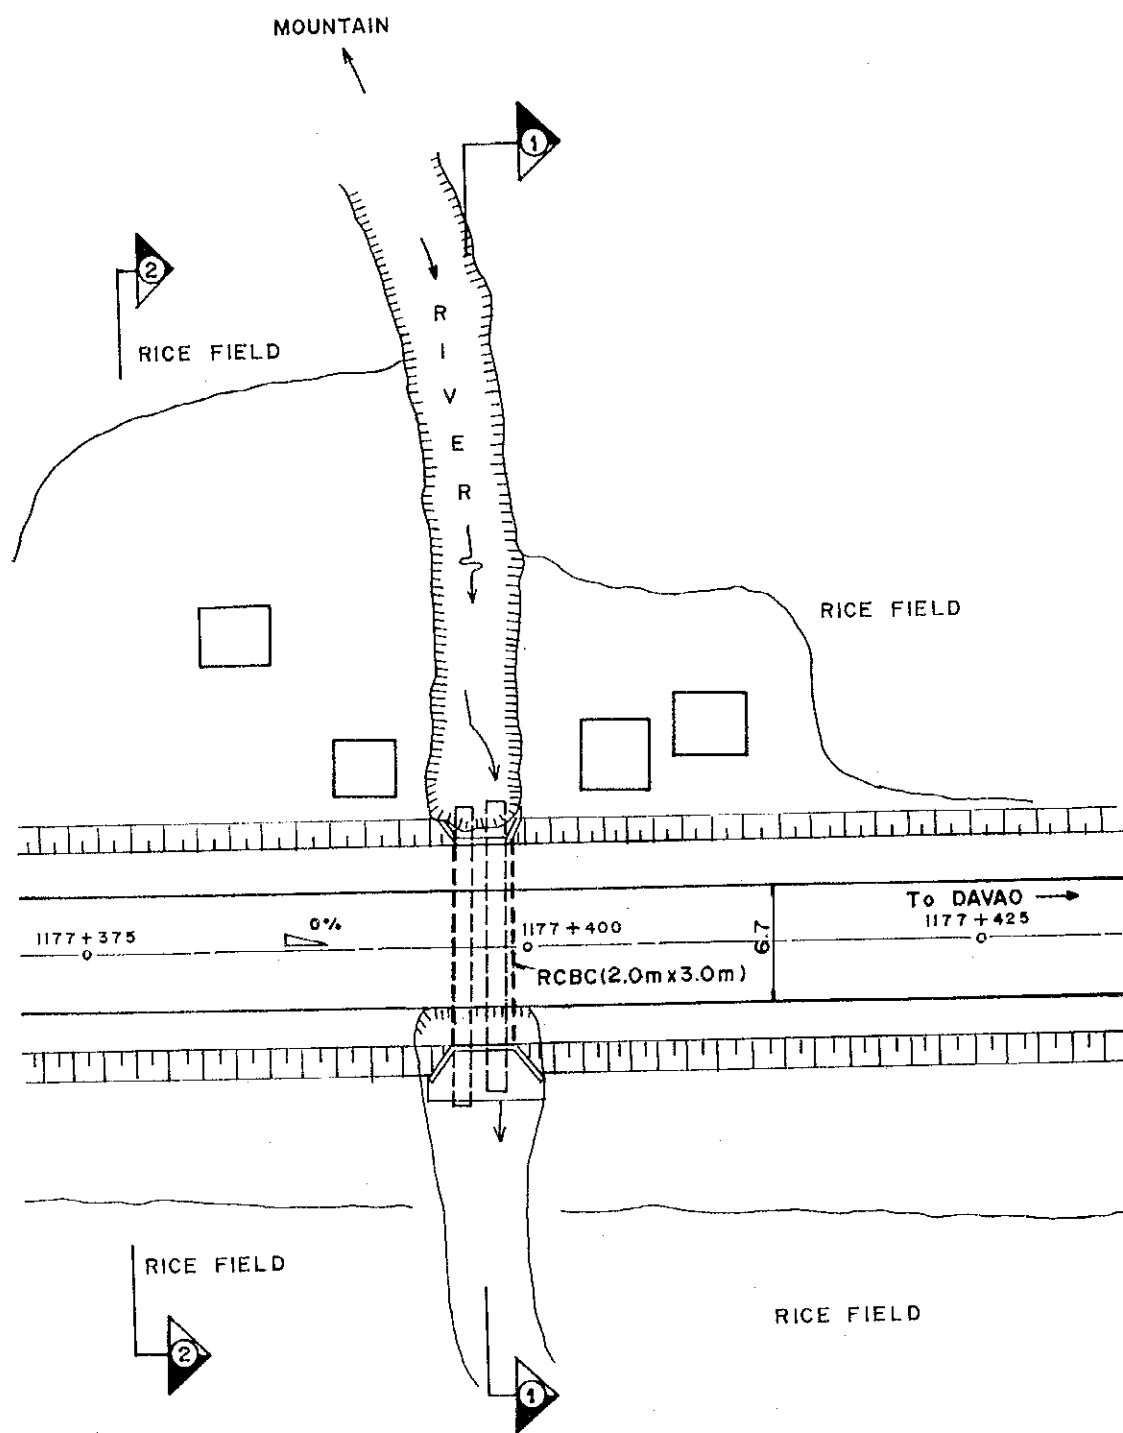
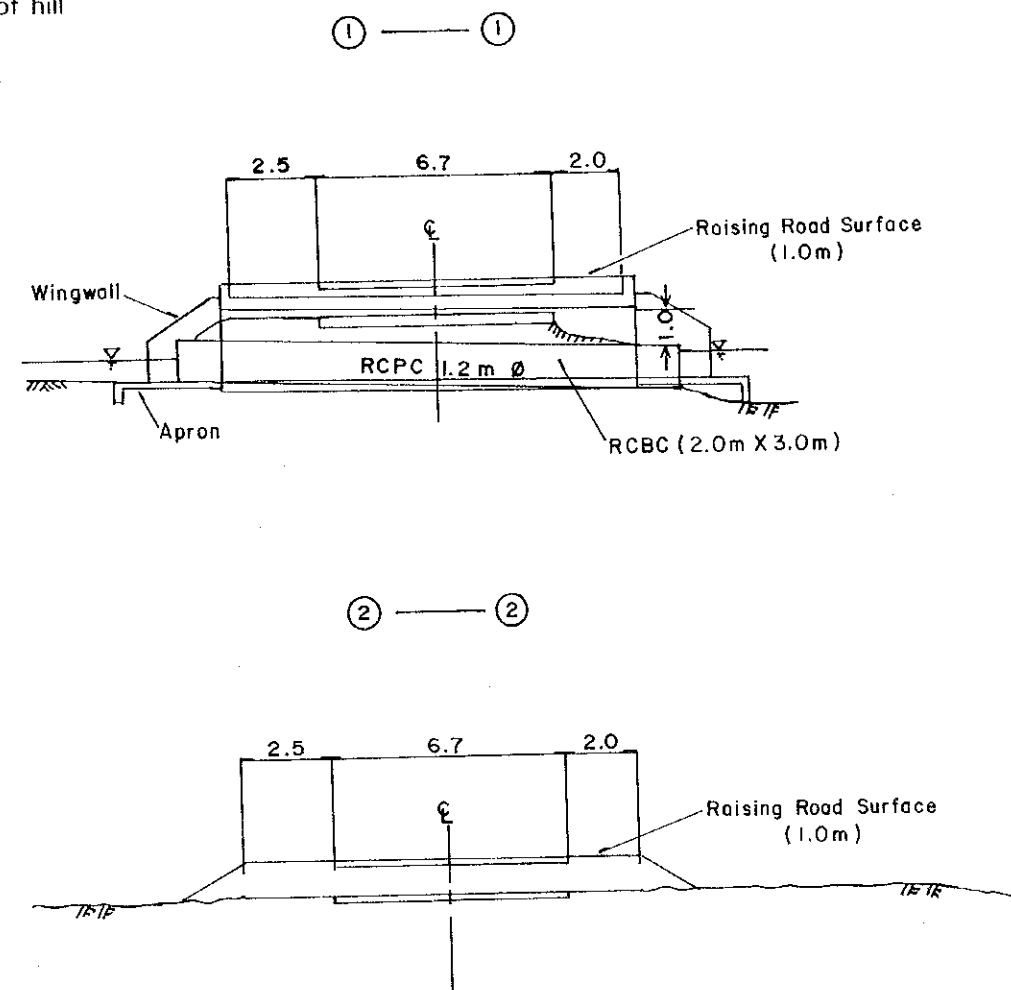
Cause of Disaster:

- 1) Flow of debris supplied by slope failures, deposited on the side of hill and flashed down by heavy rain.
- 2) Insufficient drainage capacity of pipe culvert and poor maintenance.

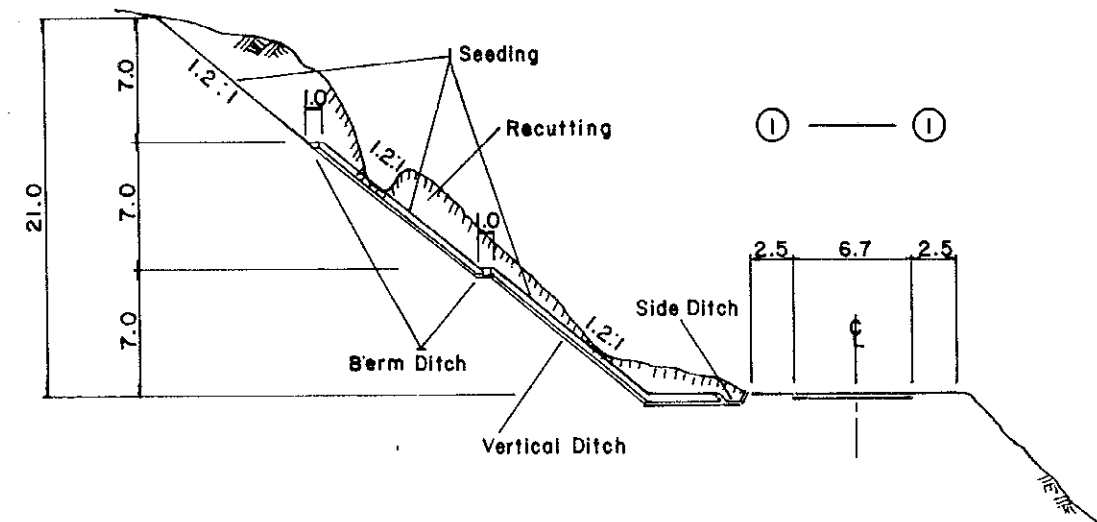
Cause of Disaster:

- 1) Surface failure of granite which has been severely weathered by rain.

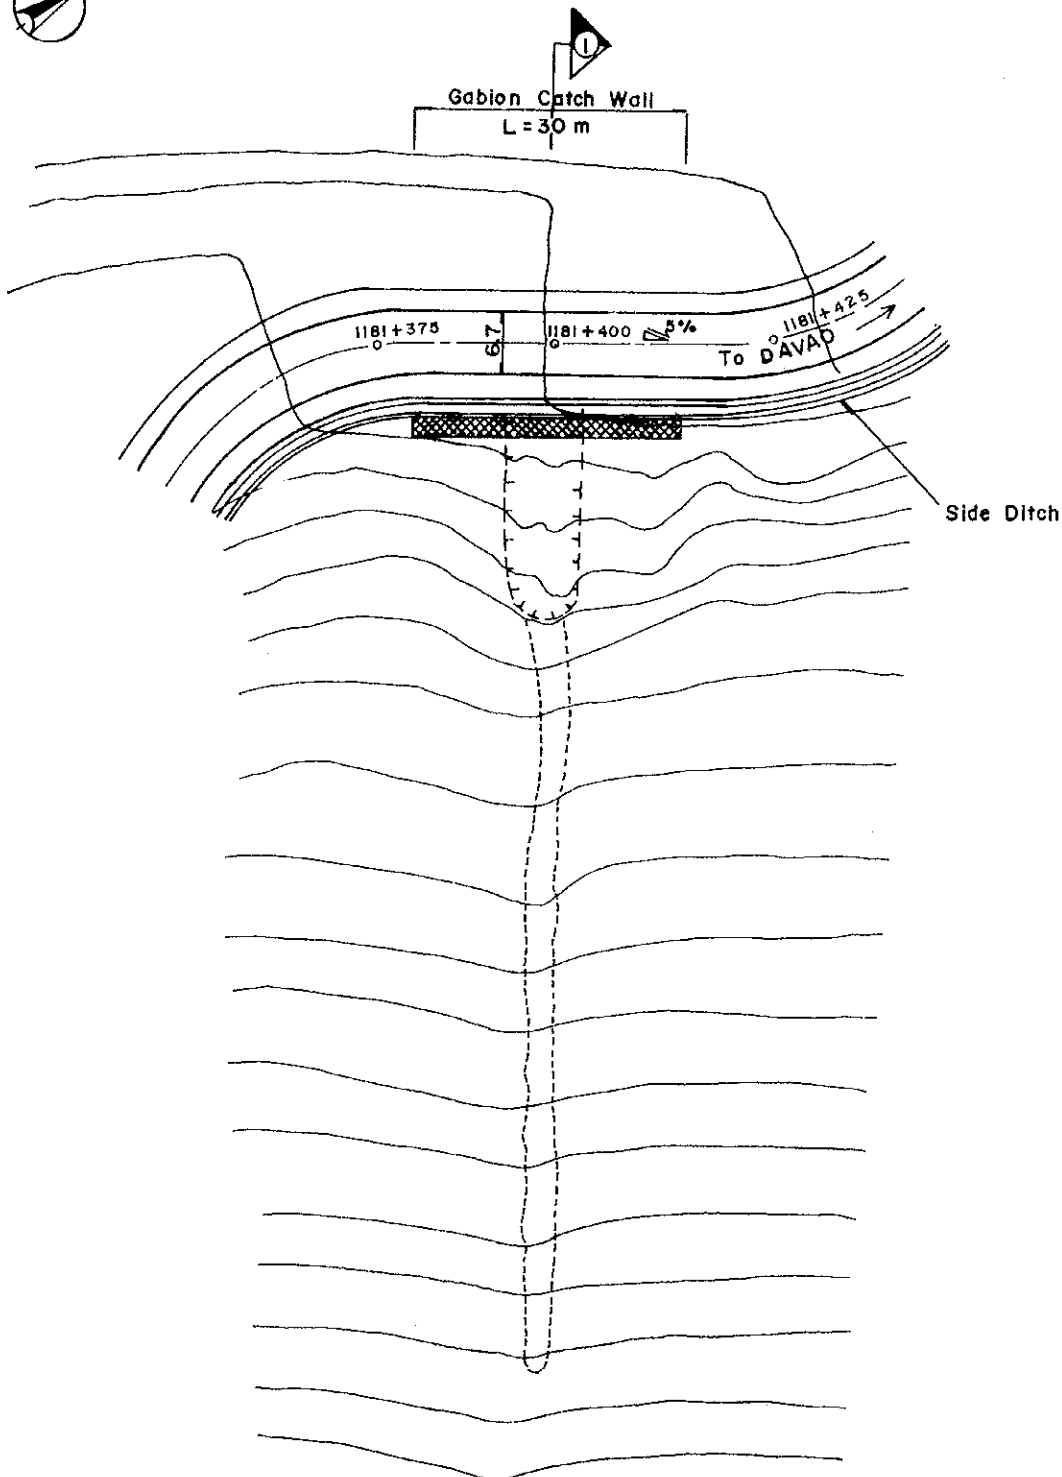
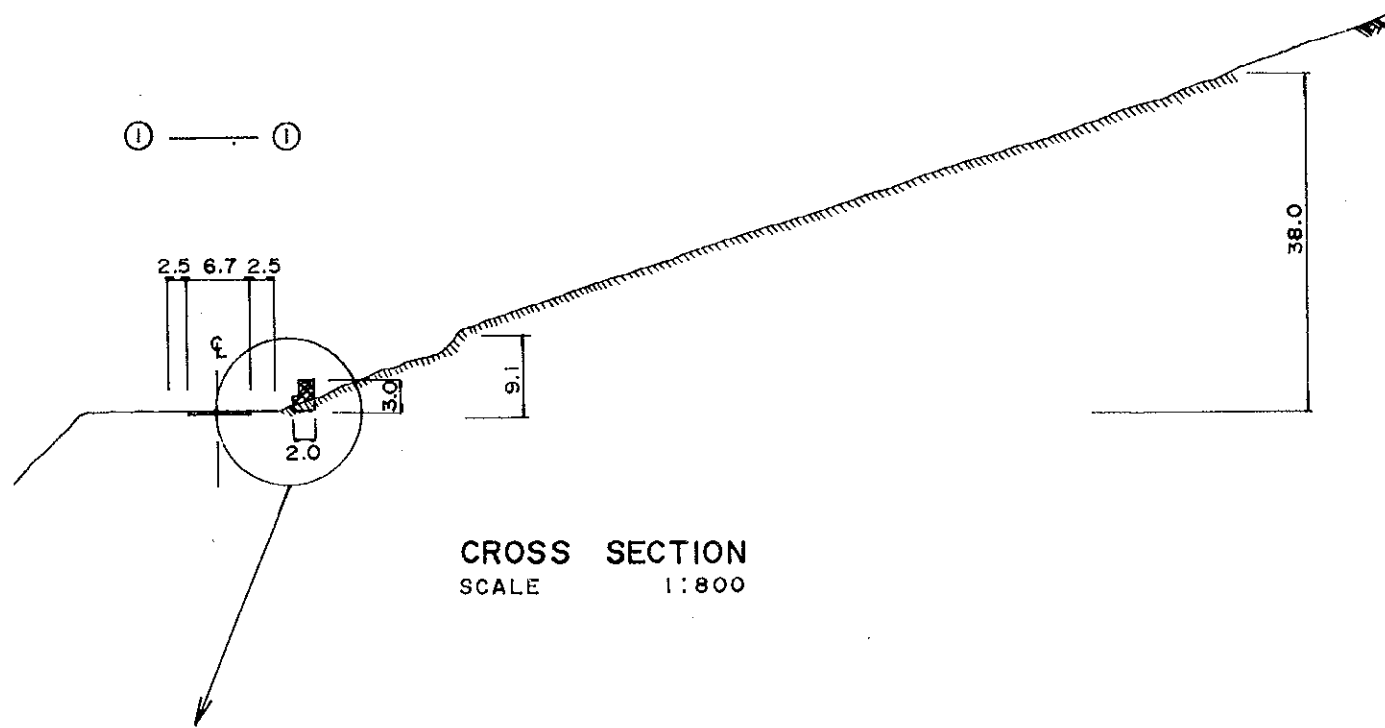
Cause of Disaster:

- 1) Flow of debris supplied by slope failures, deposited on the side of hill and flashed down by heavy rain.
