DEPARTMENT OF PUBLIC WORKS AND HIGHWAYS
REPUBLIC OF THE PHILIPPINES

FEASIBILITY STUDY
ON
PAN-PHILIPPINE HIGHWAY REHABILITATION PROJECT
(MINDANAO SECTION)

FINAL REPORT
DRAWINGS

MAY 1995

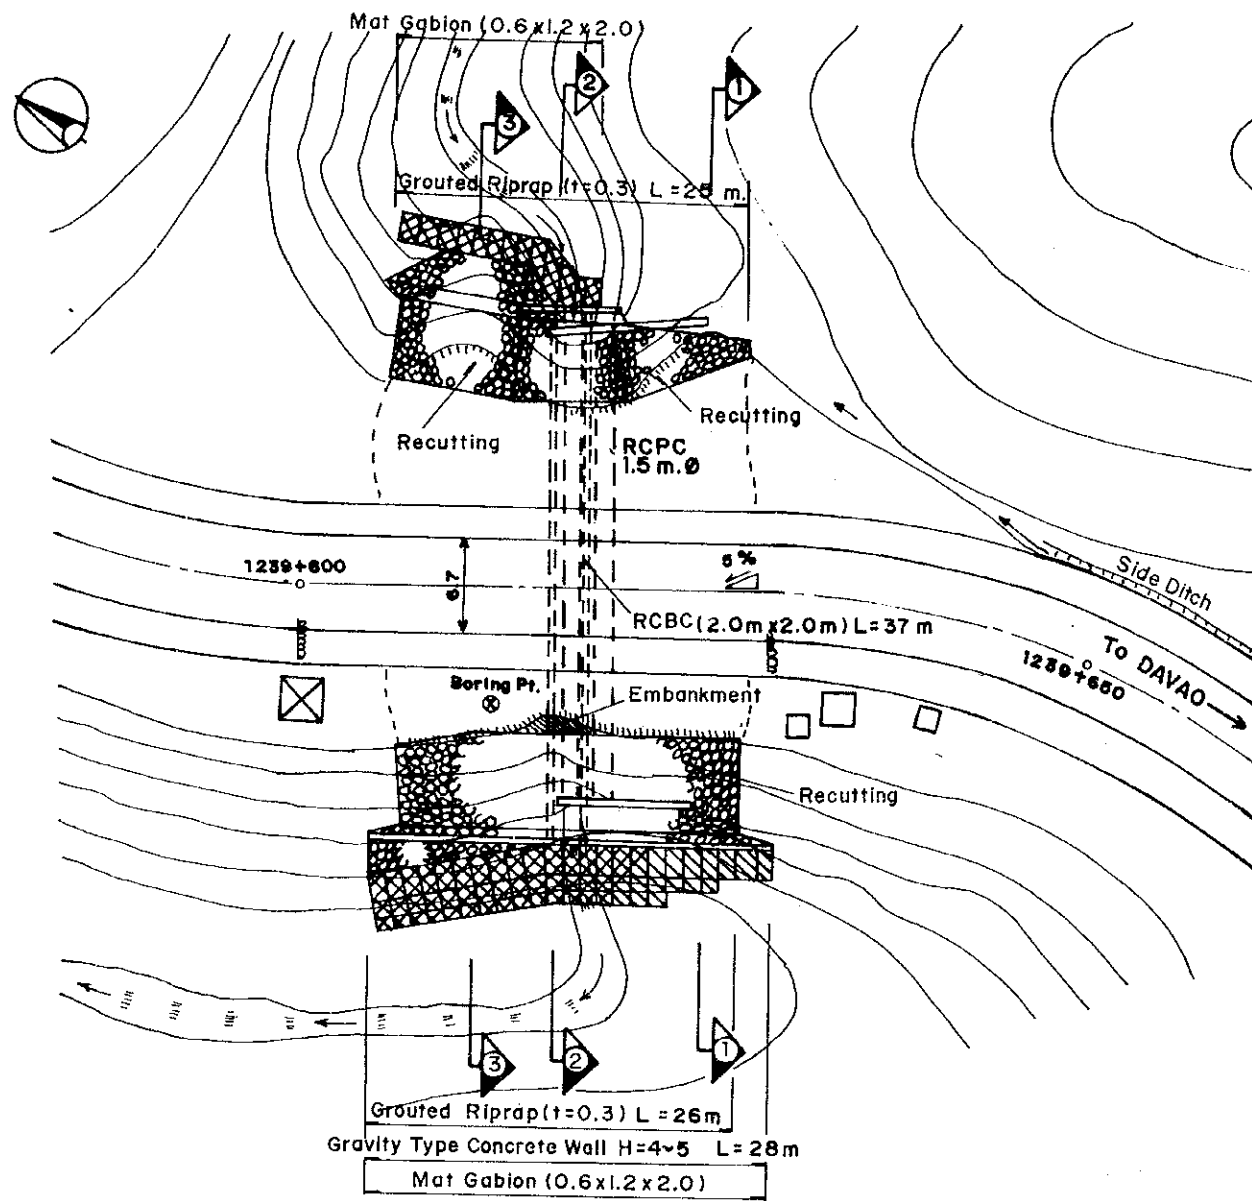
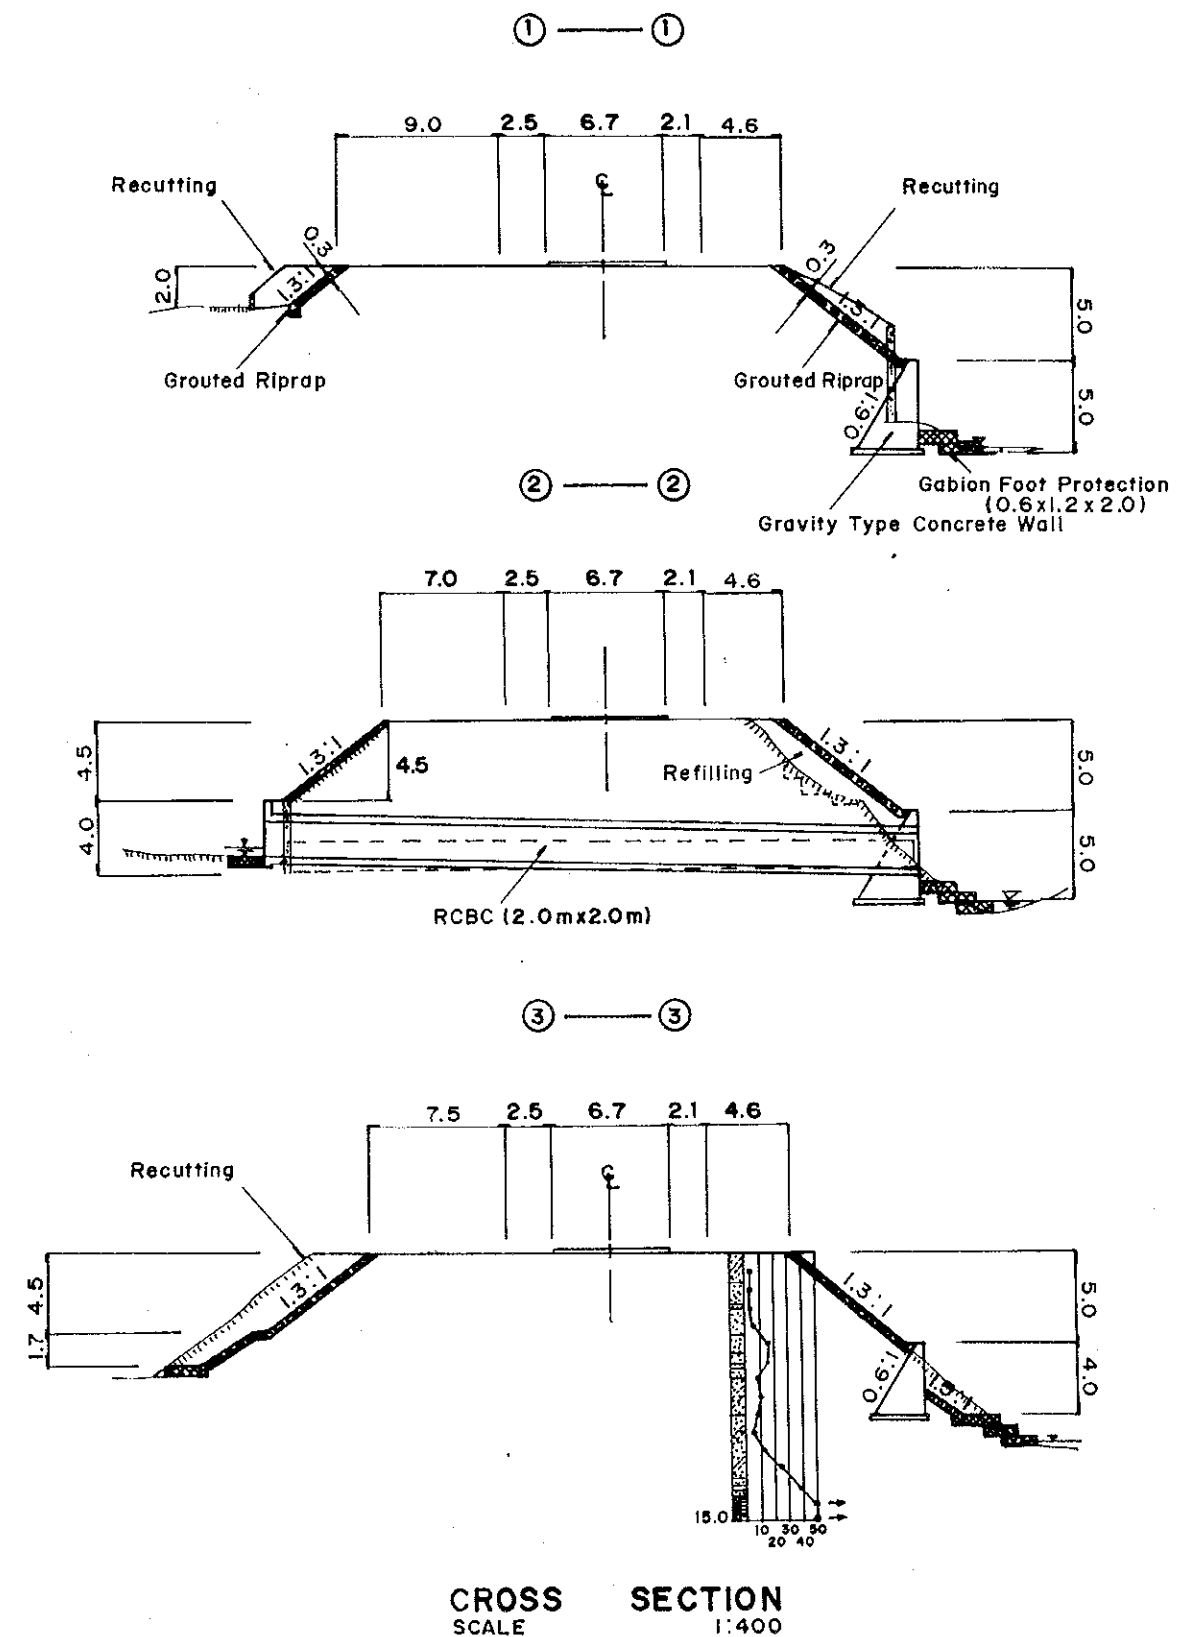
Cause of Disaster:

- 1) Risen pore water pressure in embankment due to infiltration of surface water.
- 2) Insufficient drainage capacity of pipe culvert and poor maintenance.

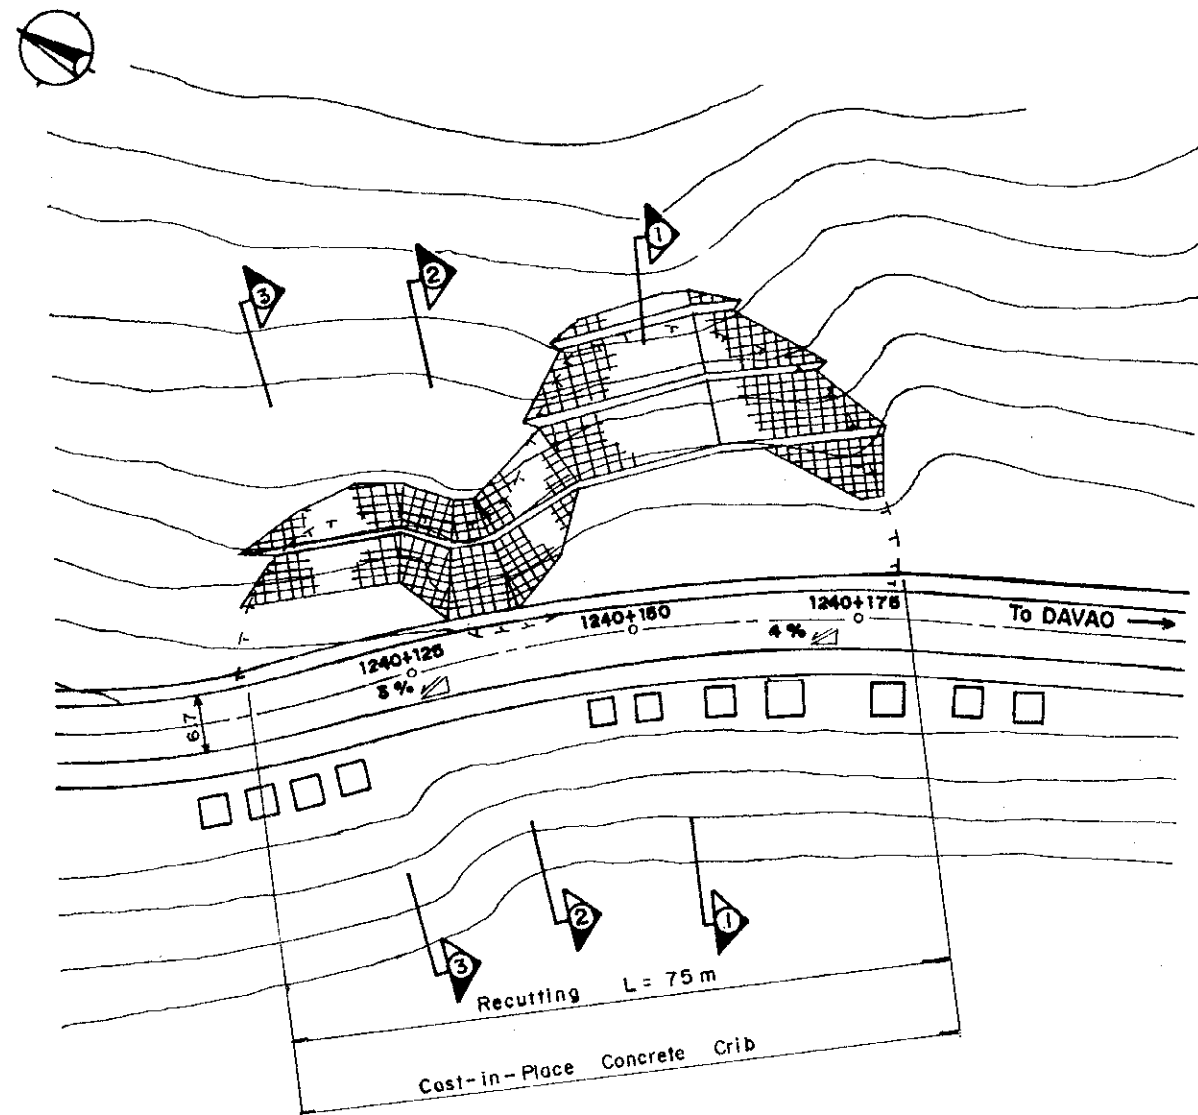
Cause of Disaster:

- 1) Surface failure induced by rain in layer of severely weathered mudstone.

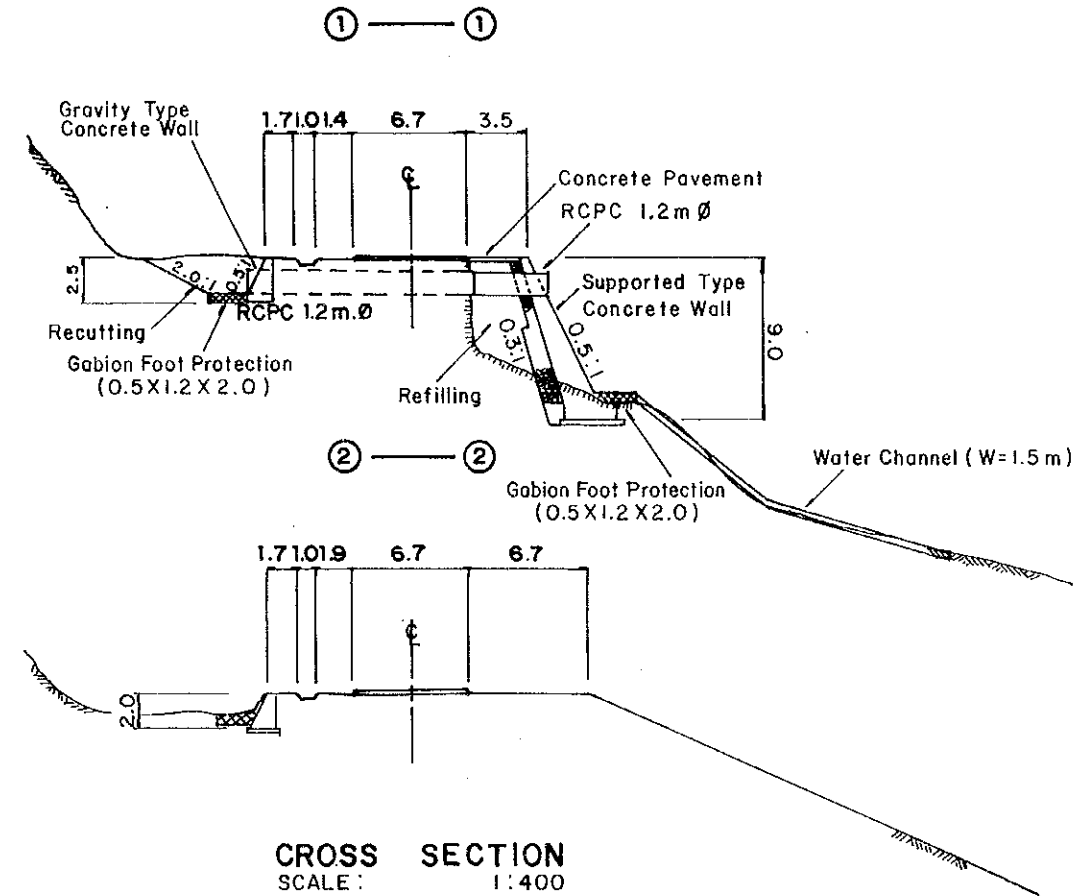
Cause of Disaster:

- 1) Insufficient drainage capacity of pipe culvert.
- 2) Erosion due to concentrated surface water on the curved portion of road.

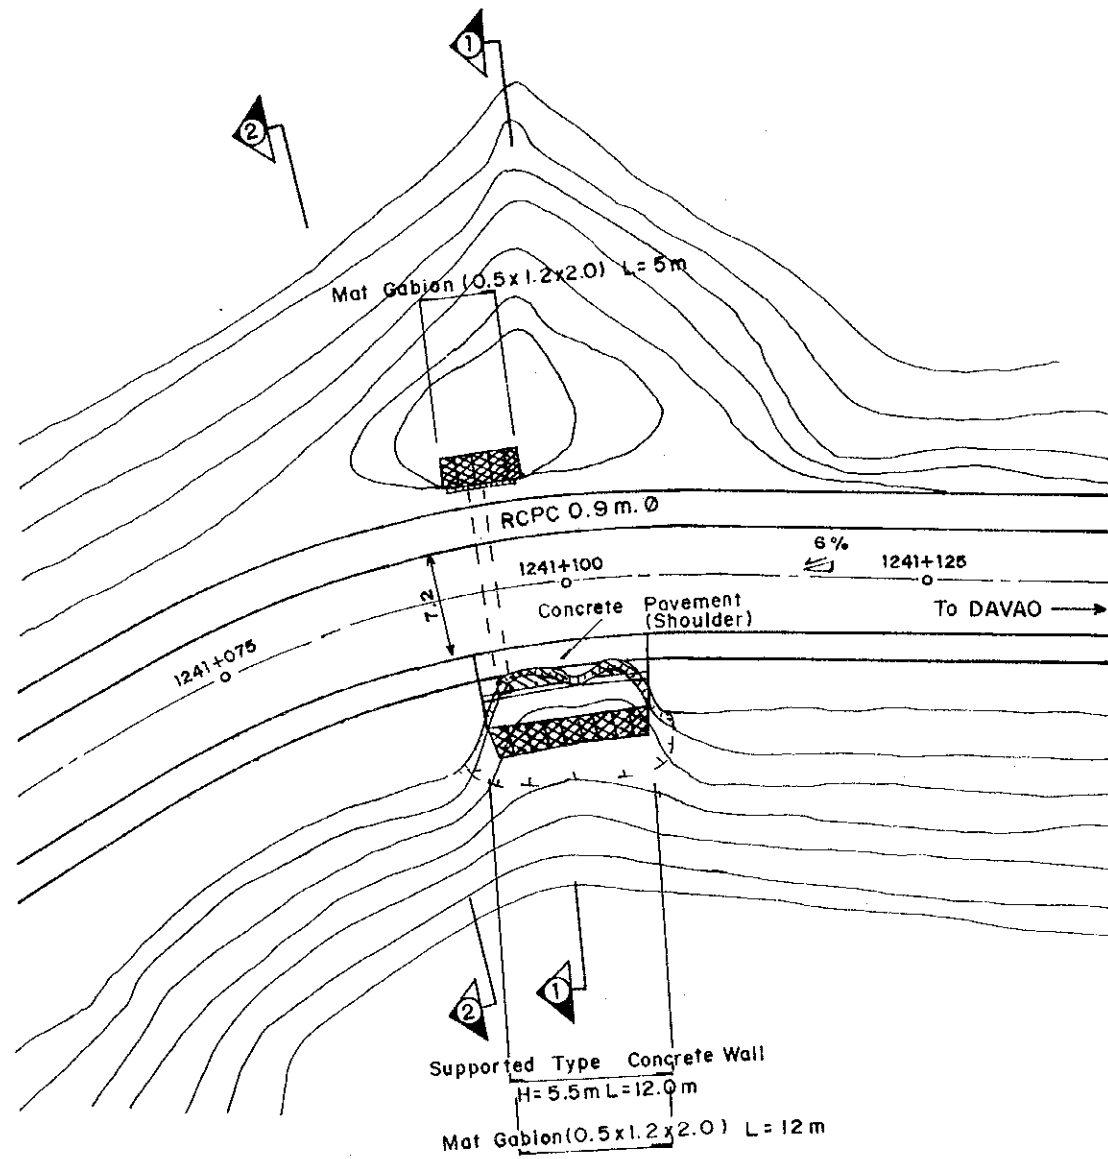
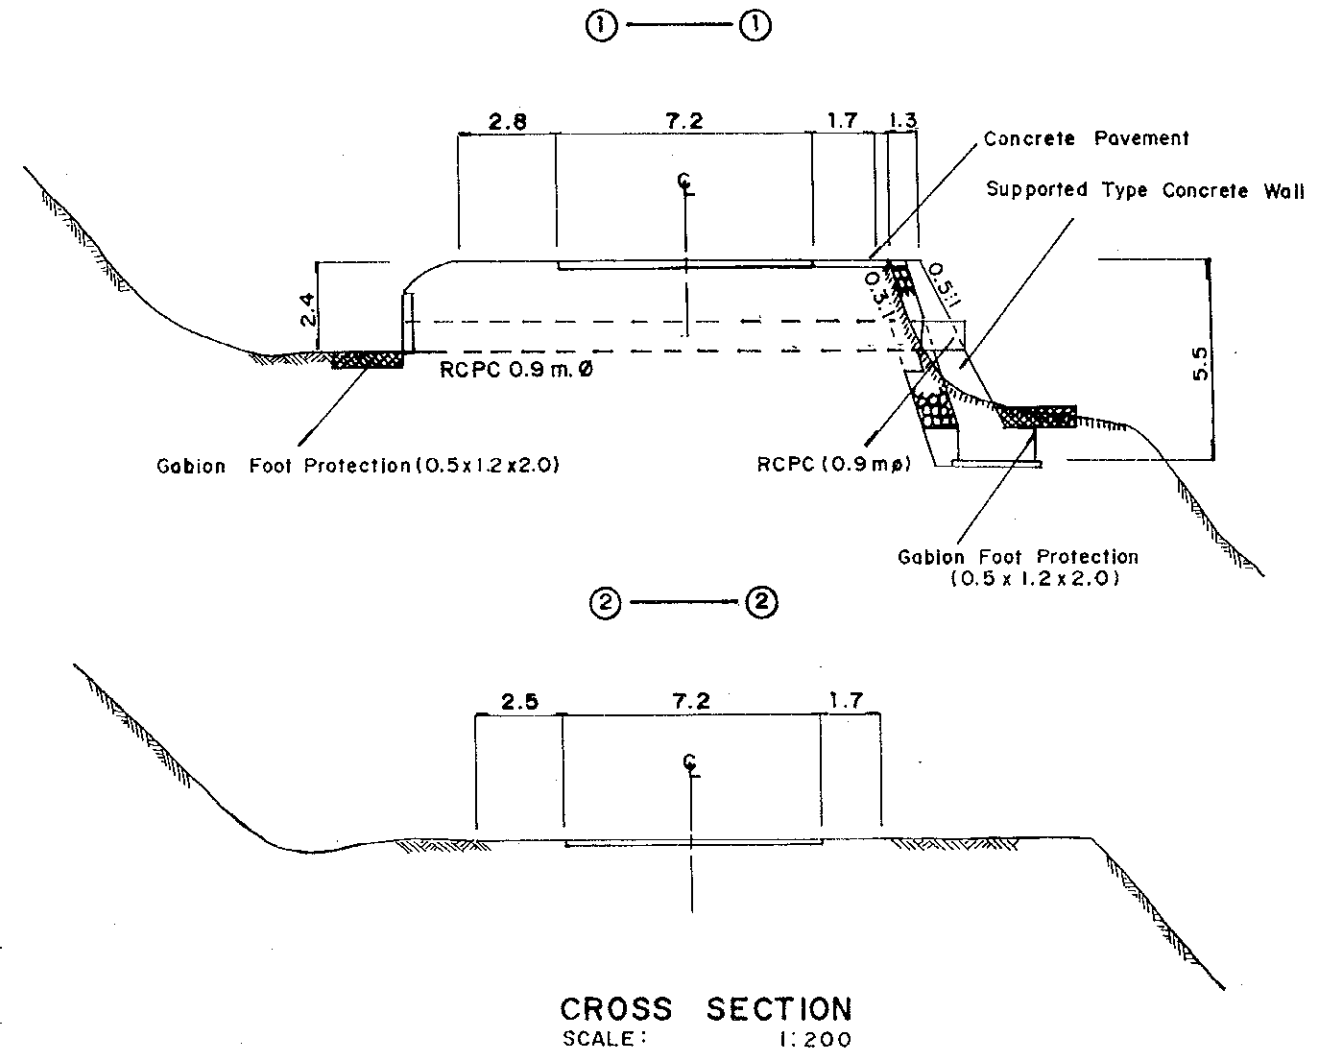
Cause of Disaster:

- 1) Insufficient drainage capacity of pipe culvert.
- 2) Erosion due to concentrated surface water on the curved portion of road.

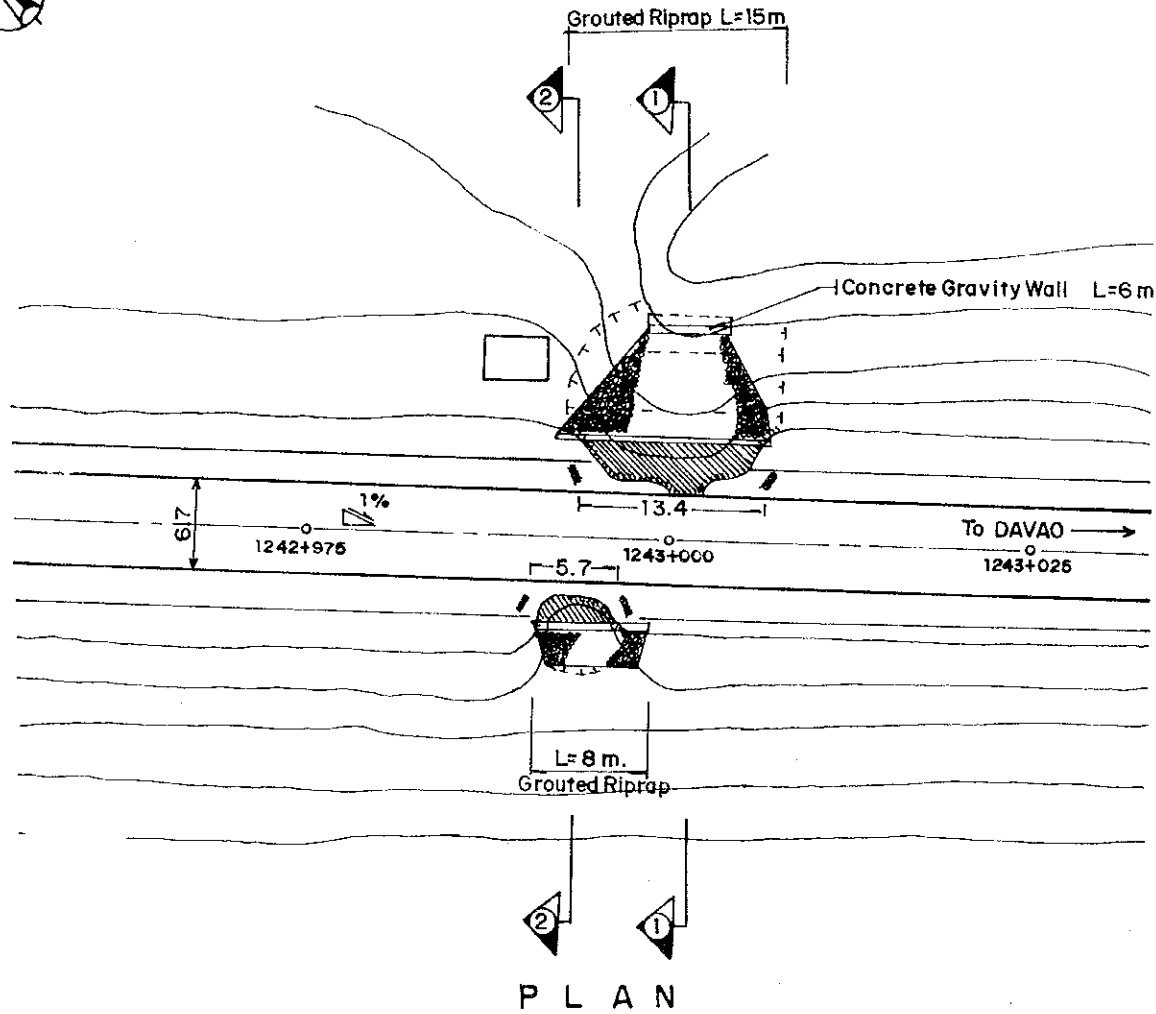
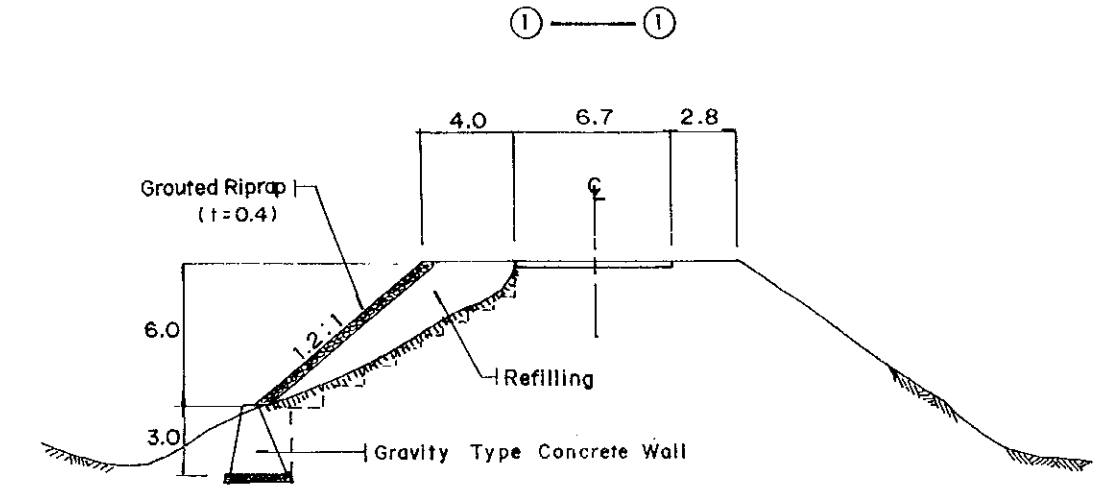
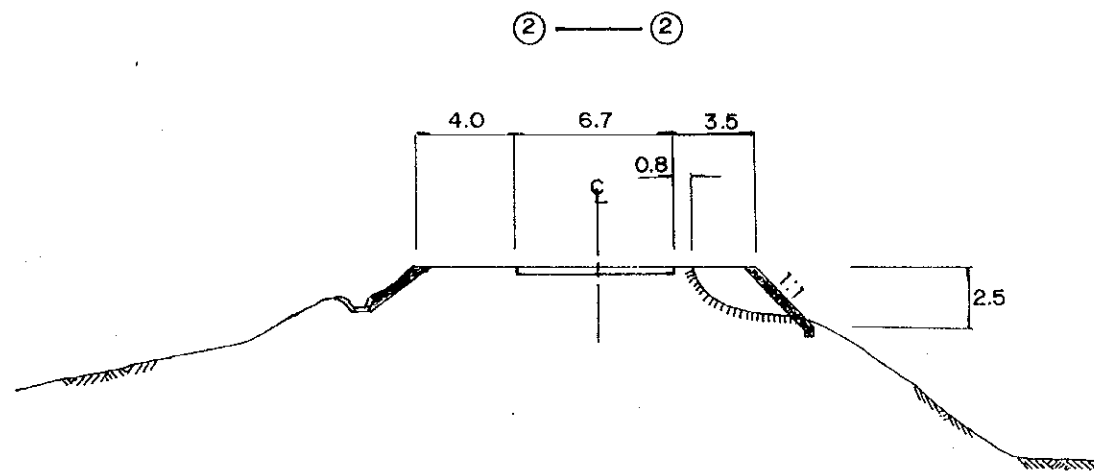
Cause of Disaster:
1) Insufficient compaction of embankment.

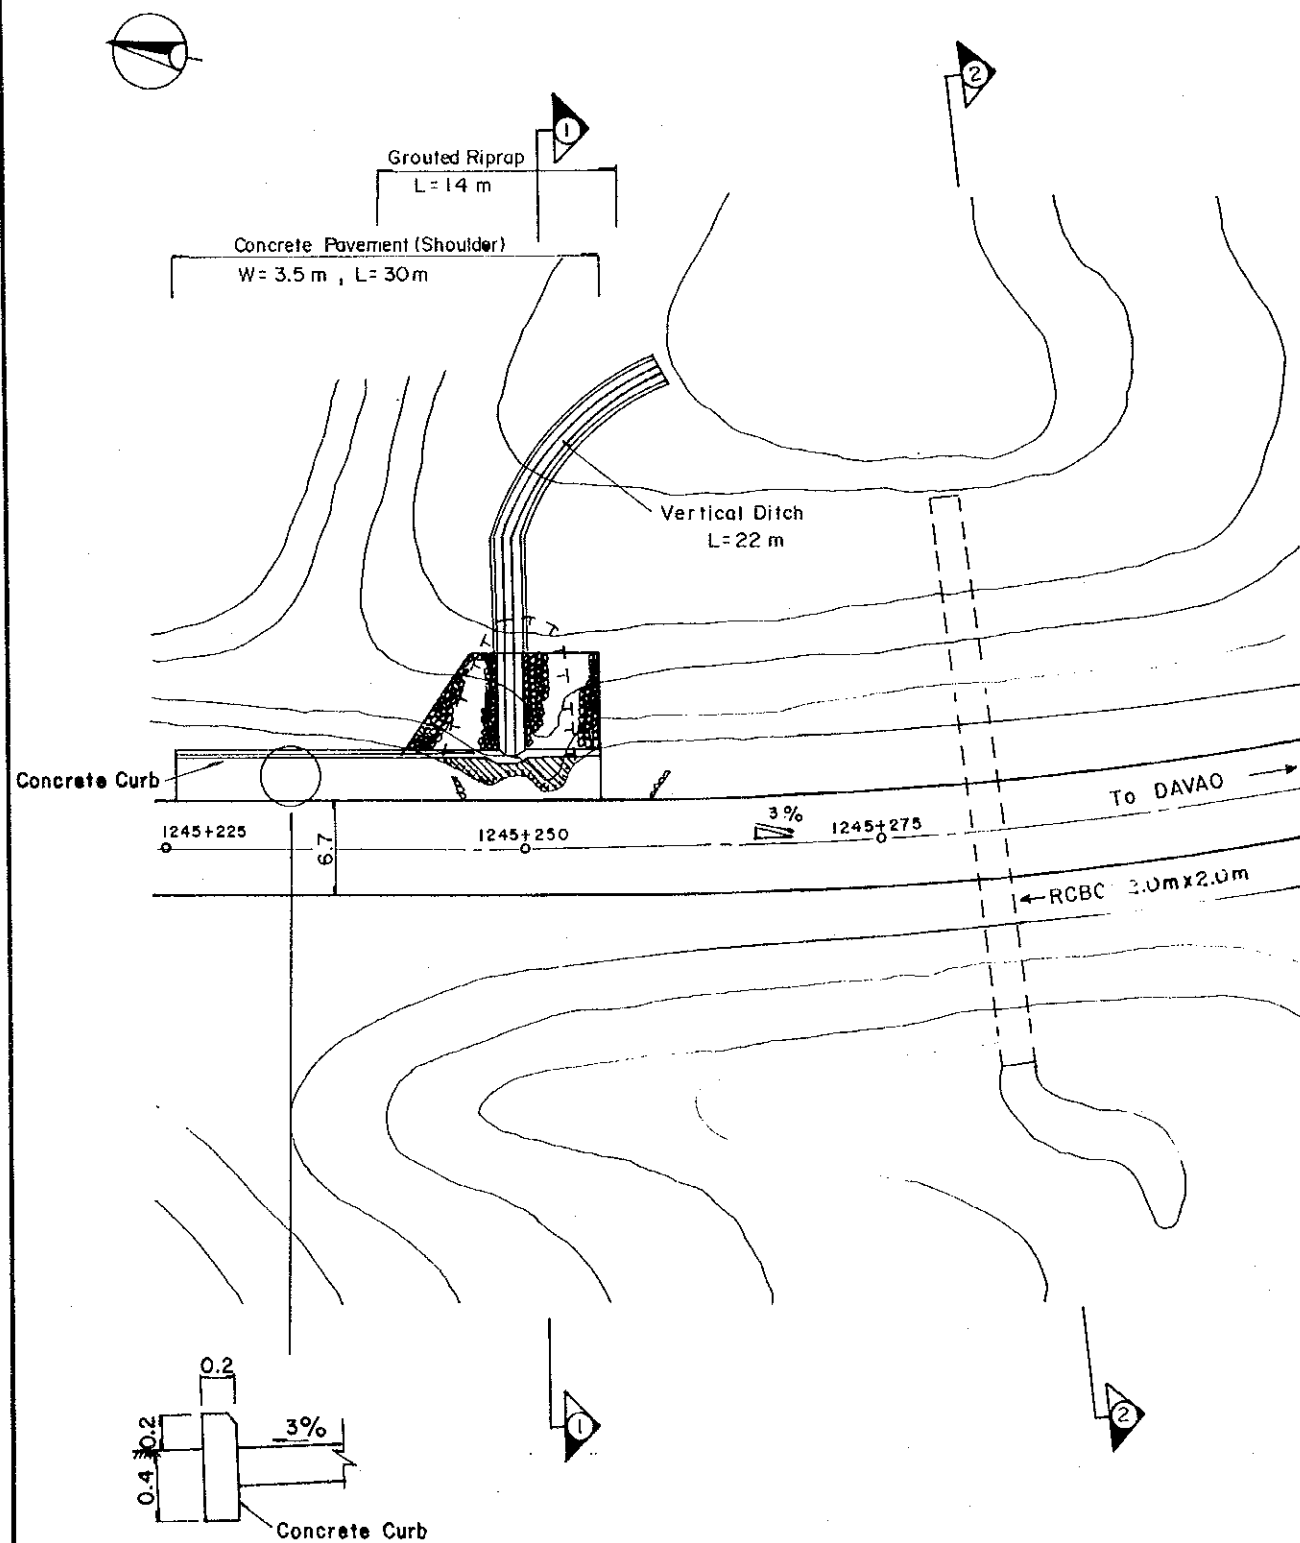
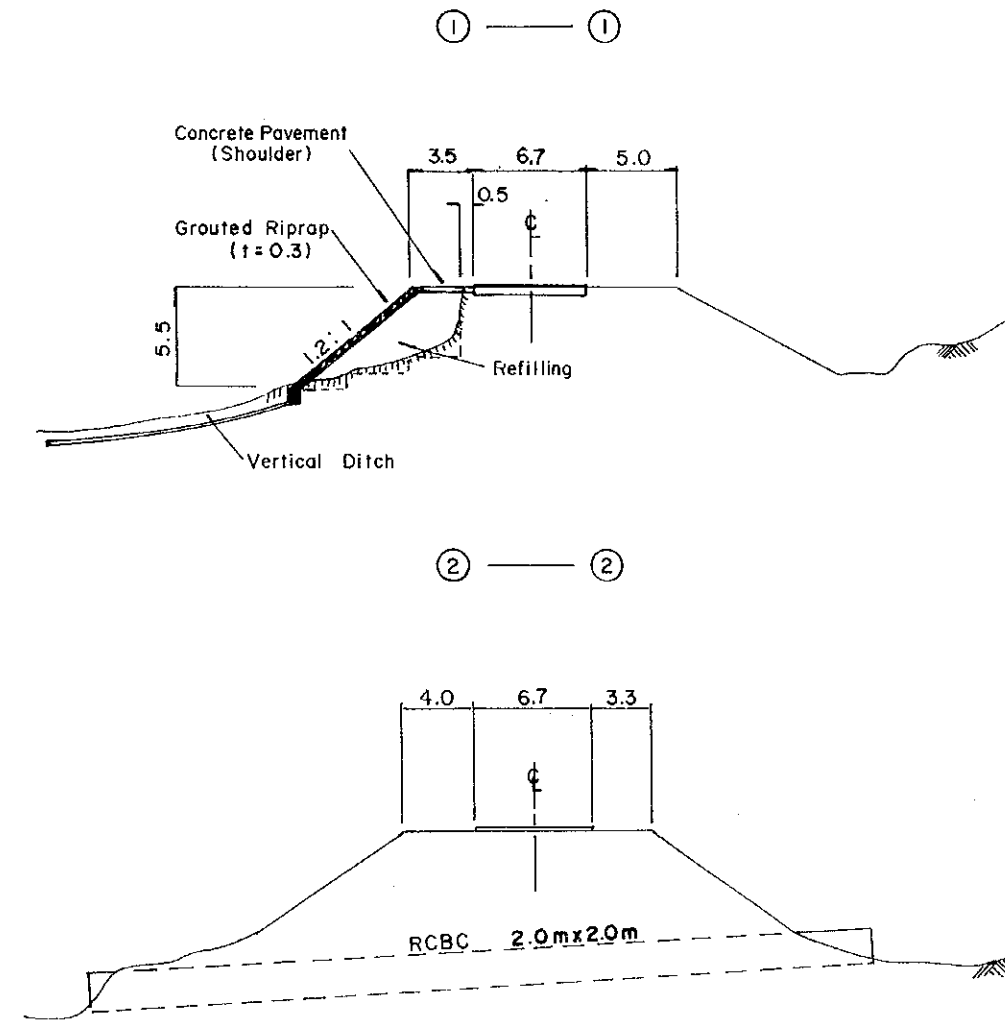
DRAWING NO.
S-26

STATION: 1245+250
EMBANKMENT SLOPE FAILURE

Cause of Disaster:

- 1) Scouring by water which was drained from hill side and road surface and concentrated on the slope due to the geometric formation of road.
- 2) Embankment slope with an unstable grade.

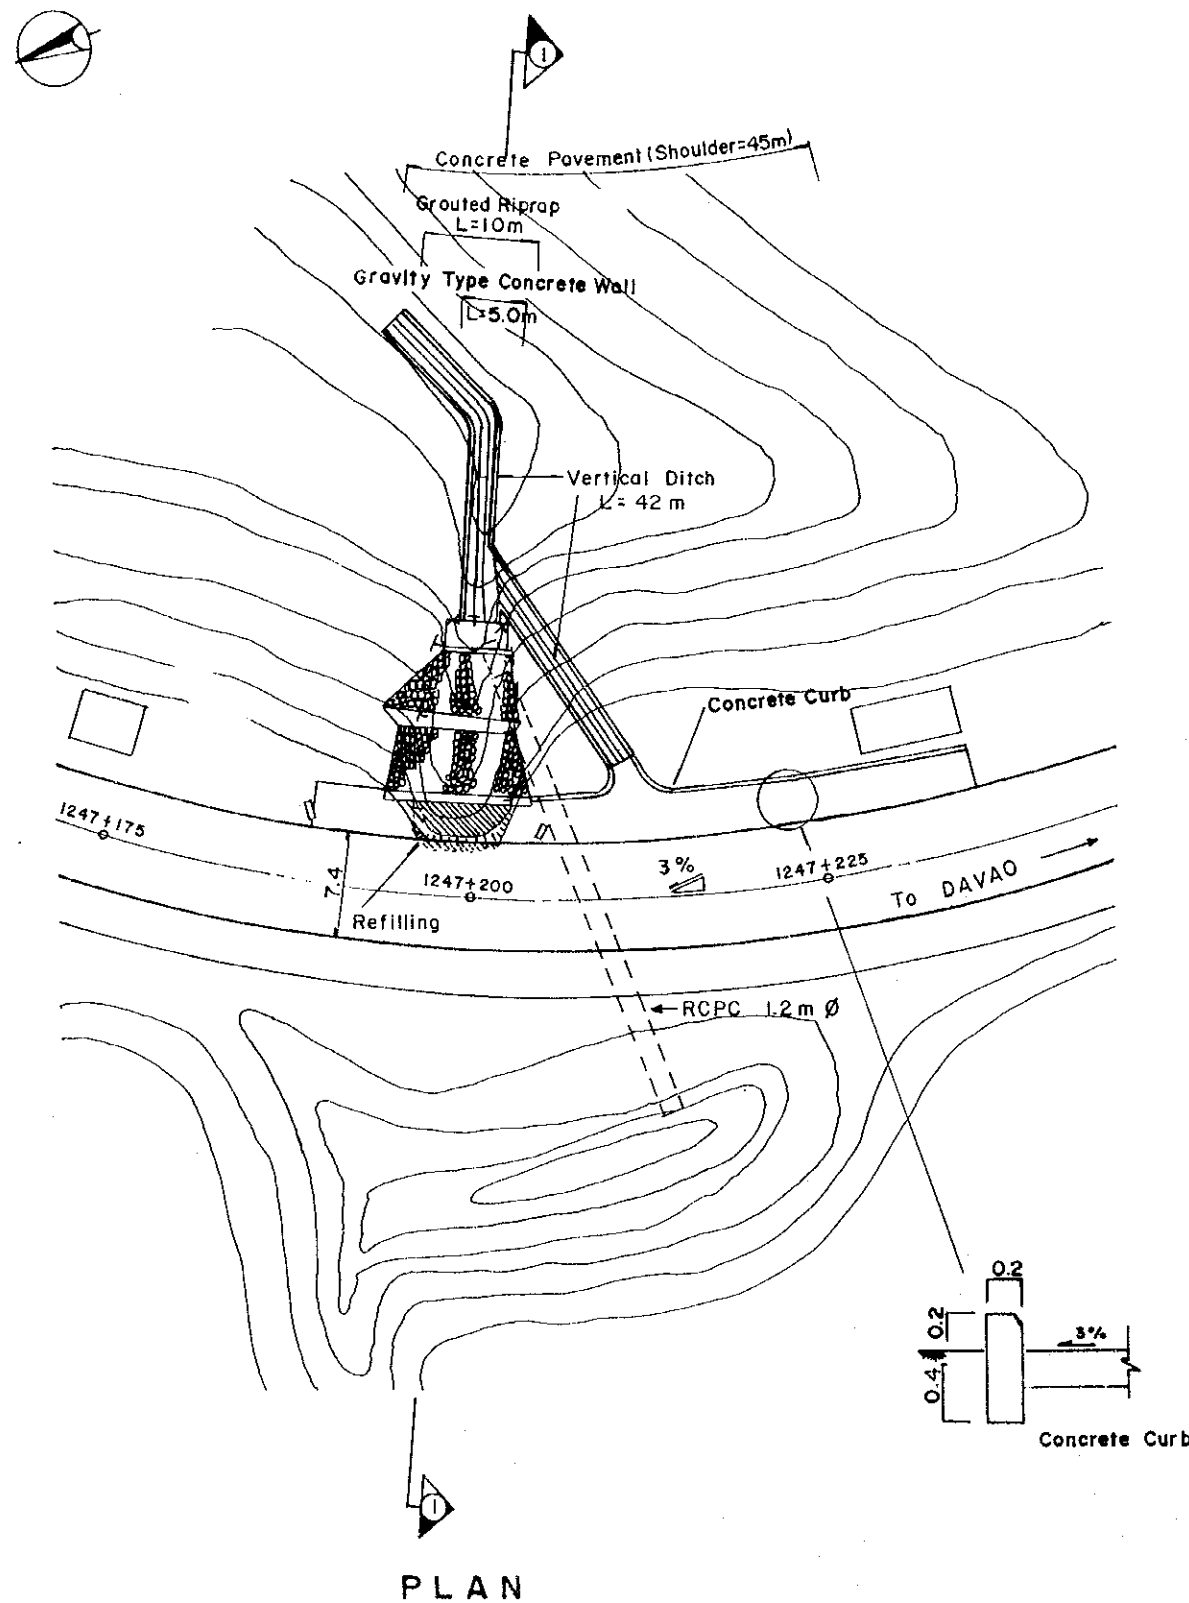
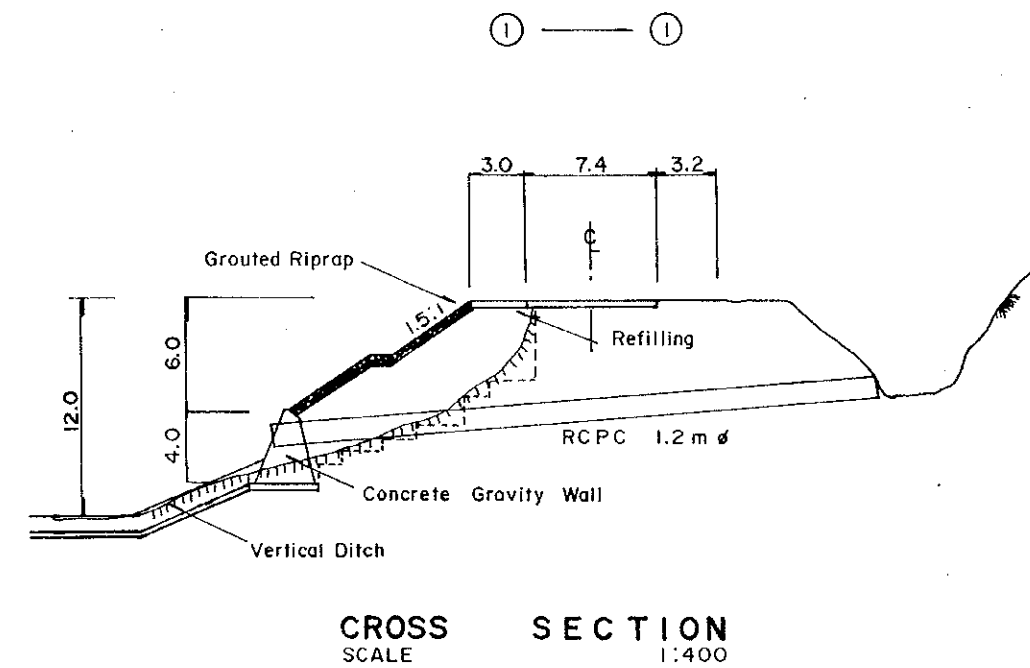
Cause of Disaster:

- 1) Erosion due to concentrated surface water on the curved portion of road.

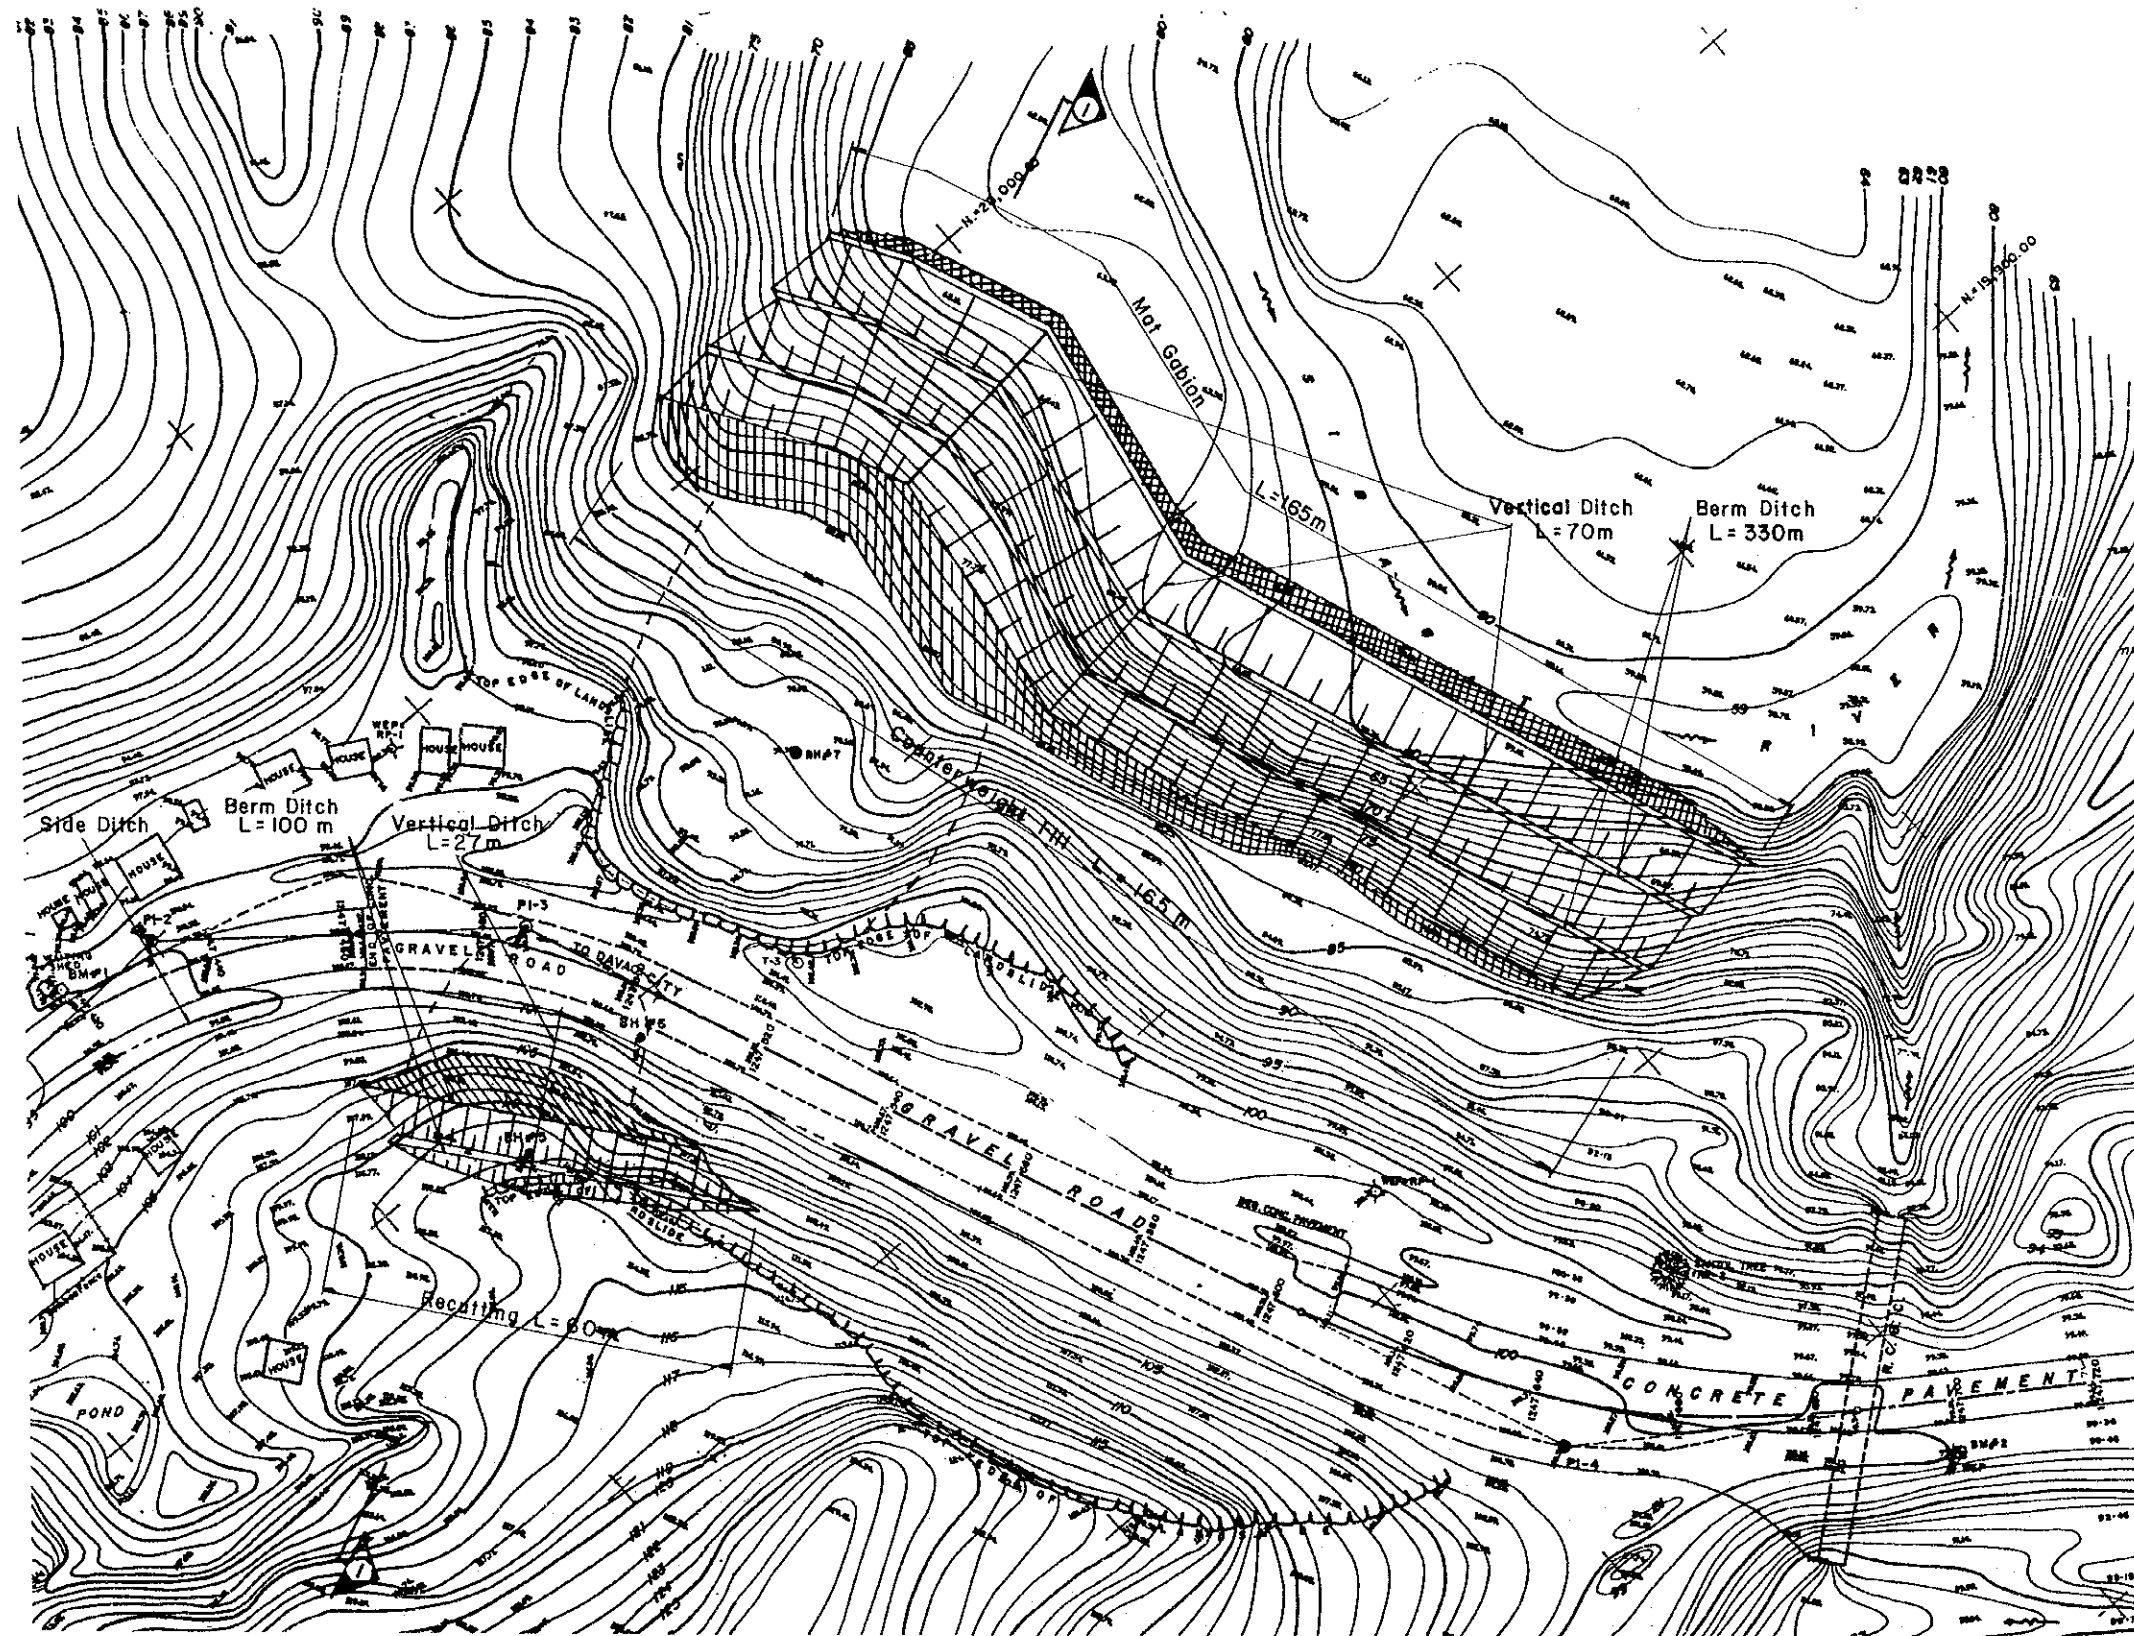
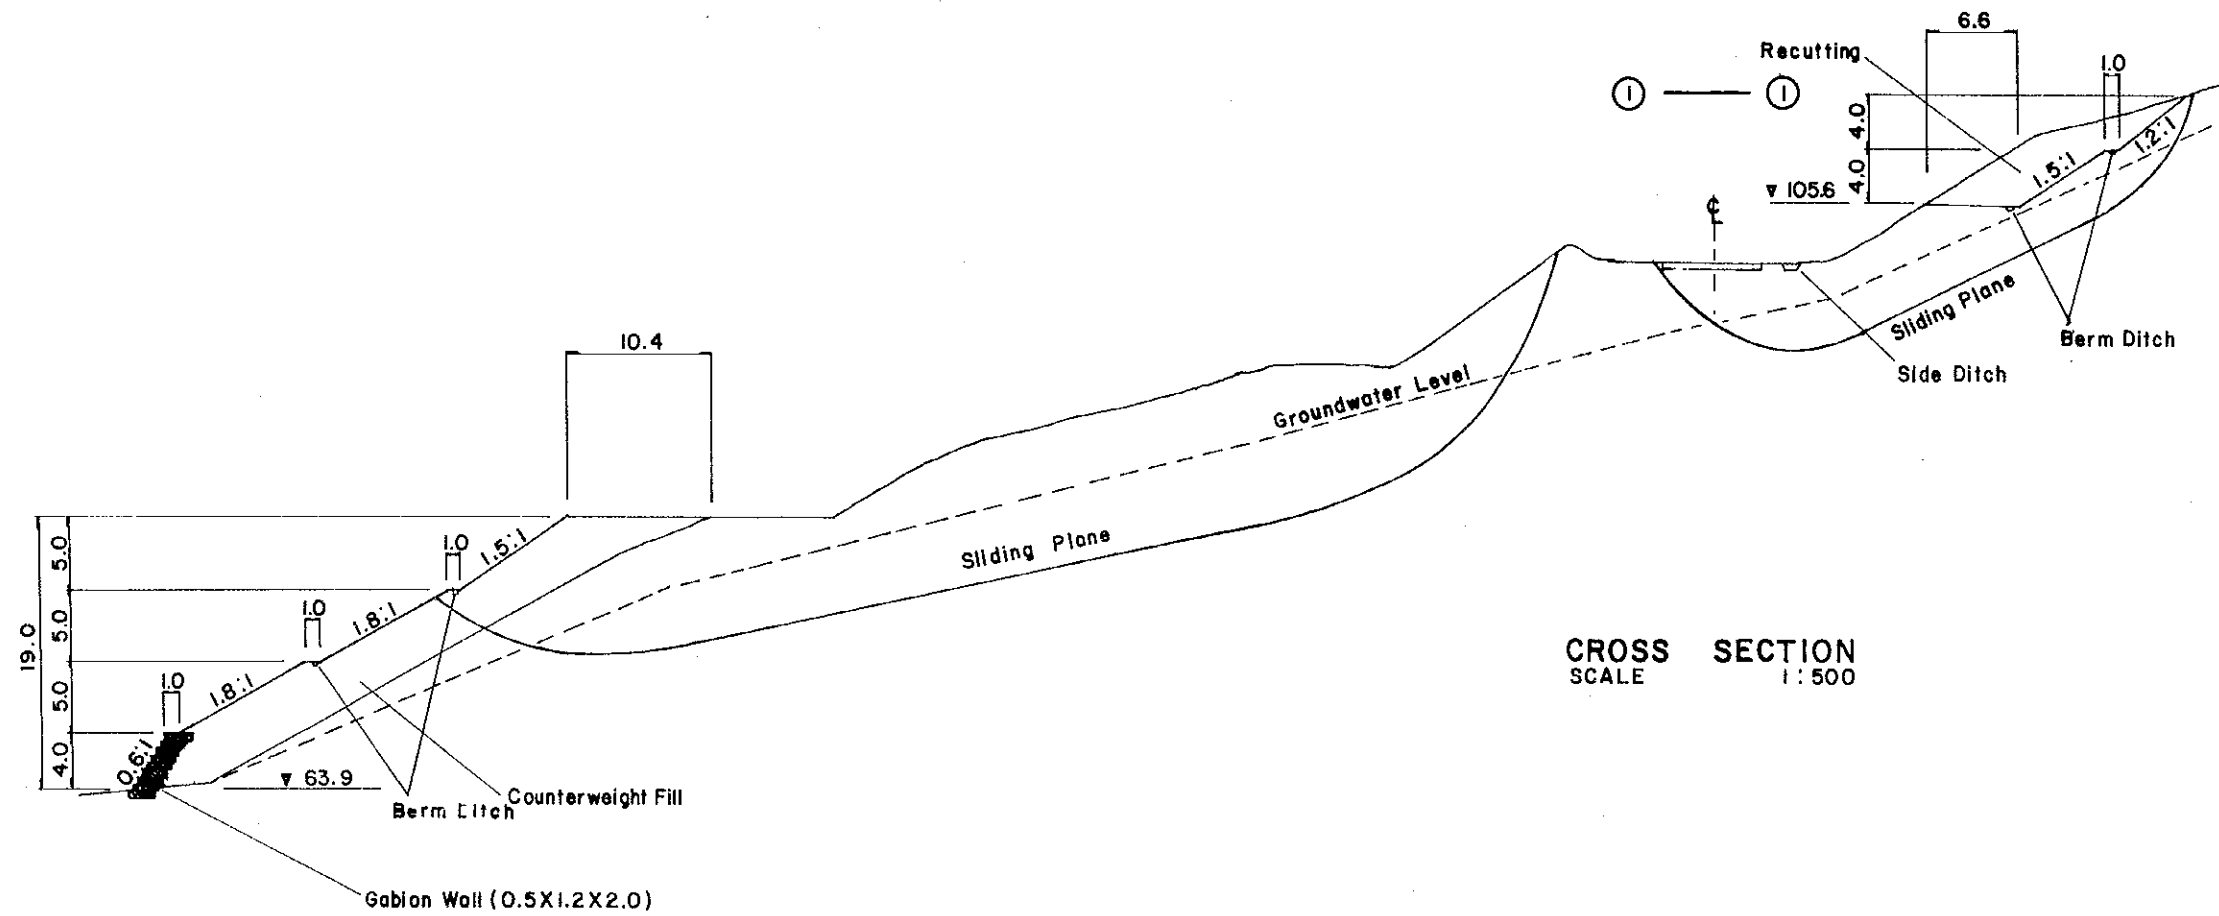
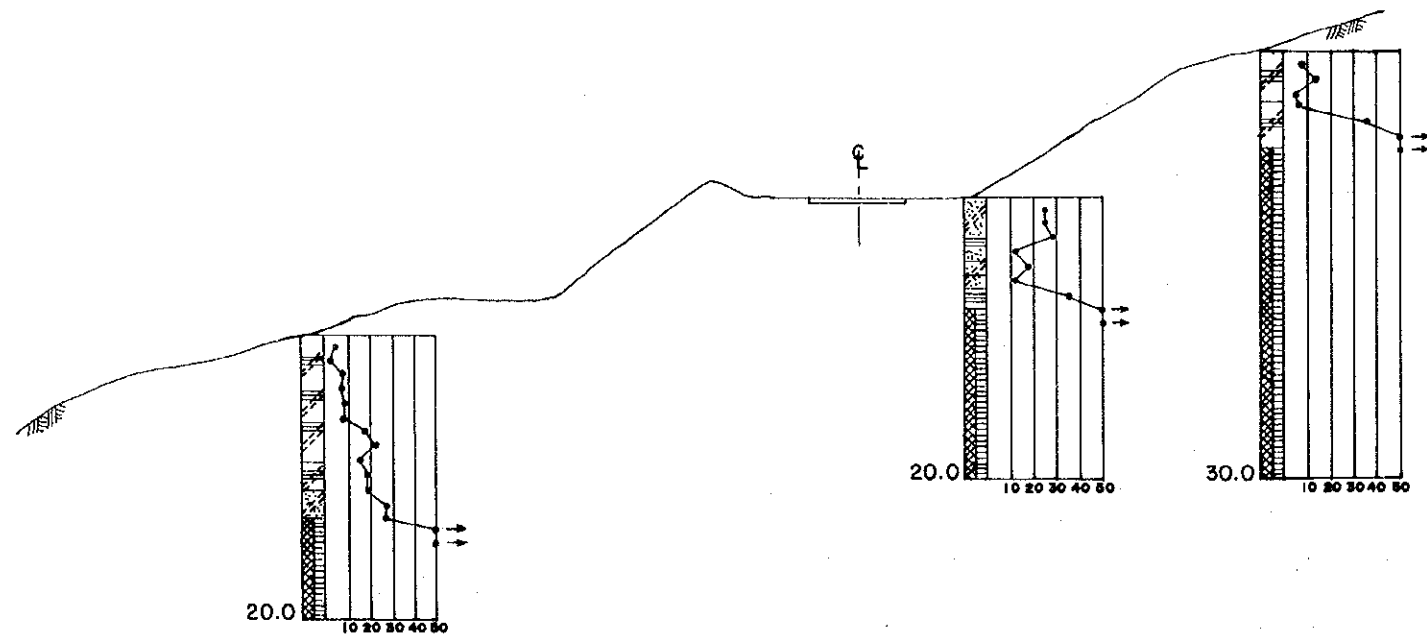
DRAWING NO.
S-29(1/2)

Cause of Disaster:

- 1) Movement along sliding plane in cohesive soil layer induced by the raise of groundwater level.
