DEPARTMENT OF PUBLIC WORKS AND HIGHWAYS
REPUBLIC OF THE PHILIPPINES

FEASIBILITY STUDY
ON
PAN-PHILIPPINE HIGHWAY REHABILITATION PROJECT
(MINDANAO SECTION)

FINAL REPORT
DRAWINGS

MAY 1995

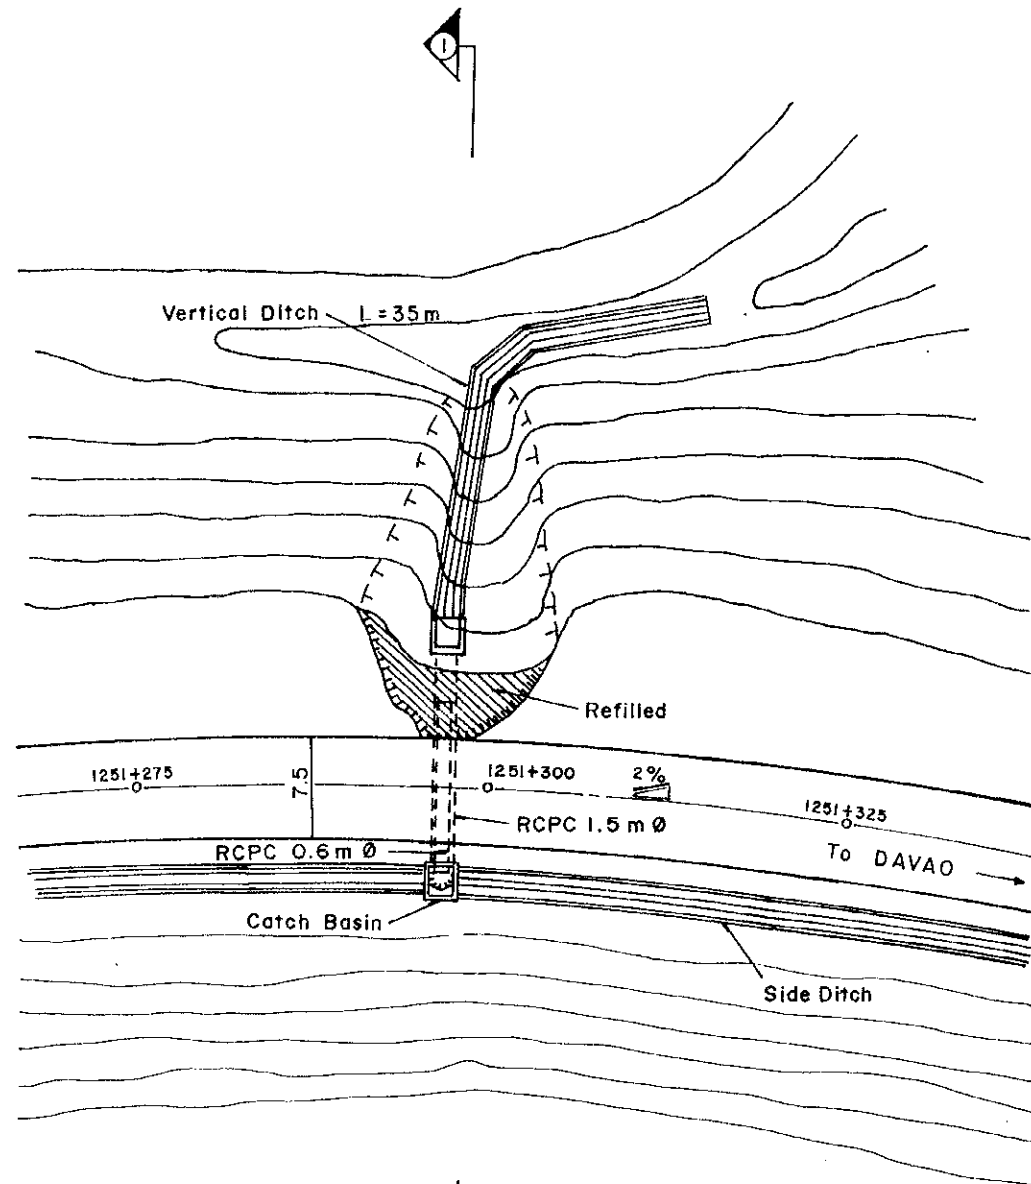
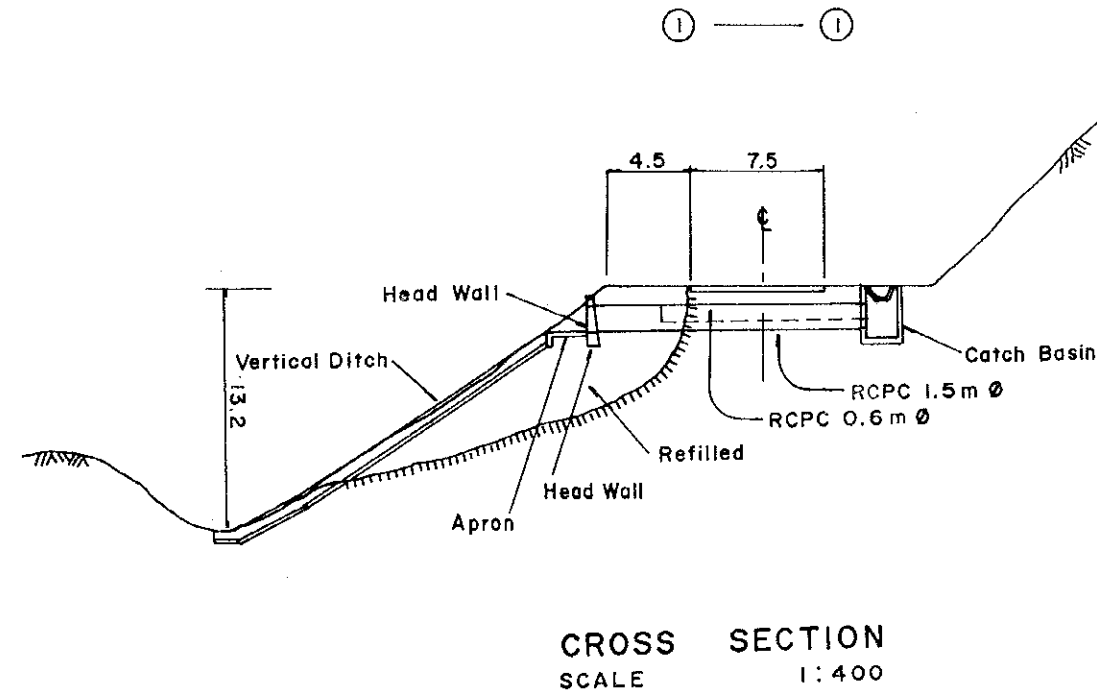
P L A N

Cause of Disaster:

- 1) Infiltration of water into boundary surface between the inclined ground and embankment.
- 2) Insufficient drainage capacity of pipe culvert.
- 3) Effect of ground water.

TYPE OF WORK	UNIT	TOTAL
5-33	RCPC (1.5 m Ø)	L.M.	15
5-36	CATCH BASIN FOR RCPC 1.5 m Ø	E.A.	1
5-27	VERTICAL DITCH	L.M.	35
5-41	HEAD WALL FOR RCPC 1.5 m Ø	E.A.	1
5-4	STRUCTURAL EXCAVATION	CU.M.	116
5-8	FOUNDATION FILL	CU.M.	75

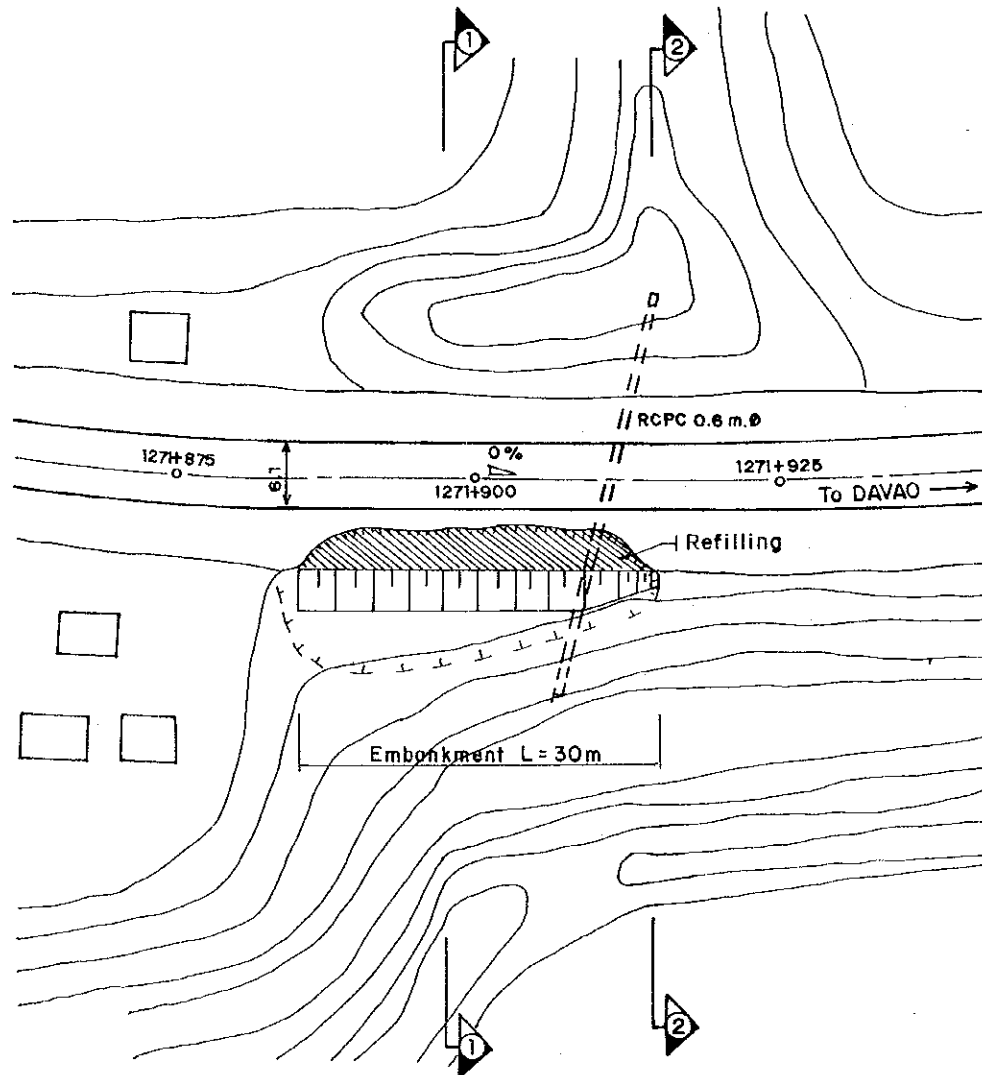
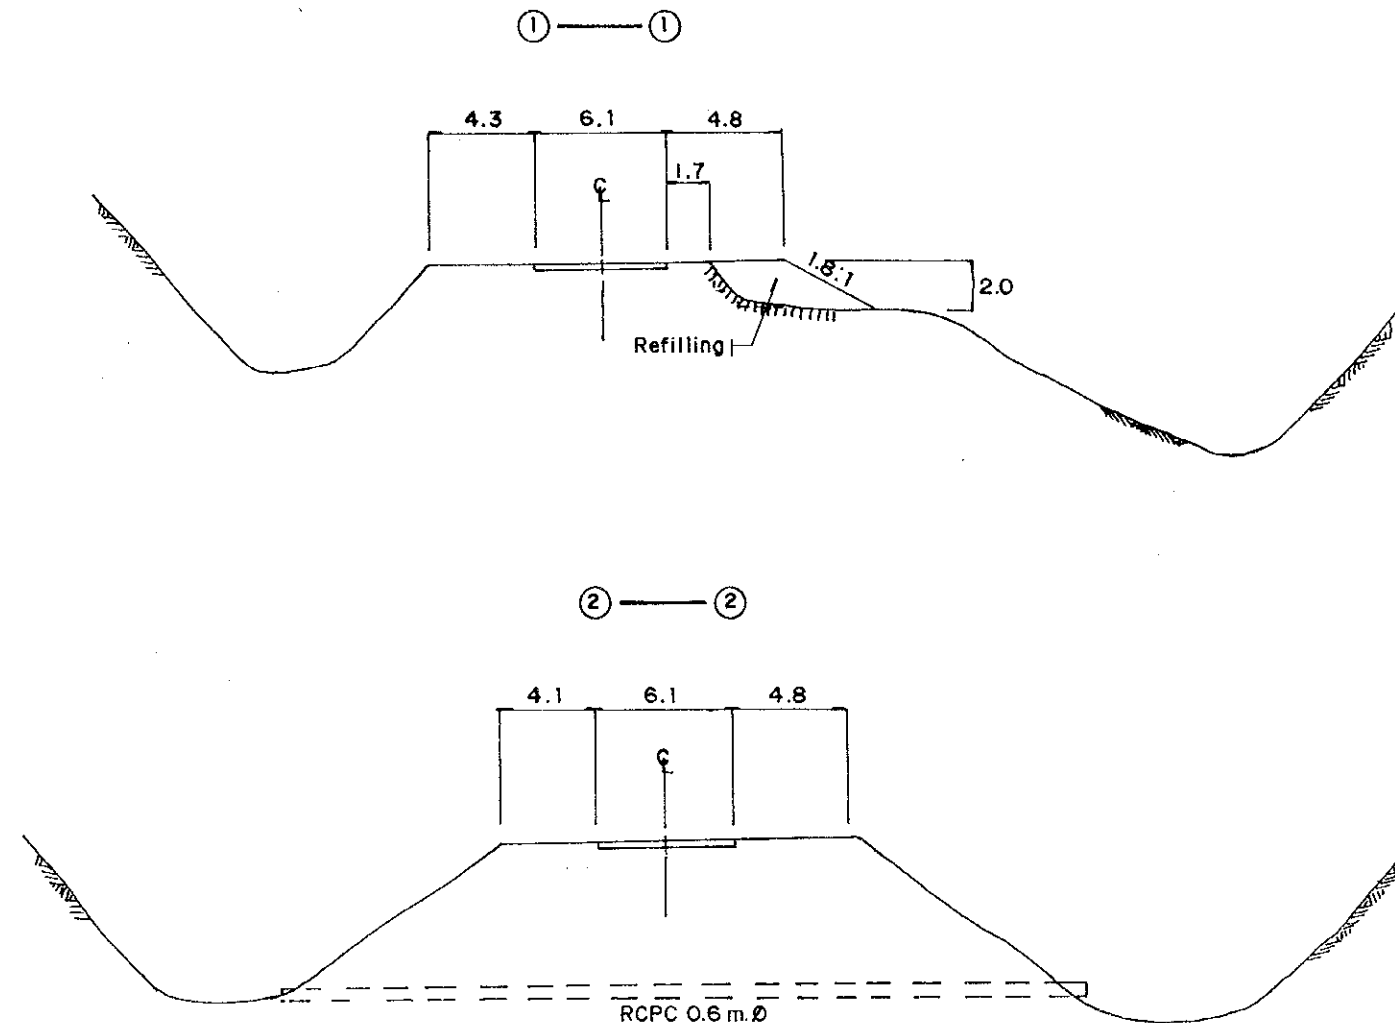
P L A N

Cause of Disaster:
1) Insufficient compaction of embankment.

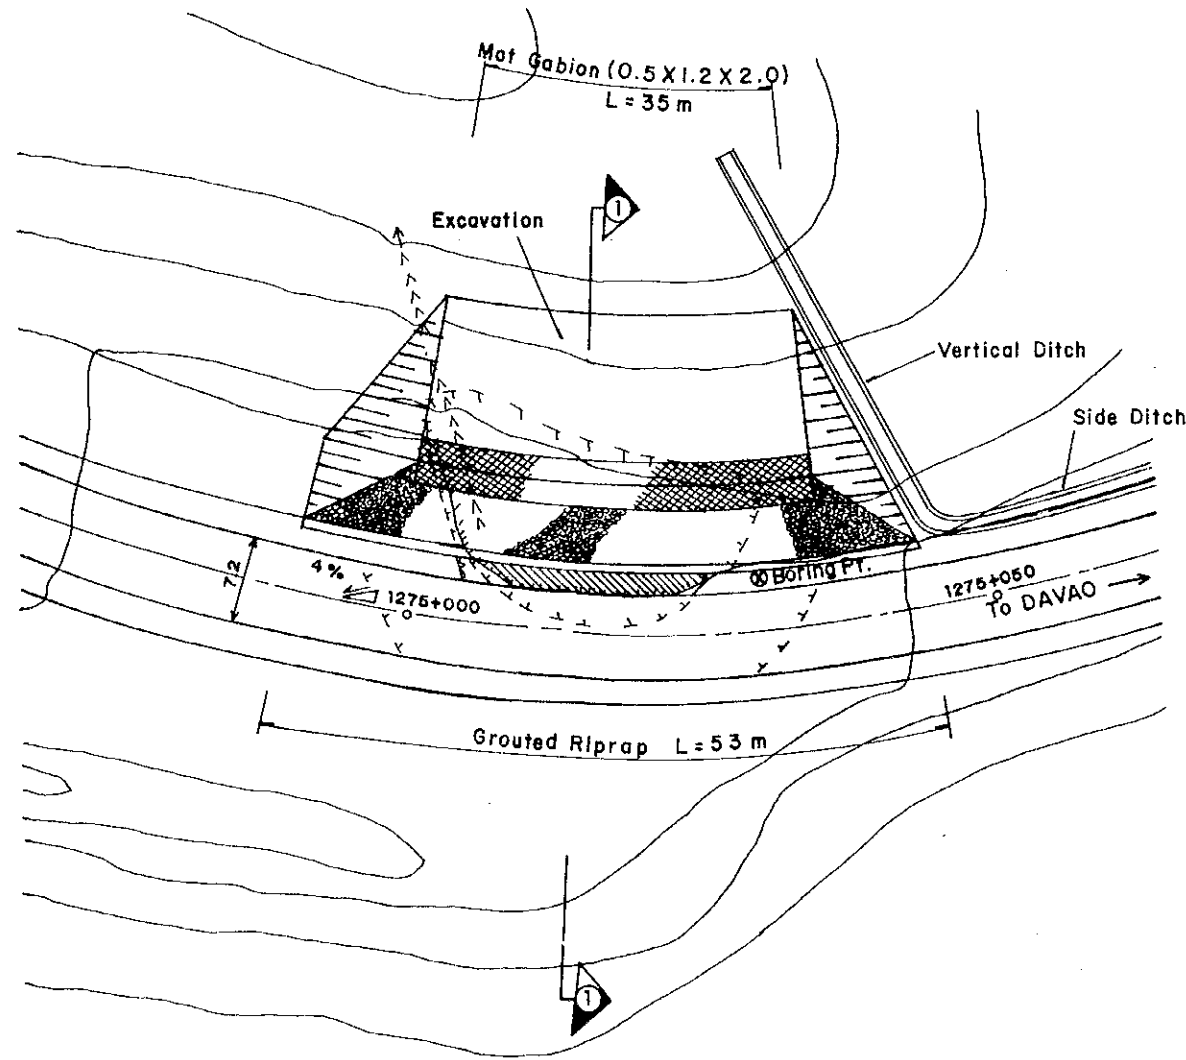
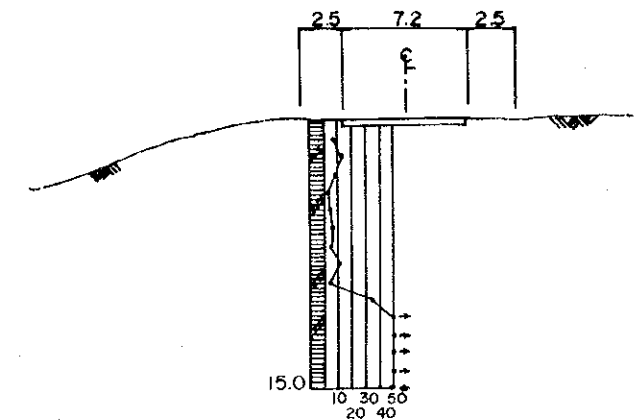
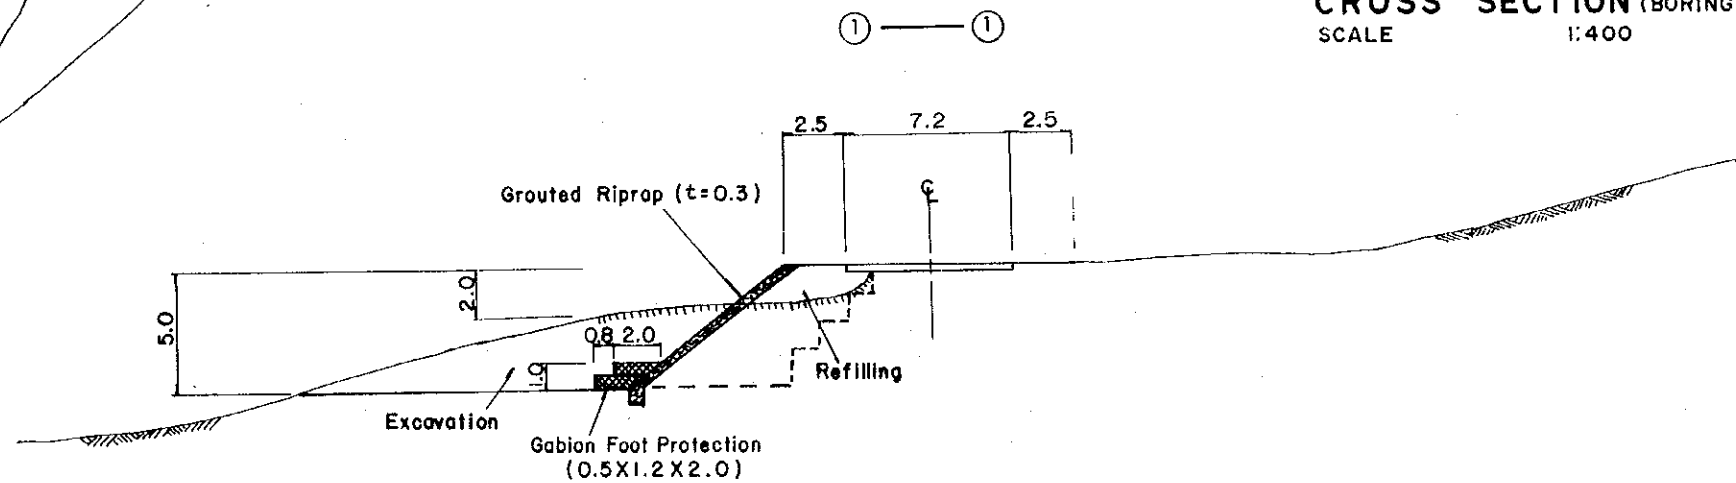
PLAN

Cause of Disaster:
1) Settlement of embankment caused by consolidation of soft ground.

TYPE OF WORK	UNIT	TOTAL
5-3	SURPLUS EXCAVATION	CU.M.	1,980
5-5	REFILLING/EMBANKMENT	CU.M.	875
5-19	GROUTED RIPRAP	CU.M.	123
5-26	GABION FOOT PROTECTION	CU.M.	70
5-27	VERTICAL DITCH	L.M.	40

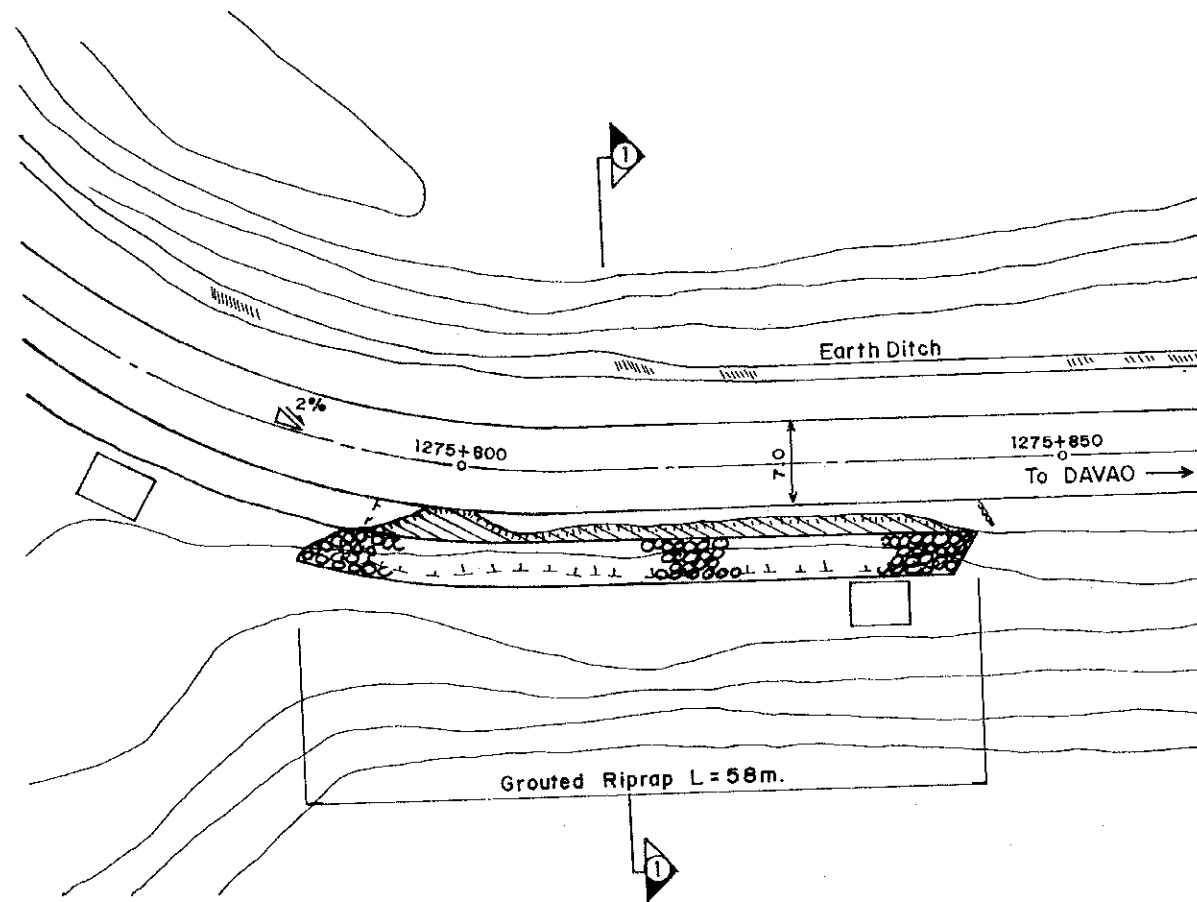
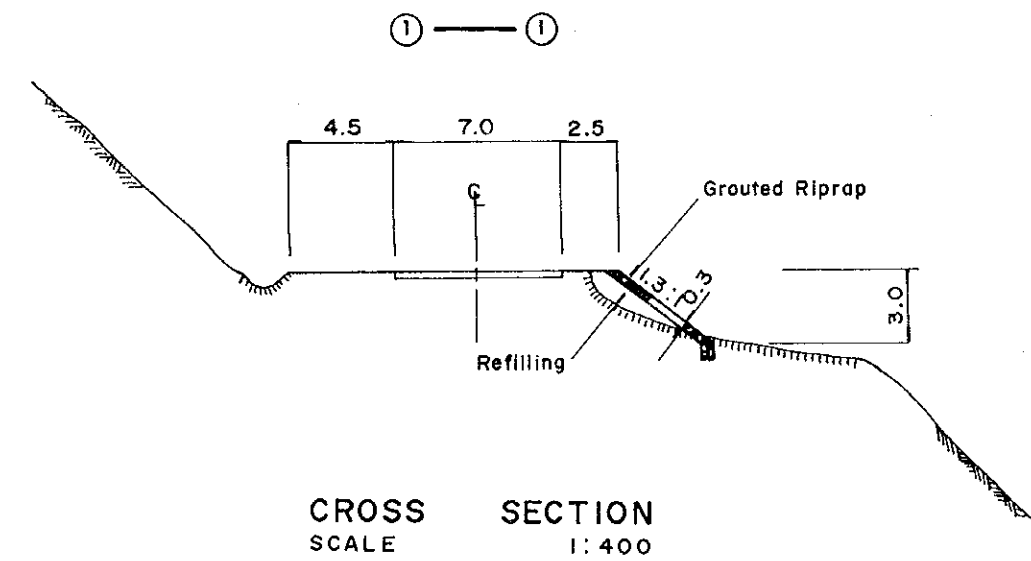
P L A N

Cause of Disaster:

- 1) Infiltration of water into boundary surface between the inclined ground and embankment.
- 2) Effect of ground water.

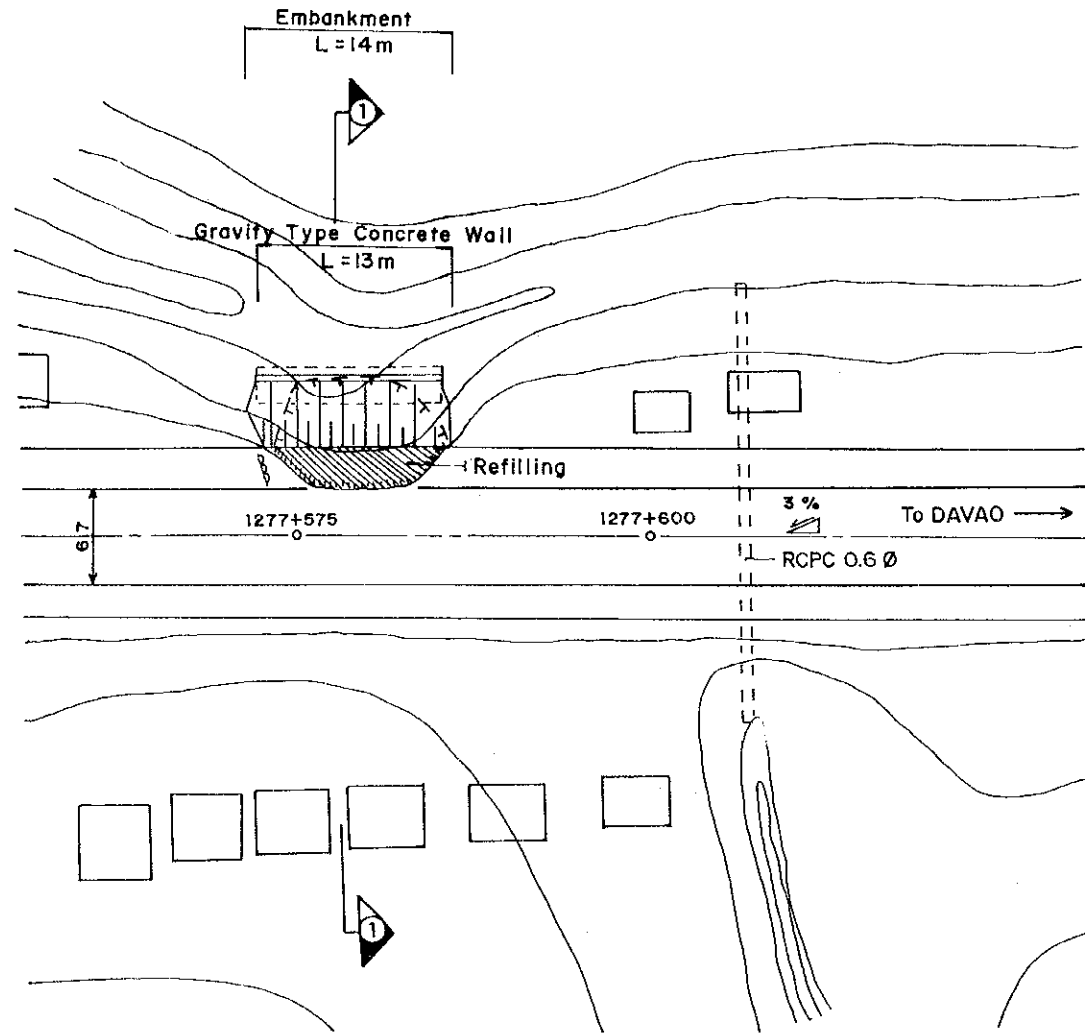
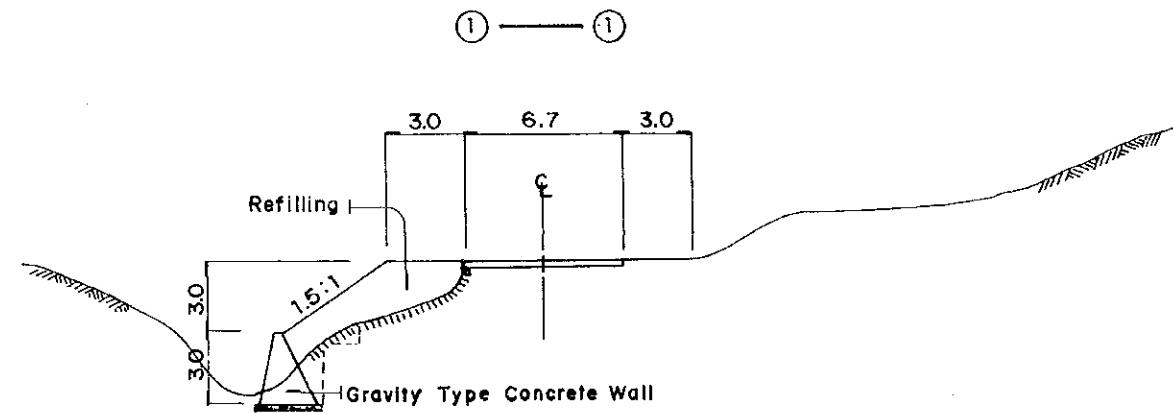
P L A N

Cause of Disaster:

- 1) Insufficient compaction of embankment.
- 2) Embankment slope with an unstable grade.

TYPE OF WORK	UNIT	TOTAL
5-5	REFILLING / EMBANKMENT	CU.M.	162
5-14	GRAVITY TYPE CONCRETE WALL	CU.M.	59
5-4	STRUCTURAL EXCAVATION	CU.M.	80
5-8	FOUNDATION FILL	CU.M.	25

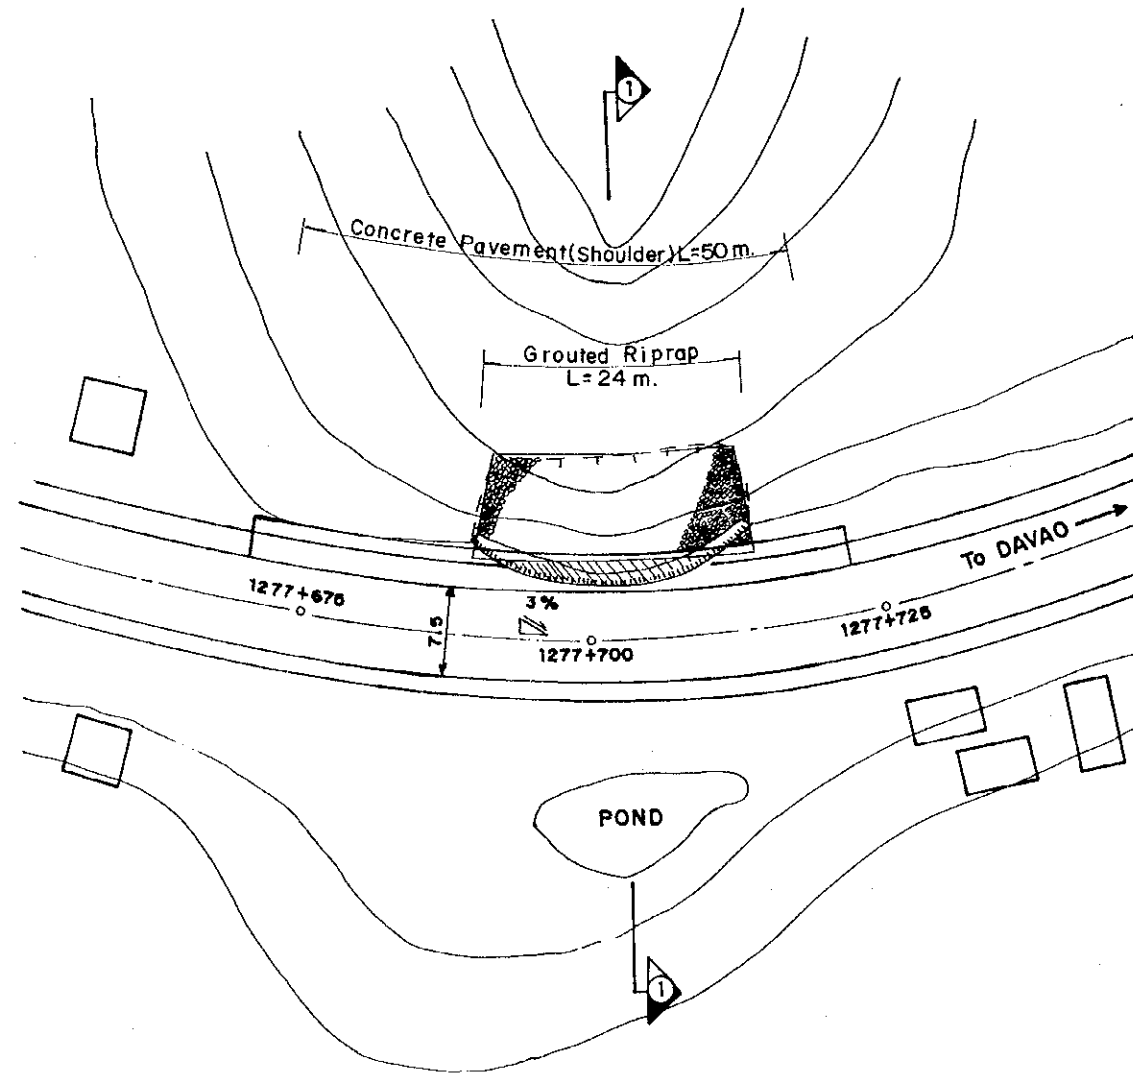
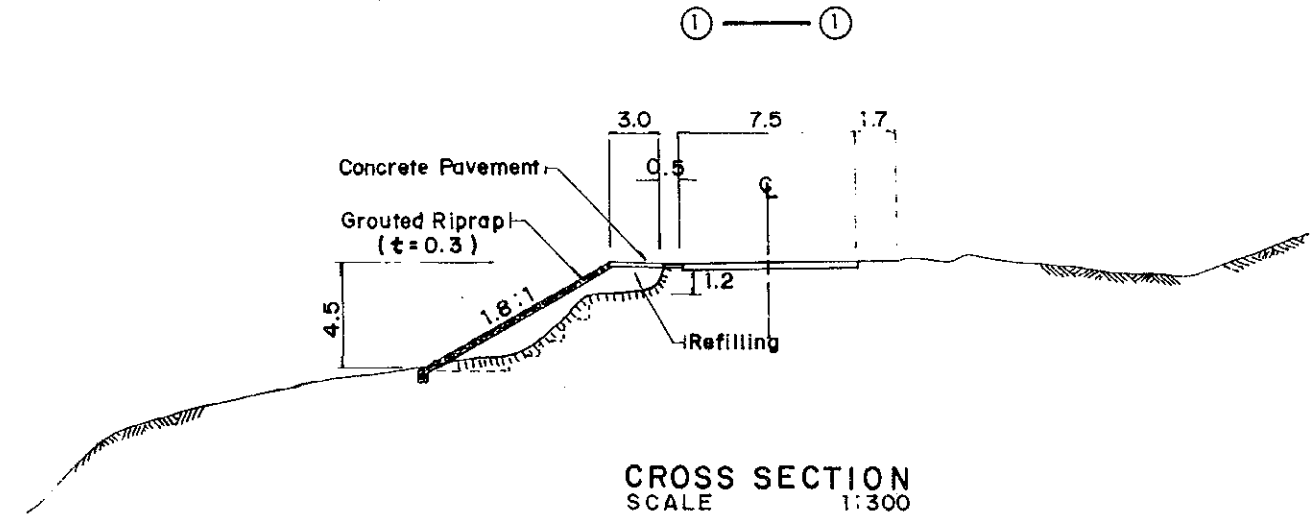
P L A N

Cause of Disaster:

- 1) Insufficient compaction of embankment.
- 2) Erosion due to concentrated surface water on the curved portion of road
- 3) Embankment slope with an unstable grade.

TYPE OF WORK		UNIT	TOTAL
5-5	REFILLING/EMBANKMENT	CU. M.	292
5-19	GROUTED RIPRAP	CU. M.	75
5-13	CONCRETE PAVEMENT (Shoulder)	SQ. M.	150

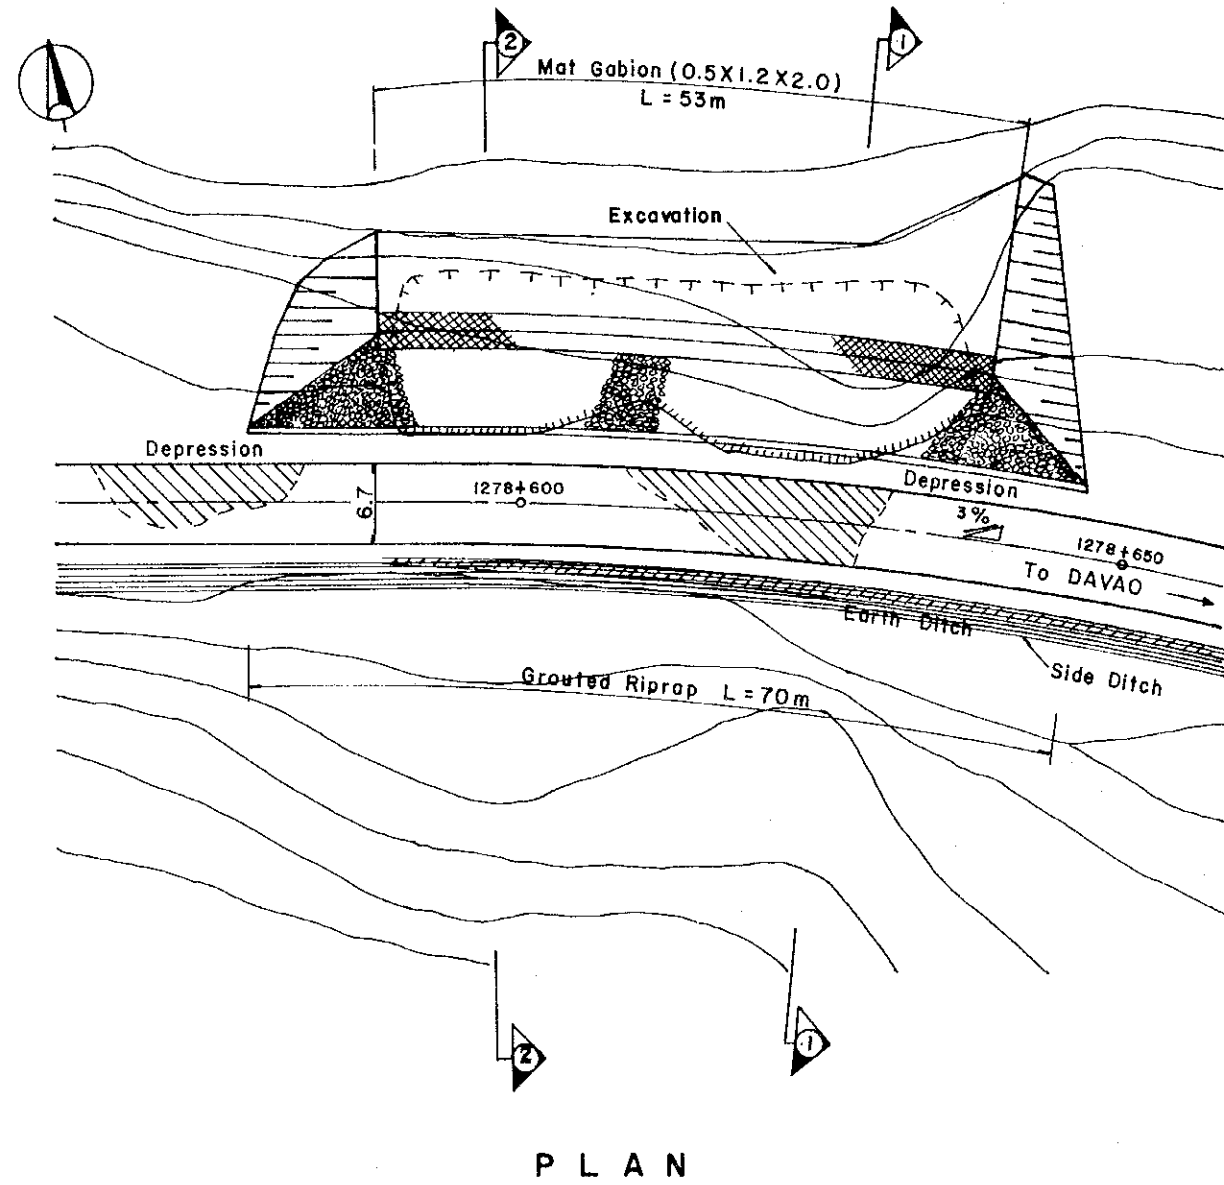
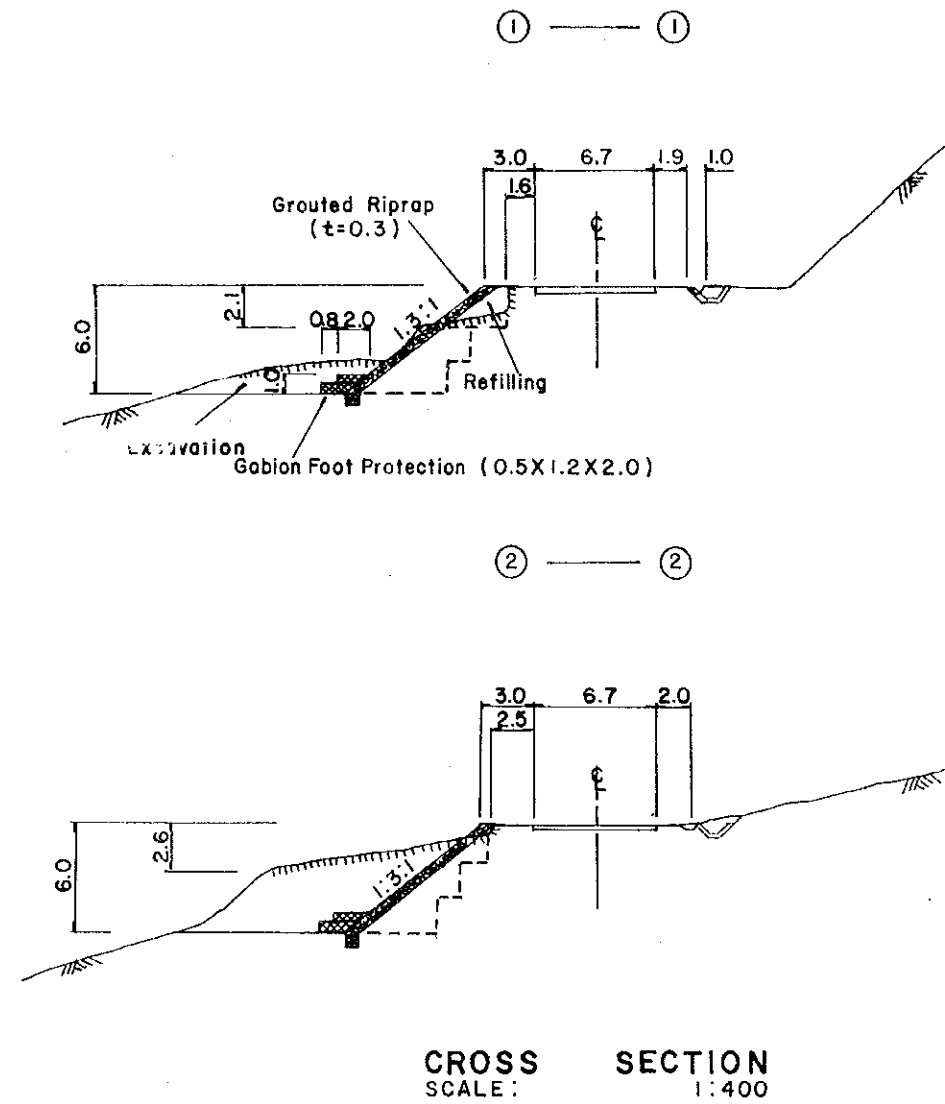
Cause of Disaster:

- 1) Settlement of embankment caused by consolidation of soft ground.
- 2) Infiltration of water into boundary surface between the ground and embankment.
- 3) Risen pore water pressure in embankment due to infiltration of surface water.

TYPE OF WORK		UNIT	TOTAL
5-3	SURPLUS EXCAVATION	CU. M.	2,200
5-5	REFILLING/EMBANKMENT	CU. M.	470
5-19	GROUTED RIPRAP	CU. M.	207
5-26	GABION FOOT PROTECTION	CU. M.	106

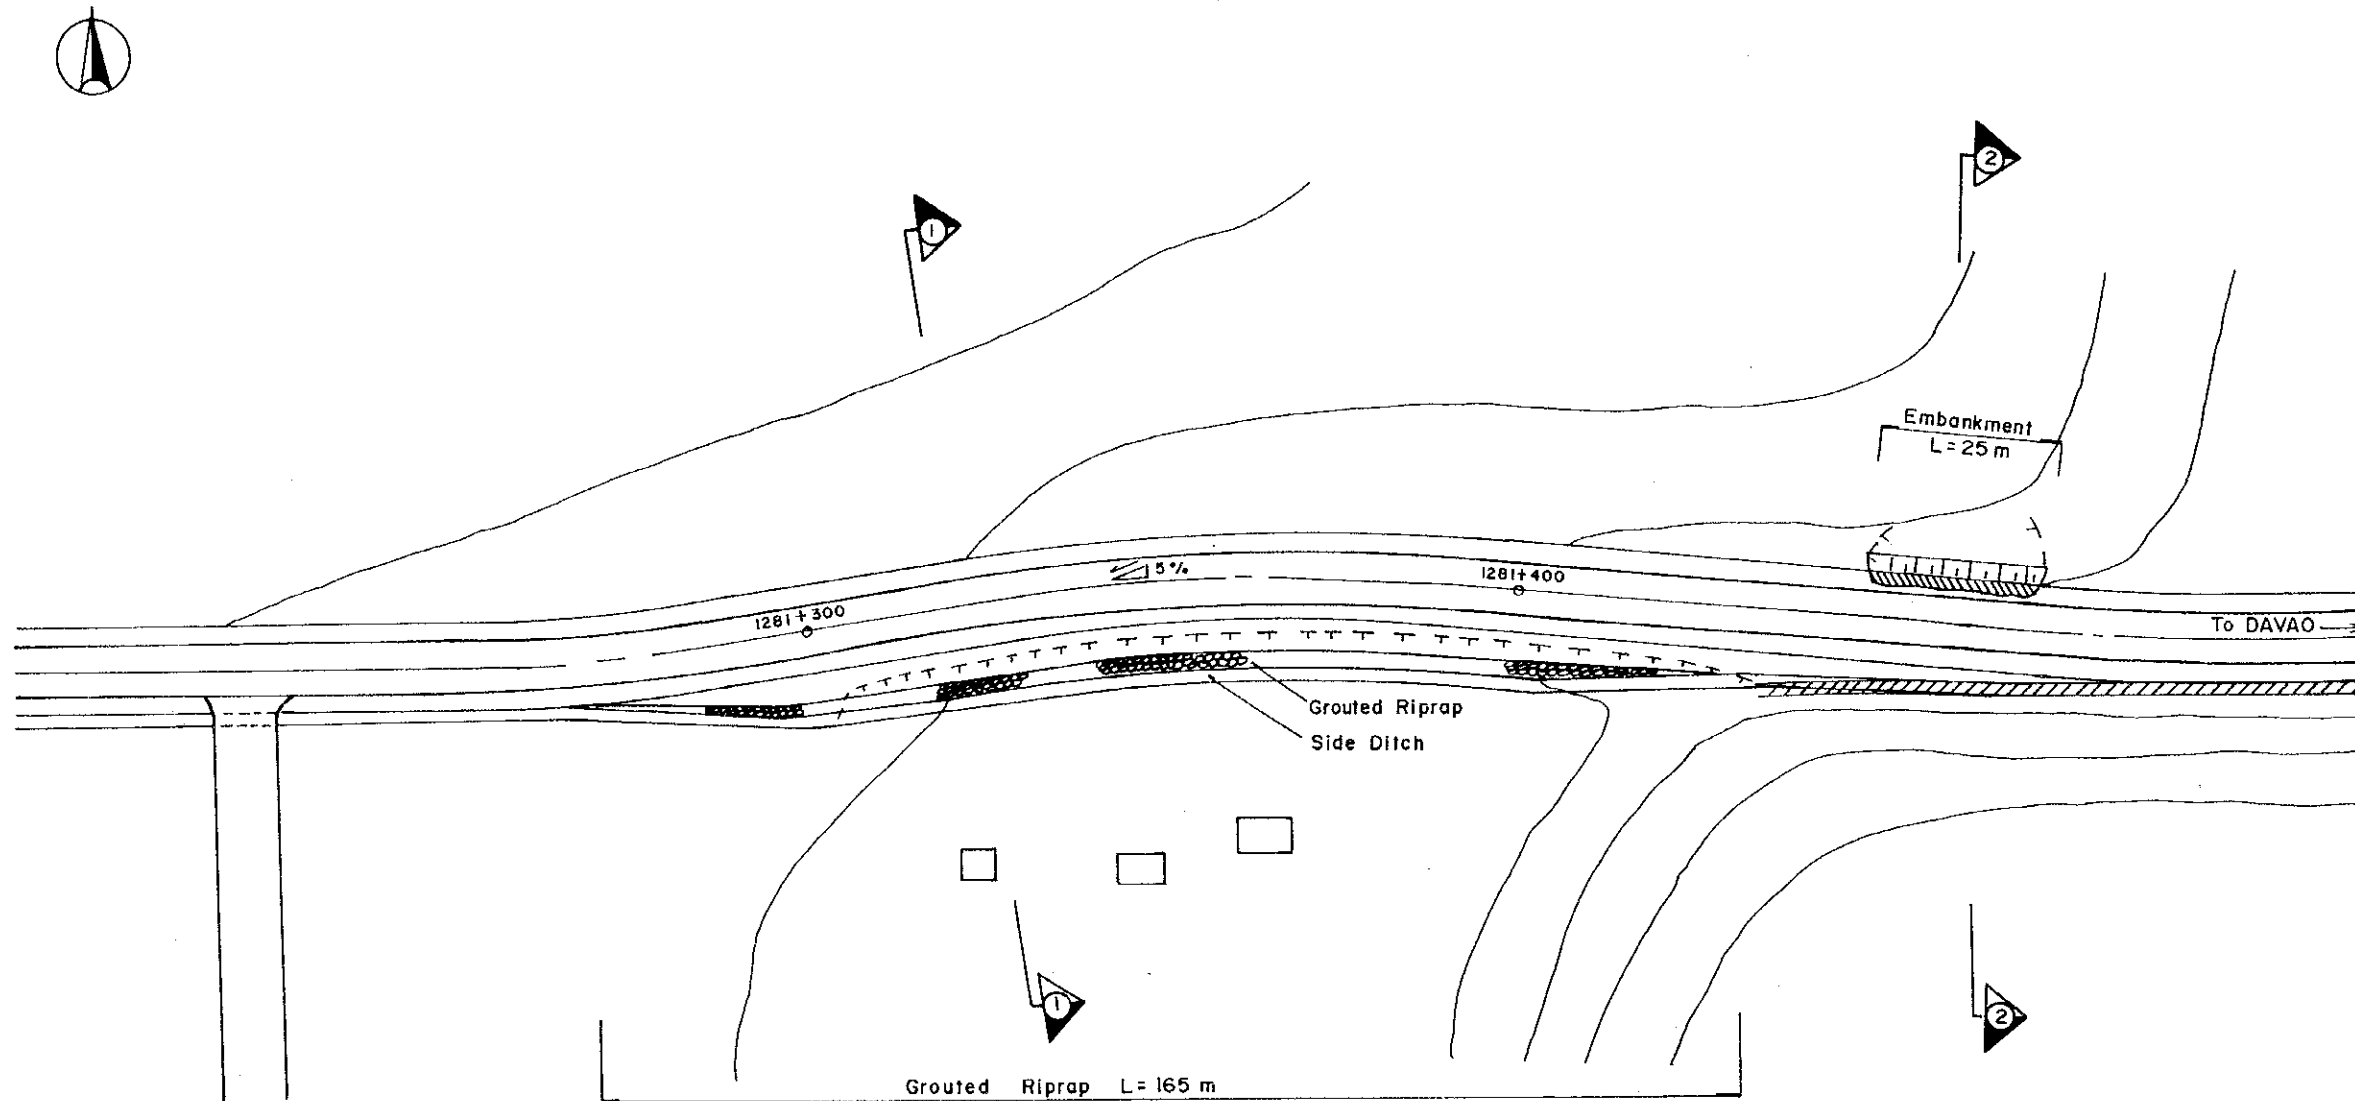
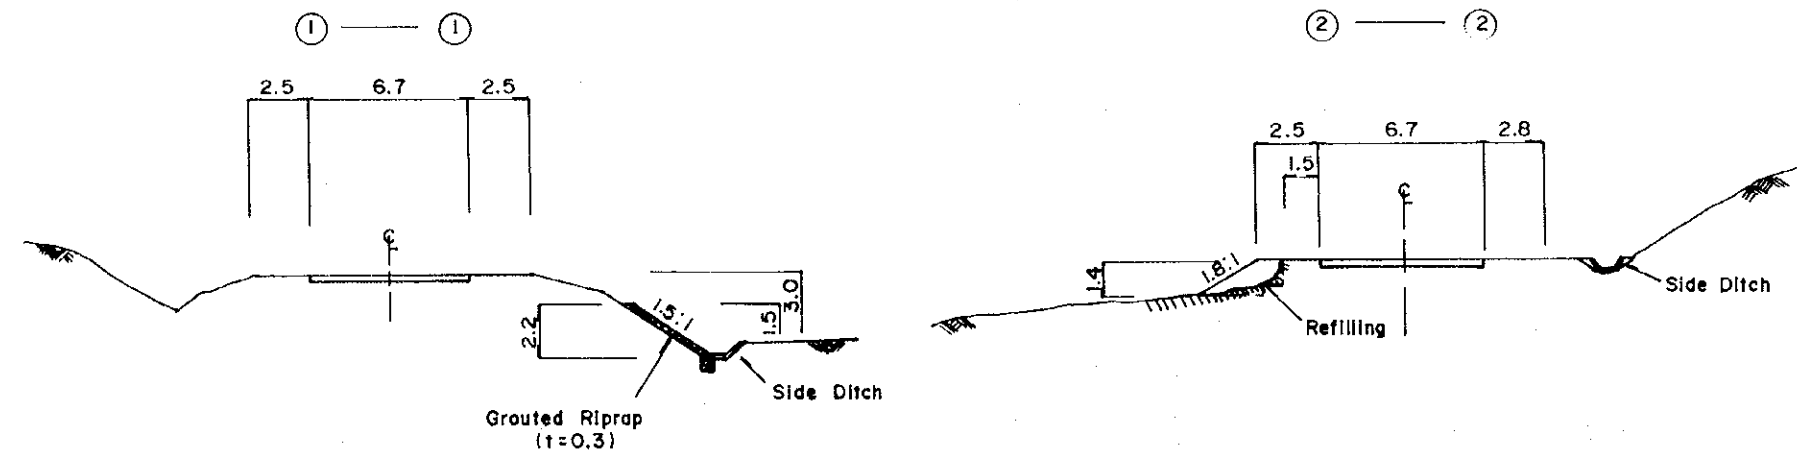
P L A N

Cause of Disaster:

- 1) Insufficient compaction of embankment.
- 2) Embankment slope with an unstable grade.

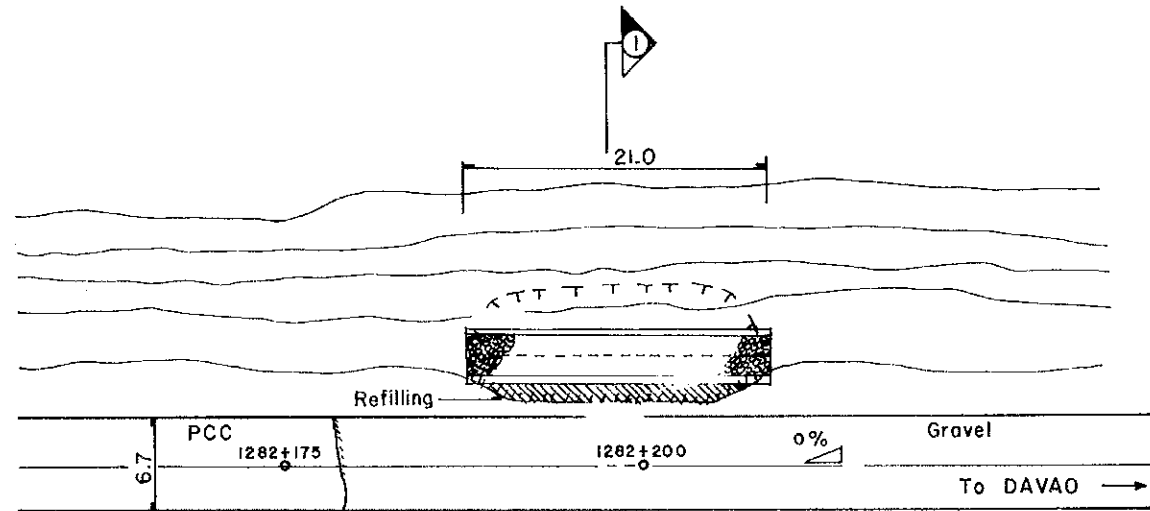
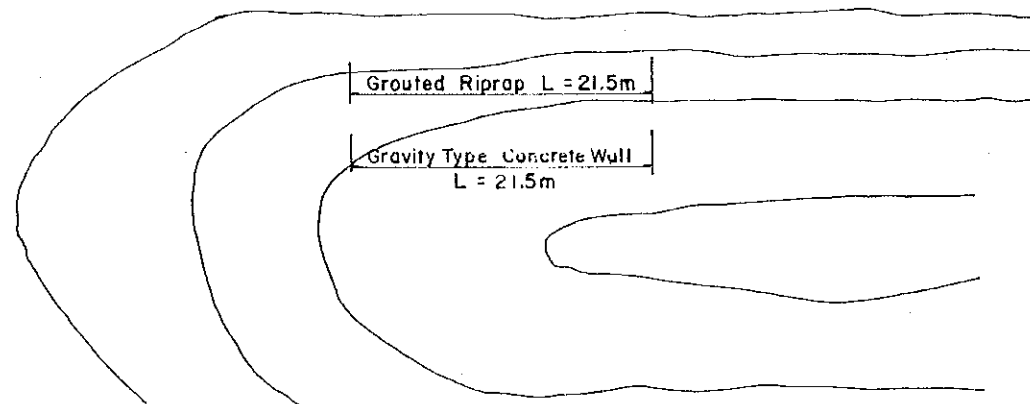
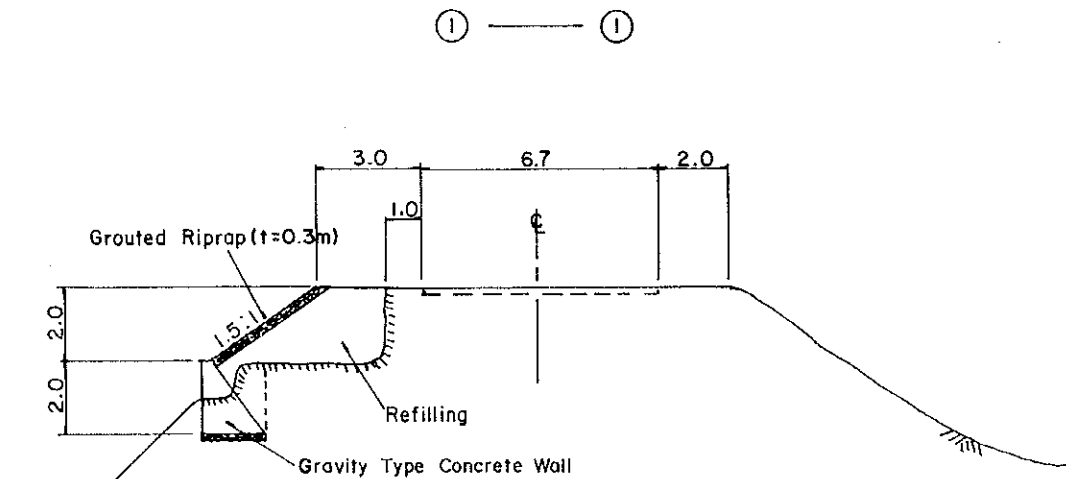
P L A N

Cause of Disaster:

- 1) Insufficient compaction of embankment.
- 2) Embankment slope with an unstable grade.

TYPE OF WORK	UNIT	TOTAL
5-5	REFILLING / EMBANKMENT	CU.M	130
5-19	GROUTED RIPRAP	CU.M	23
5-14	GRAVITY TYPE CONCRETE WALL	CU.M	43
5-4	STRUCTURAL EXCAVATION	CU.M	80
5-8	FOUNDATION FILL	CU.M	40

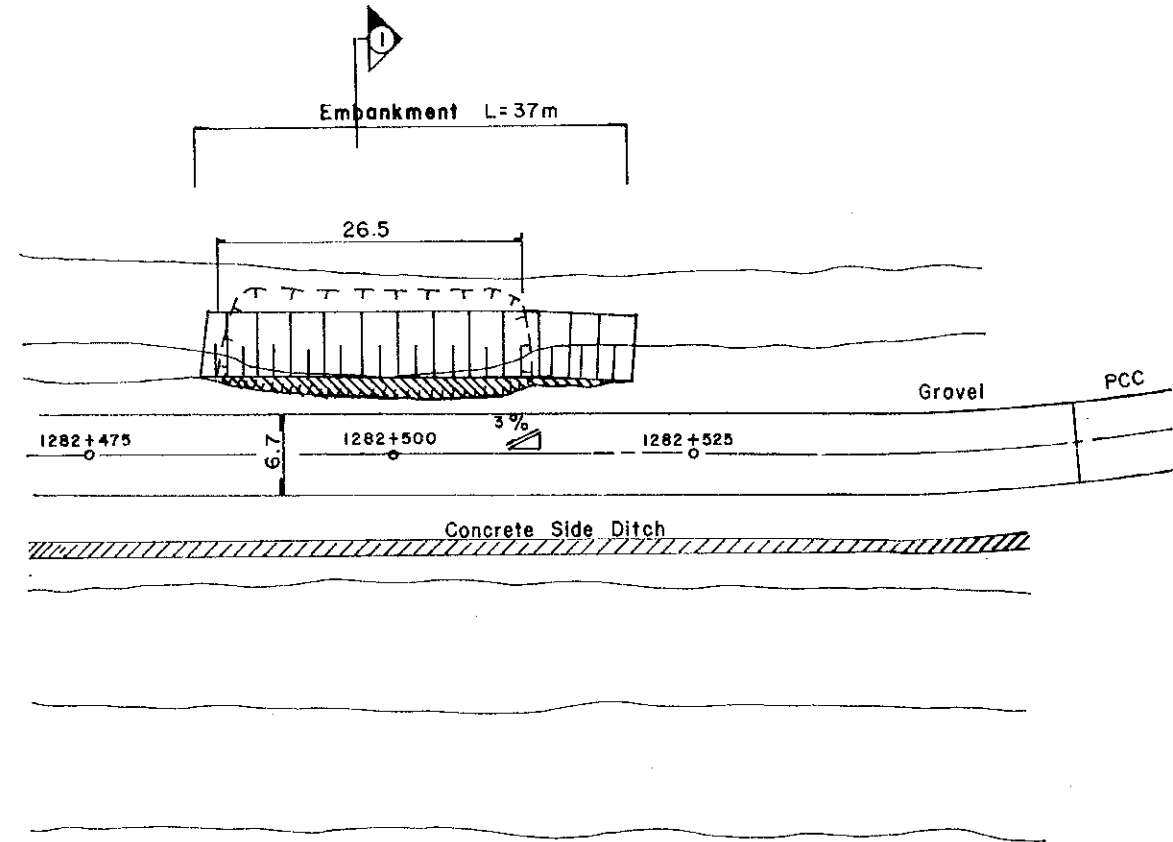
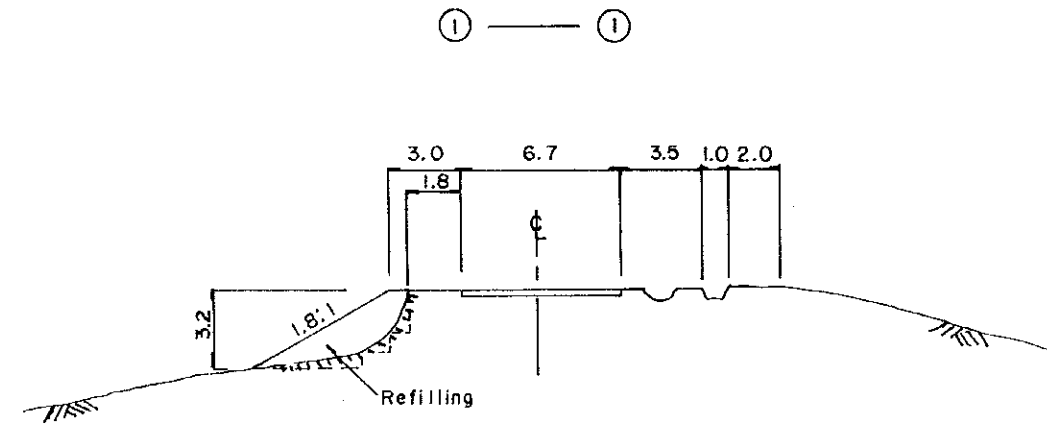
P L A N

Cause of Disaster:

- 1) Insufficient compaction of embankment.
- 2) Embankment slope with an unstable grade.
