DEPARTMENT OF PUBLIC WORKS AND HIGHWAYS
REPUBLIC OF THE PHILIPPINES

FEASIBILITY STUDY
ON
PAN-PHILIPPINE HIGHWAY REHABILITATION PROJECT
(MINDANAO SECTION)

FINAL REPORT
DRAWINGS

MAY 1995

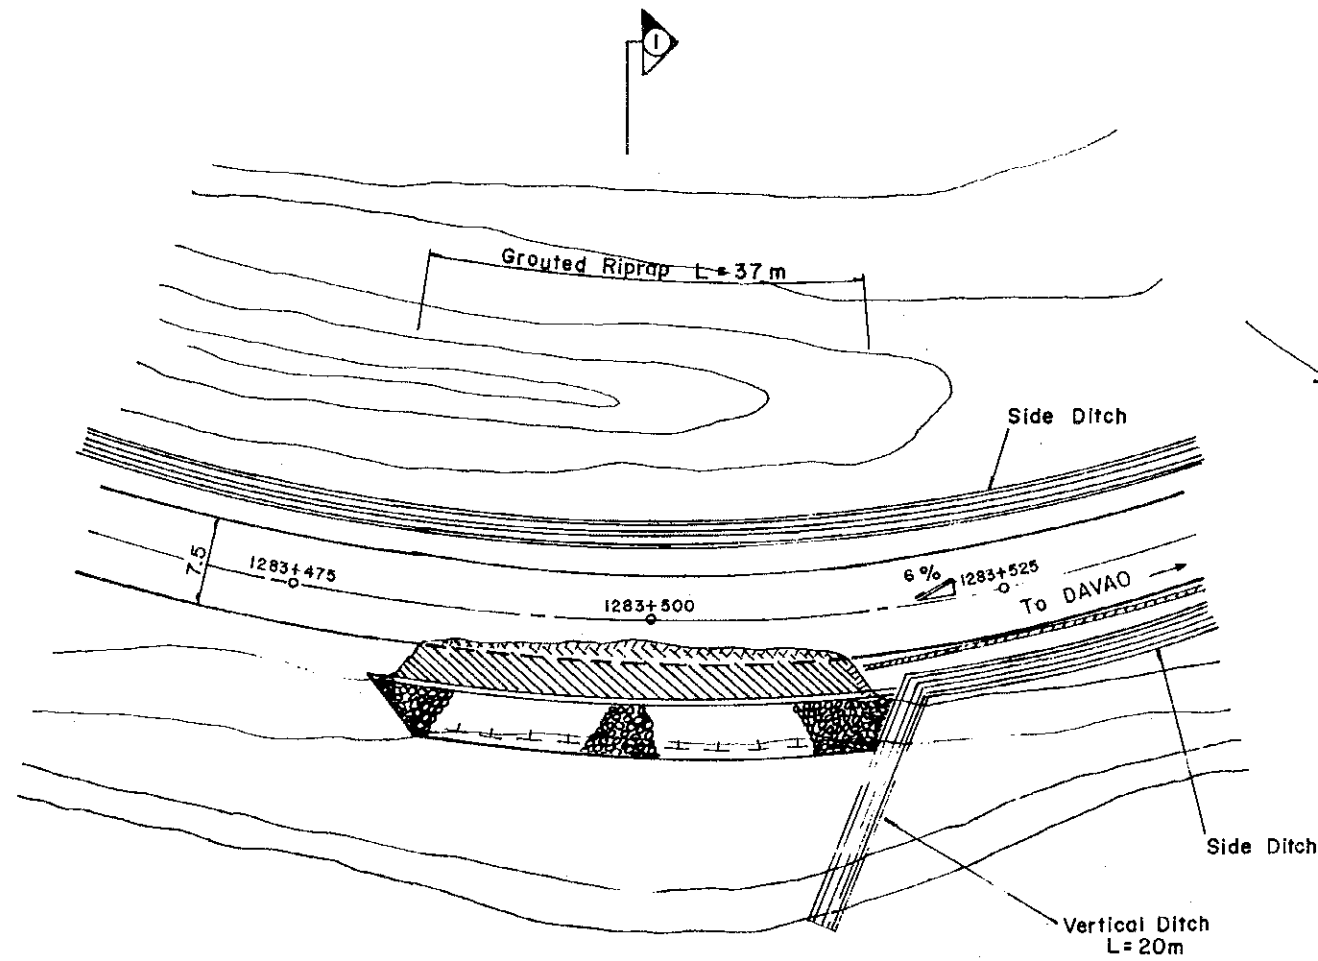
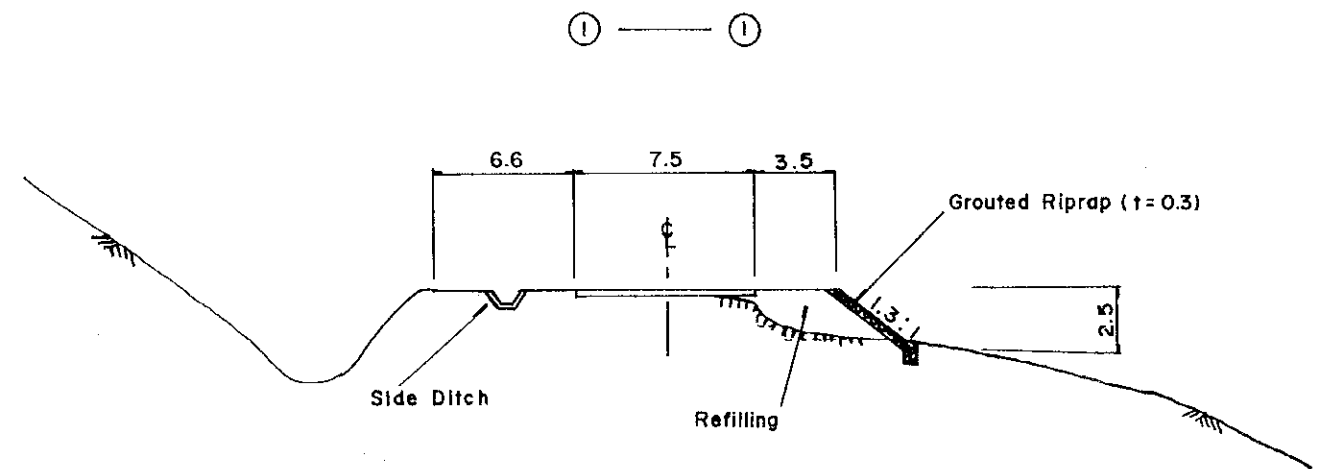
P L A N

Cause of Disaster:

- 1) Insufficient compaction of embankment.
- 2) Embankment slope with an unstable grade.

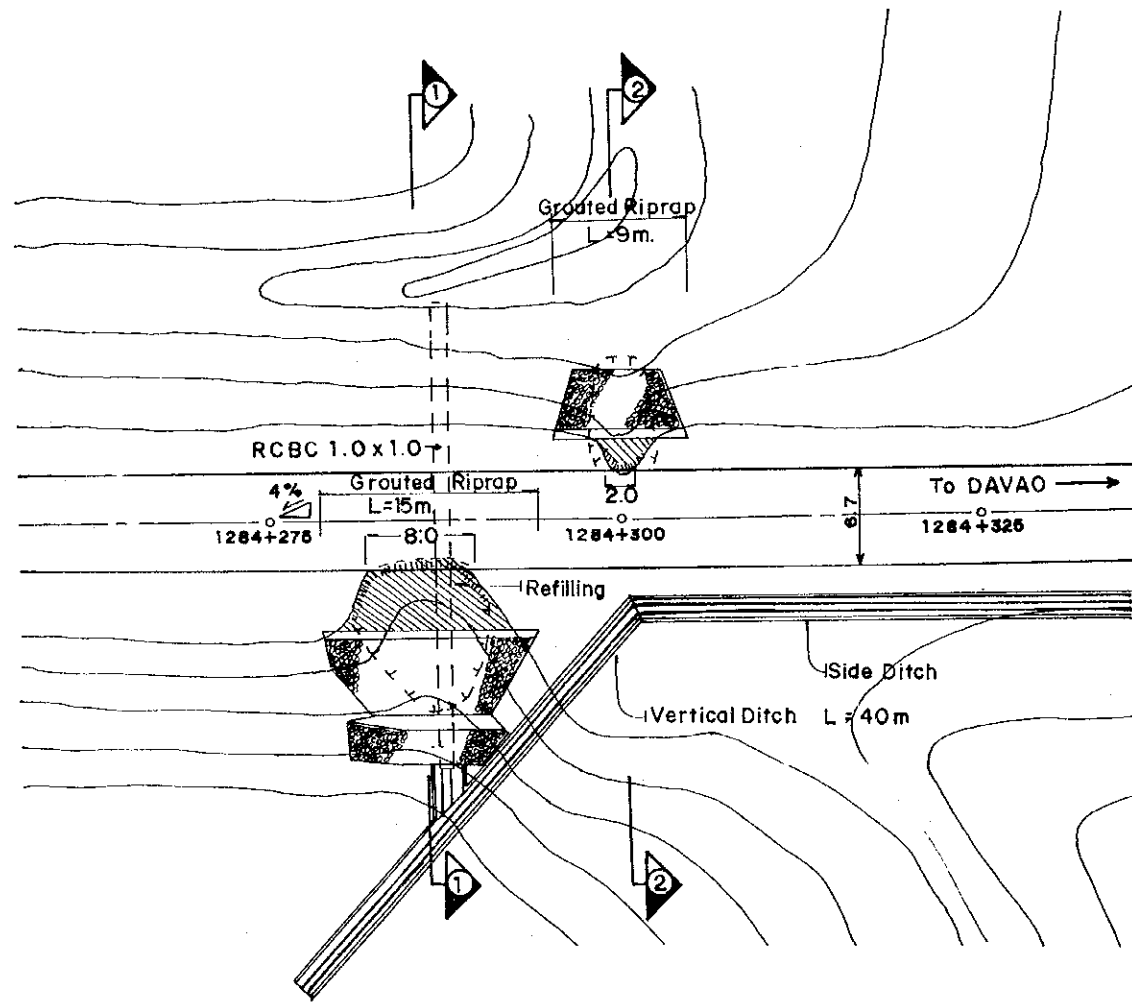
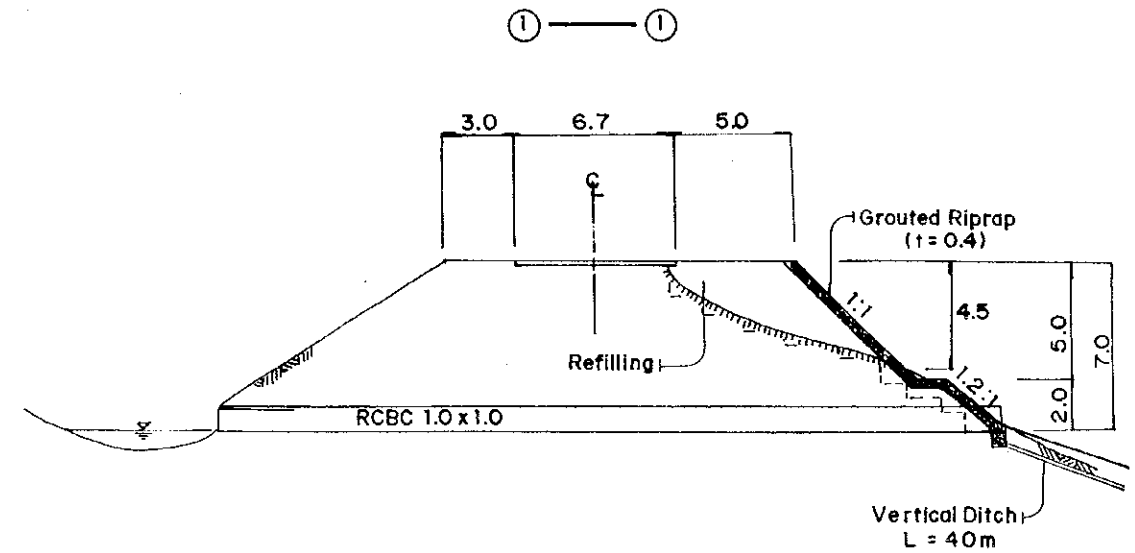
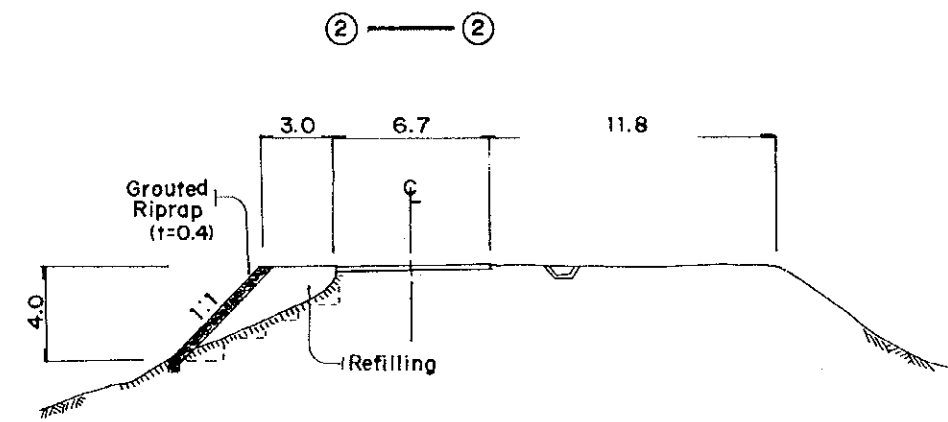
PLAN

Cause of Disaster:

- 1) Risen pore water pressure in embankment due to infiltration of surface water.
- 2) Embankment slope with an unstable grade.
