FEASIBILITY STUDY ON PAN-PHILIPPINE HIGHWAY
REHABILITATION PROJECT (MINDANAO SECTION)

SLOPE NO.: 4-38
TYPE OF DISASTER:

STATION: 1340+950
EMBANKMENT SLOPE FAILURE

DRAWING NO.
S-53

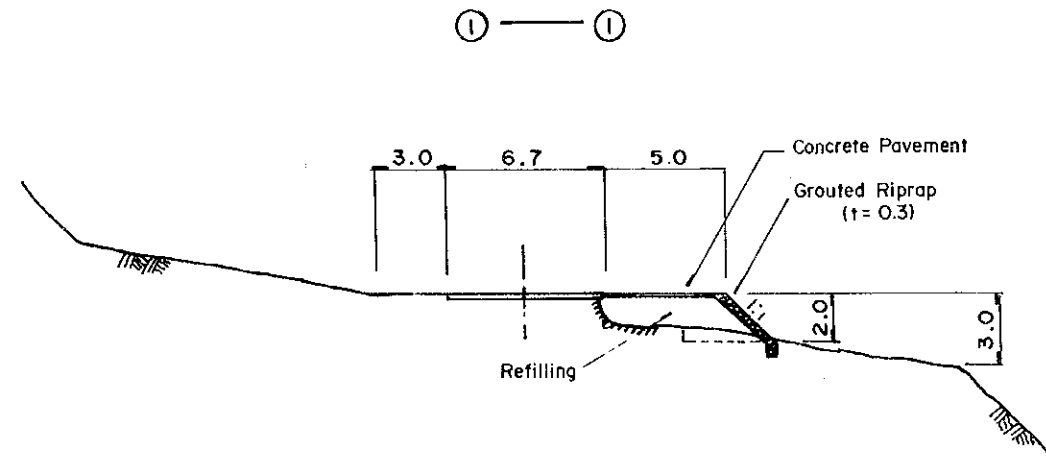
CROSS SECTION
SCALE 1:300

Cause of Disaster:

- 1) Insufficient compaction of embankment.
- 2) Scouring by water which was drained from feeder earth road and concentrated on the slope due to the geometric formation of road.

TYPE OF WORK	UNIT	TOTAL
5 - 5	REFILLING/ EMBANKMENT	CU.M	127
5 - 19	GROUTED RIPRAP	CU.M	40
5 - 13	CONCRETE PAVEMENT (SHOULDER)	SQ.M	135

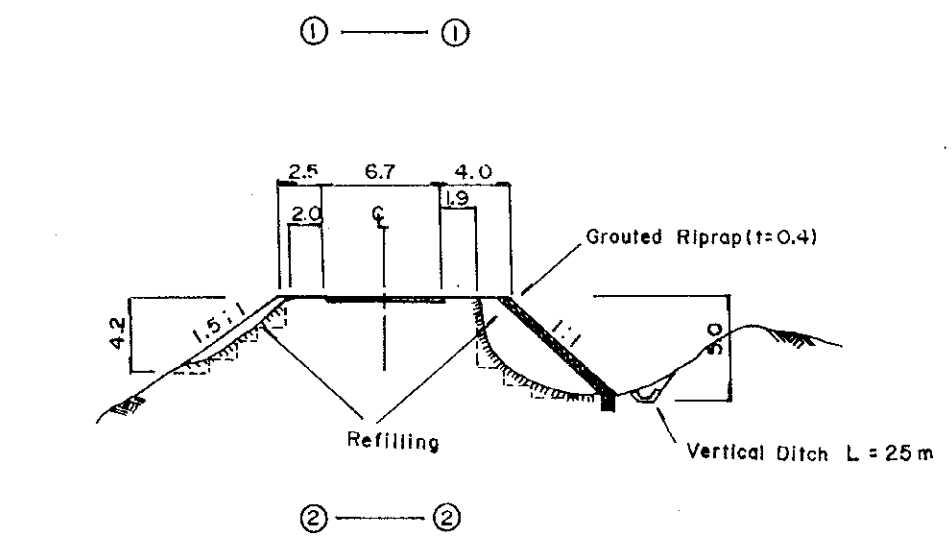
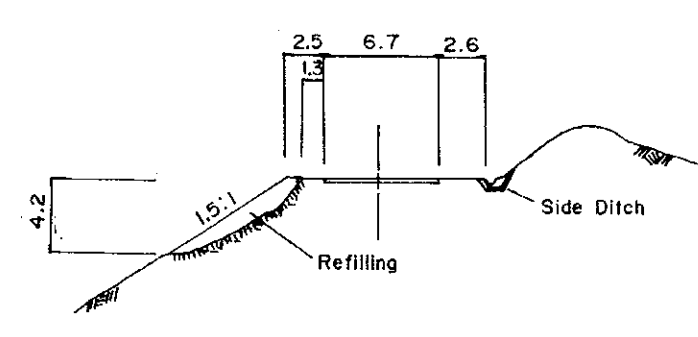
Cause of Disaster:

- 1) Insufficient compaction of embankment.
- 2) Embankment slope with an unstable grade.
- 3) Scouring by water which was drained from hill side and concentrated on the slope due to the geometric formation of road.

TYPE OF WORK	UNIT	TOTAL
5-5	REFILLING / EMBANKMENT	CU. M	644
5-19	GROUTED RIPRAP	CU. M	68
5-27	VERTICAL DITCH	L. M	25

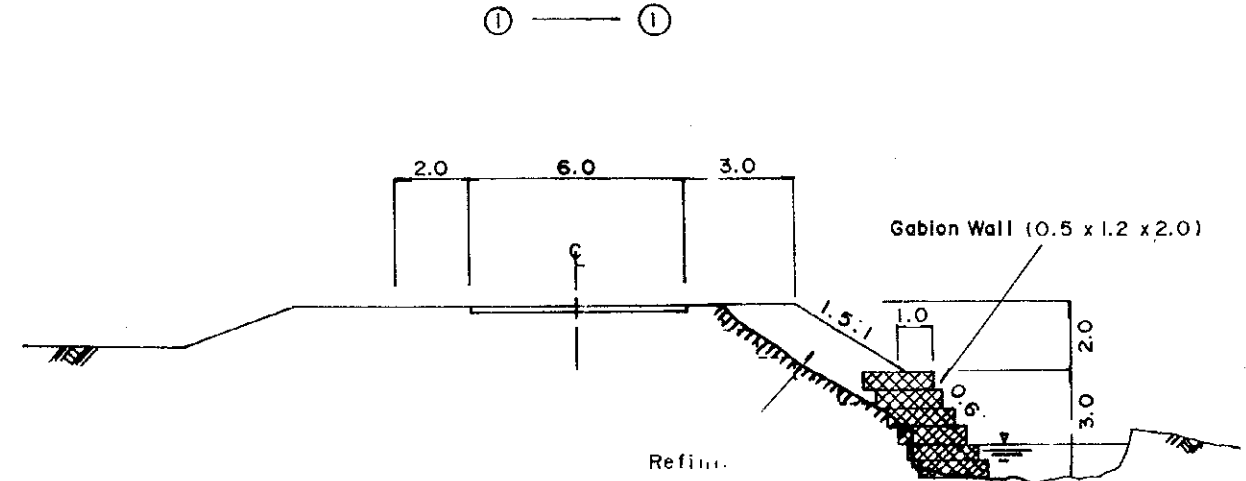
CROSS SECTION
SCALE 1:200

Cause of Disaster:

- 1) Erosion at the foot of slope by pond water.

TYPE OF WORK	UNIT	TOTAL
5-5	REFILLING / EMBANKMENT	CU. M	54
5-17	GABION WALL	CU. M	65

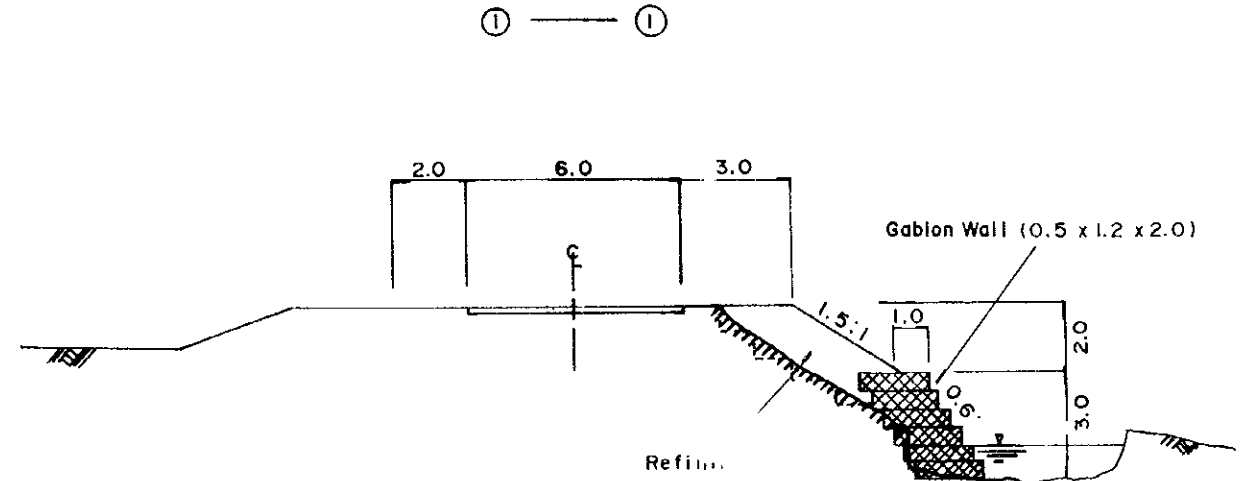
CROSS SECTION
SCALE 1:200

Cause of Disaster:

- 1) Erosion at the foot of slope by pond water.

TYPE OF WORK	UNIT	TOTAL
5-5	REFILLING / EMBANKMENT	CU. M	54
5-17	GABION WALL	CU. M	65

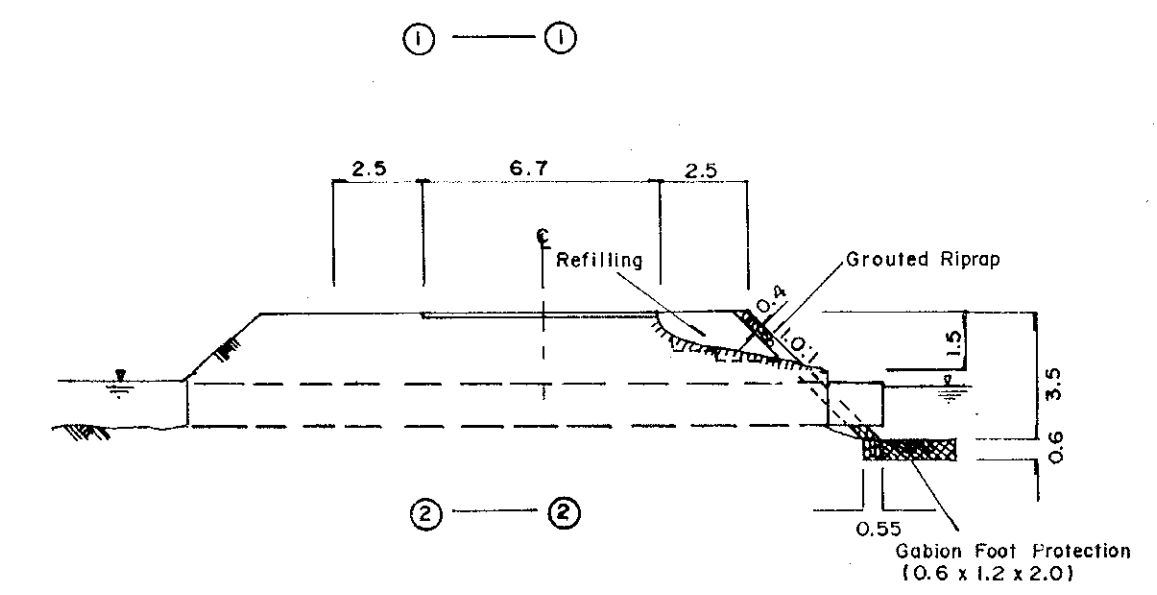
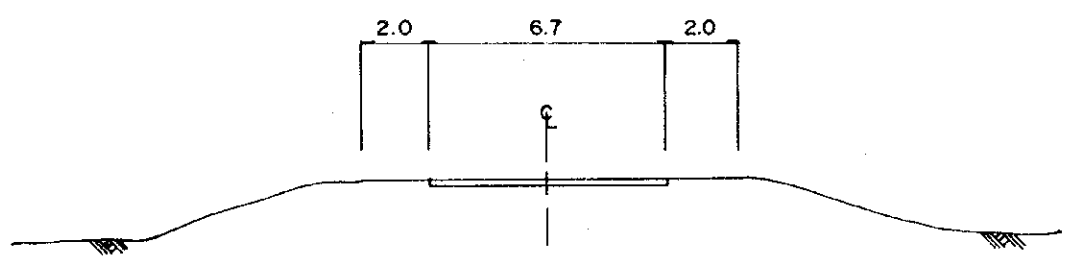
CROSS SECTION
SCALE 1:200

Cause of Disaster:
1) Erosion at the foot of slope by pond water.
2) Insufficient compaction of embankment.

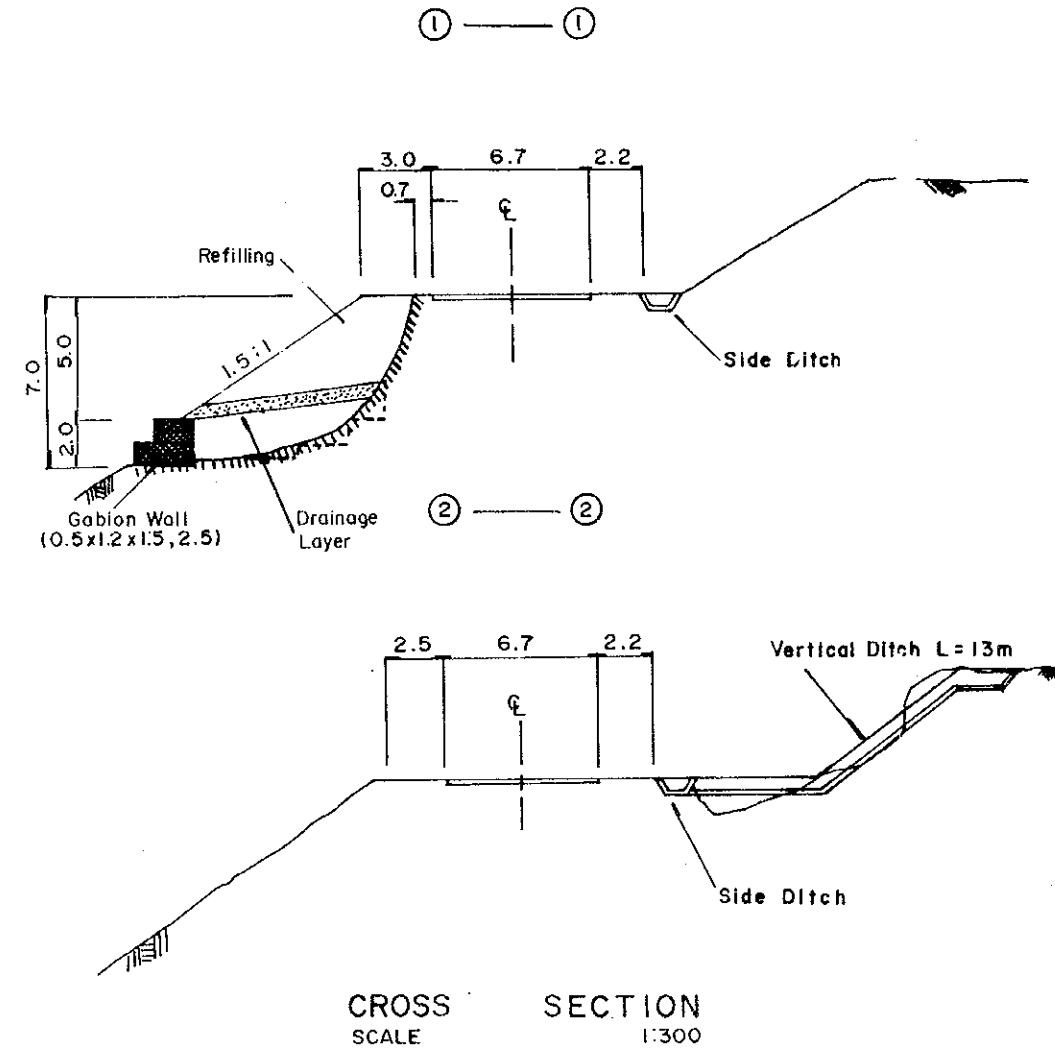
CROSS SECTION
SCALE 1:300

Cause of Disaster:

- 1) Infiltration of water into boundary surface between the ground and embankment.
- 2) Effect of ground water.
- 3) Embankment slope with an unstable grade.

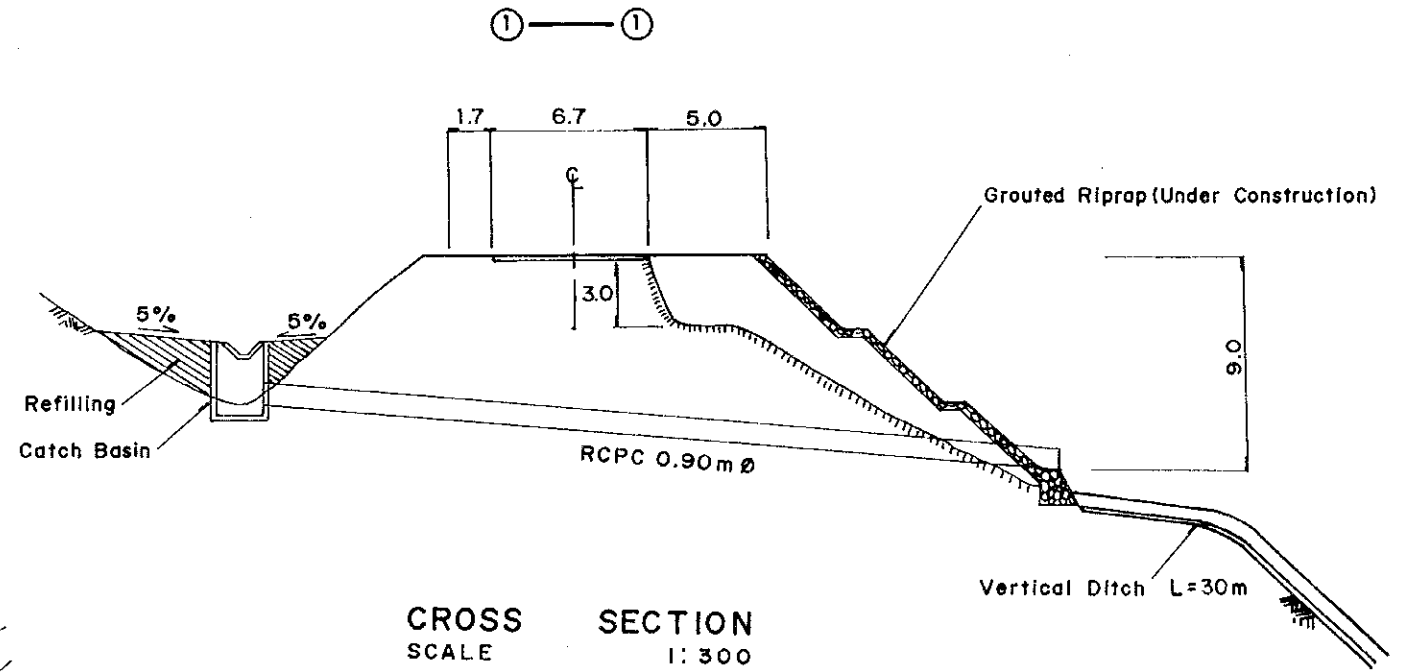
CROSS SECTION
SCALE 1:300

Cause of Disaster:

- 1) Inadequate inlet facility of pipe culvert.
- 2) Infiltration of water into boundary surface between the ground and embankment.

TYPE OF WORK	UNIT	TOTAL
5-5	REFILLING / EMBANKMENT	CU. M.	15
5-37	CATCH BASIN FOR RCPC 0.90m Ø	E. A.	1
5-27	VERTICAL DITCH	L. M.	30

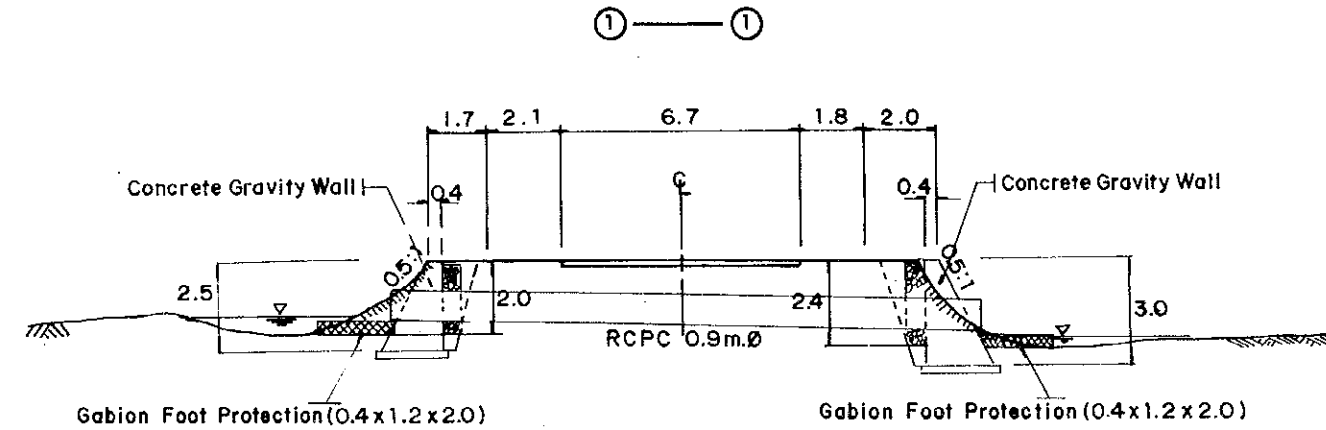
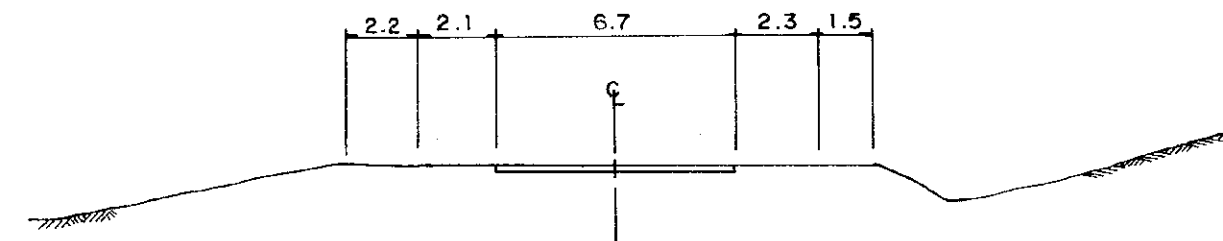
CROSS SECTION
SCALE 1:200

Cause of Disaster:

- 1) Erosion at the foot of slope by pond water.
- 2) Inadequate inlet facility of pipe culvert.

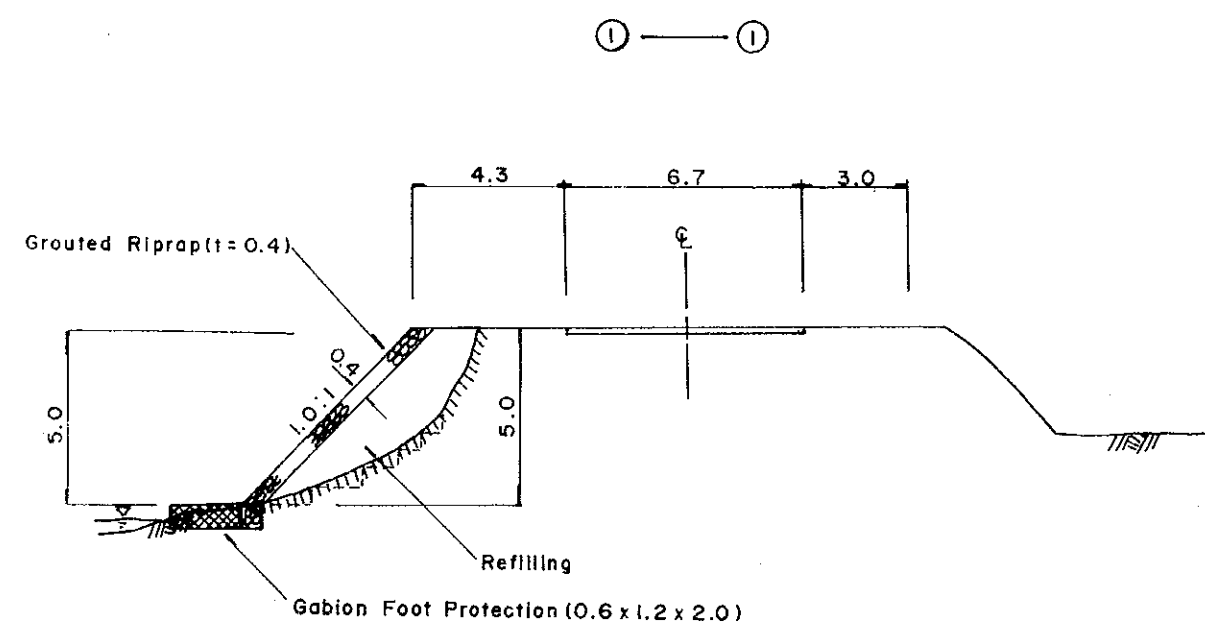
CROSS SECTION
SCALE 1:200

- Cause of Disaster:
- 1) Erosion at the foot of slope by pond water.
 - 2) Scouring by stream from river into the pond.
 - 3) Embankment slope with an unstable grade.

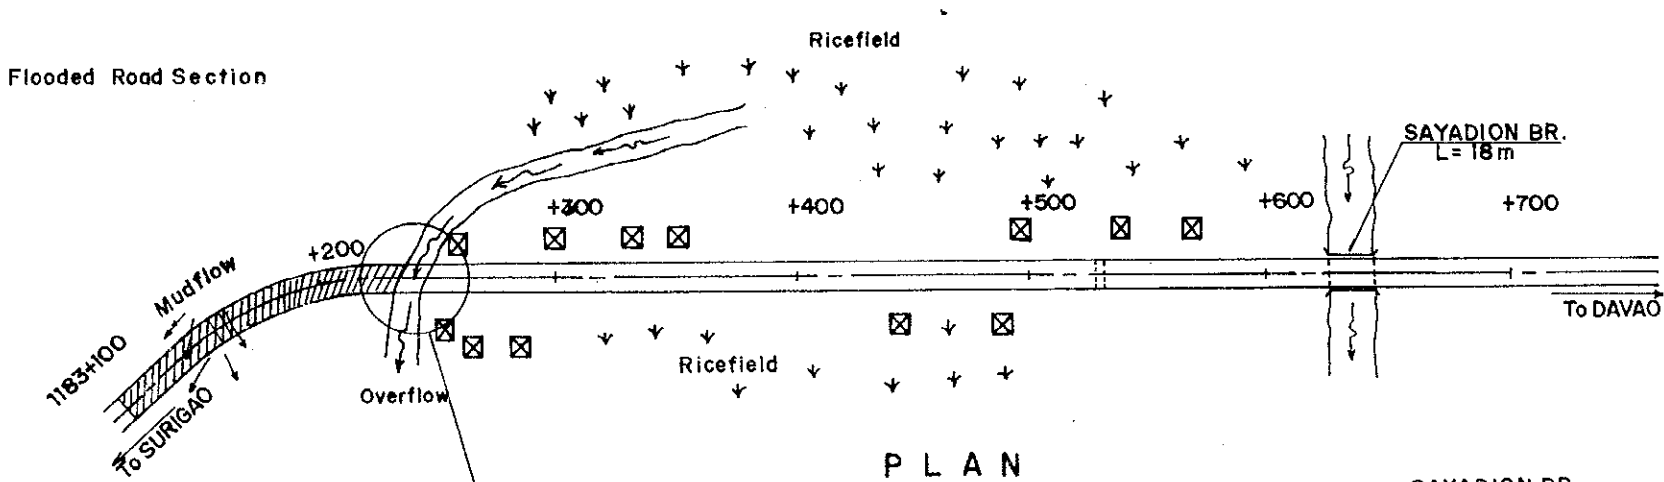
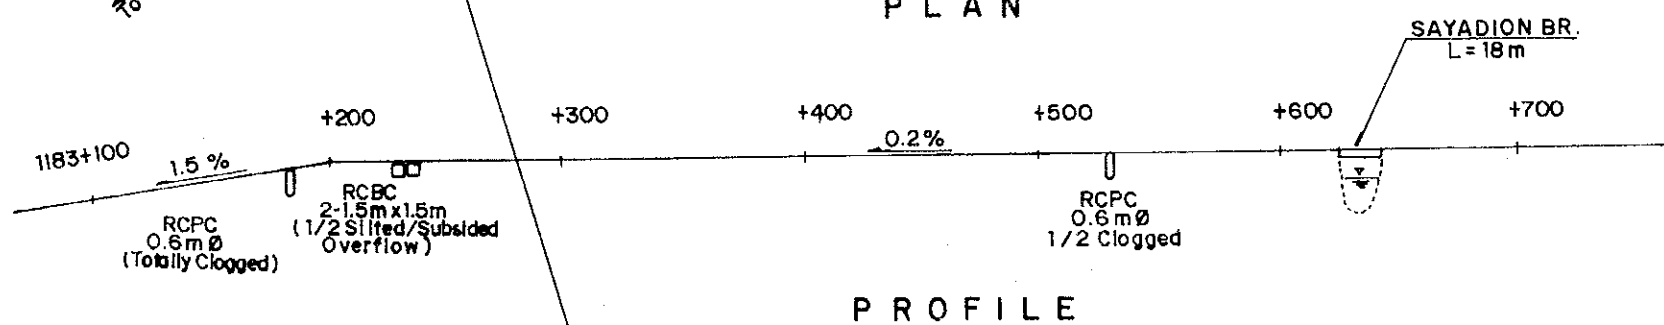
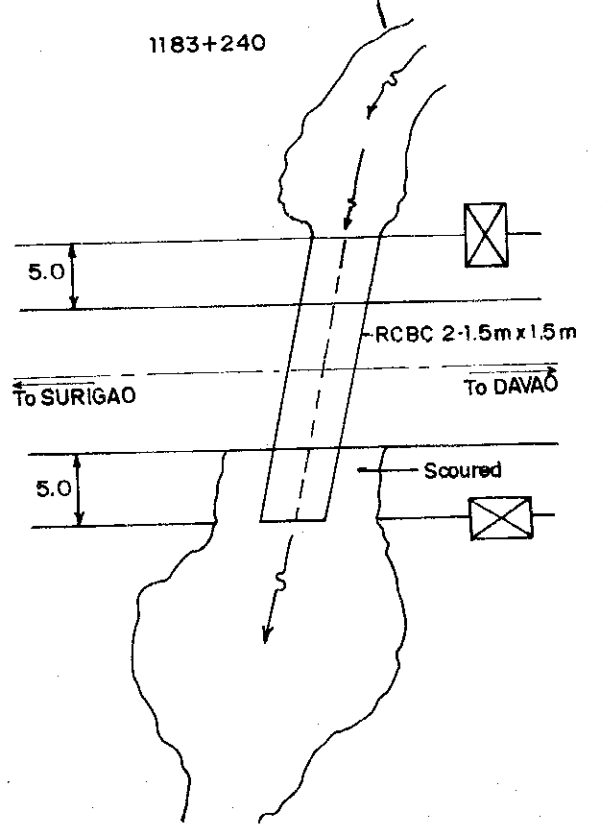
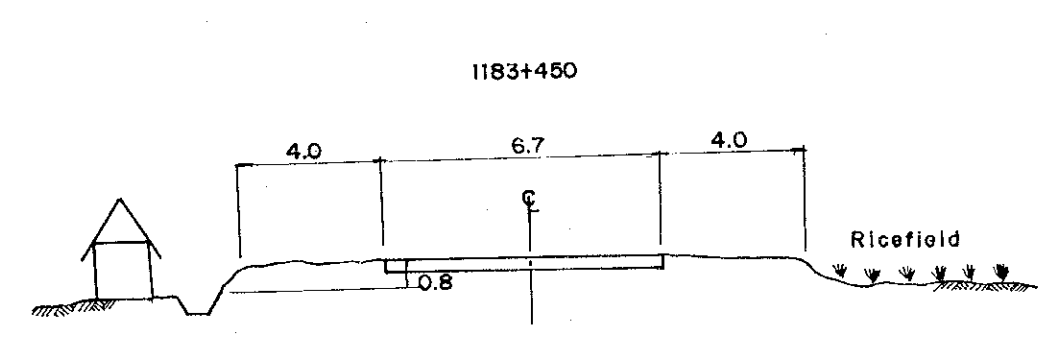
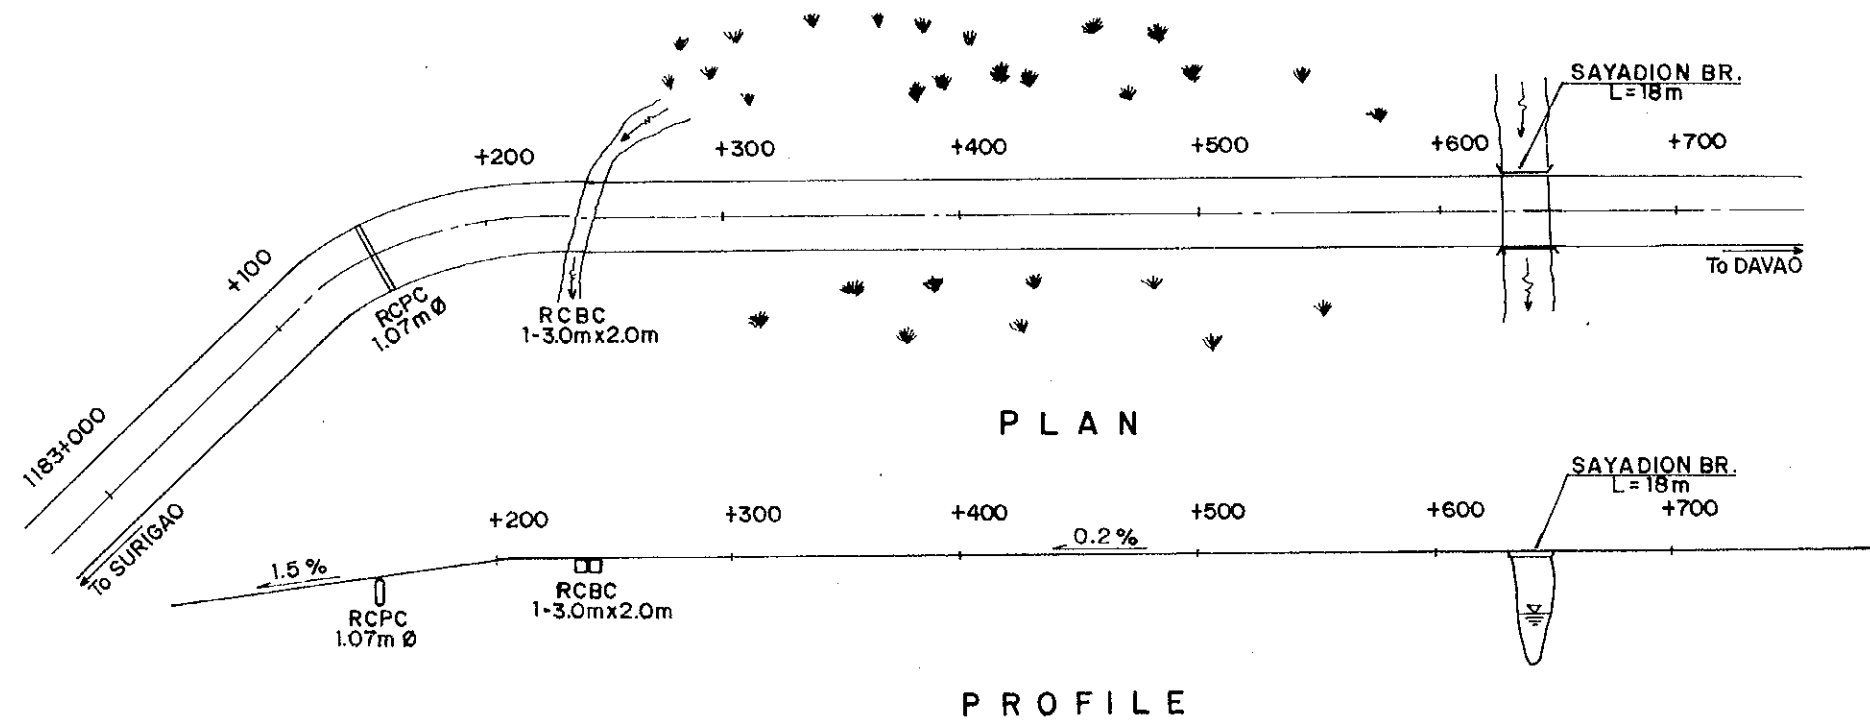
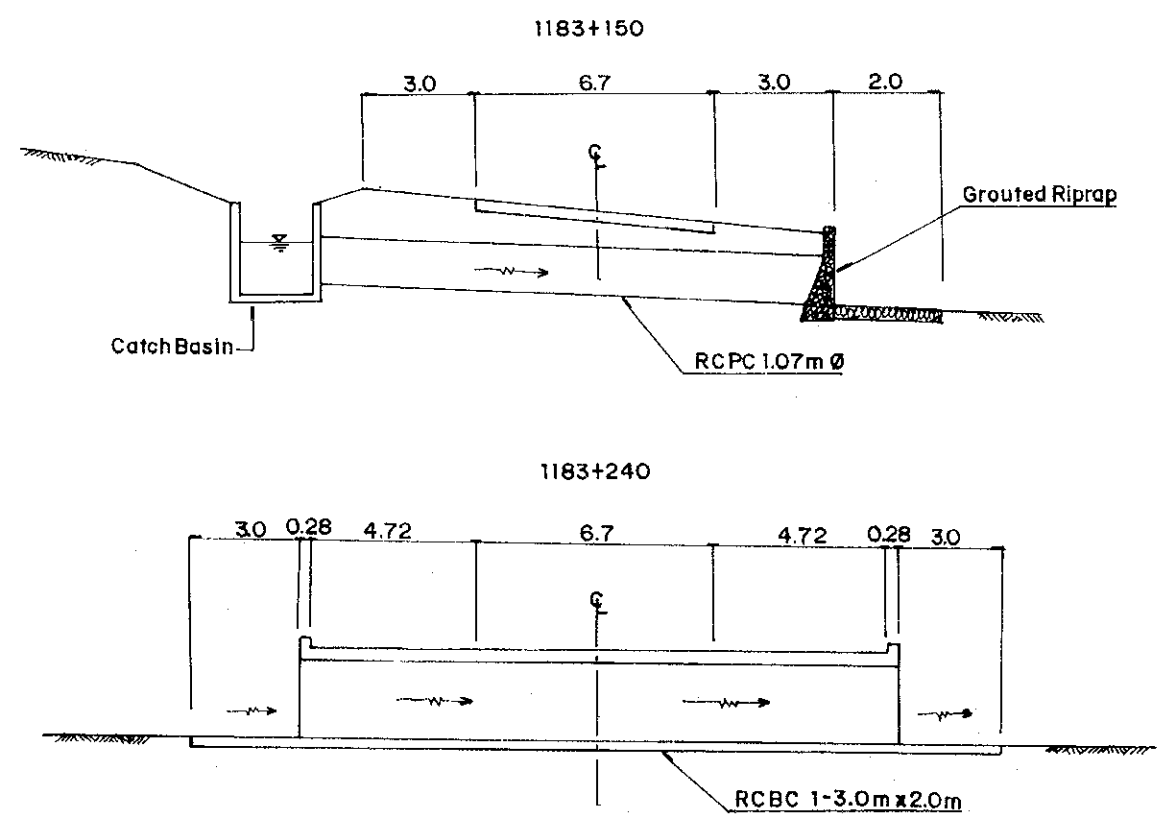
DRAWING NO.
F-7(1/2)

FLOOD SECTION NO. : 7 STATION : 1183+100 - 1183+200
FLOOD TYPE : III EXISTING CONDITION

ITEM NO.	TYPE OF WORK	UNIT	TOTAL
6-6A	RCBC, 1-3.0m x 2.0m	m	17
6-12A	Wingwall for RCBC 1-3.0m x 2.0m	each	2
6-15	RCPC, 1.07m dia.	m	17
6-20	Catch Basin for 1.07m dia. RCPC	each	2
7-1	Grouted Riprap	cu. m.	1.75

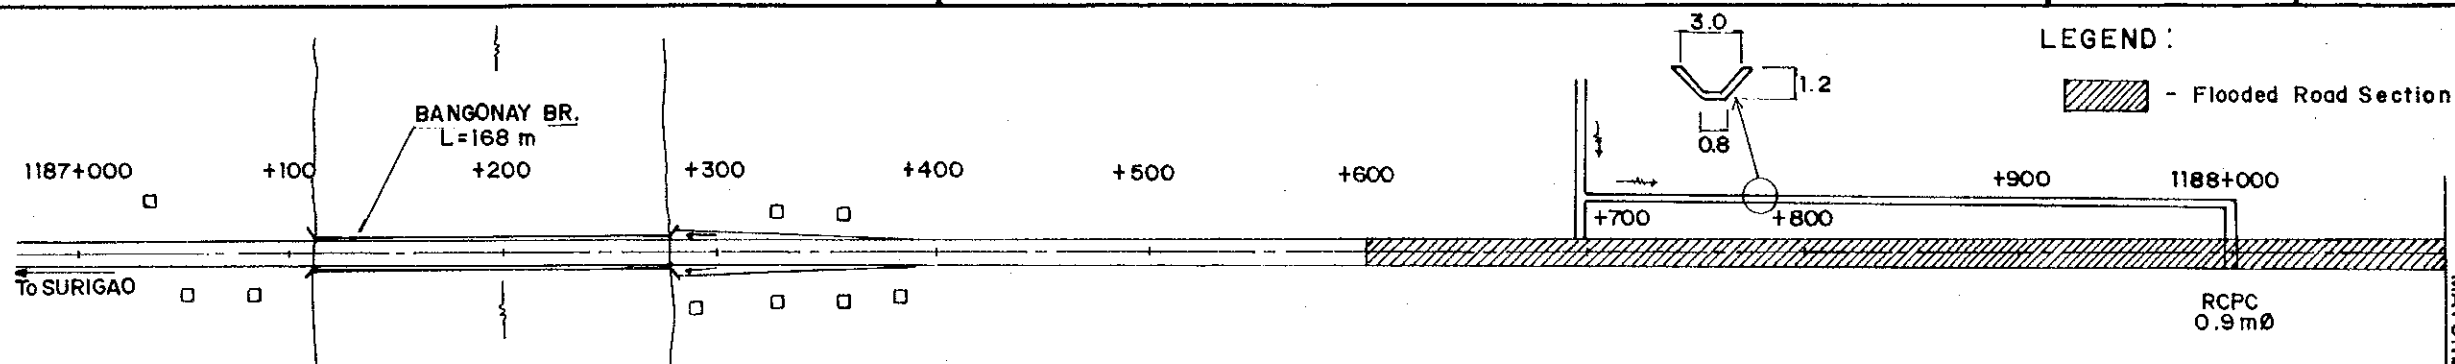
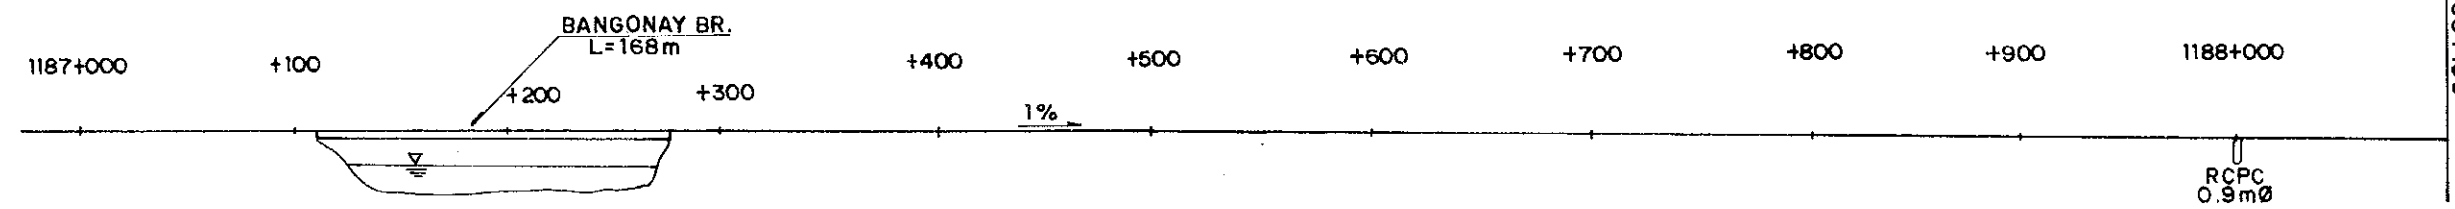
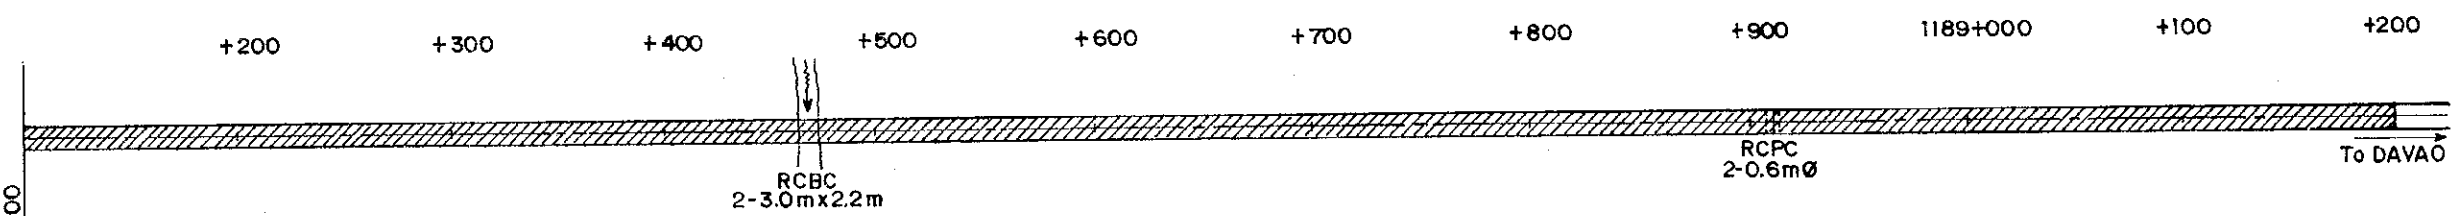
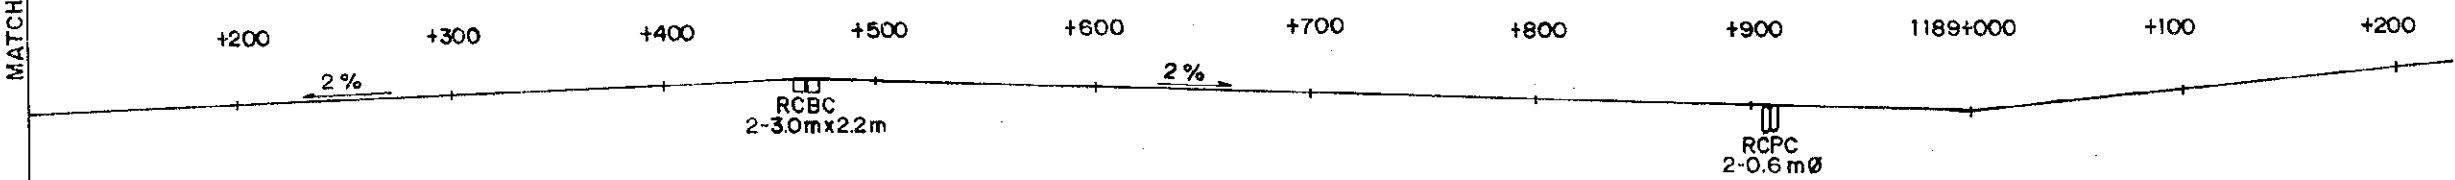
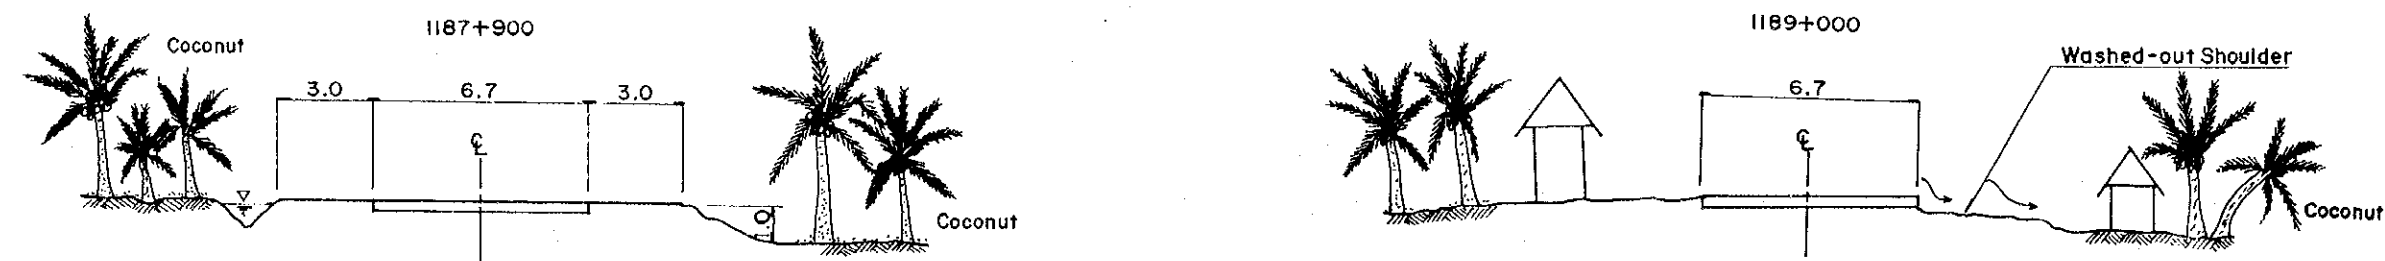
DRAWING NO.
F-9(1/2)

STATION : 1187+600 - 1189+200
EXISTING CONDITION

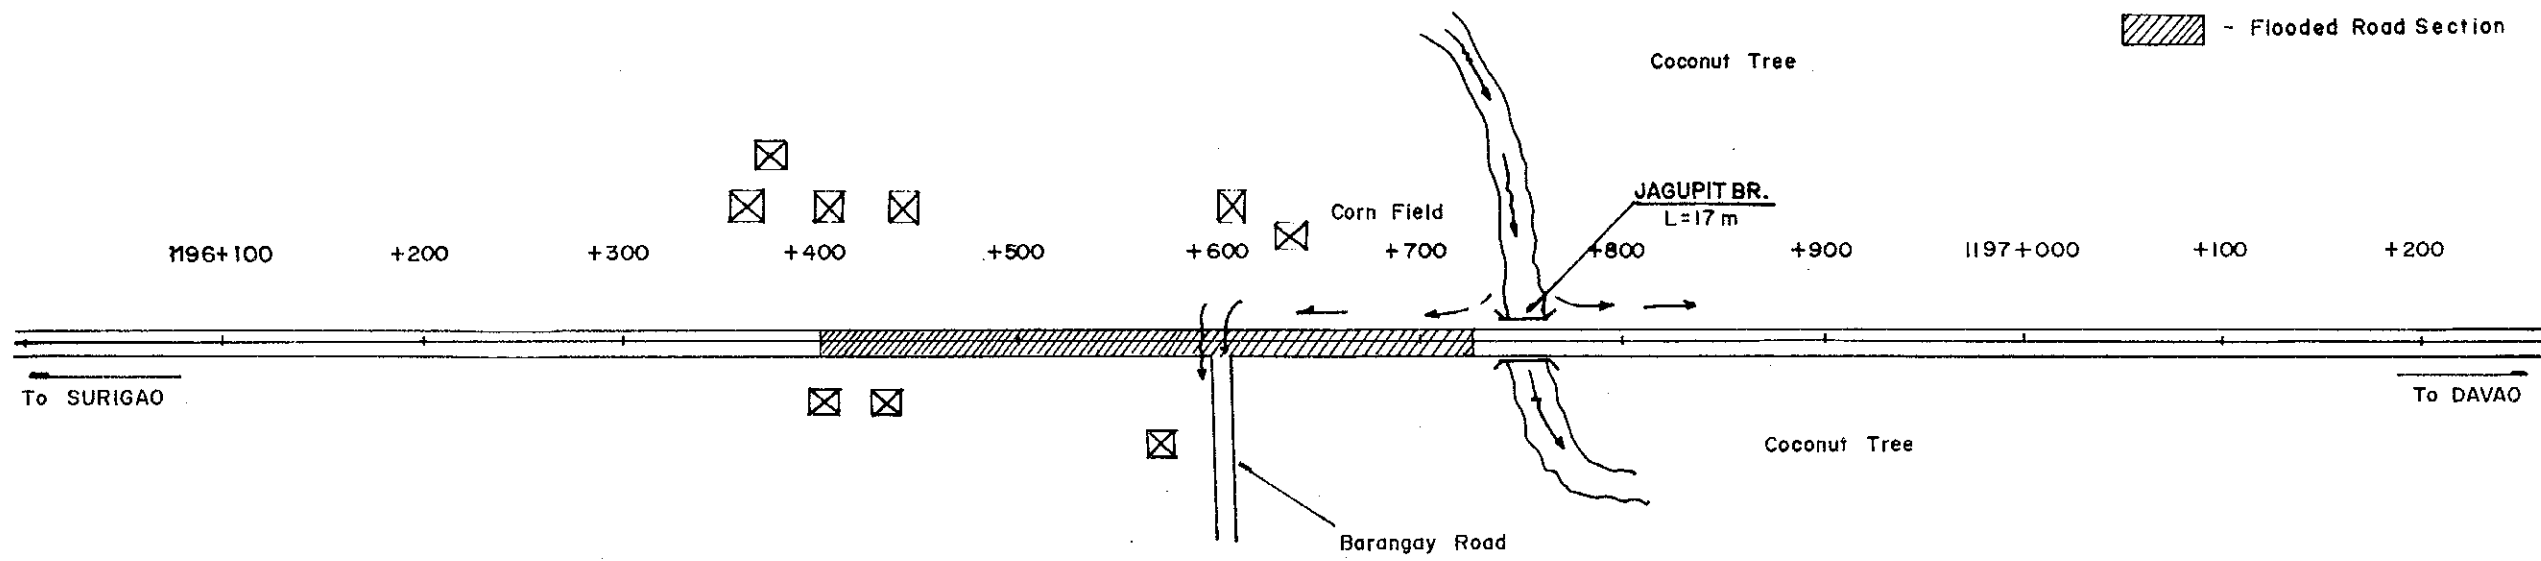
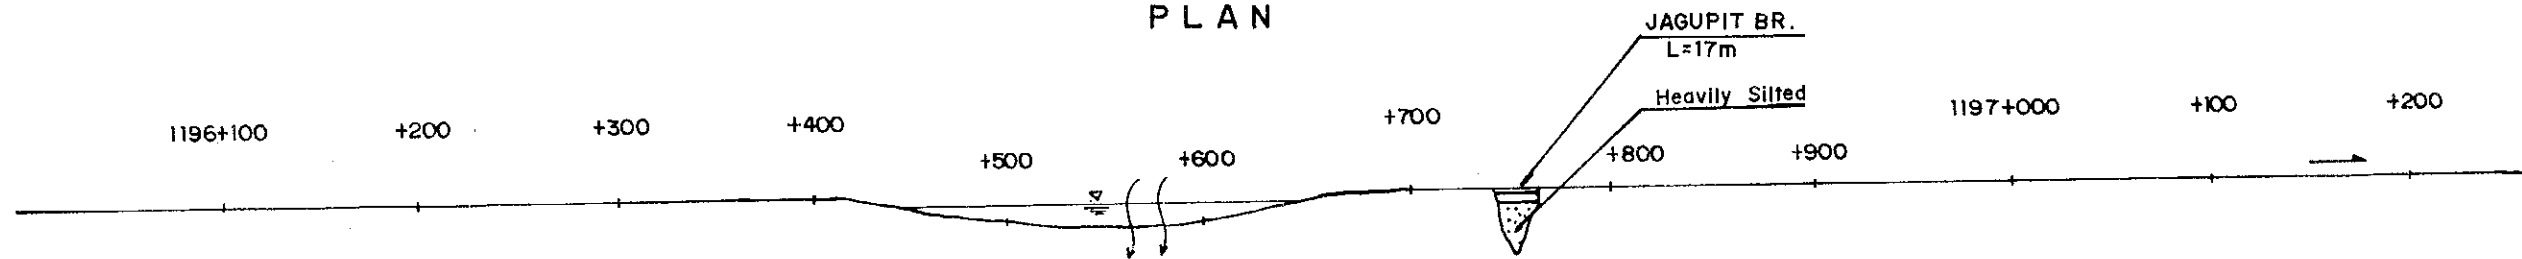
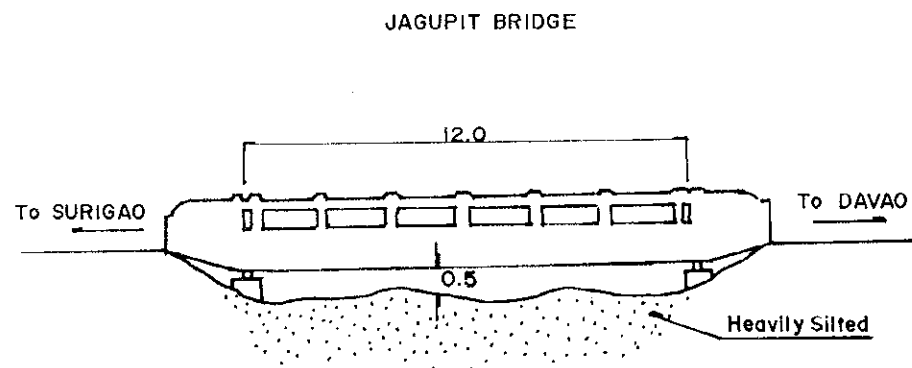
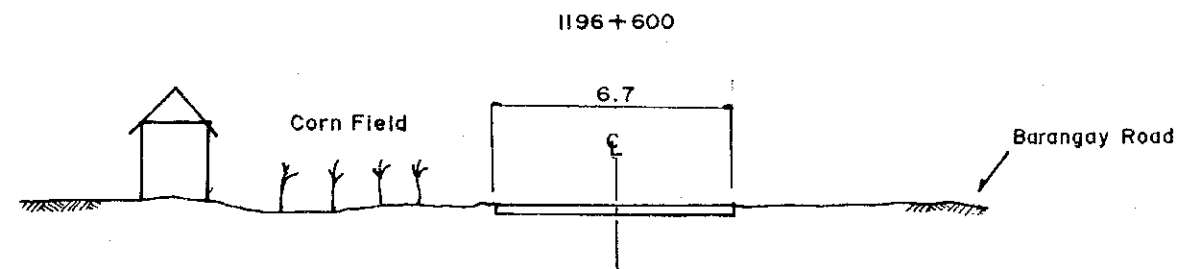
FLOOD SECTION NO. : II STATION : 1196+400-1196+720
FLOOD TYPE : III EXISTING CONDITION

- Flooded Road Section

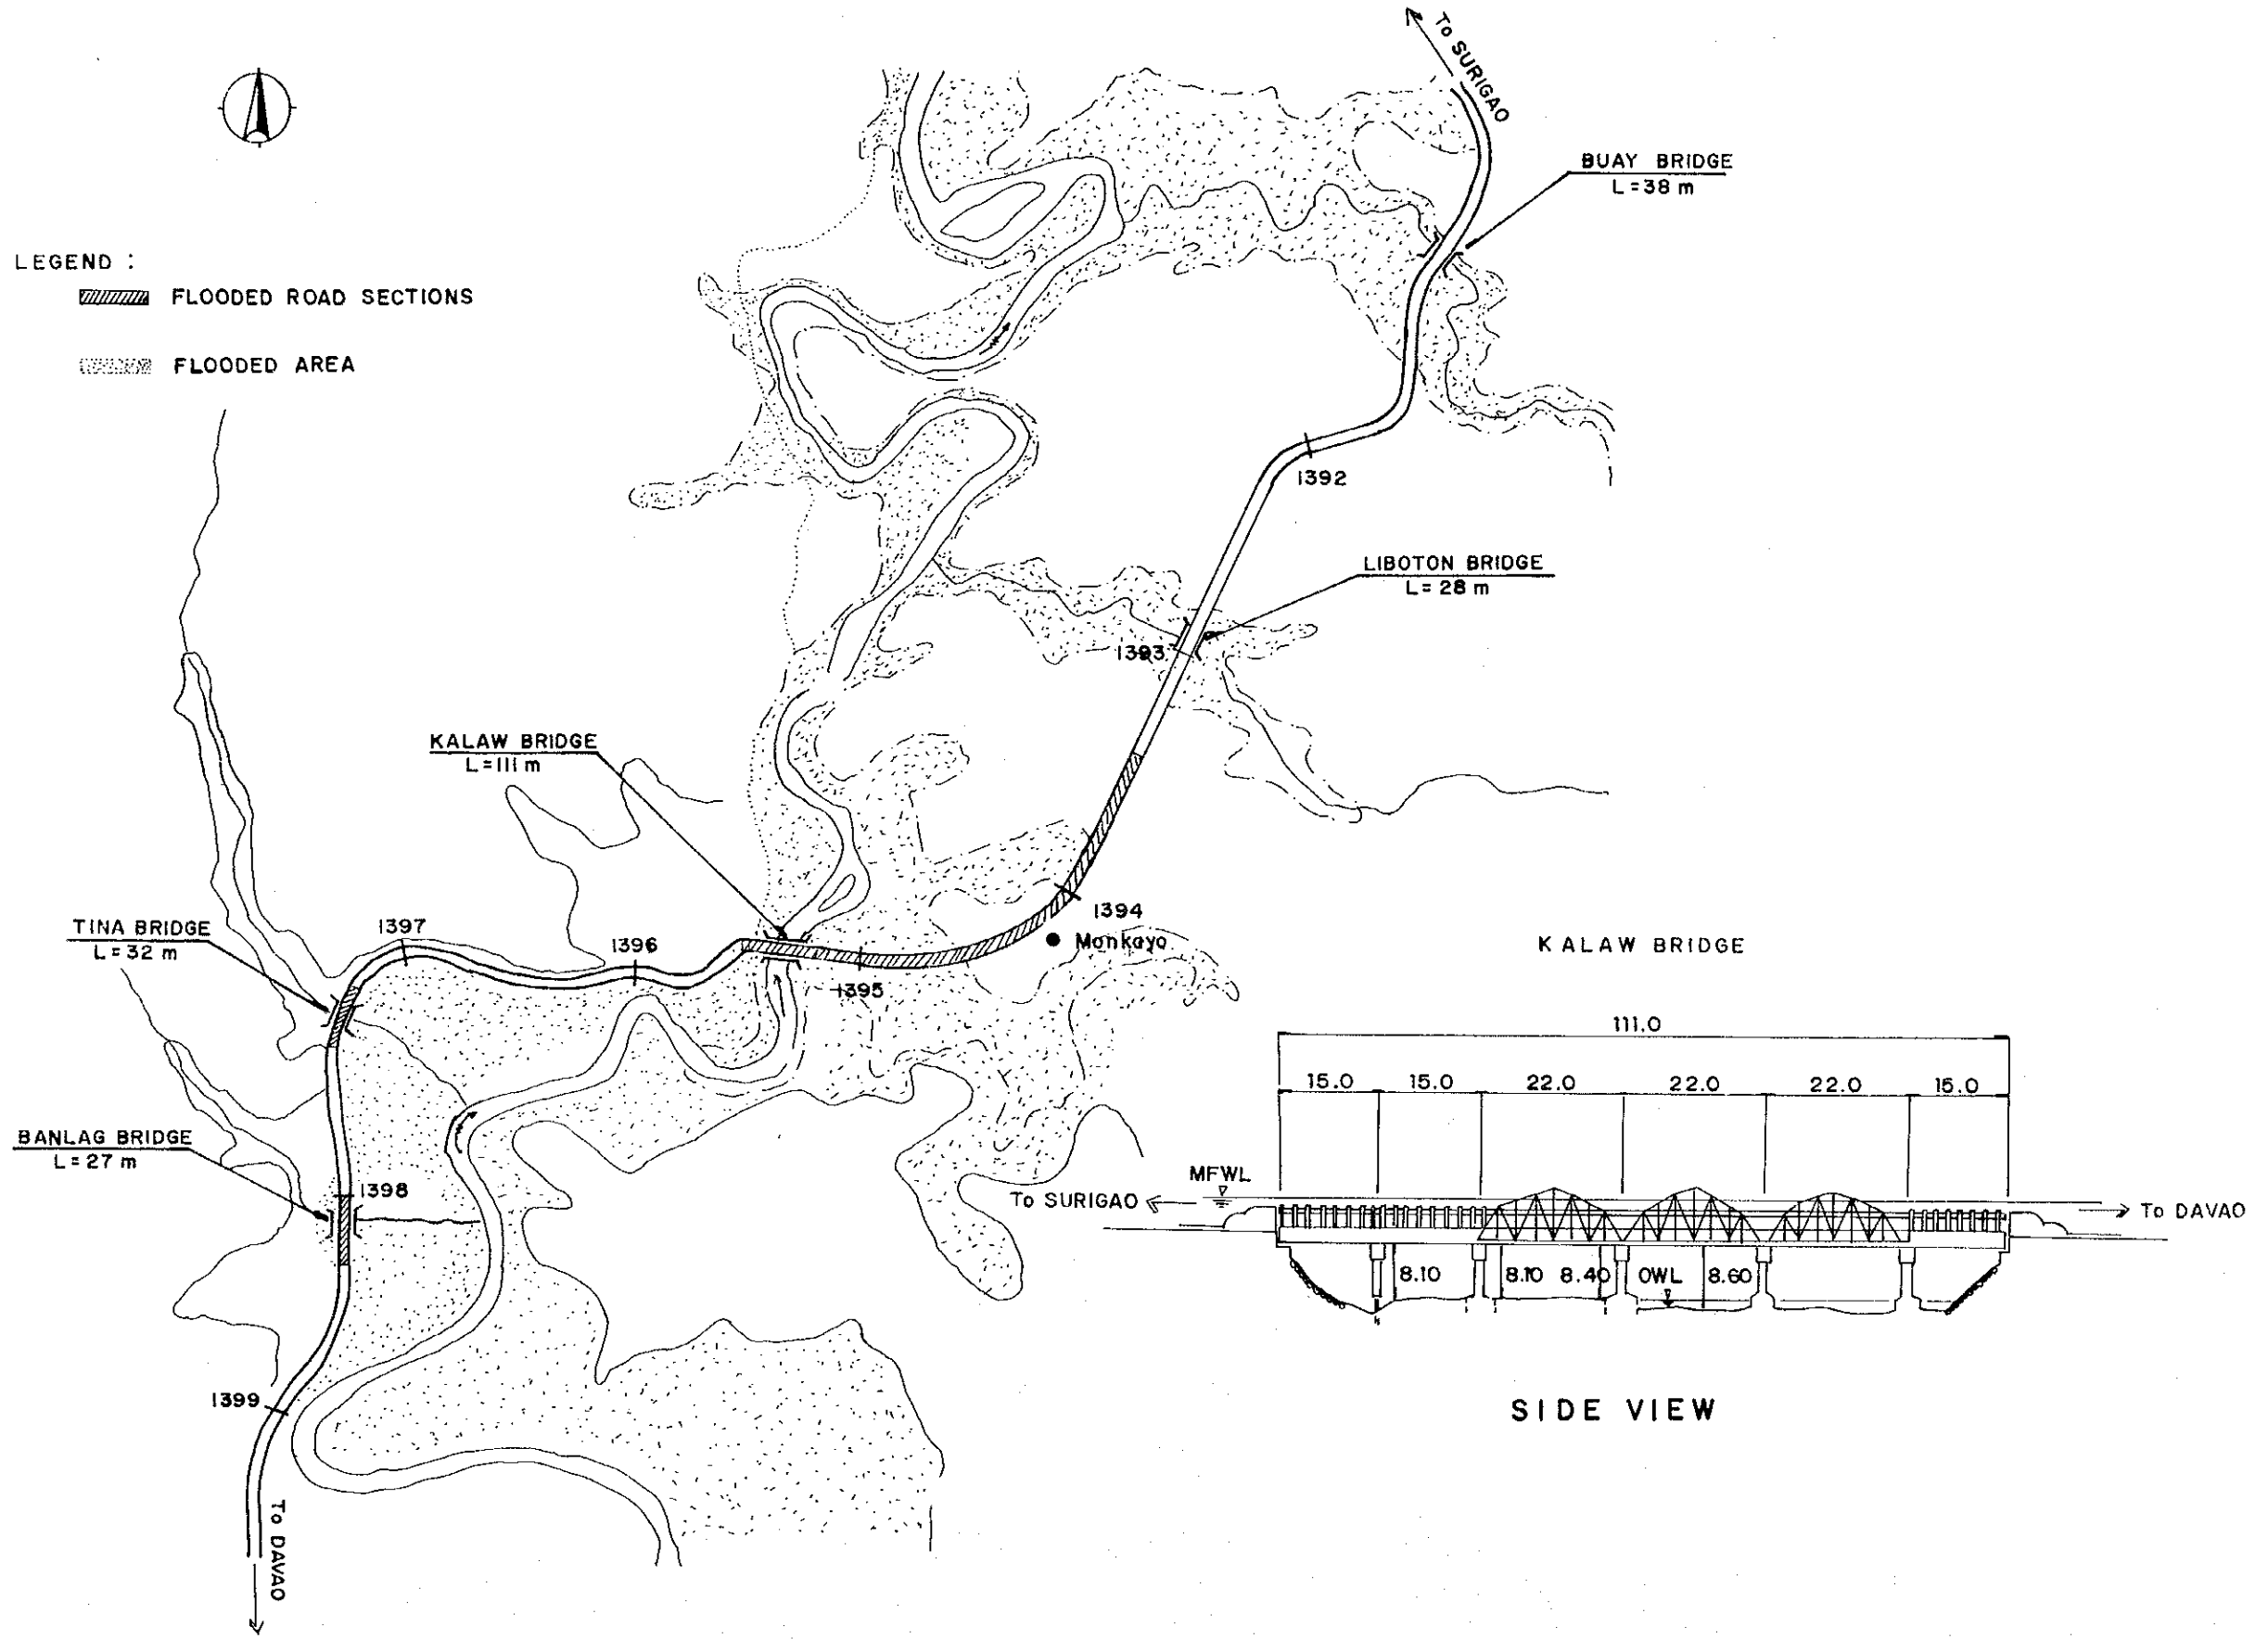
FLOOD SECTION NO. : 17 STATION : 1393+400 - 1398+300
FLOOD TYPE IV EXISTING CONDITION

FLOODED AREA
