4.6.3 Existing Status of Damages

4.7.3 Existing Status of Damages

4.8.3 Existing Status of Damages

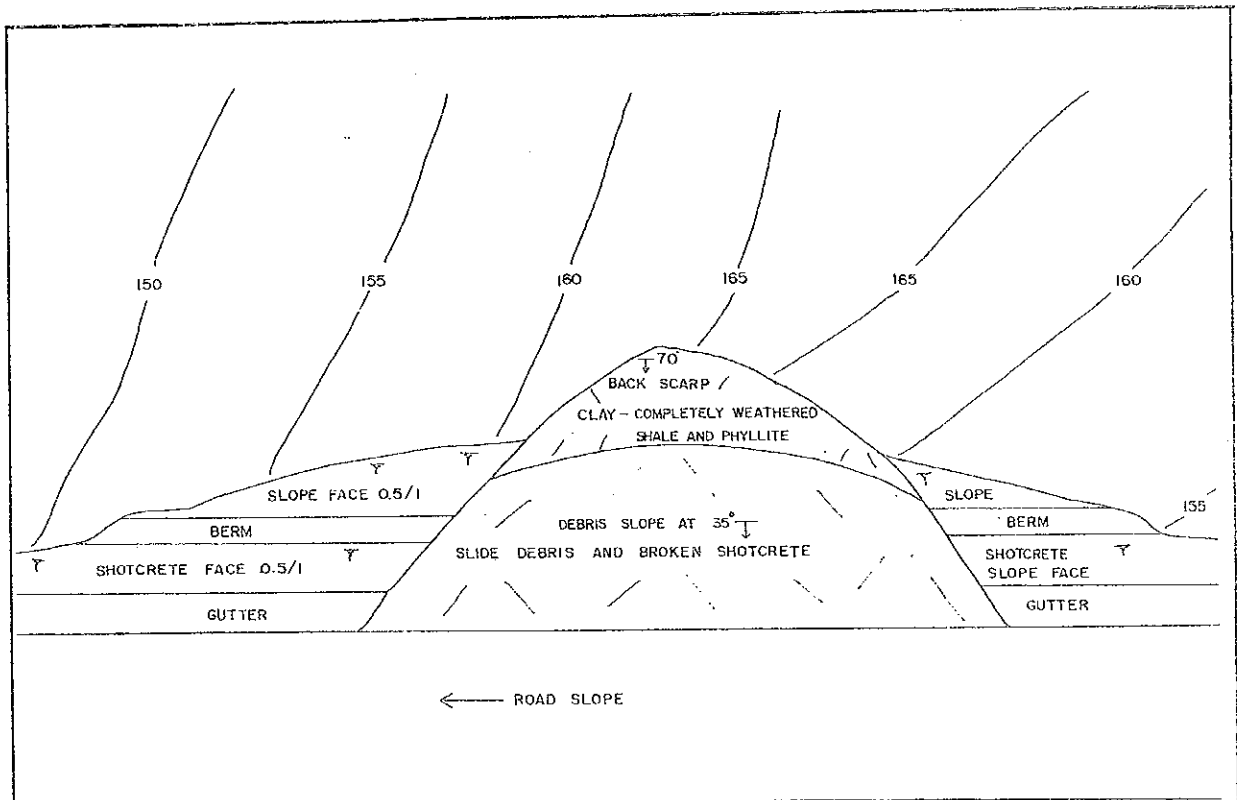
Fig. 4.6.4 Details of Disaster Spot

3. Spot 410/3: Rotational Landslide on a Cut Slope (SD-2-6)

The existing conditions are illustrated in Fig. 4.6.4.

SPOT 410/3 KM. 82.100
EXISTING CONDITIONS

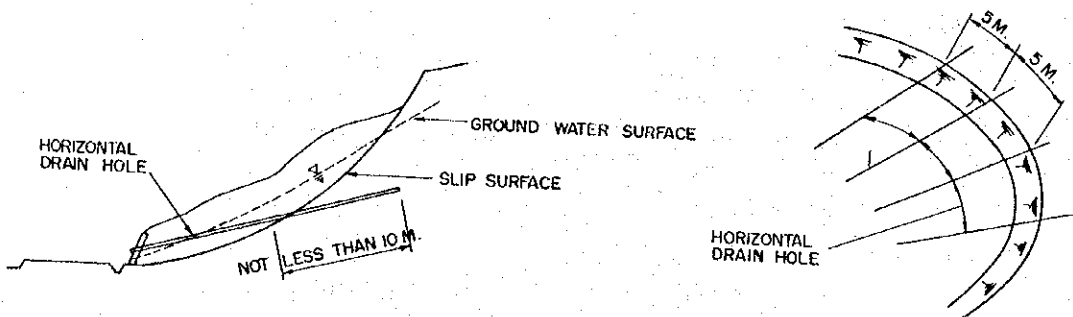
Fig. 6.2.19 Horizontal Drain Holes

- a drain hole 66mm in diameter is made by boring,
- a hard polyvinyl chloride pipe is inserted into the bored hole to sustain the hole and to collect and drain the water,
- boring is done at an upward angle of 5 degrees, and installed about 10 meters into the water holding layer outside of the sliding plane,
- drain holes are made at intervals of 5 meters along the sliding plane.
