LOCAL GOVERNMENT ENGINEERING DEPARTMENT,
MINISTRY OF LOCAL GOVERNMENT, RURAL DEVELOPMENT
AND COOPERATIVES
THE PEOPLE'S REPUBLIC OF BANGLADESH

BASIC DESIGN STUDY REPORT
ON
THE PROJECT FOR THE CONSTRUCTION OF
MULTIPURPOSE CYCLONE SHELTERS (II)
IN
THE PEOPLE'S REPUBLIC OF BANGLADESH

(APPENDIX 9. RESULTS OF SITE CONDITIONS SURVEY
APPENDIX 10. RESULTS OF NATURAL CONDITIONS SURVEY)

JAPAN INTERNATIONAL COOPERATION AGENCY
JAPAN ENGINEERING CONSULTANTS CO., LTD.

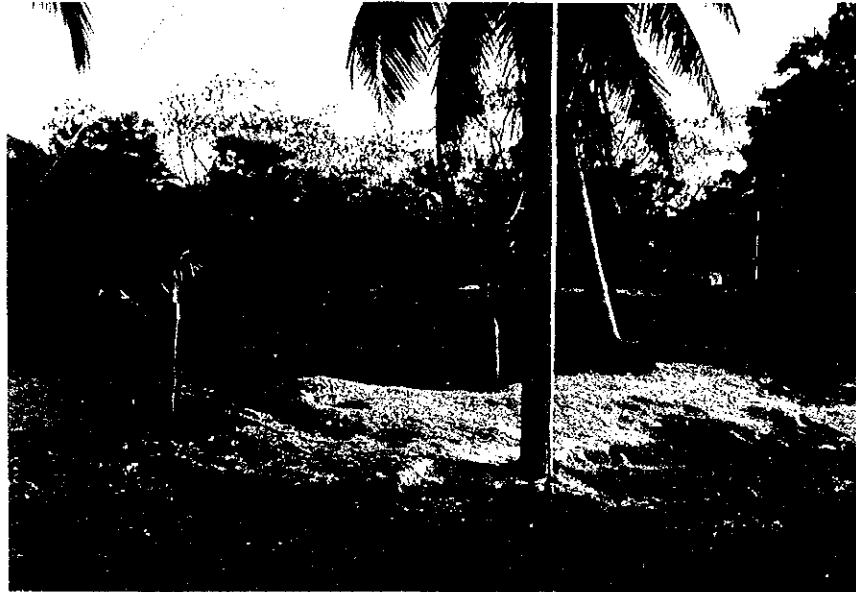
- 2) Road Conditions *1 Km Road*
 - Kind of Pavement: Earth, Gravel, Brick, Asphalt, Concrete.
 - Condition of Pavement: Good, Not so good, Bad
 - Road Width : *2.5 to 3.0 m* *Road gets muddy in rainy seasons*

Road Conditions
near the Site

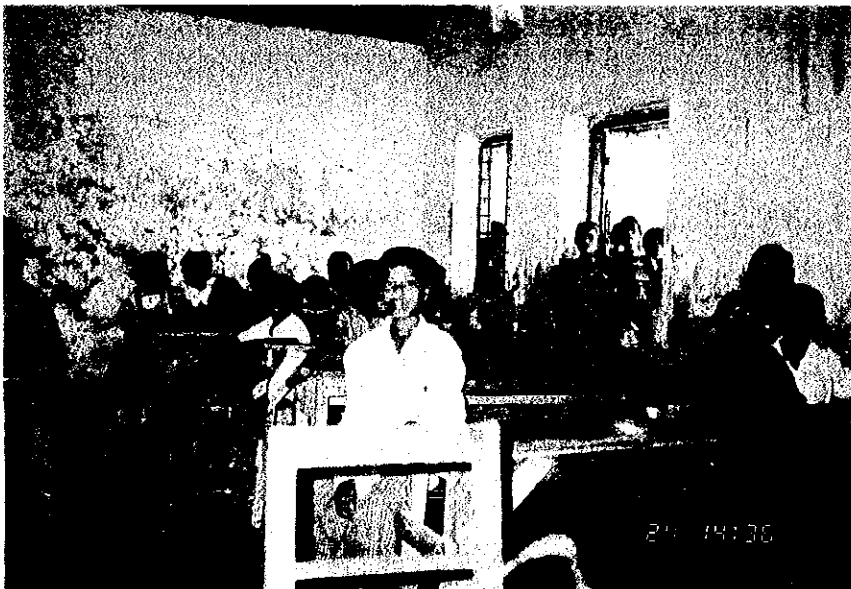
Current Conditions
of A Classroom

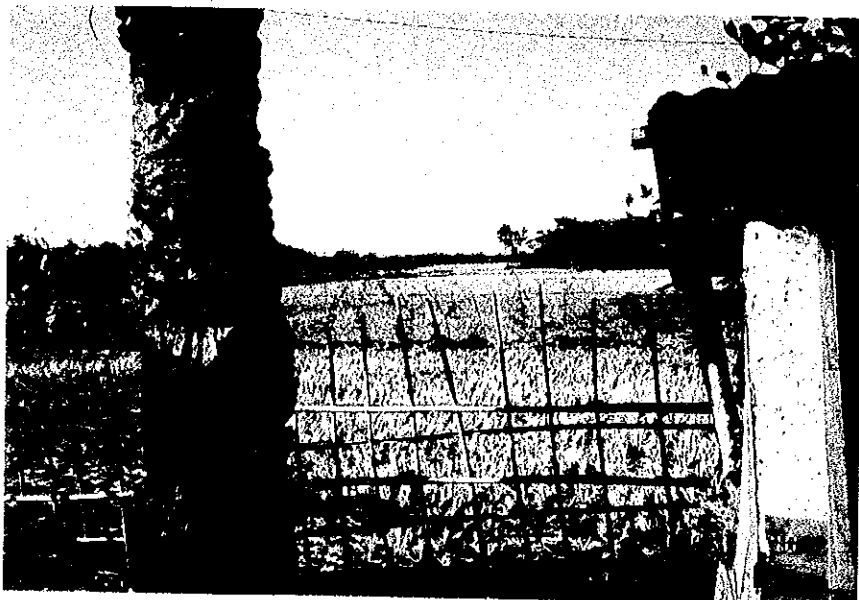
- Condition of Pavement: Good, Not so good, Bad
 - Road Width : 2.0 m *Road gets muddy in rainy season*
 - Passable Vehicle: Motor cycle, Rikisha, Sedan, Jeep, Truck (2 ton) *only in dry season*

Road Conditions
near the Site

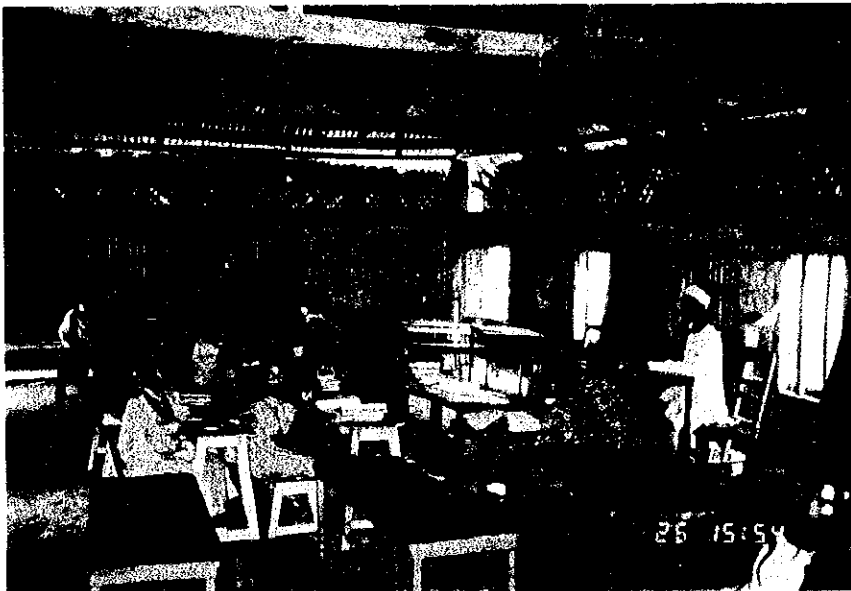
Current Conditions
of A Classroom

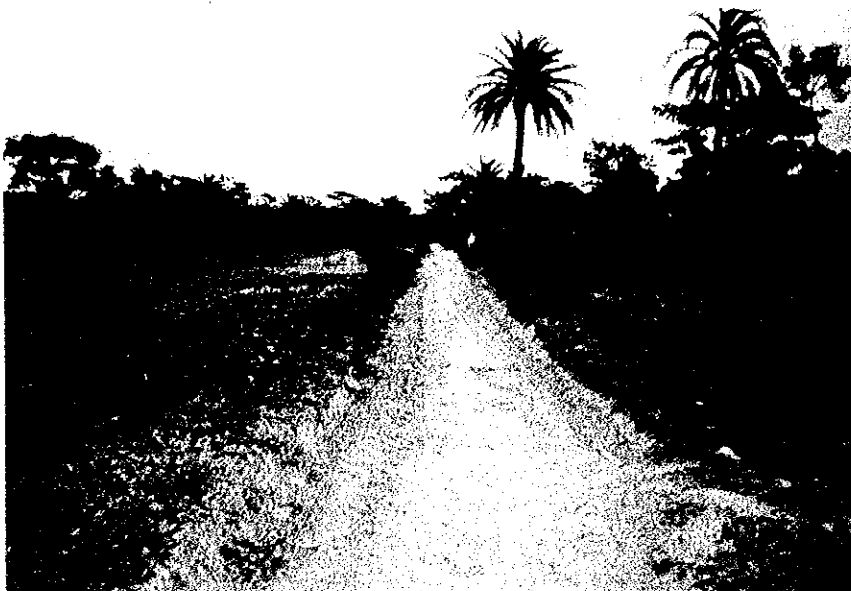
Road Conditions
near the Site

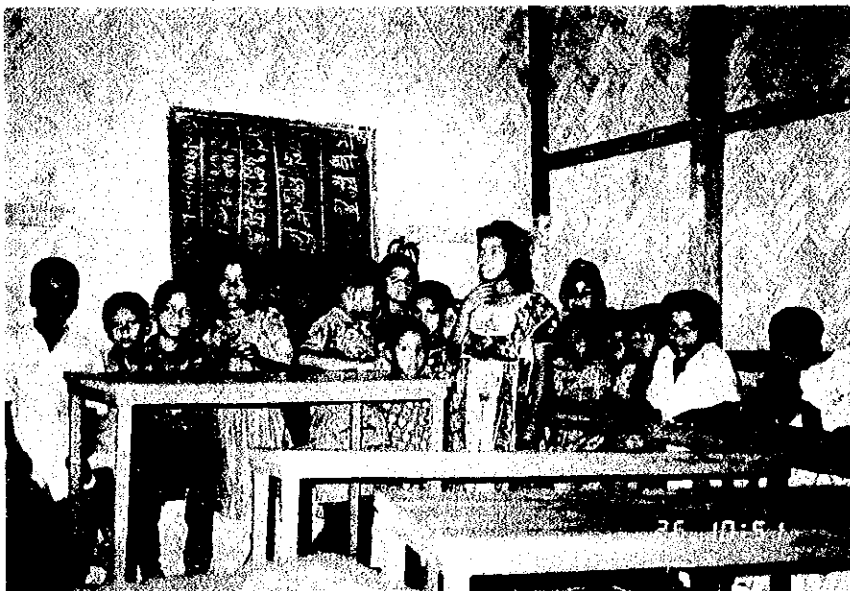
Current Conditions
of a Classroom

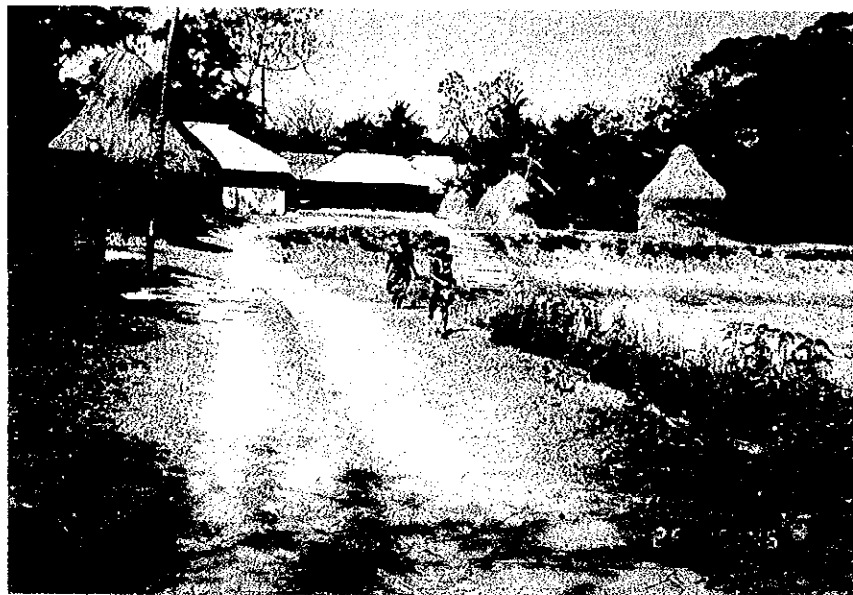
Road Conditions
near the Site

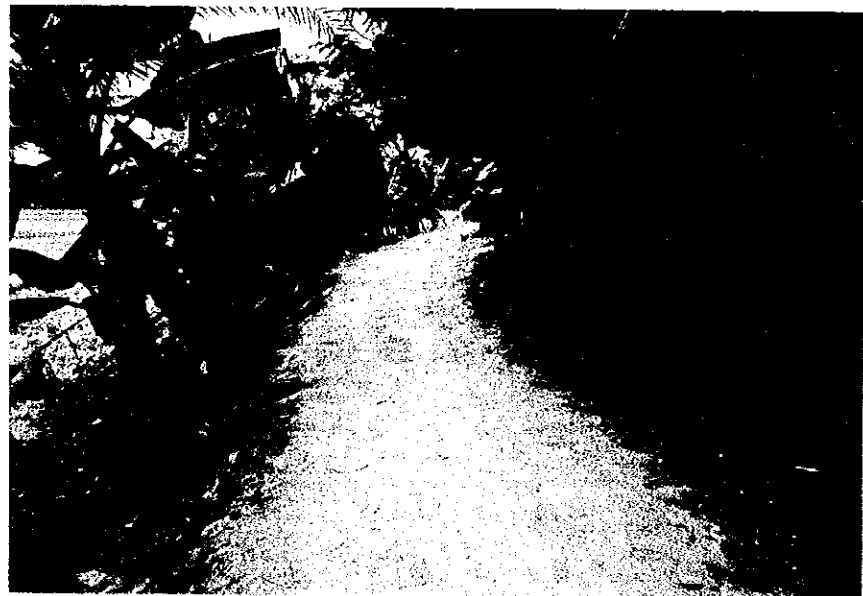
Road Conditions
near the Site

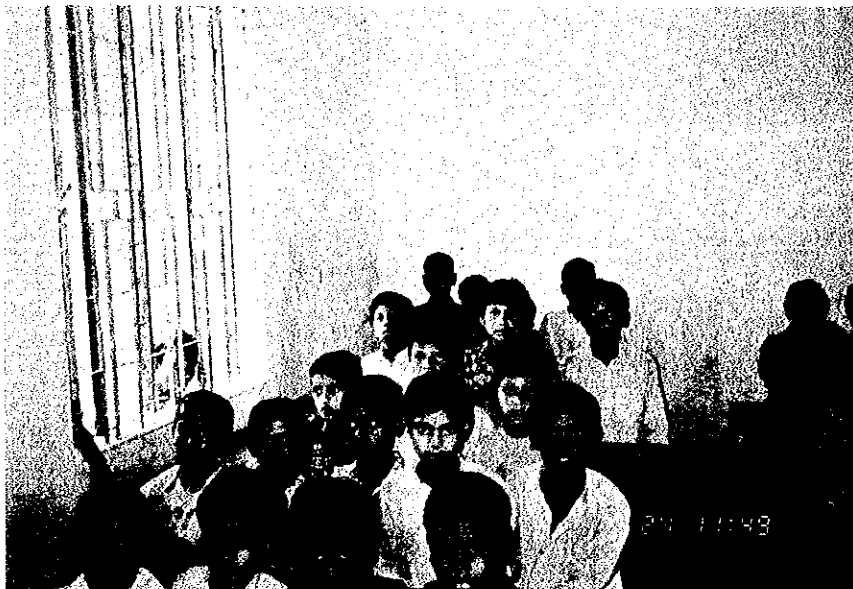
Current Conditions of a Classroom

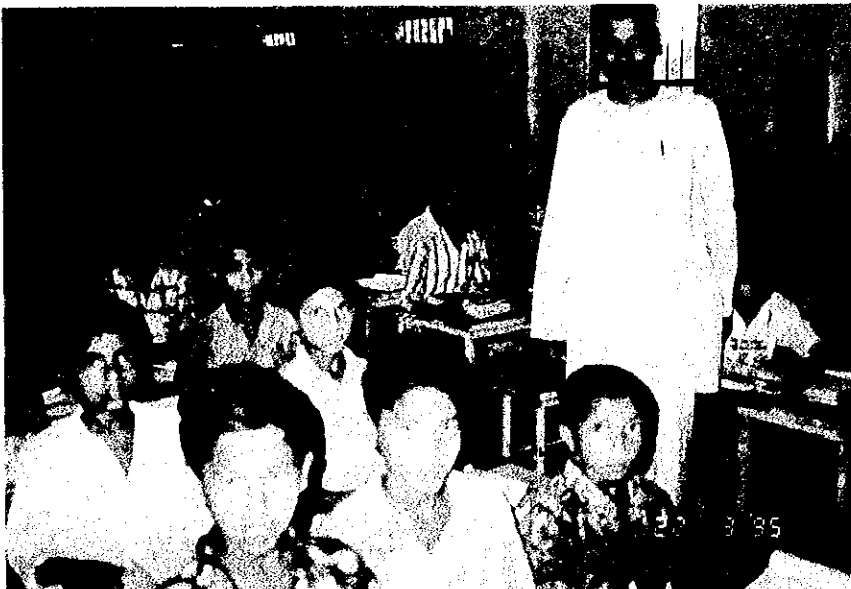
Current Conditions
of A Classroom

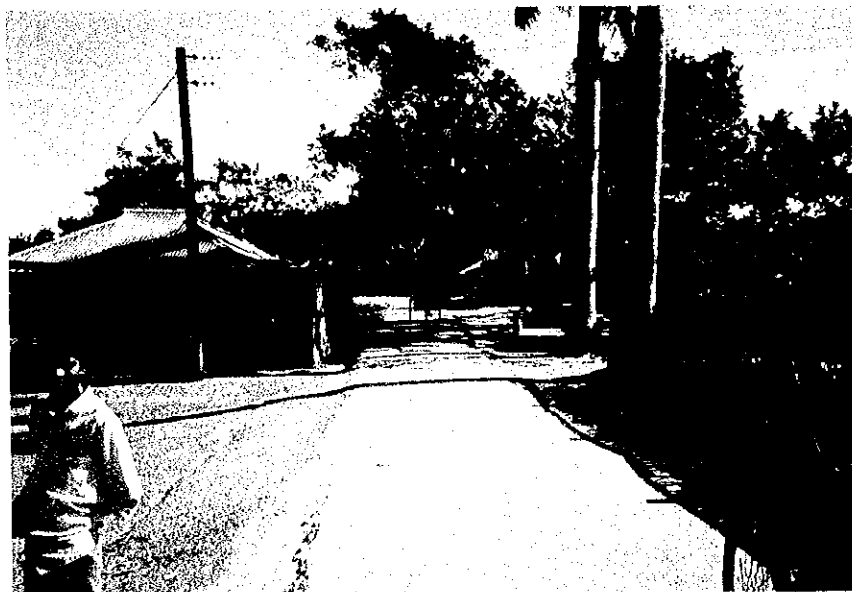
Road Conditions
near the Site

5. Accessibility
 - 1) Nearest Station. Port. Main Road Distance: 6.0 km
 - 2) Road Conditions
 - Kind of Pavement: Earth Gravel, Brick, Asphalt, Concrete.

- Condition of Pavement: Good, Not so good, Bad
 - Road Width : 2.5 m
 - Passable Vehicle: Motor cycle, Rikisha, Sedan, Jeep, Truck (2.0 ton)
 - Necessity for Repair of Road: Yes No. (only in dry season)

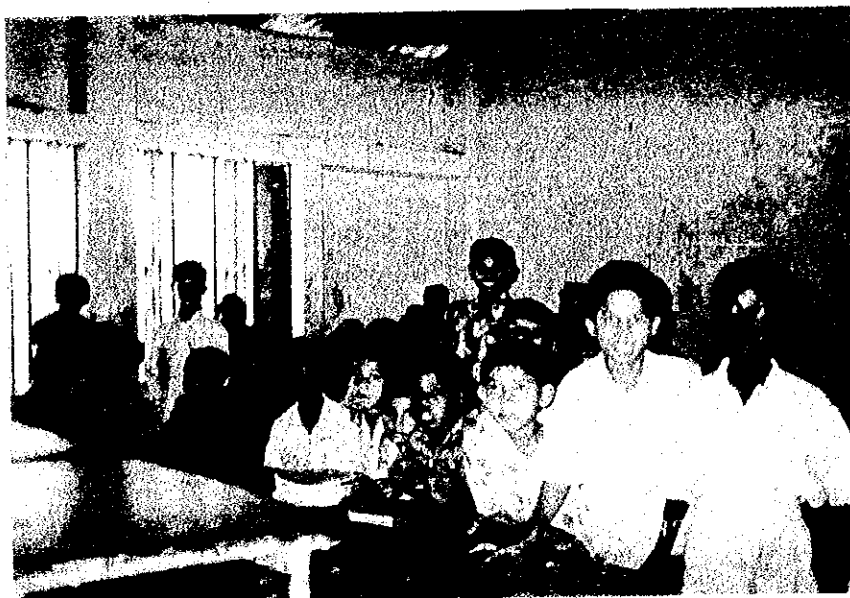
Current Conditions
of A Classroom

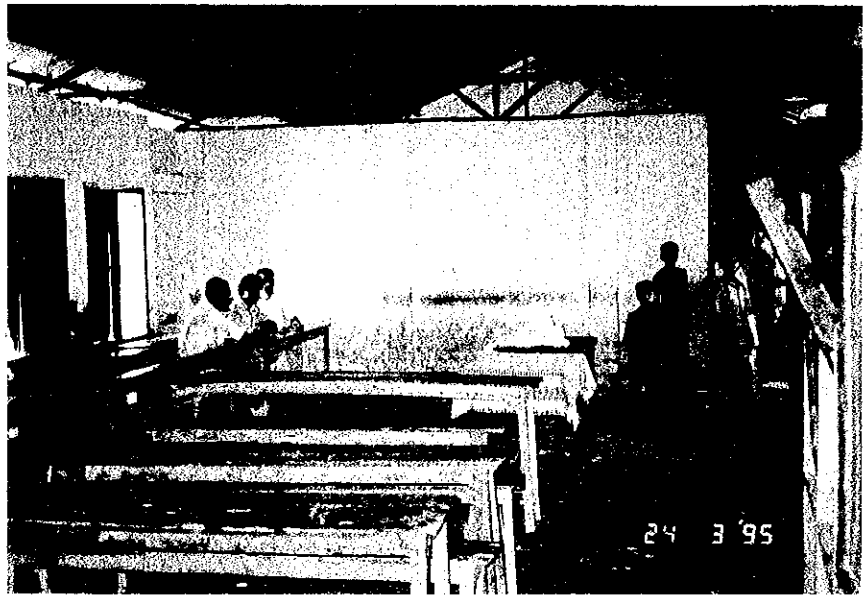
Current Conditions
of A Classroom

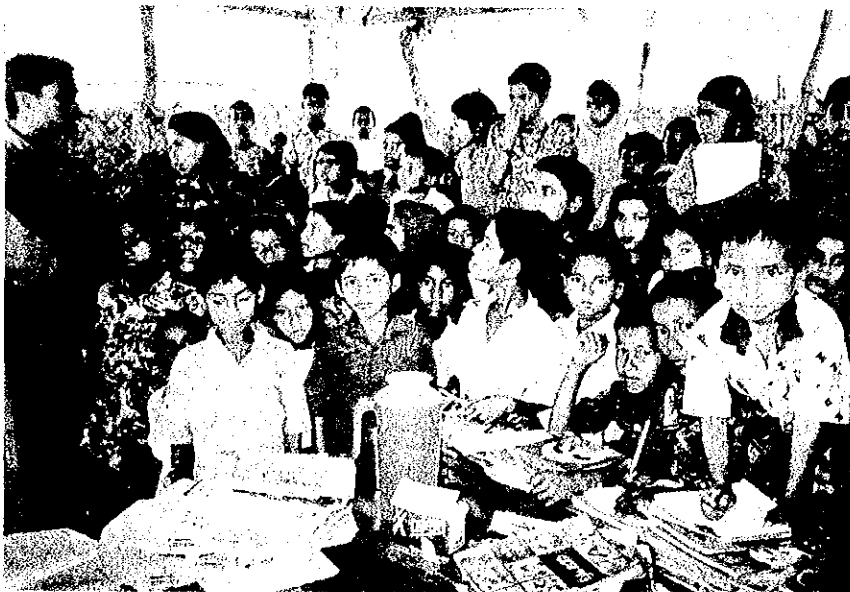
Current Conditions
of A Classroom

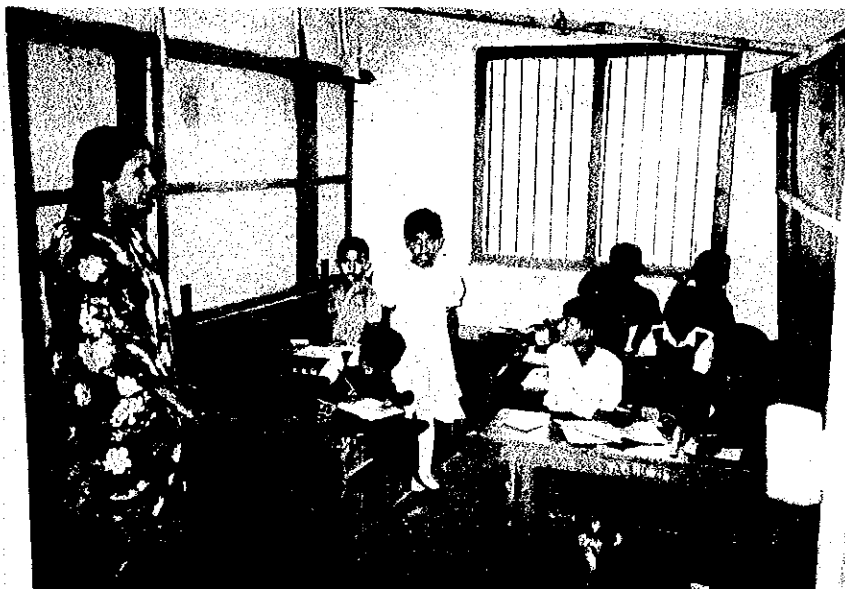
Current Conditions
of A Classroom
