SITE SURVEY CHECK LIST

(Date: 1995/ 3 / 24)

1. Site No. 27
2. Name of School: East Char Algi Registered NGPS
3. Site Location : District; Laxmipur Thana : Rangate
 Union : Char Algi no. 9 Village: Char Algi

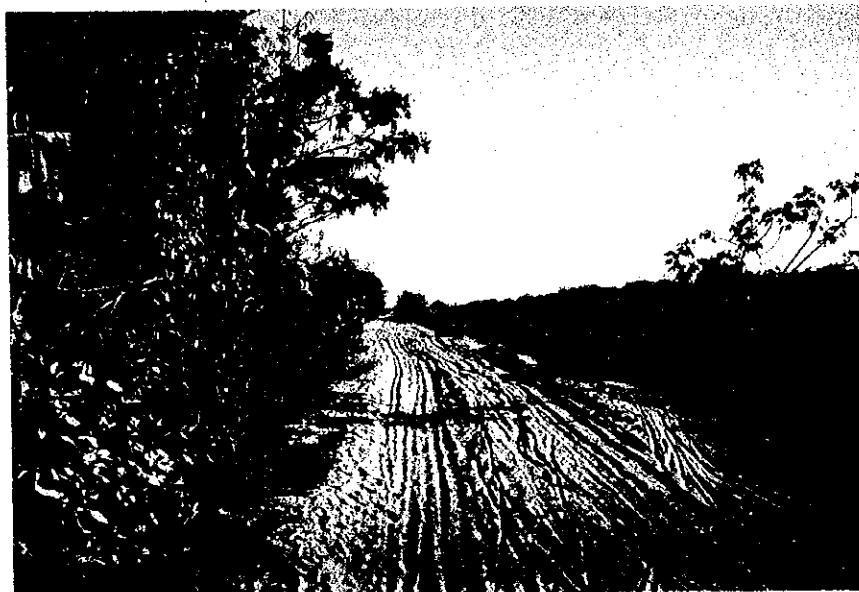
Road Conditions
near the Site

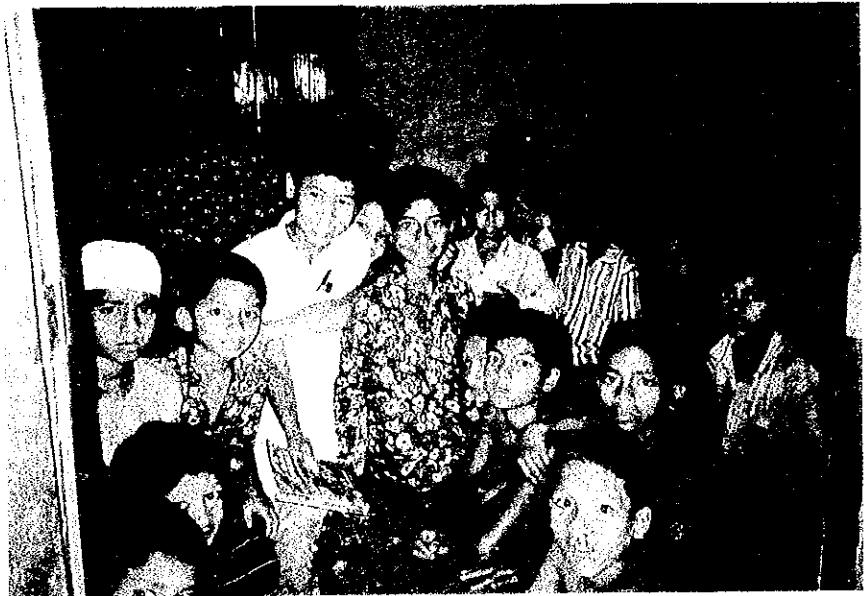
Current Conditions
of A Classroom

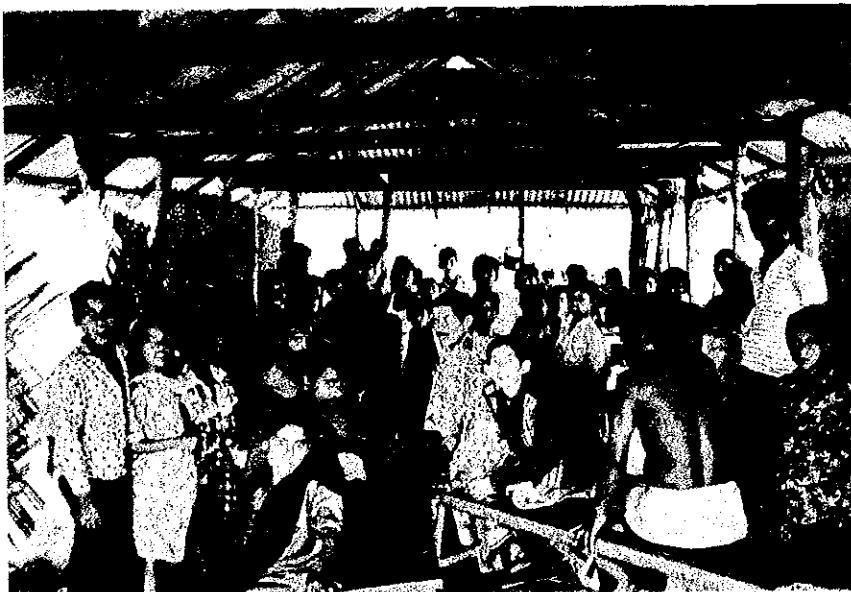
Current Conditions
of A Classroom

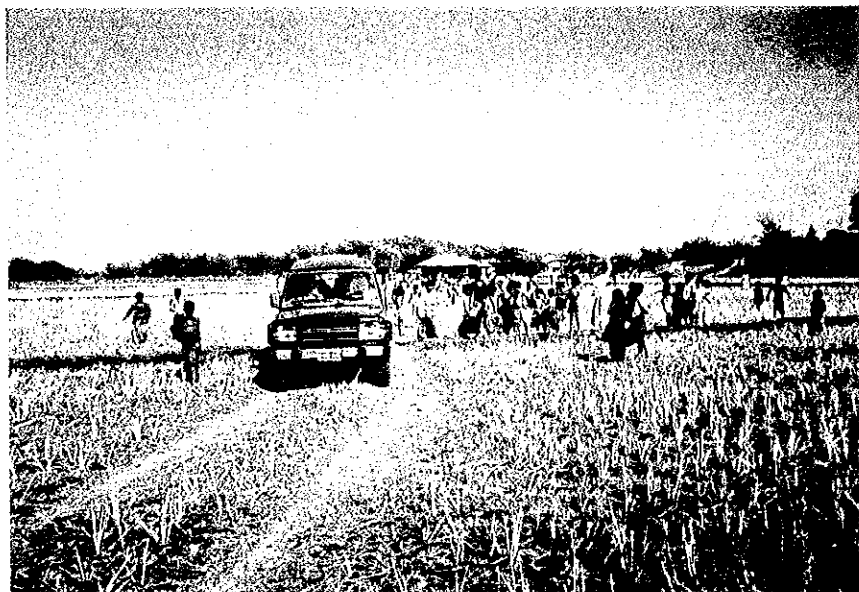
Road Conditions
near the Site

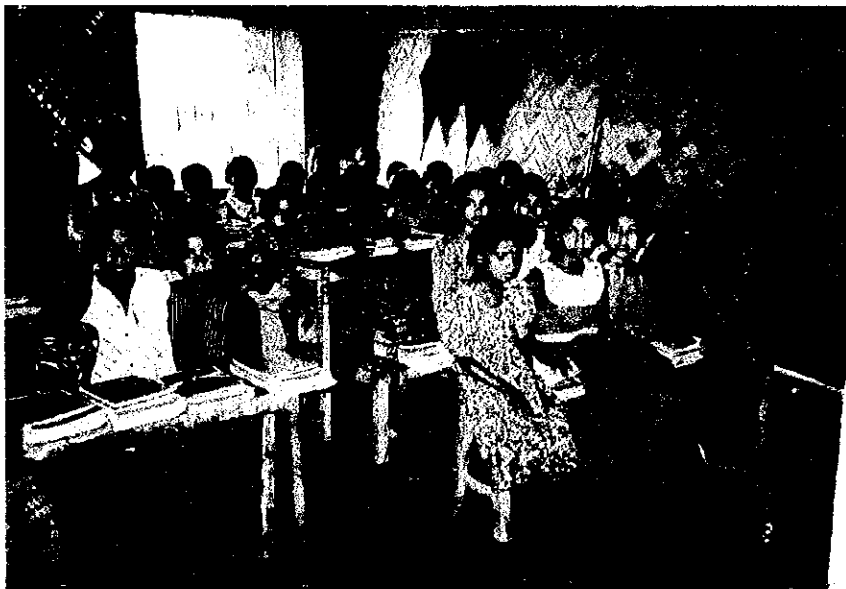
Current Conditions
of A Classroom

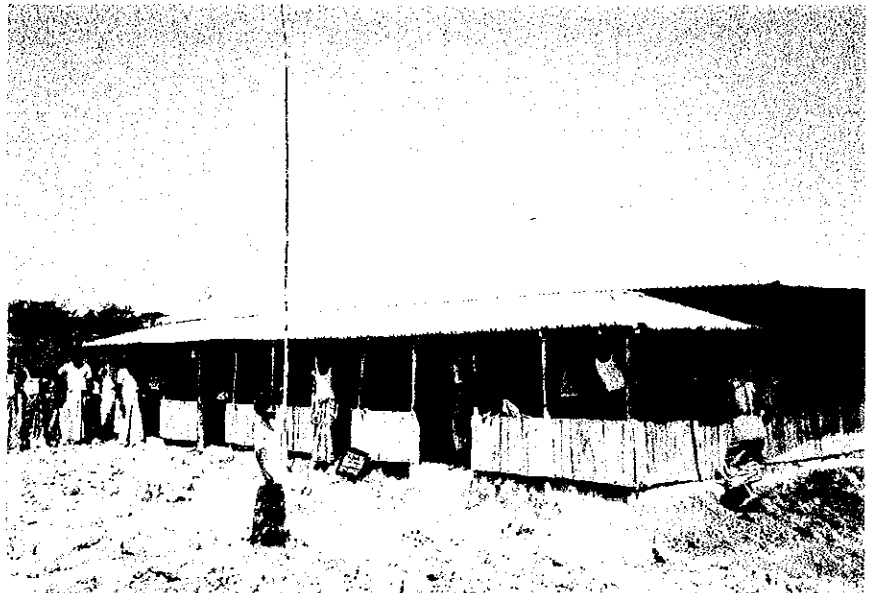
Overall View of
the School Building

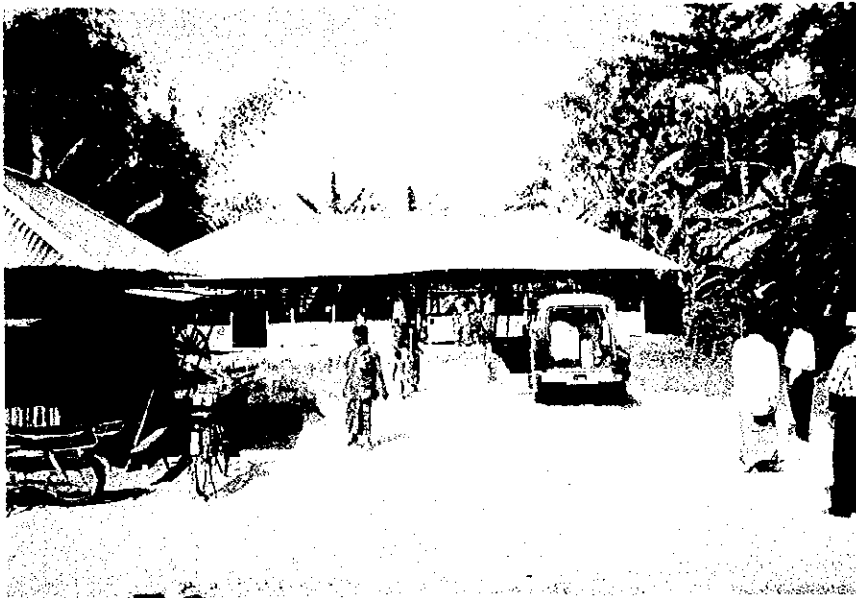
Overall View of
The School Site

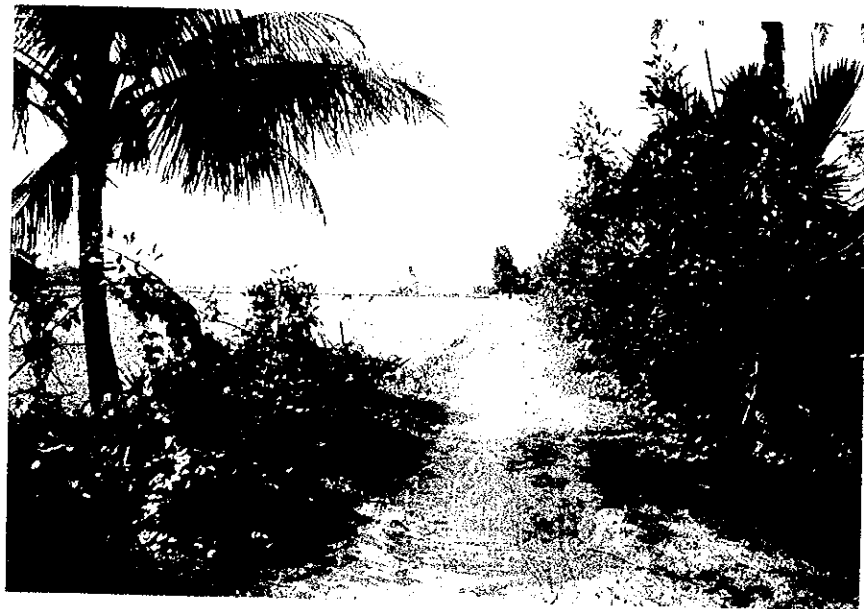
Road Conditions
near the Site

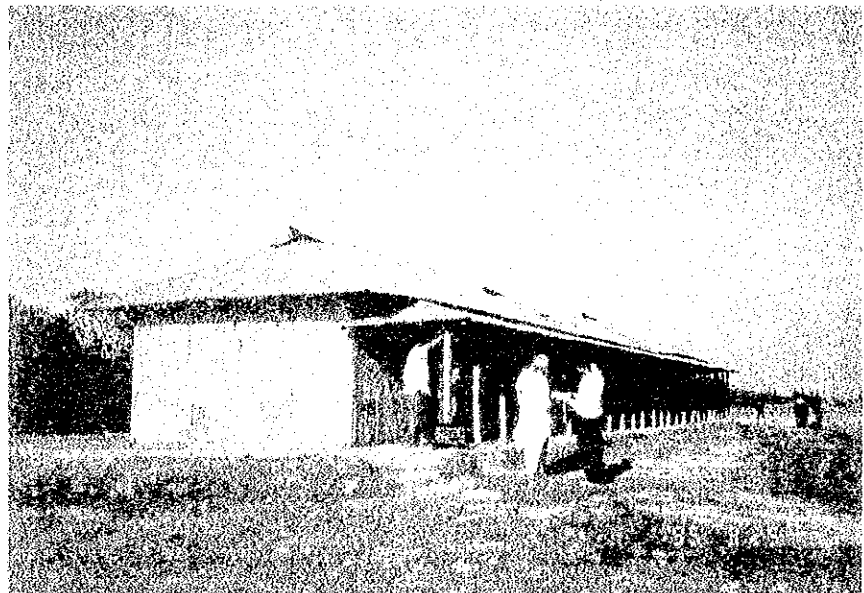
Overall View of
the School Site

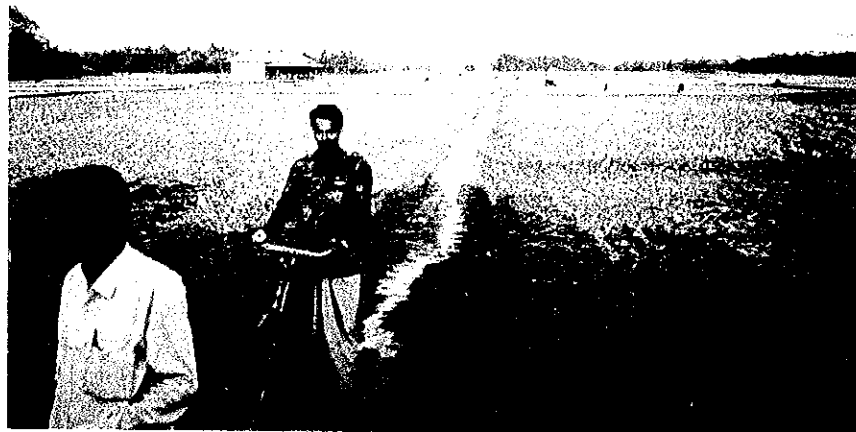
Existing Cyclone Shelter:
located about 0.9km away
from the School Site

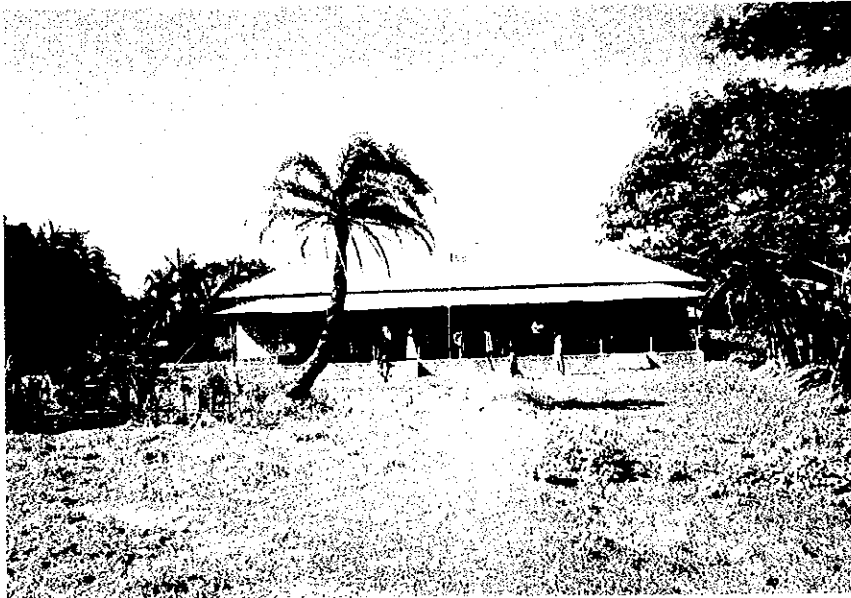
Overall View of
the School Site

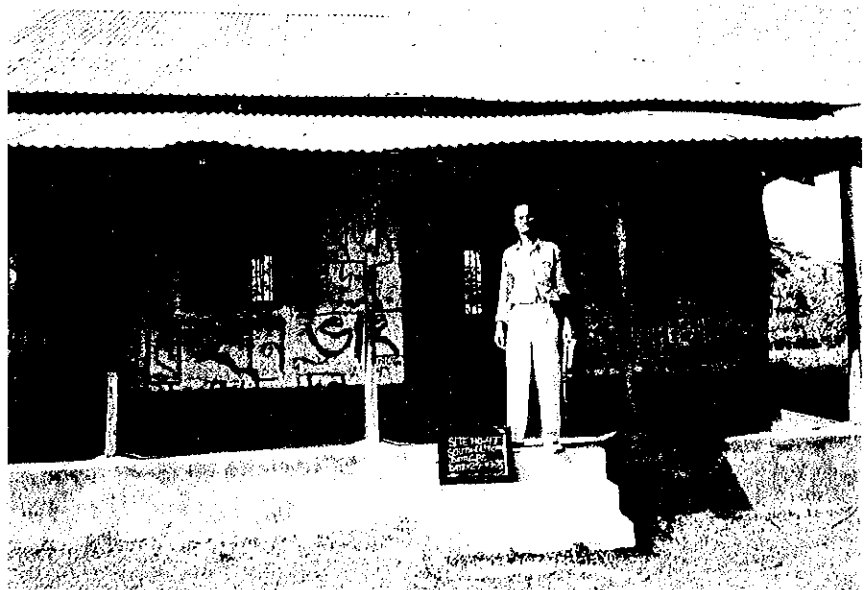
View of the School
Building

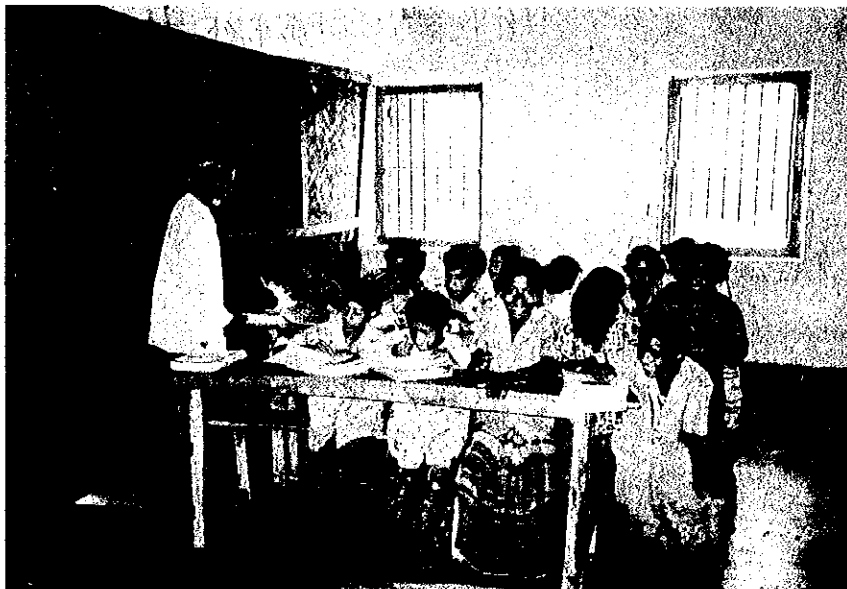
Current Conditions
of A Classroom

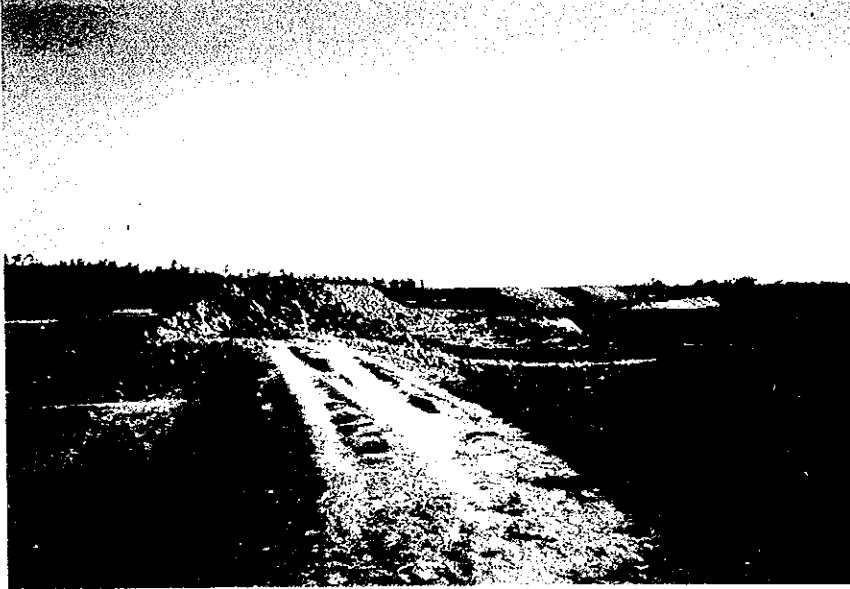
Current Conditions
near the Site
(Embankment being
constructed)

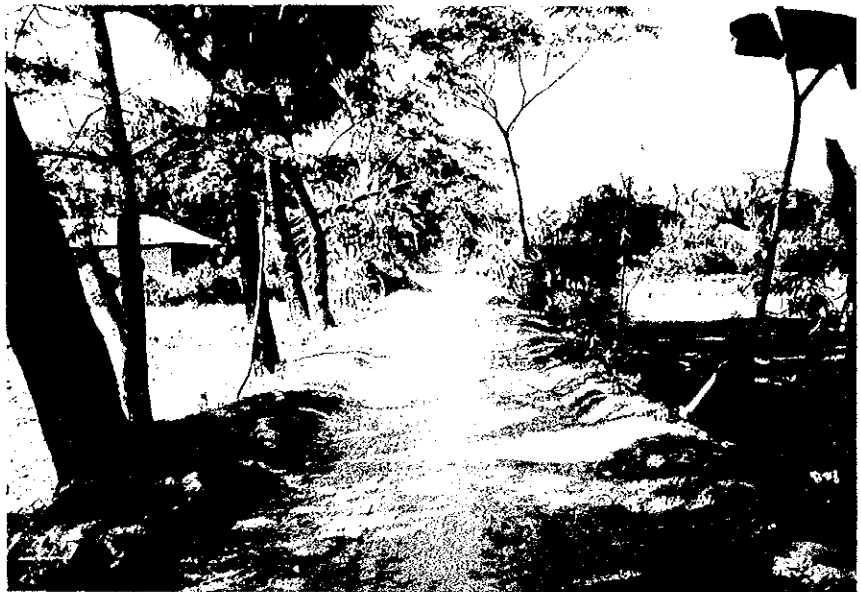
Road Conditions
near the Site

- Condition of Pavement: Good, Not so good, Bad
 - Road Width : 1.52.0m & pushcart Road gets muddy in rainy seasons.
 - Passable Vehicle: Motor cycle, Rikisha, Sedan, Jeep, Truck (ton)

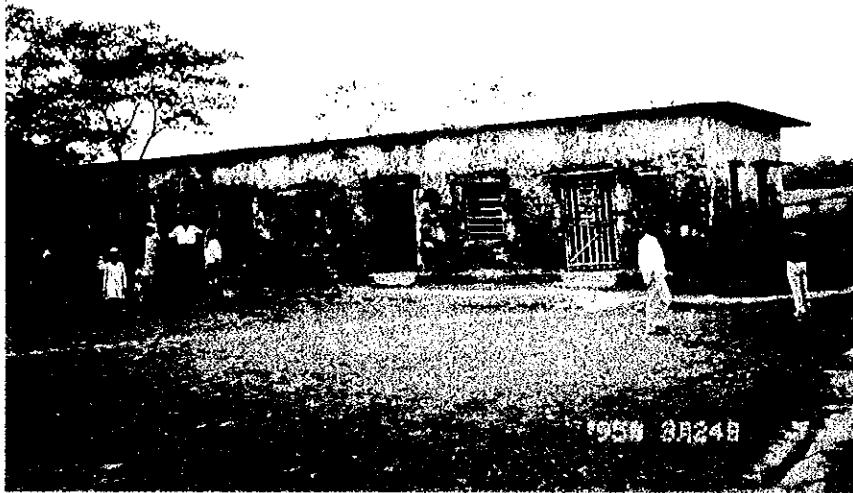
Overall View of
the School Site

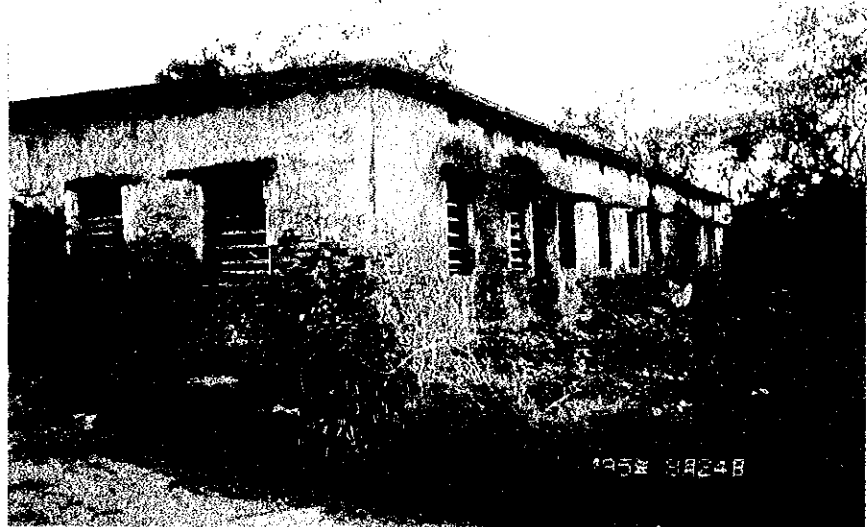
View of the School
Building

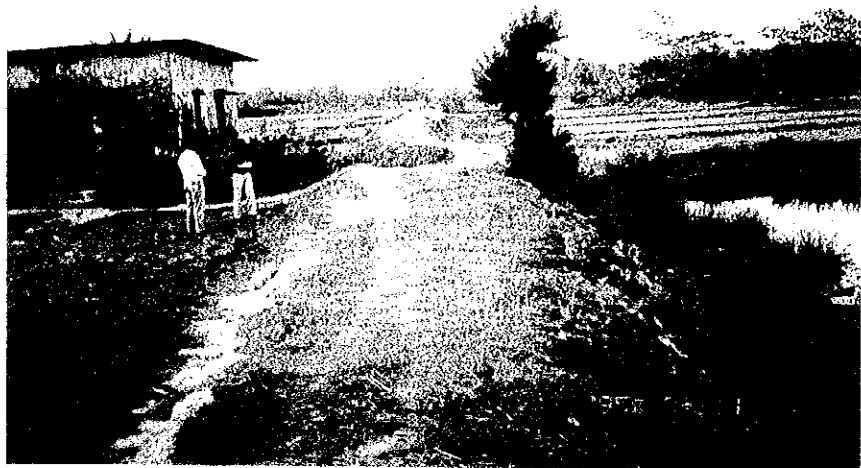
Road Conditions
near the Site

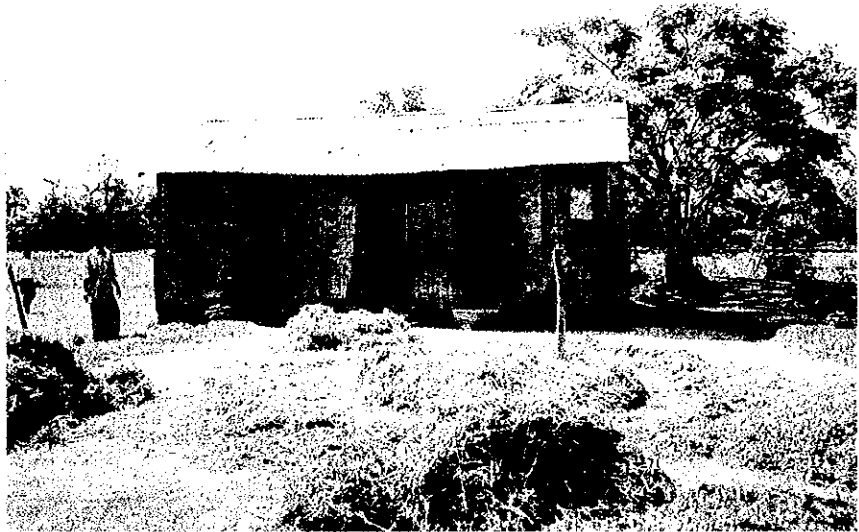
Overall view of
the School Building

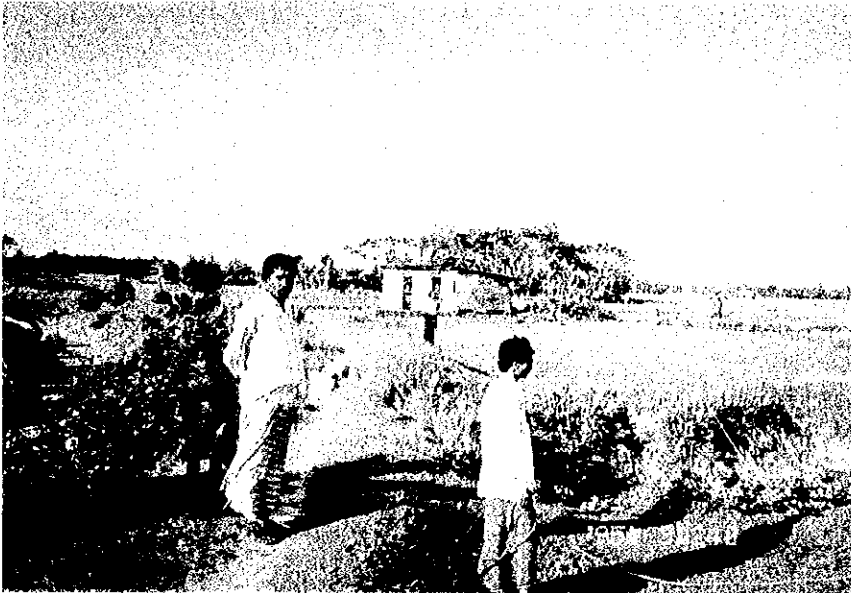
Overall View of
the School Site

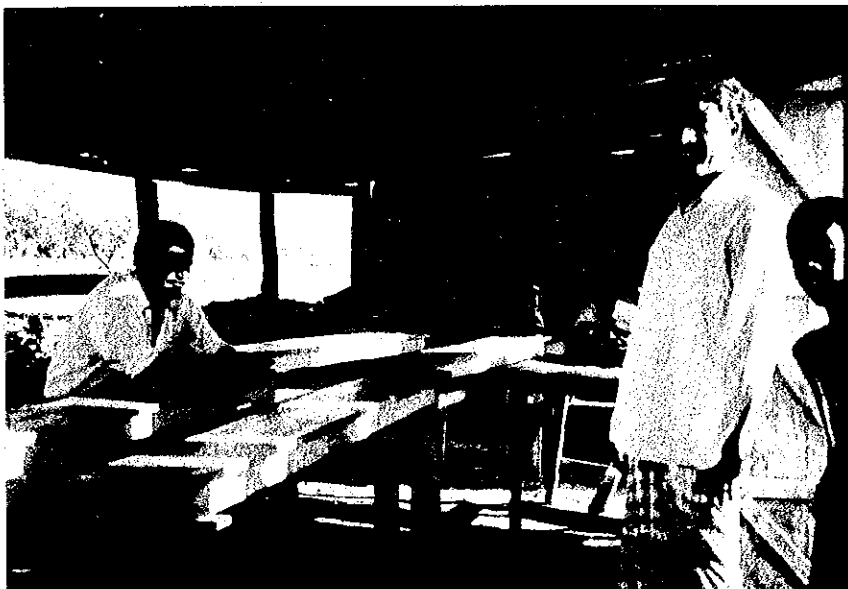
Current Conditions
of A Classroom
