バングラデシュ人民共和国  
 第3次多目的サイクロンシェルター建設計画  
 基本設計調査報告書

バングラデシュ人民共和国  
第3次多目的サイクロンシェルター建設計画  
基本設計調査報告書

〔資料10. サイト状況確認調査結果〕  
〔資料11. 自然条件調査結果〕

平成7年10月

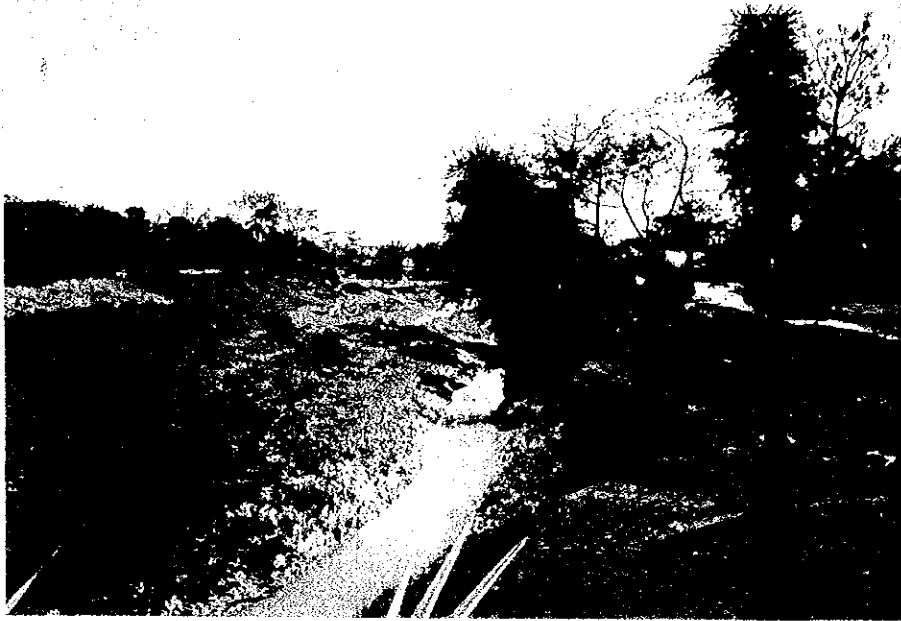
アクセス道路に沿って  
深い水路あり
