5. Cost Estimation Borne by the Receipient Country

A2-1 Bridge Construction (3/3) Cost Estimation Borne By Viet Nam

7. Overview of Bridge Site Survey Results

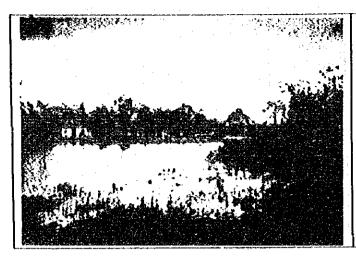
NO. 15 LUONG NHA BRIDGE

4 hours via Viet Thi from Ha Noi to bridge site.
Access road to the site is one lane and unpaved road.
Substructure of existing bridge has bad damage and Log Bridge is connected to both sides of river, therefore only pedestrians and motorbikes can pass over the bridge. Site is located along DA river.
DA river is tributary of Red river therefore equipment and materials for bridge will be transported by boat.
The nature of the soil is deposit from DA river (clay soil).
High water level is near deck slab during flood season.
Difference of water levels in flood season and in dry season is abou 5 m.

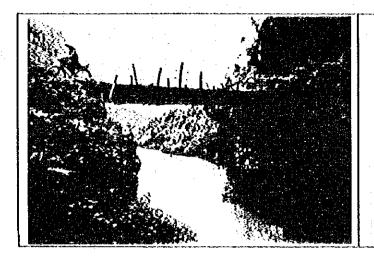
NO. 29 BAN AI BRIDGE

Bridge site is 2 km distant from the junction with Ntional Rd. 6. Site is located among mountains.
Rocks are exposed on the river bed and spread foundation is likely to be applicable.
Existing abutments can be reused after renovation.
Surface condition of access road is fair.
