6.4 Structural Investigation

THE STUDY ON
 THE MAINTENANCE AND REHABILITATION of
 HIGHWAY BRIDGES in THE REPUBLIC of TURKEY
 AUGUST, 1996
 ORIENTAL CONSULTANTS COMPANY LIMITED
 in association with
 JAPAN OVERSEAS CONSULTANTS COMPANY LIMITED

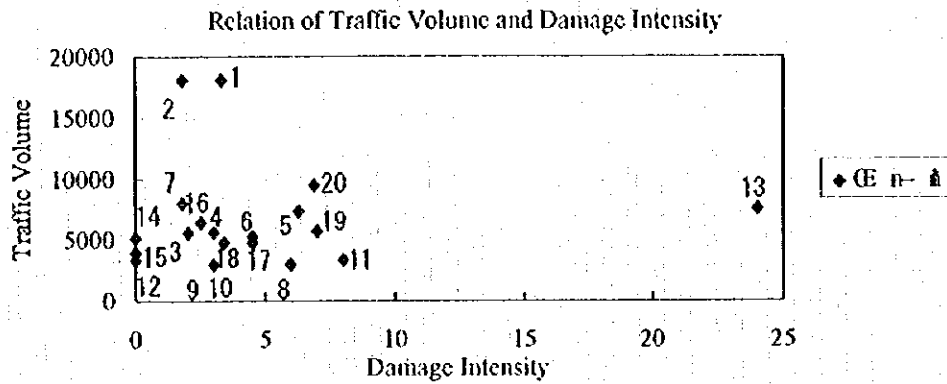
Figure - 7.1.1 Relation of Traffic Volume and Damage Intensity

In Table - 7.1.2, the characteristic damaged bridges, whose damage intensity is less than 2.0, are Hilal-II and Akcay. Hilal-II suffers from intensive cracks caused by Alkali-Silica Reaction on the column surface. The shearing cracks on Akcay, is caused by the increased vehicle loading on the Gerber portion of concrete girder. Both the bridges shall be considered by structure and material type for maintenance and rehabilitation study.

As these bridges are situated on the national highway, the traffic volume is to increased every year. The traffic growth is a direct result of the increased socio-economic situation in the country. The relation ship of traffic volume and damage intensity, which are of socio-economic importance and stability of bridge, are shown in Figure - 7.1.1.

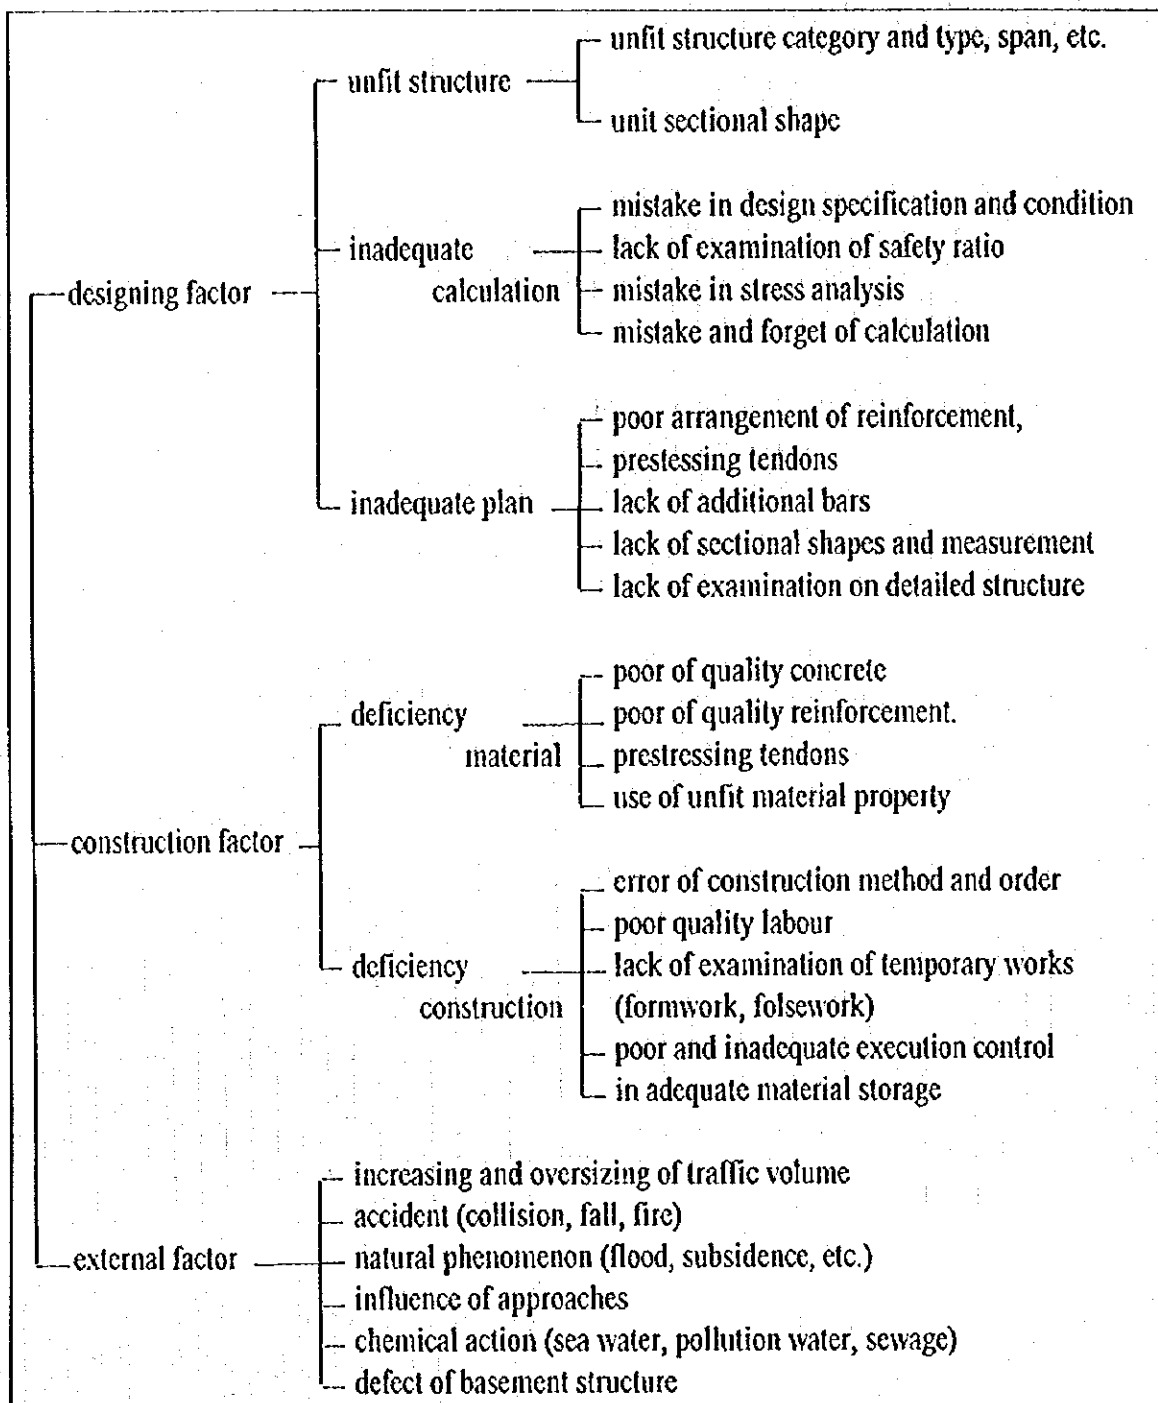
Figure - 7.2.1

The deterioration of concrete structures is caused by many factors such as traffic collision damage, structural failures due to over-stress and/or loss of section, freeze and thaw, settlement of foundation, chemical attack, failure of expansion joints, scours, silting, poor design details, construction deficiencies and corrosion of reinforcing steel, as shown in Figure - 7.2.1.

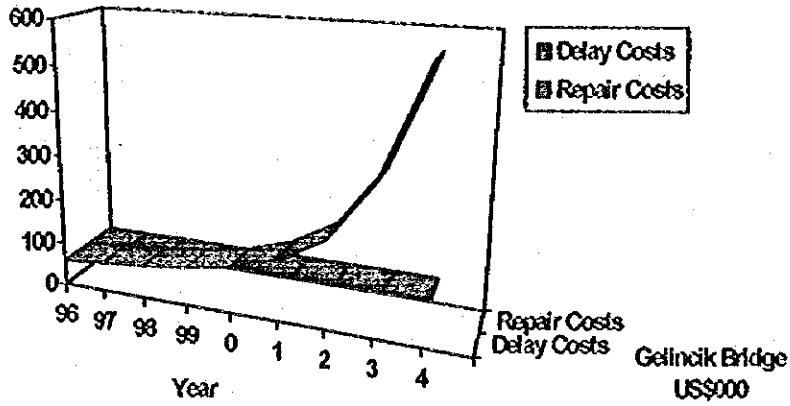
EXAMPLE OF INCREASING TRAFFIC DISRUPTION COSTS

In order to make these kinds of decisions, it is essential to have information on the likely costs of traffic disruption at any bridge. An example of the way in which traffic disruption costs can escalate as time passes and as traffic grows is illustrated by Gelincik Bridge, as shown in Figure - 8.3.1 below.

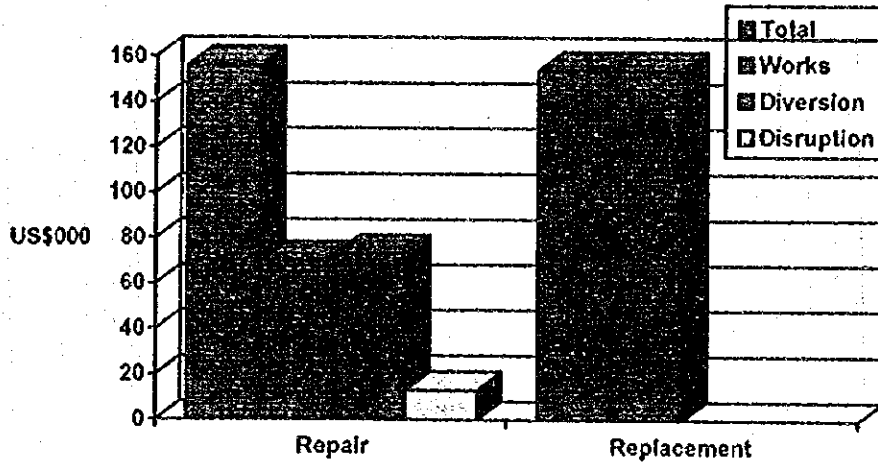
BABADAT BRIDGE - COSTS OF REPAIR V REPLACEMENT

Again, with the other ten bridges, as with the original ten, repair was always a better option than replacement. The only exception to this situation was the Babadat Bridge, as illustrated in Figure - 8.3.2 below.
