THE STUDY ON  
 THE MAINTENANCE AND REHABILITATION OF  
 HIGHWAY BRIDGES in THE REPUBLIC of TURKEY  
 AUGUST, 1996  
 ORIENTAL CONSULTANTS COMPANY LIMITED  
 in association with  
 JAPAN OVERSEAS CONSULTANTS COMPANY LIMITED

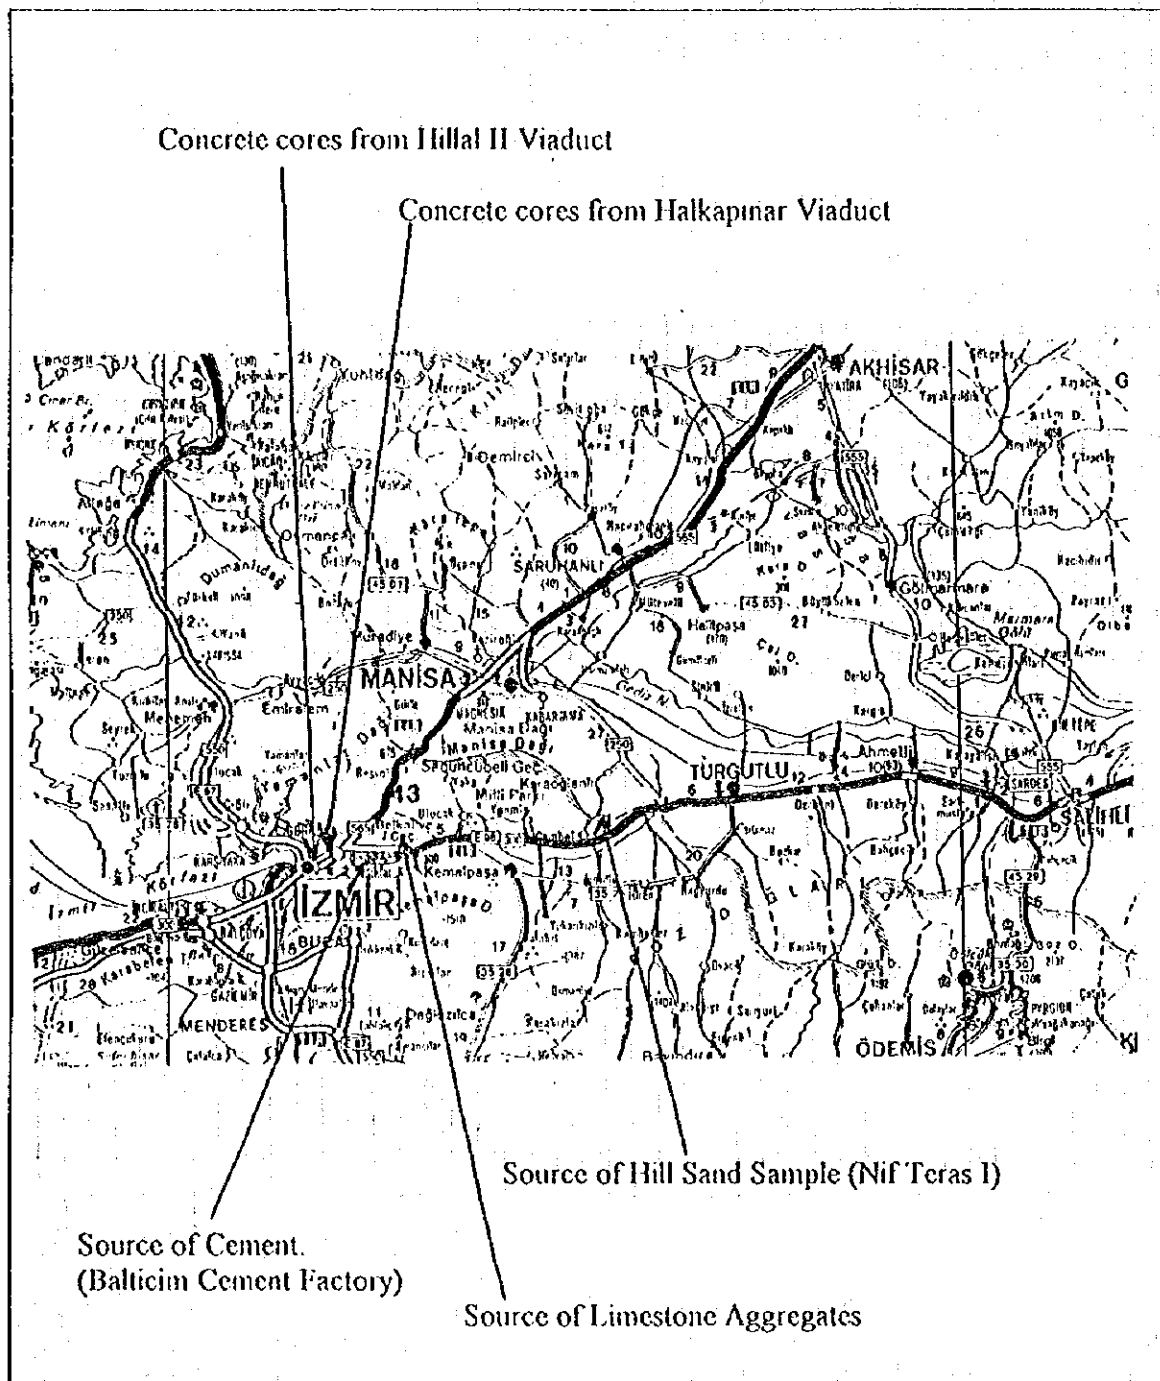
Figure - 12.2.1  
Location of Samples for preliminary  
testing

Details of both concrete core locations and concrete constituent sample locations are illustrated in Figure - 12.2.1.
