5.6 Site Geology and Characteristics of Riverbed Material

CHAPTER 6
CONDITION OF EROSION IN
THE VICINITY OF MEGHNA BRIDGE

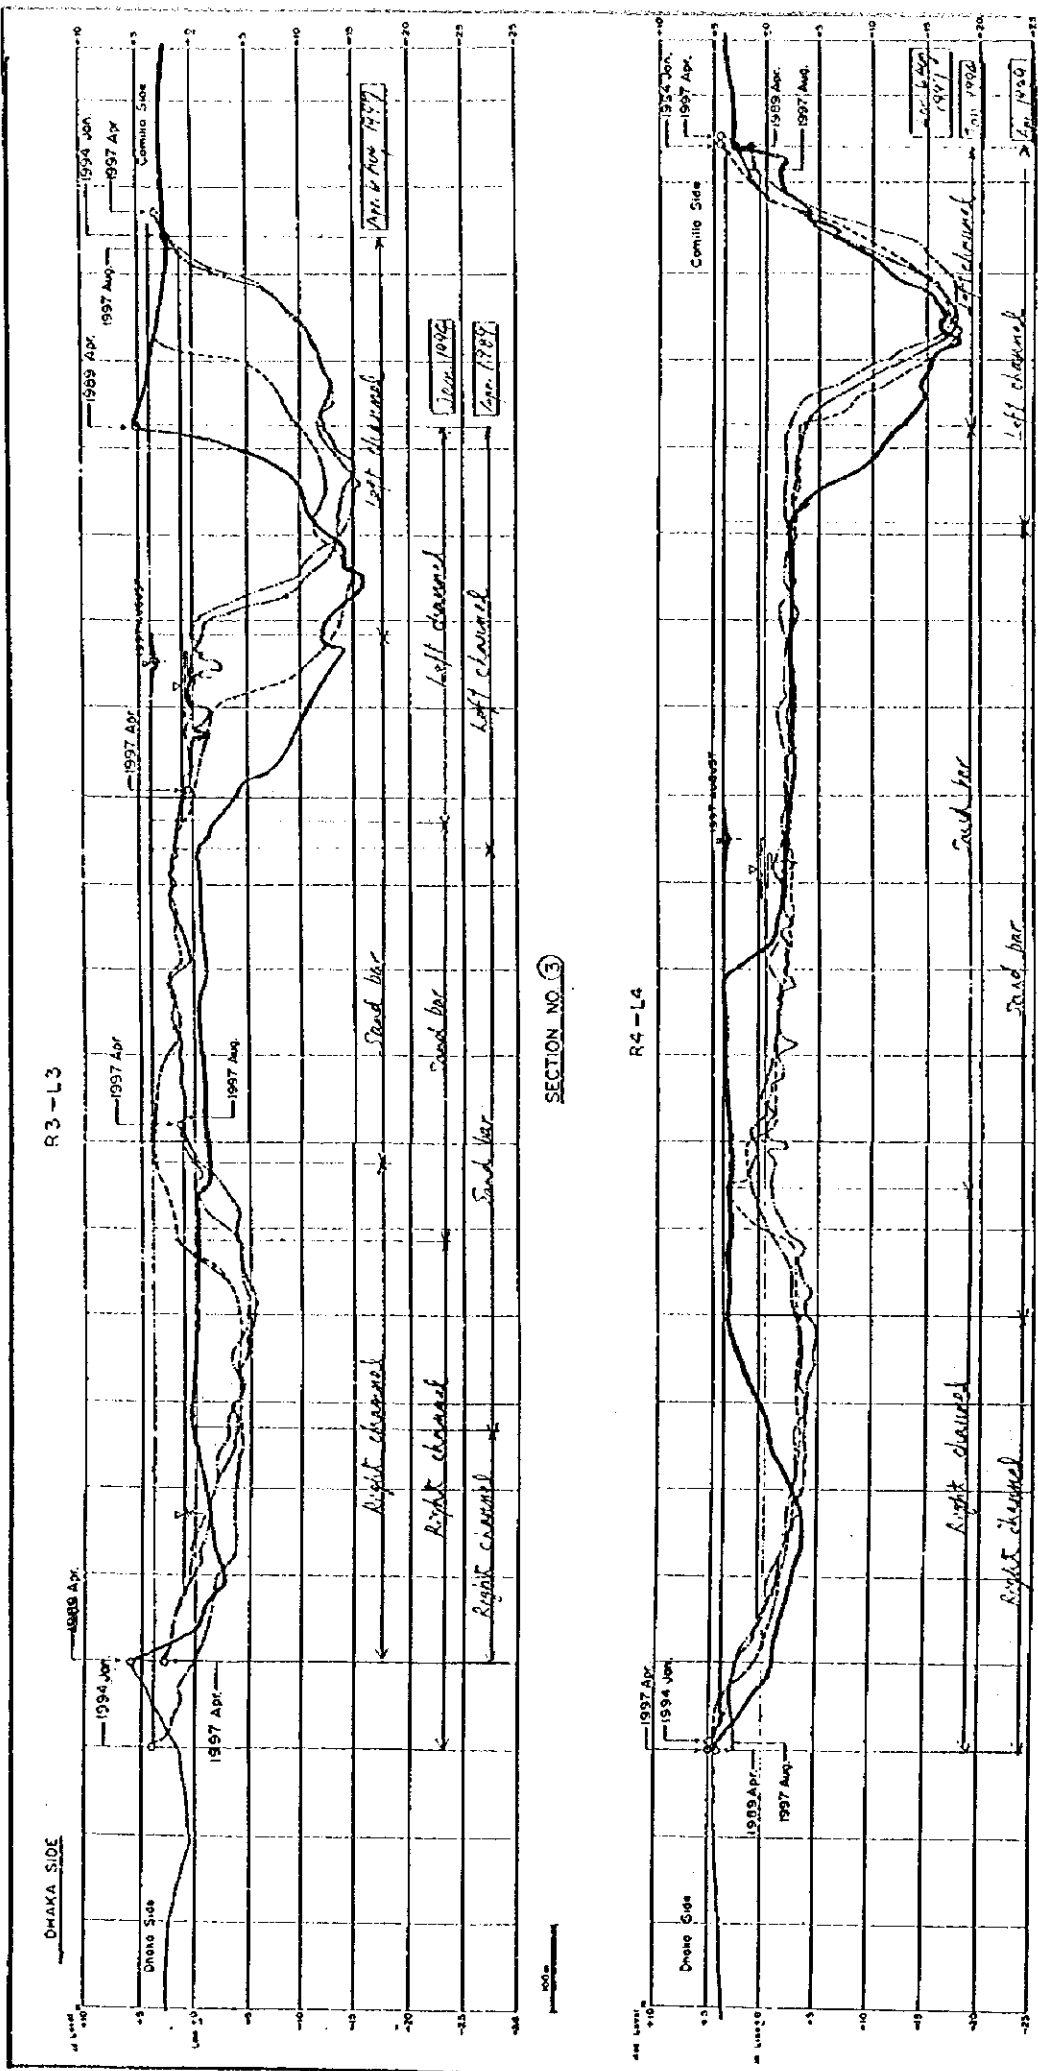
Figure 6.2.1 River Cross-Sections of No.3 and 4

The cross-sections of R3 - L3 and R4 - L4 are shown in Fig. 6.2.1. Based on this figure, a quantitative analysis of the change of the right side channel, the sand bar and the left side channel was carried out. The results are summarized in Table 6.2.1, which shows the tendency of expansion of the right side channel and reduction of the left side channel.

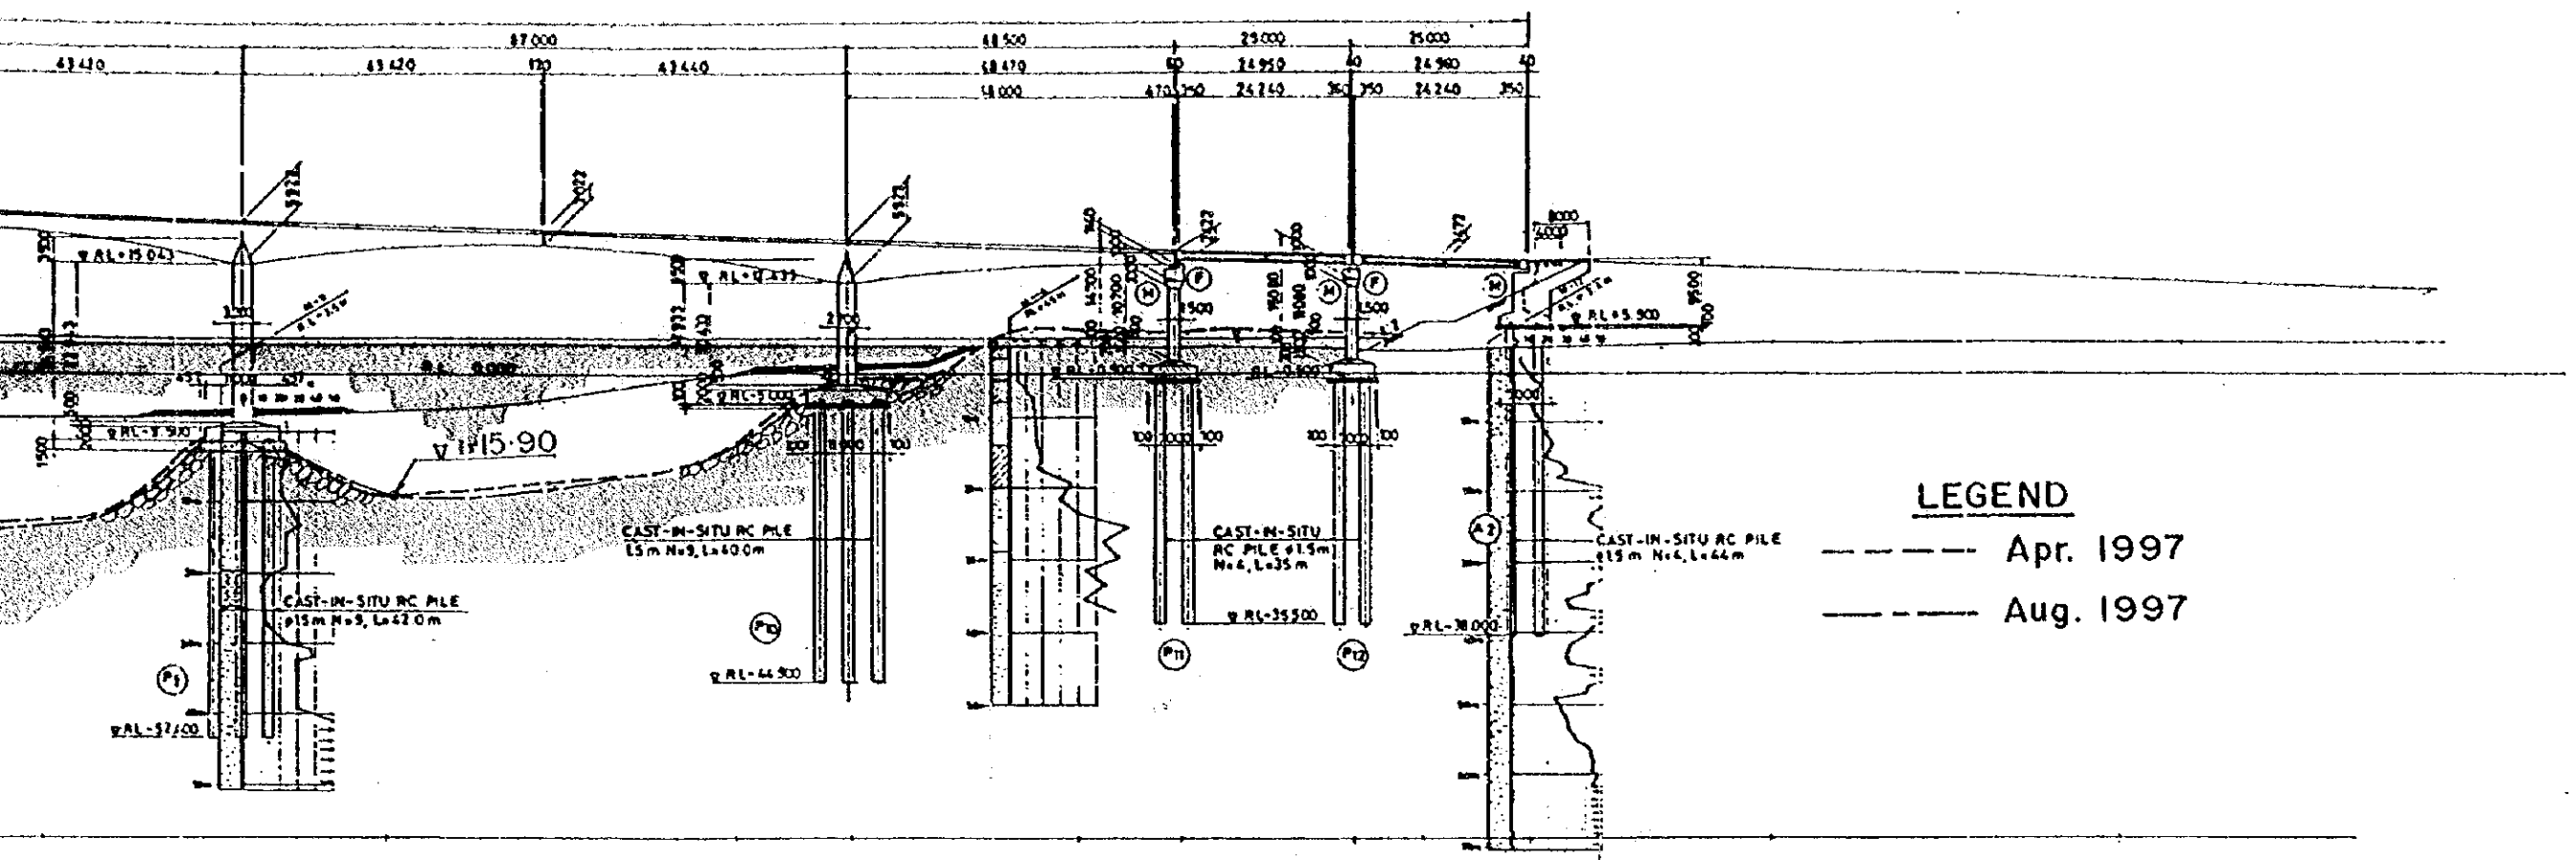
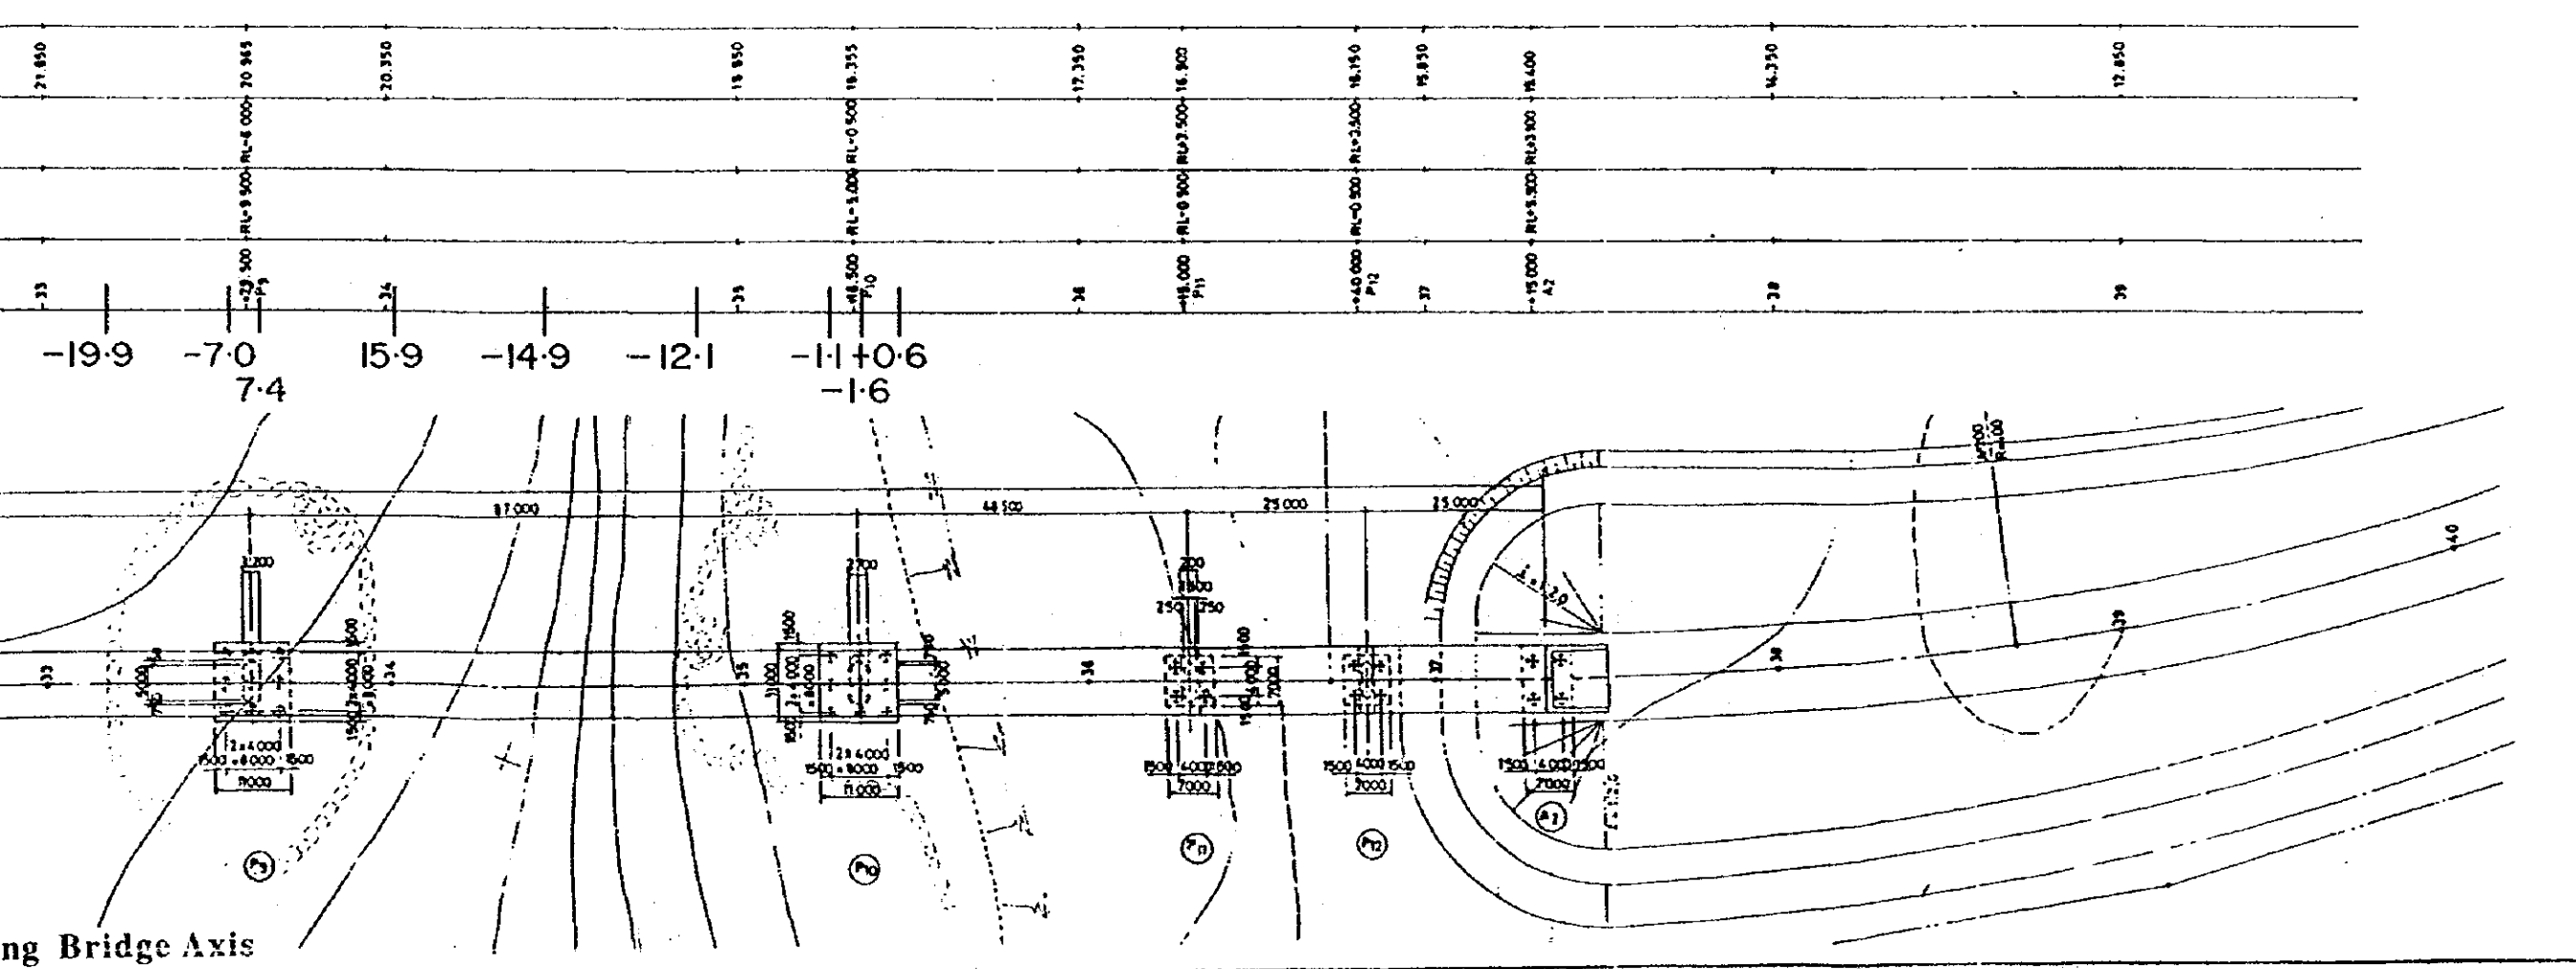
Furthermore, it was confirmed that the lower plane of the concrete footing was severely scoured but no piles were exposed. This shows that the riprap played a function of protection against scouring. At the P8, base concrete (1.5 m thickness) was separated beneath the footing at some portions.

The stone pitching consists of rubble stone with a diameter of 15 cm to 30 cm. A stable cone-shaped surface is formed around the piers from the footing to the riverbed with an angle of 20 to 45 degrees in a radius of 20 m to 30 m. Further, random scattering of pitched stones can be seen on the riverbed at some portions. But the cone shape as a whole remains.

In view of the above situation, the provision of additional protection works by stone pitching around the existing stone mats is recommended.

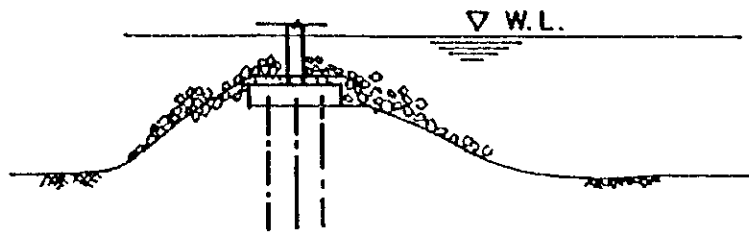
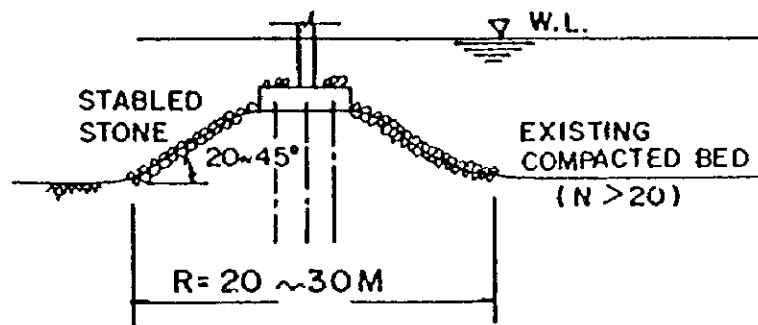
Fig. 6.3.2 Process of Scouring near the Bridge Piers

On the Dahka side of the pier, the pitched stone mat forms a slope of the slope approx. 25 m long and the riverbed consists of a loose sand layer. The present riverbed including the pier section is considered to be experiencing the process as shown in Fig. 6.3.2.

- (ii) The pitched stones fell down as the scouring of the riverbed proceeded.

- (iii) The pitched stones formed a cone shape and became stable on the present riverbed,

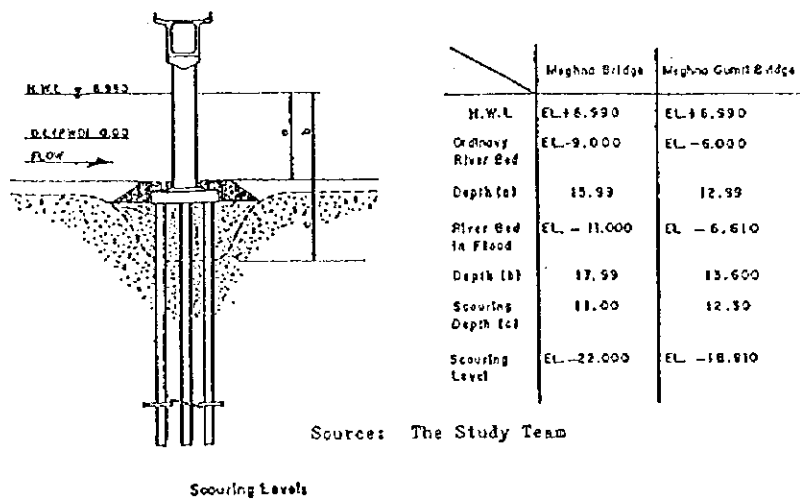
Figure 6.4.2 Scour Depths

Therefore, it can be concluded that the existing bed elevation R.L.=-22.0 is safe from the structural viewpoint. In particular the riverbed between P7 and P9 is composed of a hard sand layer and the scouring has not occurred.

In order to prevent further scouring in the future, however, the provision of protection works around the piers and the riverbed between the piers is recommended. Besides, river cross-section survey along the centerline of the bridge should be conducted periodically in the future.

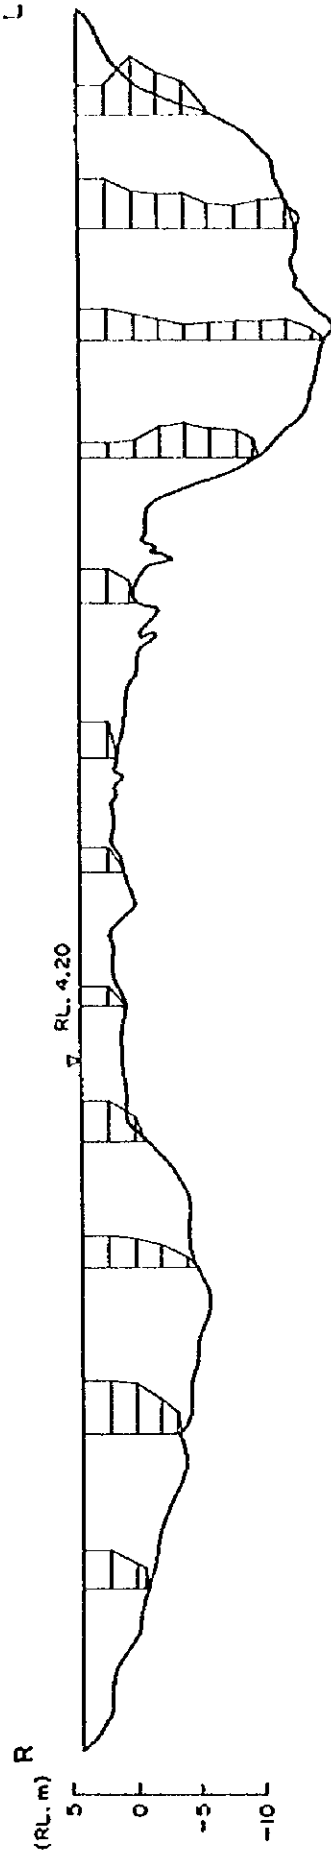
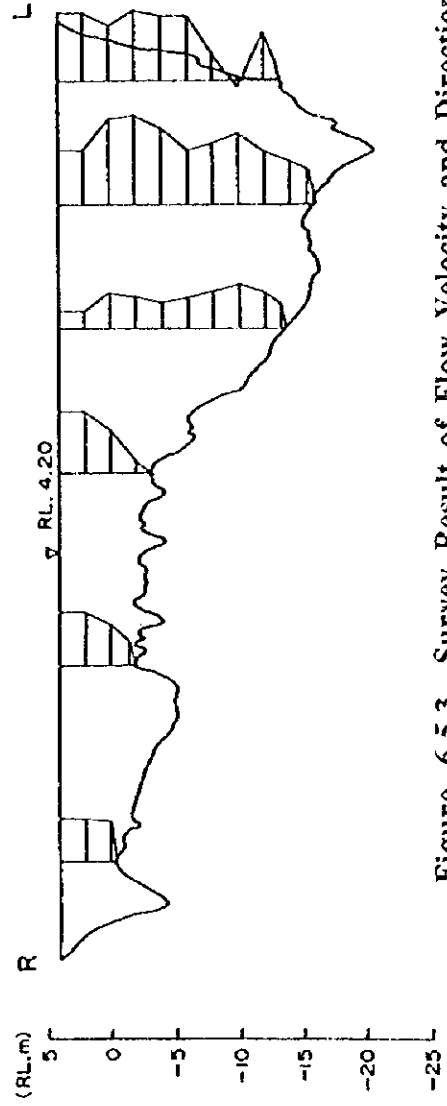
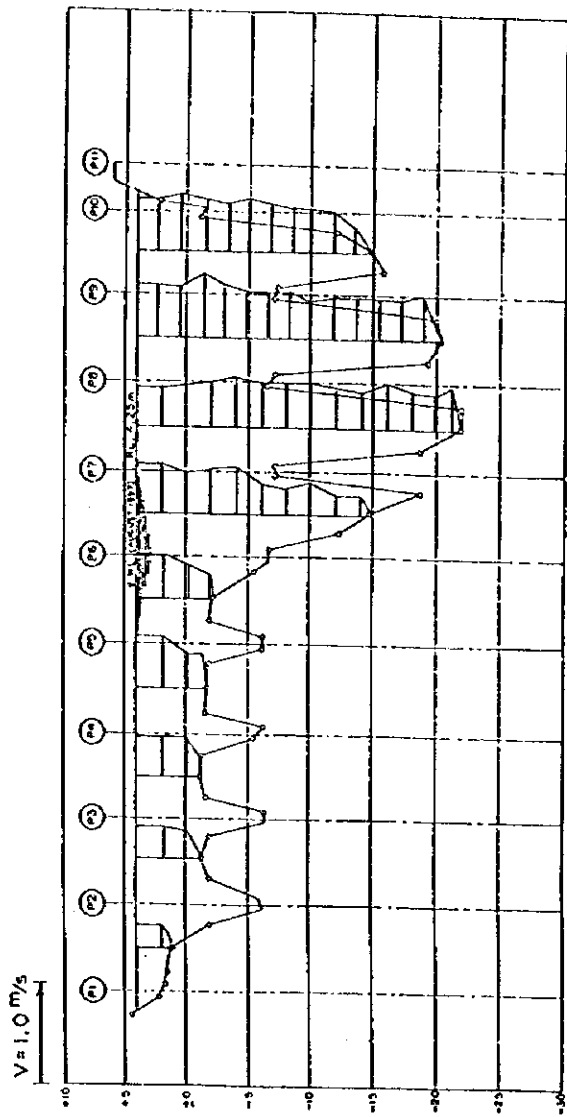
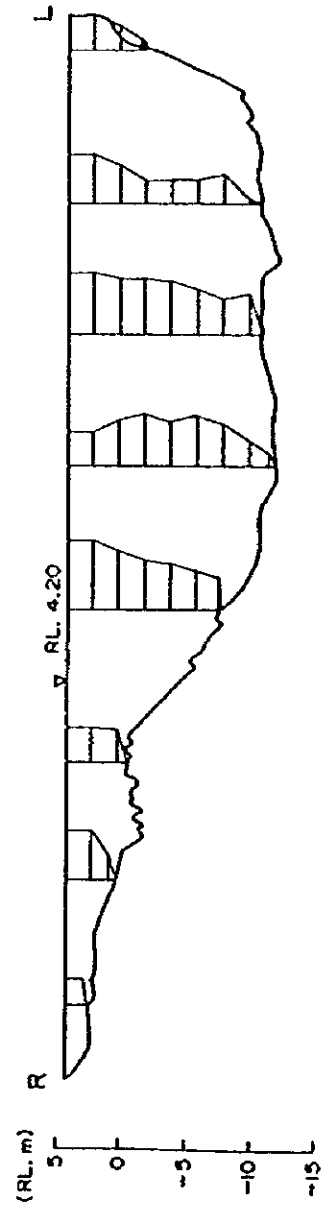
Figure 6.5.3 Survey Result of Flow Velocity and Direction (along river cross-section) (1/2)

RDI - LDI: Near the center of the thalweg, flow velocity is relatively large.

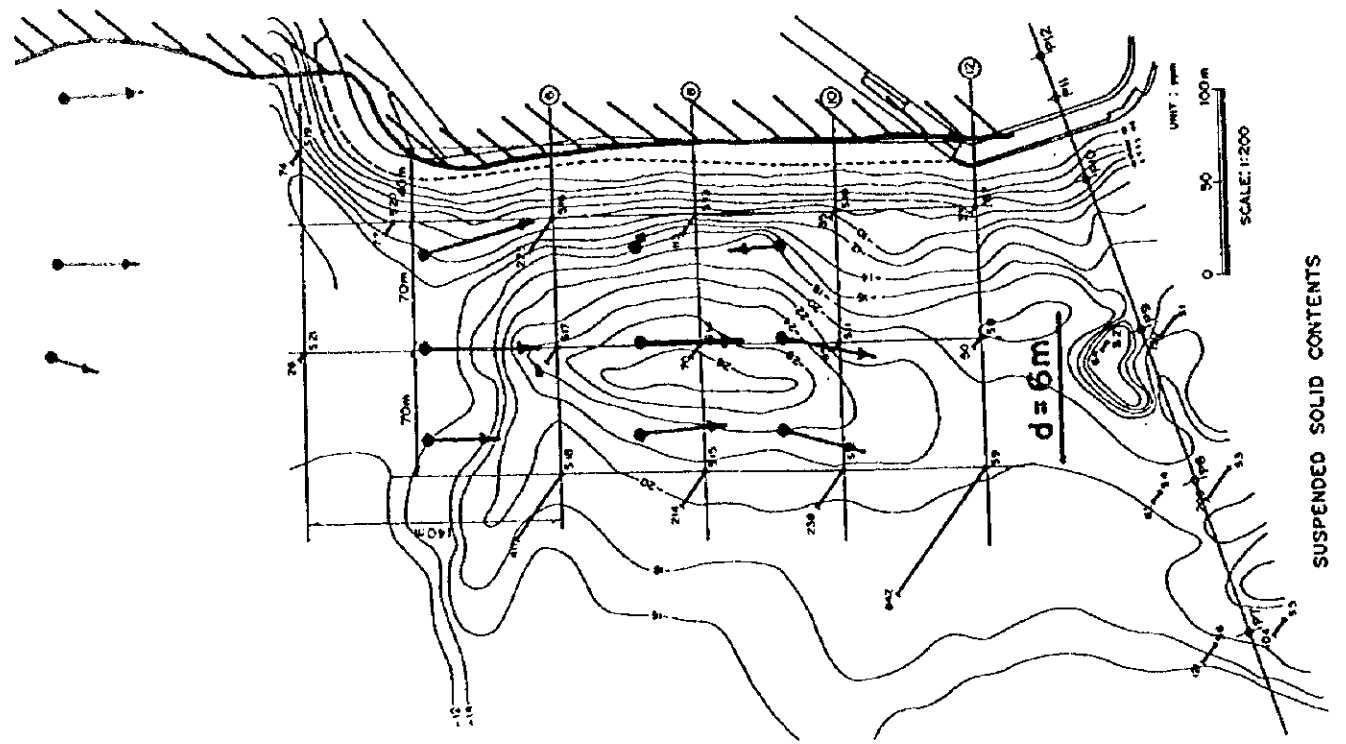
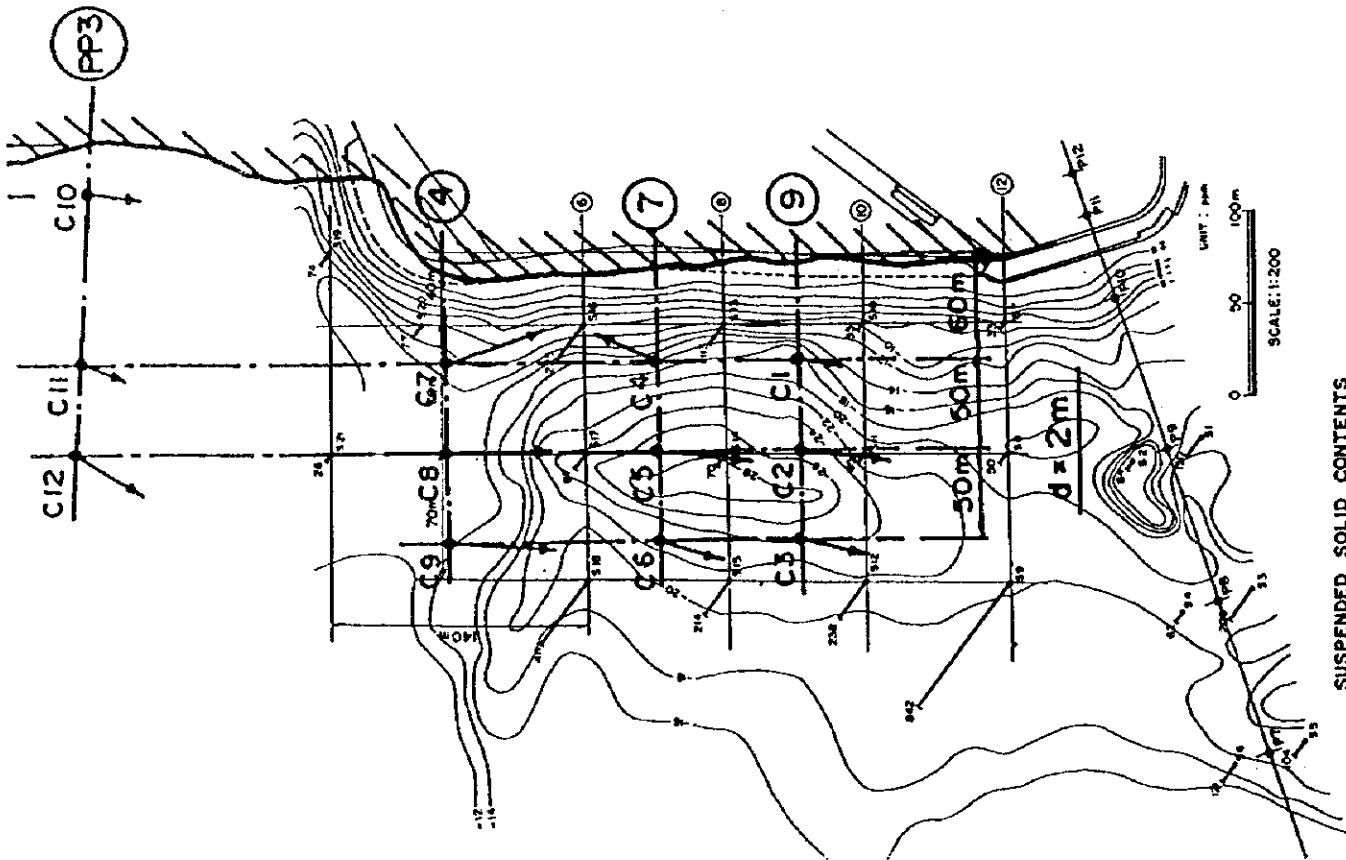
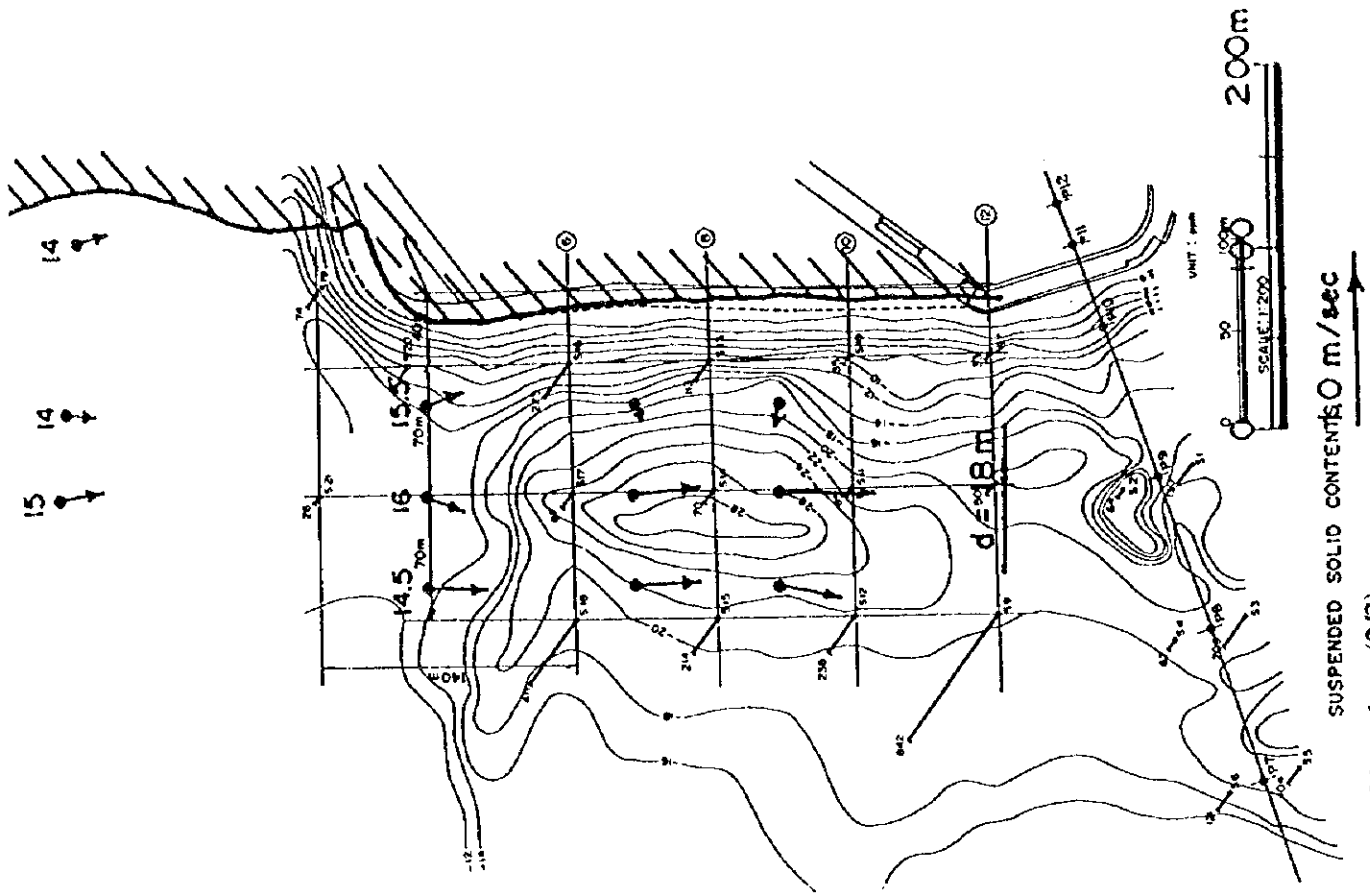
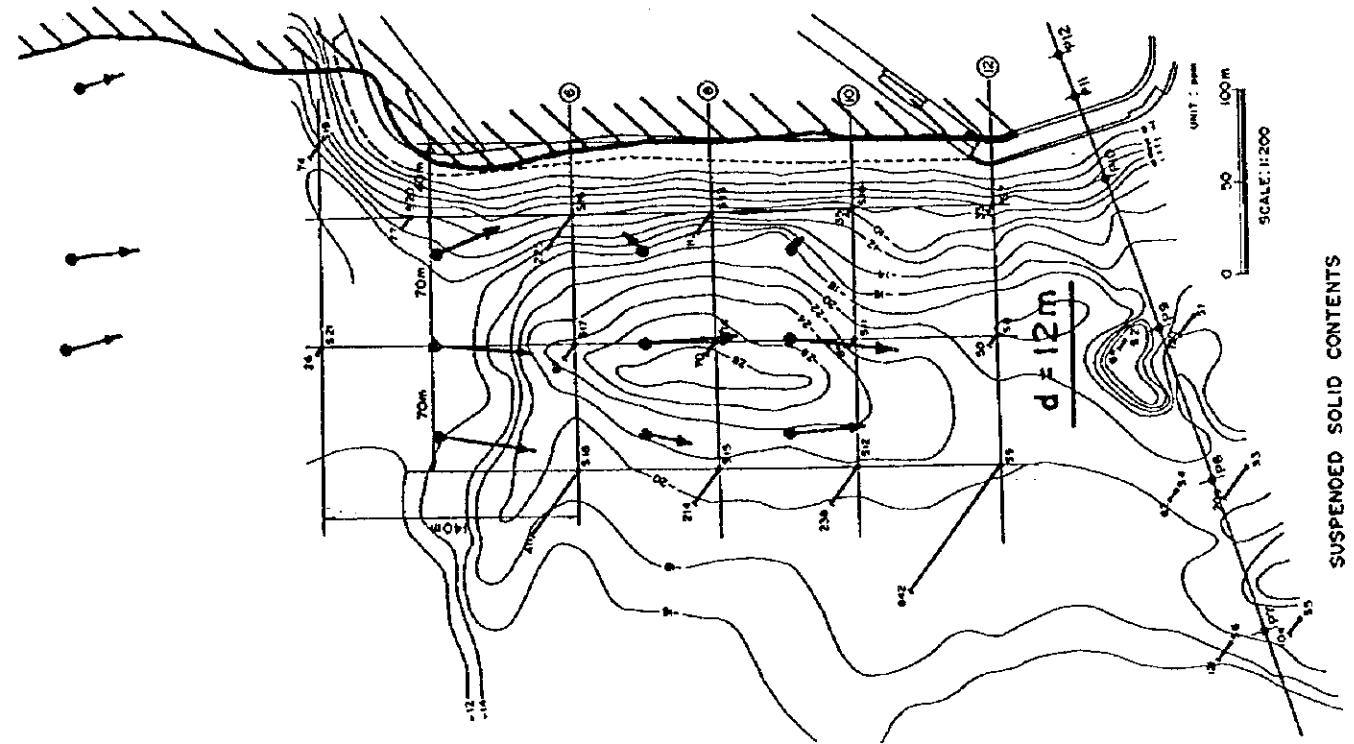
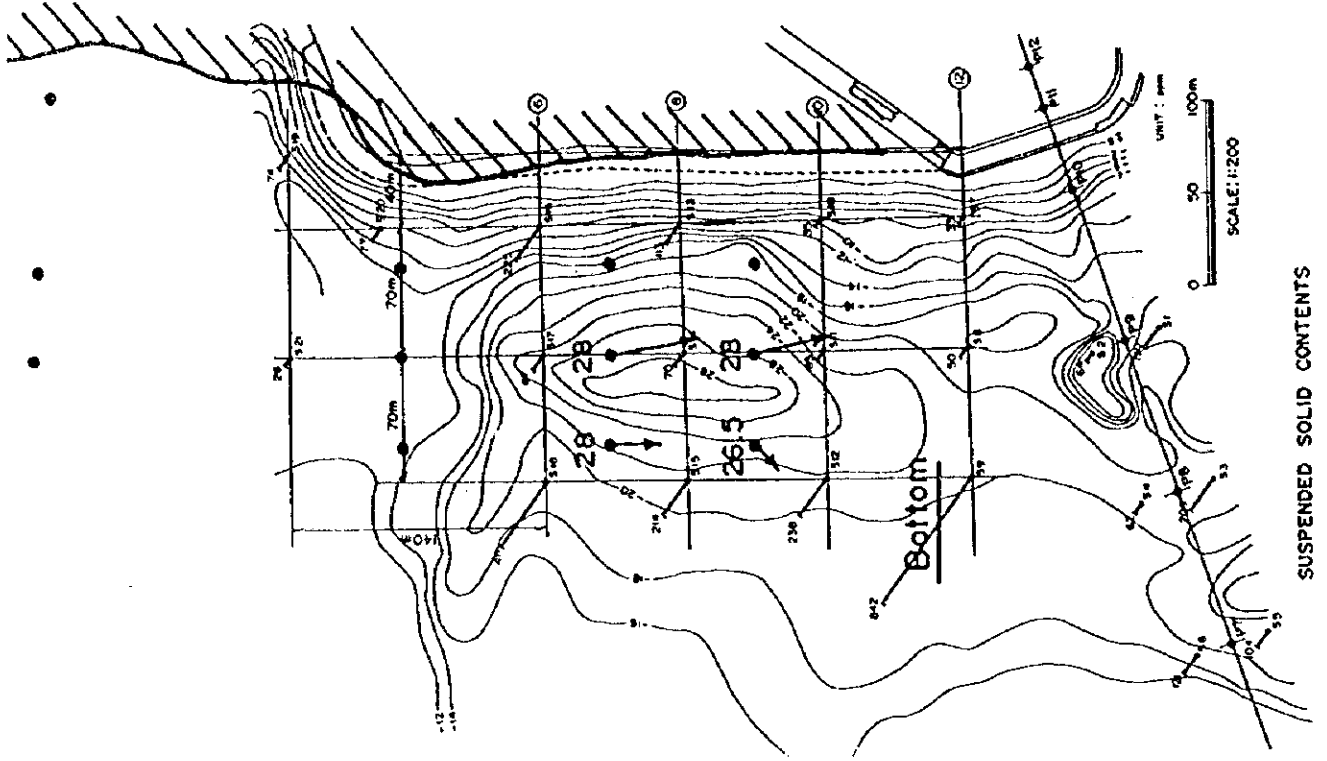
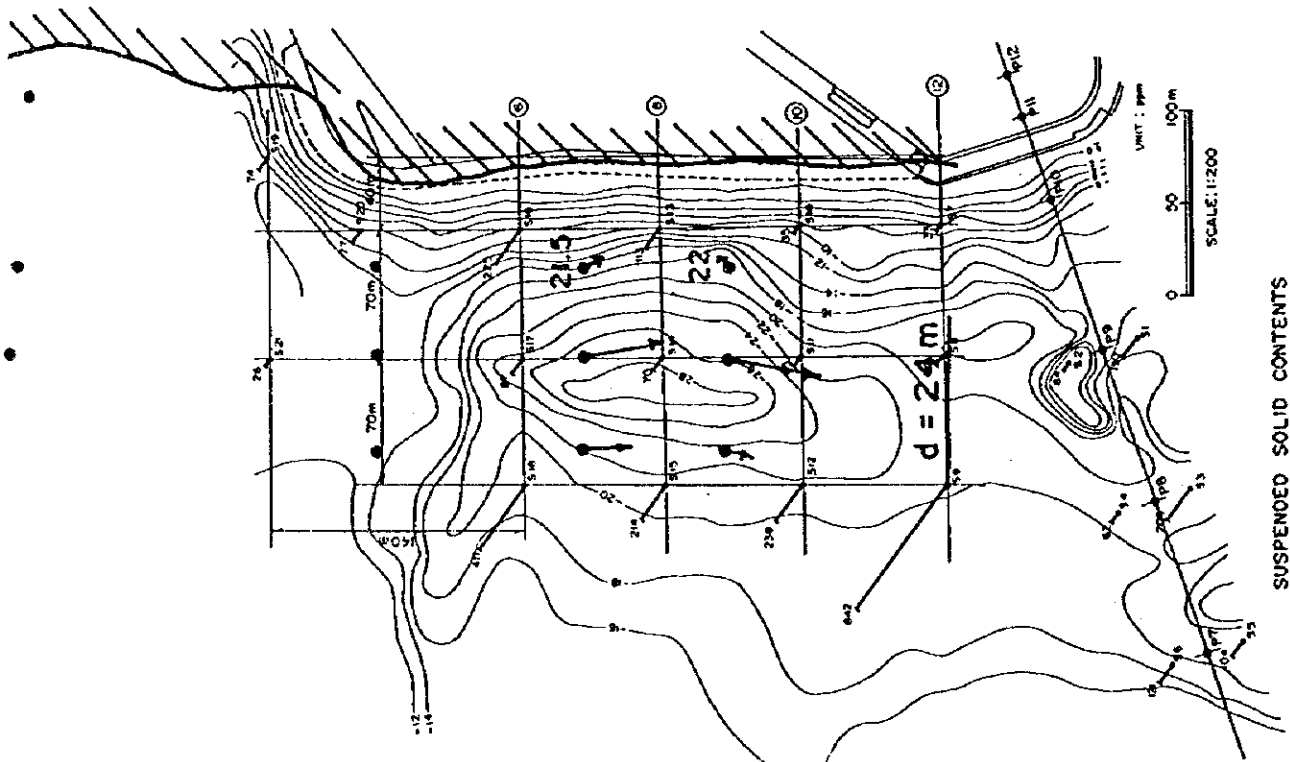
Figure 6.5.5 Plan of Flow Velocity and Direction (1/3)

The result of laboratory test for SS contents is shown in Table 6.5.3 and illustrated in Fig. 6.5.7 with the contour line of the riverbed which was drawn based on the echo sounding in the Second Survey. According to this record, more than twice concentration of SS was observed on the downstream side of P8 and P9 compared with that on the upstream side of the piers. At pier P7, the upstream SS concentration was a little higher than the downstream one.

On the other hand, in front of the existing revetment a relatively high SS concentration was observed along the survey line between P8 and P9. This survey line approximately coincides with the boundary of the dead

flow area due to the gap of the shoreline between the existing revetment and its upstream stretch. Accordingly, the turbulence of suspended solid accumulated on the riverbed due to vortexes is deemed as one of the reason for high concentration. As a whole, the observed values near the revetment are higher than those at on the downstream side of the piers.

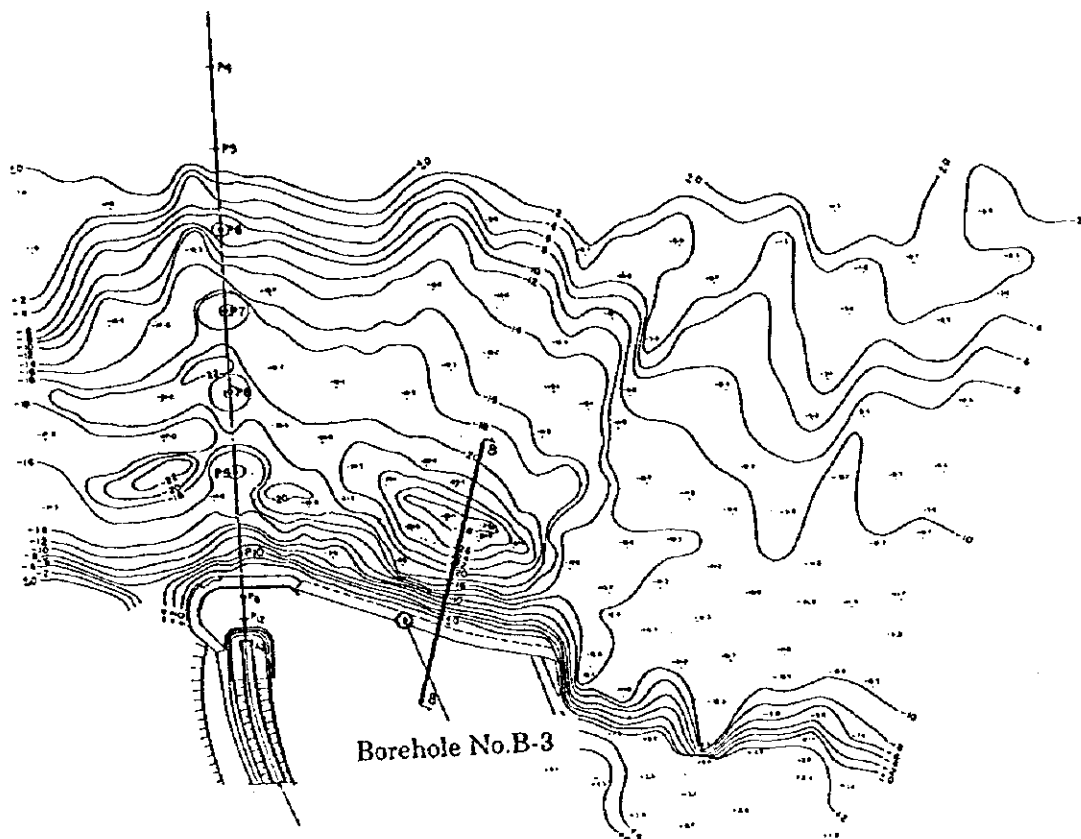
Figure 7.1 Location of Stability Verification of Revetment

The stability of the existing revetment at Section 8-8 where the deepest riverbed scouring (Figure 7.1), was checked.

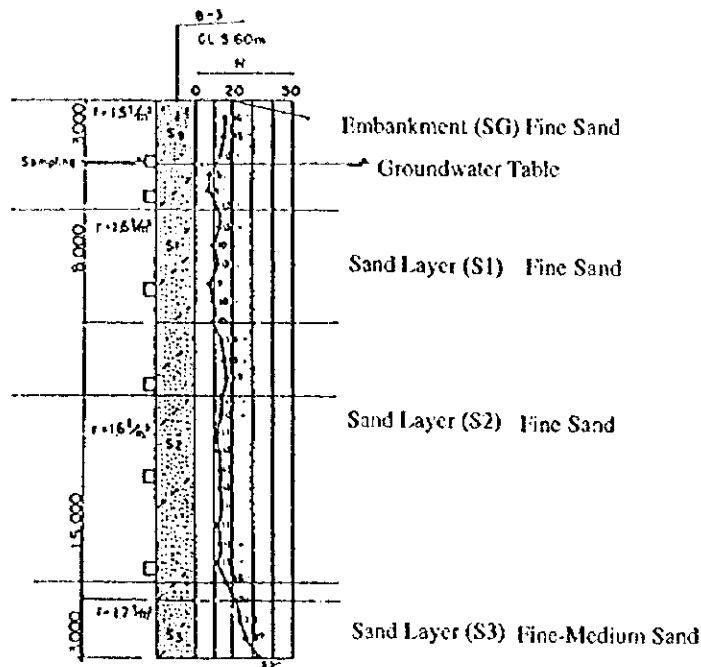
Figure 7.2 Boring Log of Borehole No. B-3

To provide soils data for stability analysis, borings and laboratory tests were carried out. Figure 7.2 shows the boring log of Borehole No. B-3 (see Figure 7.1 for the location).
