5.6 Site Geology and Characteristics of Riverbed Material

CHAPTER 6
CONDITION OF EROSION IN
THE VICINITY OF MEGHNA BRIDGE

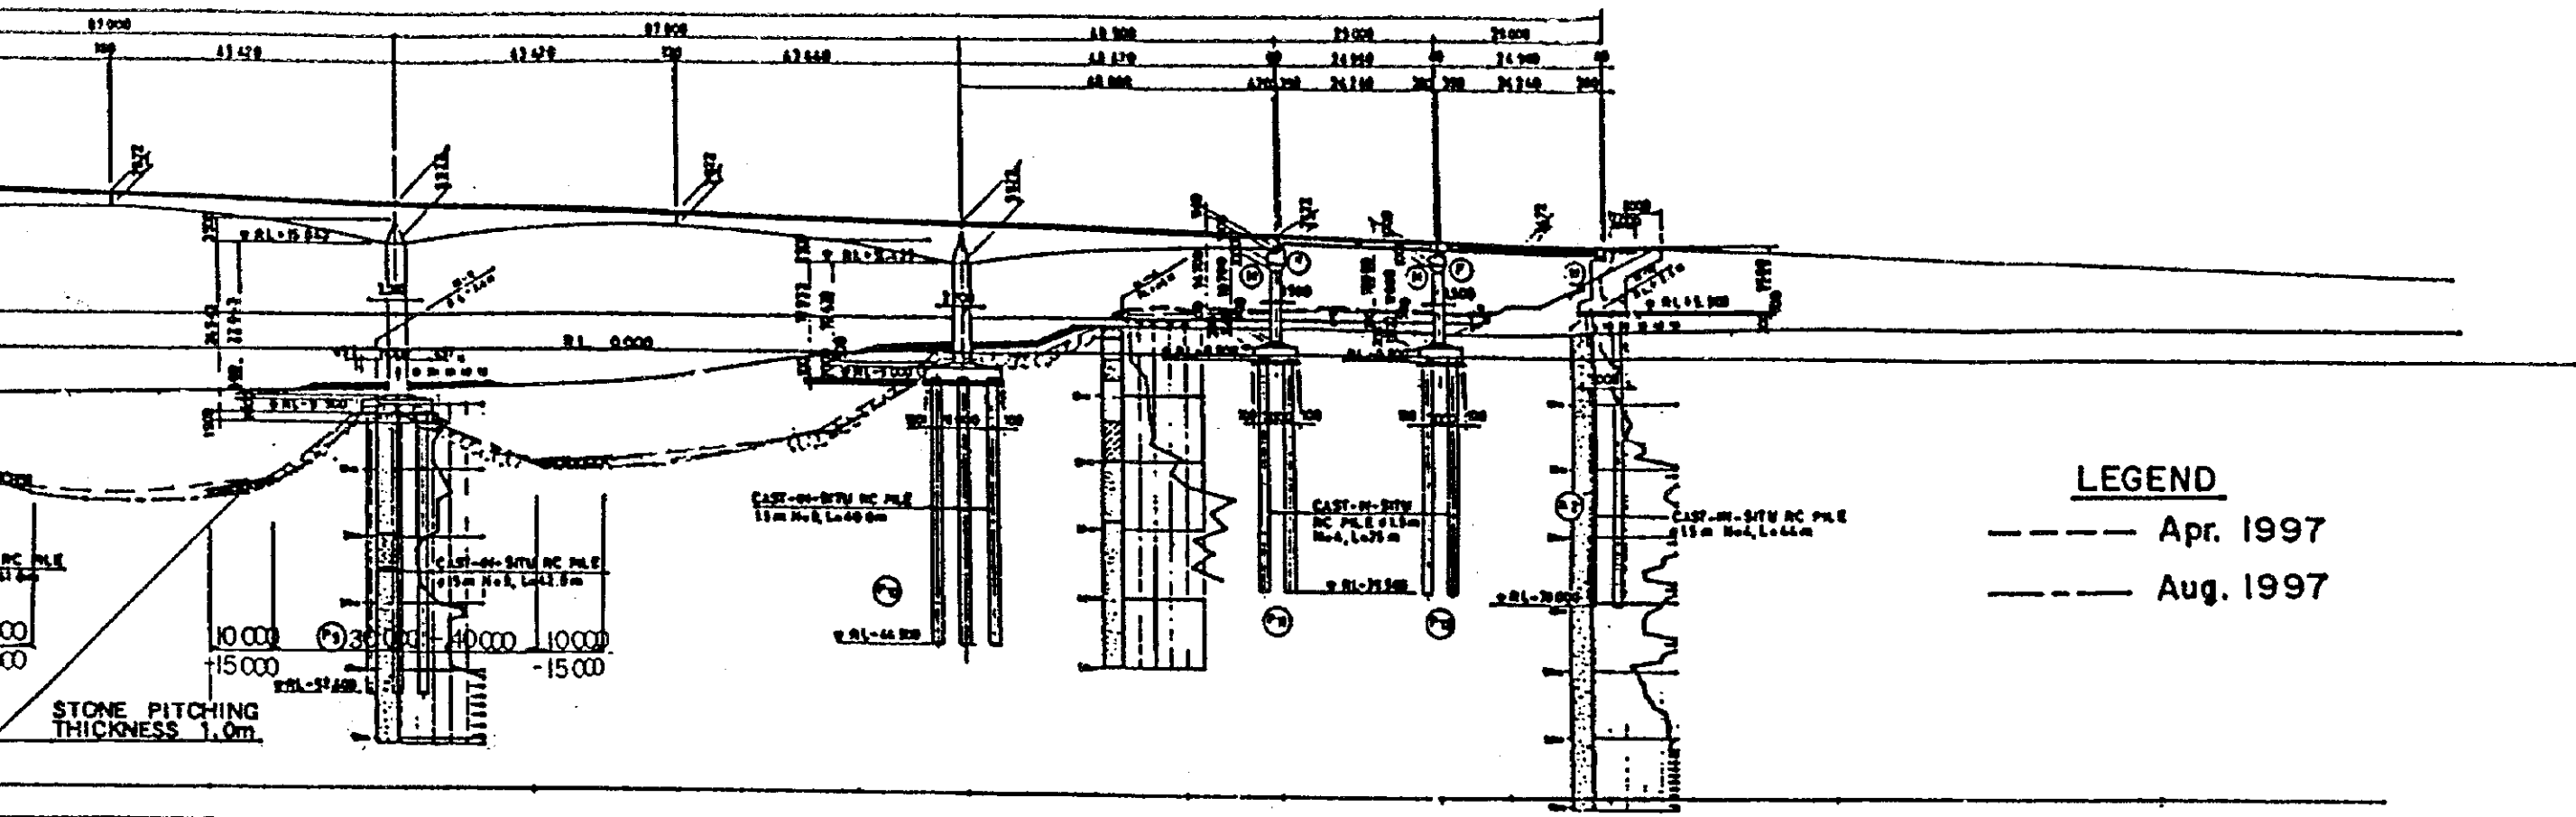
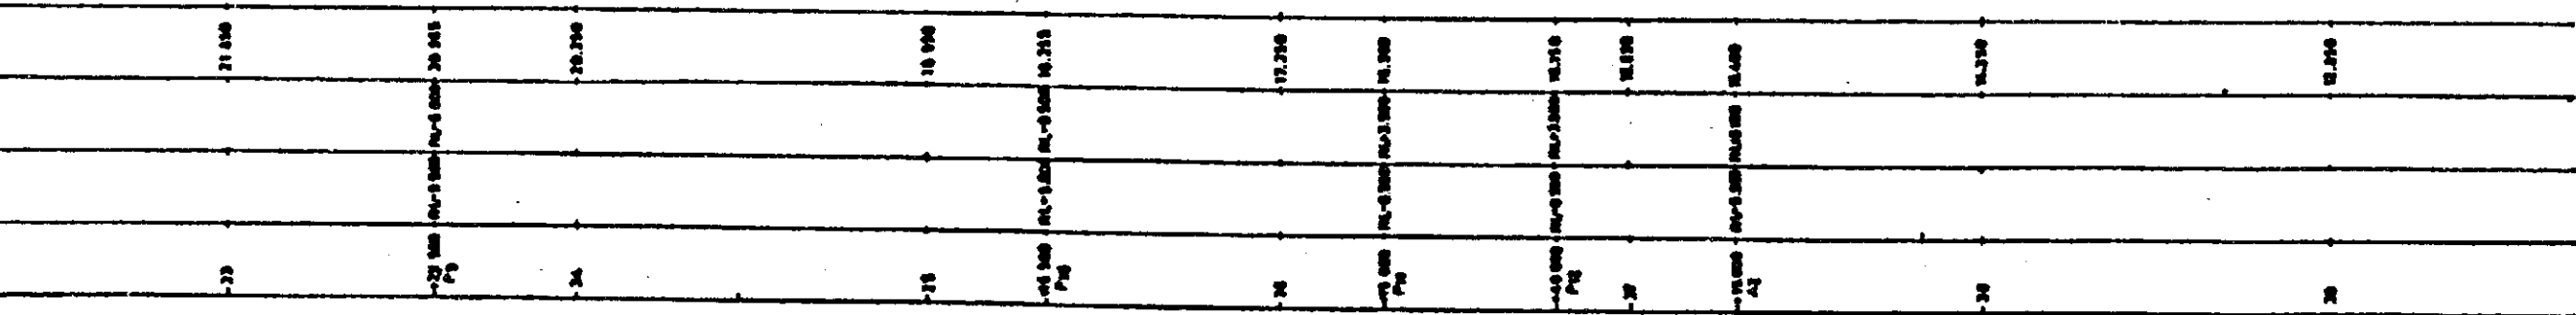
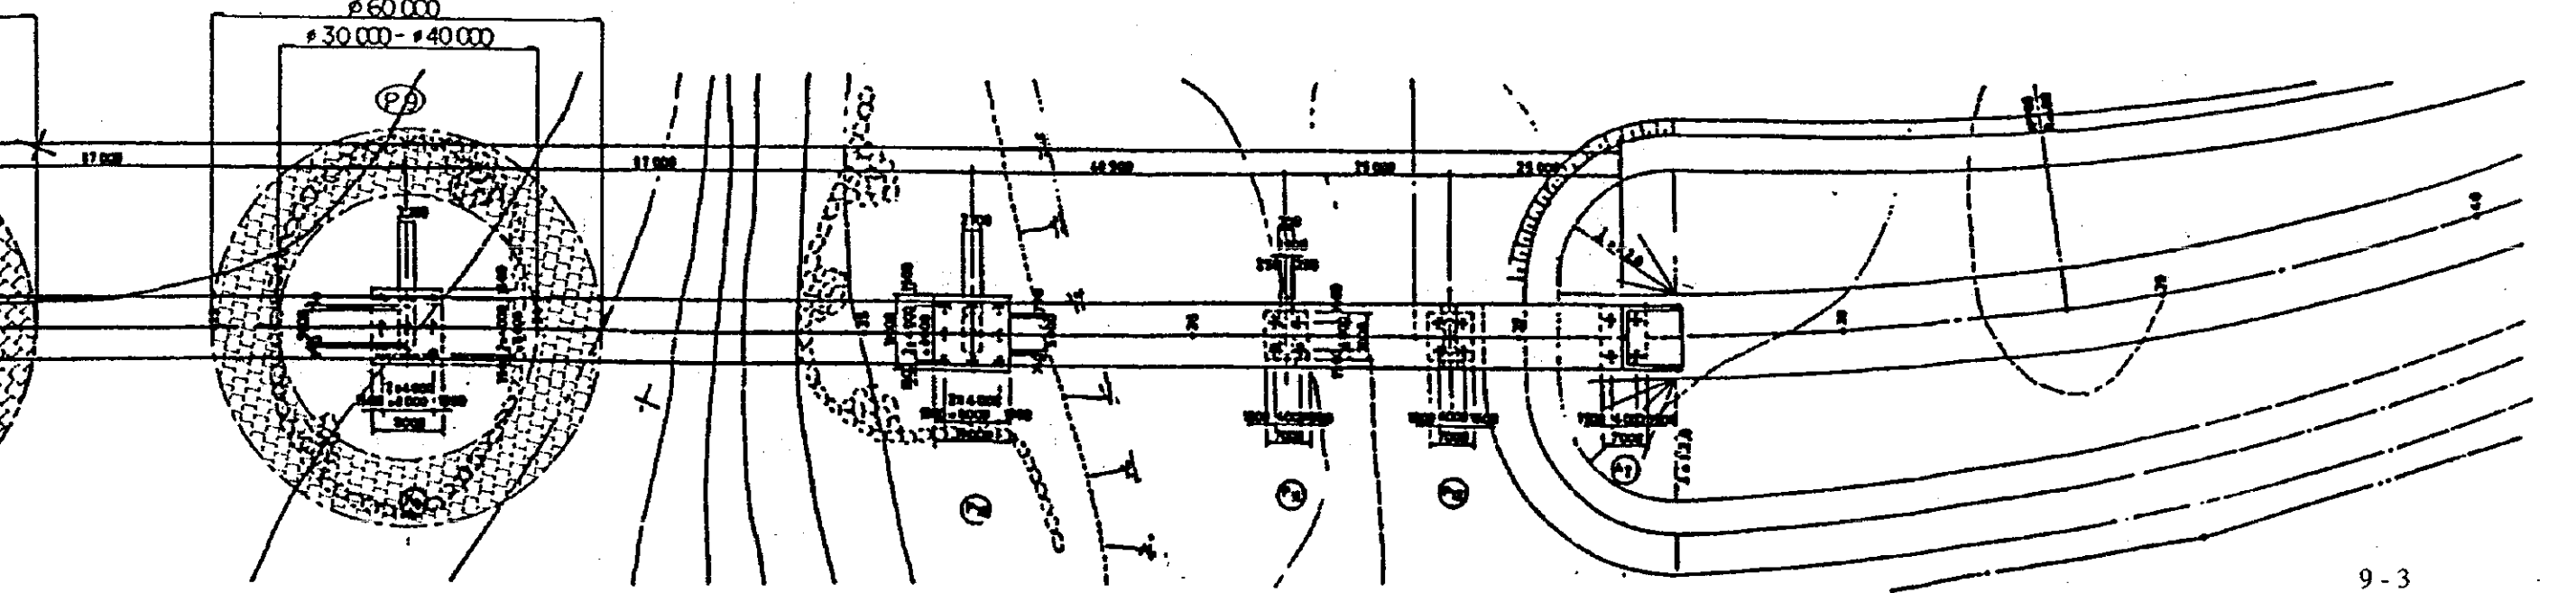
Figure 9.1 Protection on the Riverbed

At present, the areas around the foundations of piers P7, P8 and P9, which are located in the riverbed lowering area, are covered with stone mats provided for the protection of pier foundations and the existing stone mats are forming lenticular shapes. The riverbed between stone mats is composed of a hard sand layer (N-value; 30 to 40), therefore scouring would not proceed easily. However, the thickness of the said sand layer is relatively small. The stratum below R.L. -24 m to -26 m is composed of silty sand layers. Therefore in the case the existing exposed sand layer is eroded, further scouring may occur unexpectedly rapidly.

In view of the above situation, the provision of additional protection works by stone pitching around the existing stone mats is recommended.

- a. River bed armoring around the bridge pier footings (P7, P8 and P9)
 - One meter thick stone mat protection.
- b. River bed armoring for the deeply scoured area in front of the existing revetment (on the left bank, about 250 meters upstream of the Meghna bridge)
 - One meter thick sacked gravel mat protection.
- c. Grading work around the Comilla side abutment and the repair of the existing revetment
 - Grading of the area on the rear side of the existing revetment and replacement of existing concrete filled fabric tubes with new gabions.

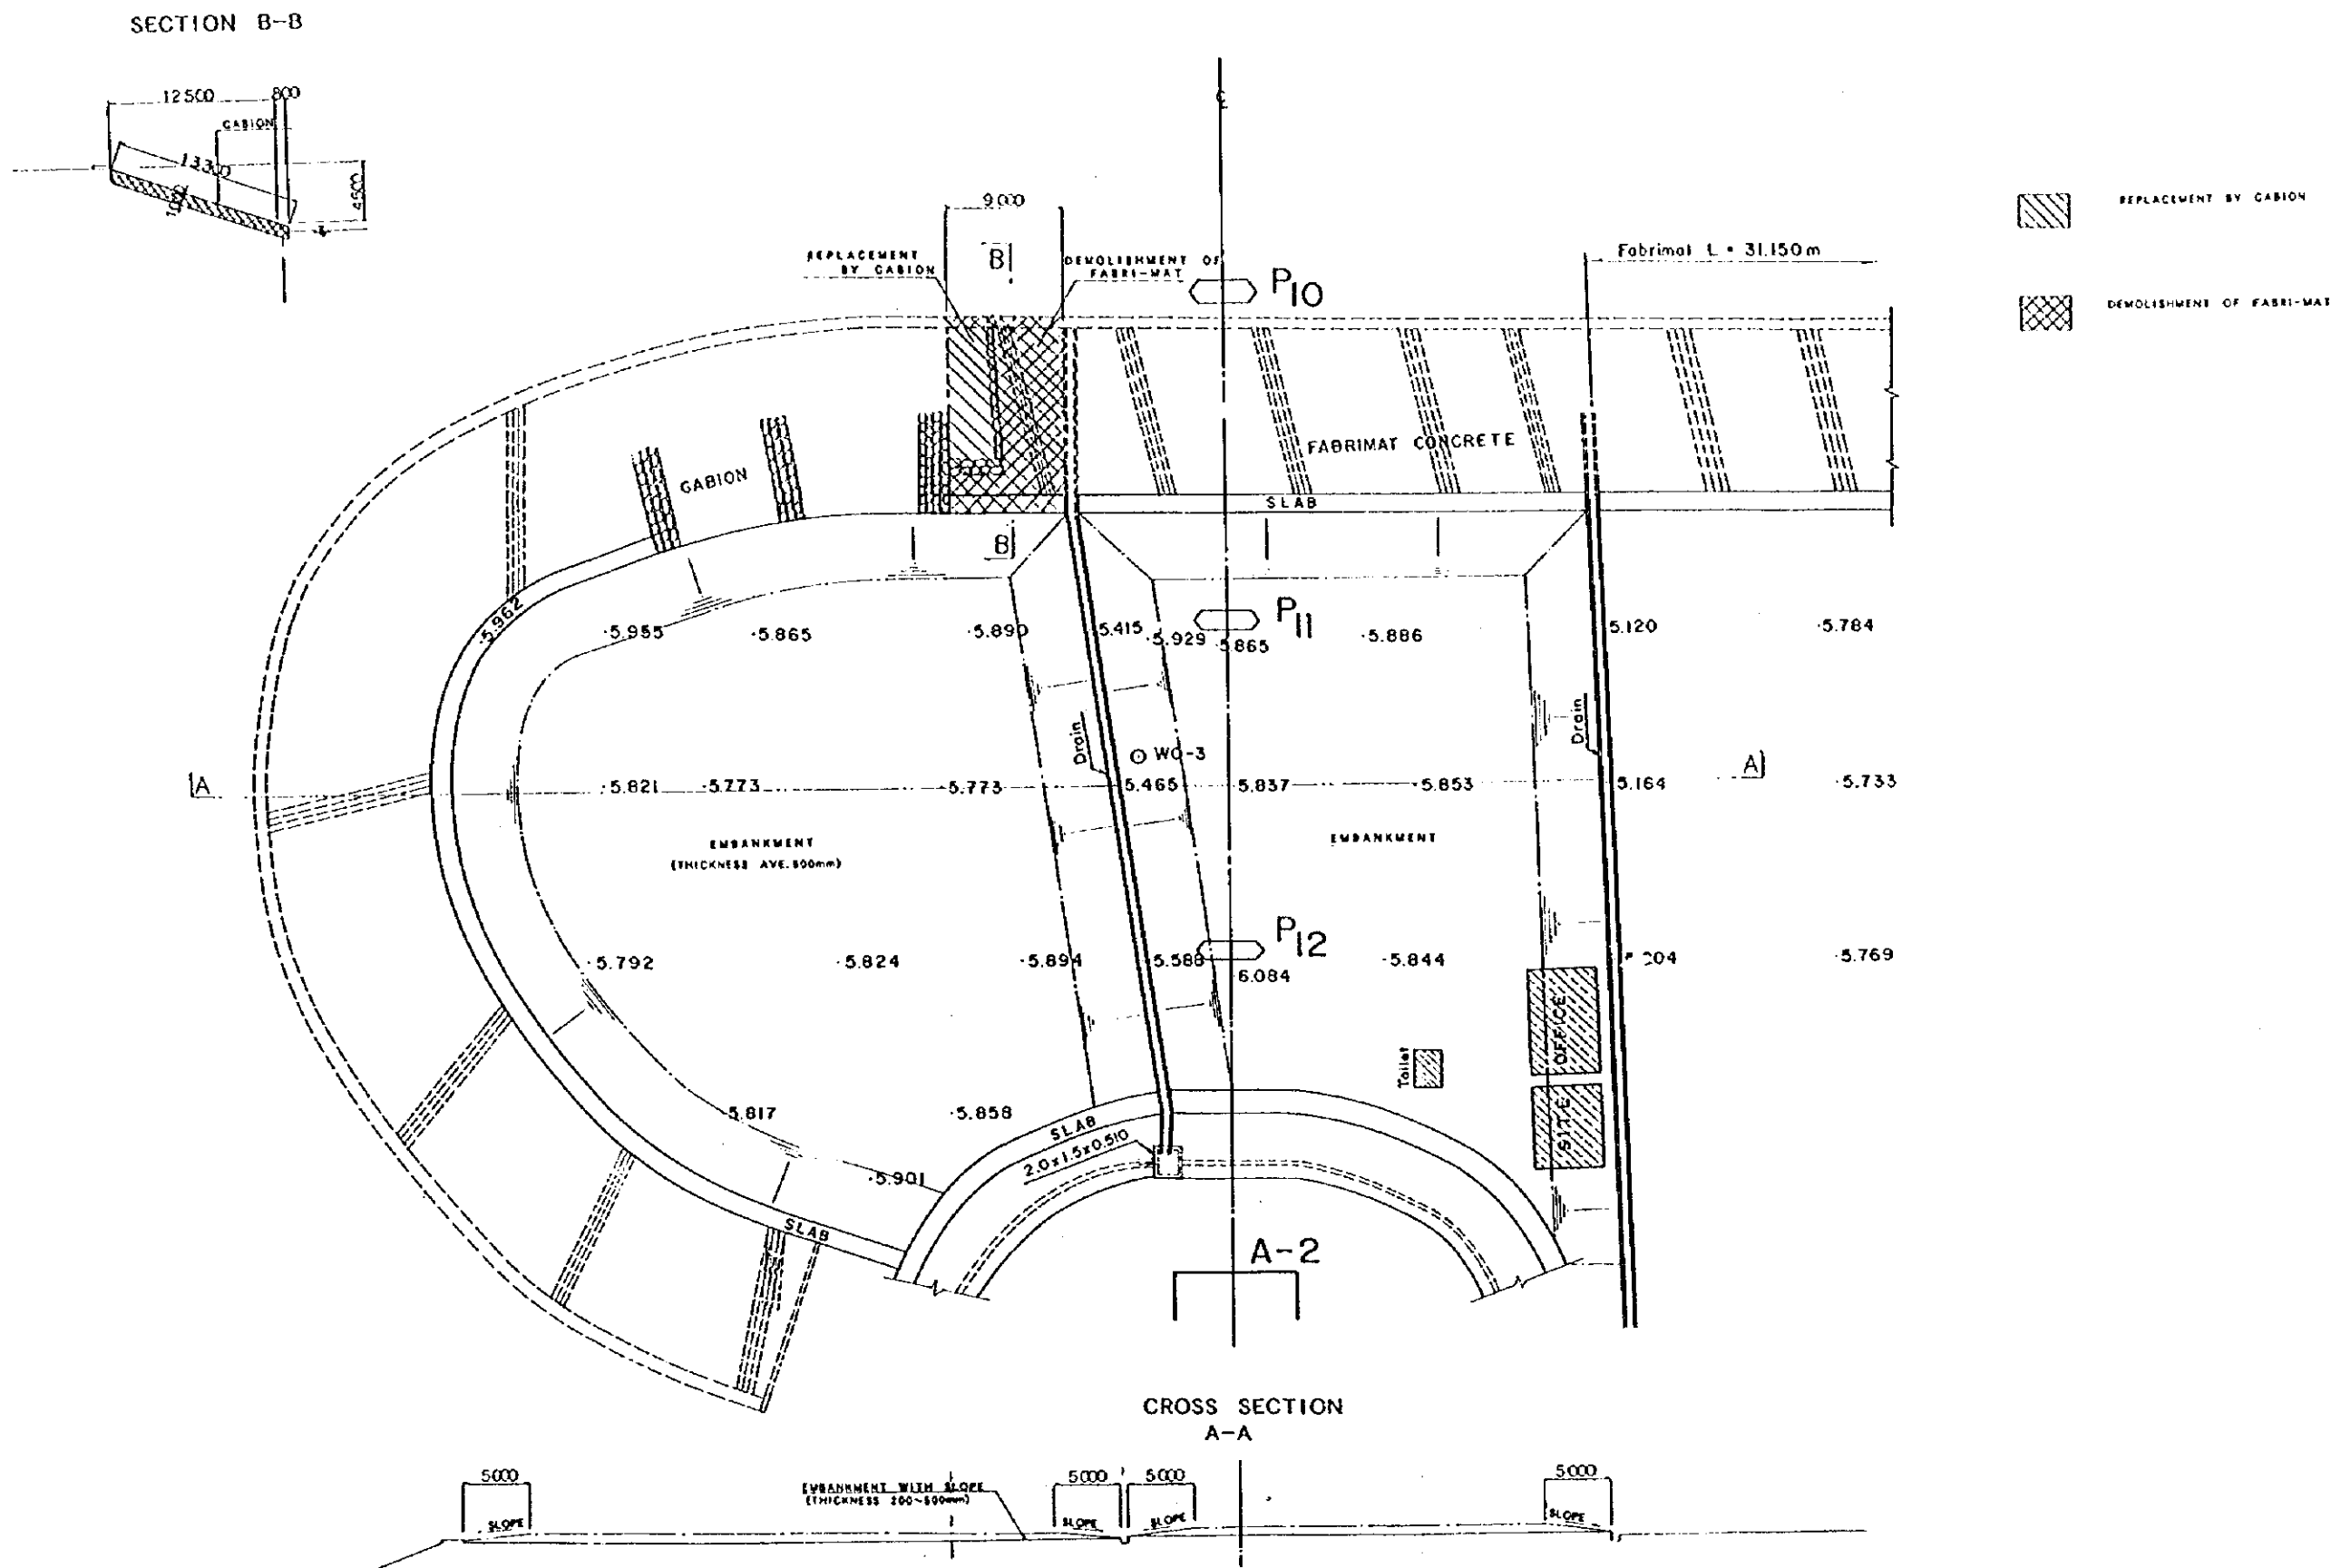
Figure 9.5 Grading and Gabion Works

When the rear side of the revetment can not drain rainwater properly, both the embankment and the revetment will be affected by excess pore water pressure and surface water seepage. In particular, near the abutment where the existing geotextile form concrete is located grading work is recommended to enhance surface drainage and to increase the stability of the revetment.
