2.6 REHABILITATION PRIORITY AND PROJECT INVESTMENT PLAN

3.2 GENERAL BRIDGE INSPECTION

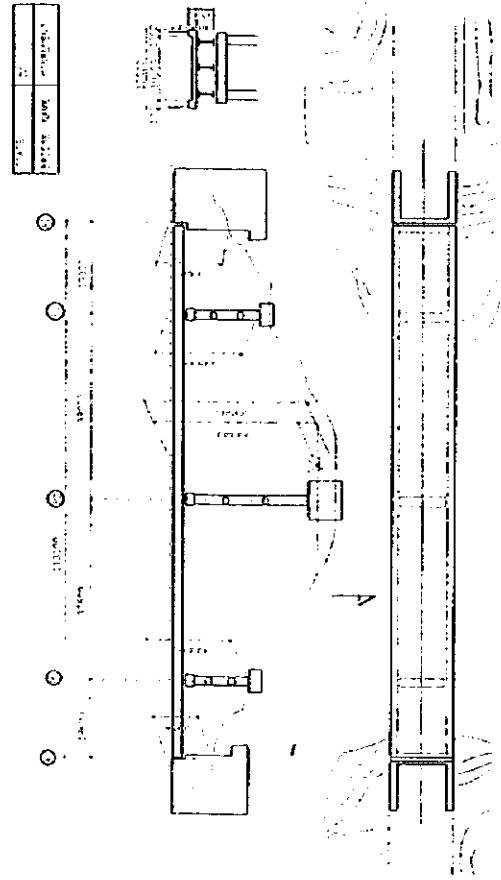
Figure 3.3 General View Drawing of Inspected Bridge

BRIDGE NAME: CONFLUENCIA

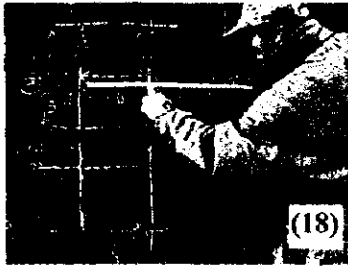
Cautin (88)

The scene of detection and the Pachometer used are shown on the following Photographs (18) and (19) respectively.
