MINISTRY OF PUBLIC WORKS
THE REPUBLIC OF CHILE

**THE REHABILITATION AND CONSERVATION
PROGRAM ON THE BRIDGES
IN
THE REPUBLIC OF CHILE
(PHASE 2)**

**APPENDIX II
(VOLUME 4/8)**

RESULTS OF GENERAL INSPECTION

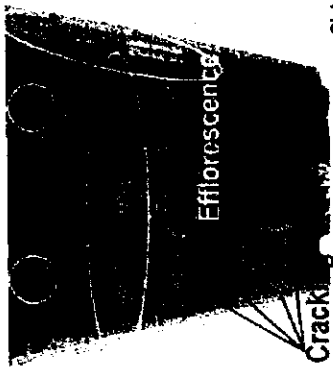
<p>Cracking</p> <p>Efflorescence</p> <p>Slab-4</p>

<p>Cracking</p> <p>Efflorescence</p> <p>A2 Abutment</p> <p>12,000</p> <p>19,000</p> <p>18,600</p> <p>A1 Abutment</p> <p>Slab-4</p> <p>Slab-1</p>	Cracking	<table border="1"> <thead> <tr> <th>X</th> <th>Y</th> <th>Z</th> <th>All member</th> </tr> </thead> <tbody> <tr> <td></td> <td>Large</td> <td>Large</td> <td>II</td> </tr> <tr> <td></td> <td>Small</td> <td>Small</td> <td>II</td> </tr> <tr> <td>Large</td> <td>Medium</td> <td>Large</td> <td>II</td> </tr> <tr> <td></td> <td>Small</td> <td>Small</td> <td>III</td> </tr> <tr> <td></td> <td>Small</td> <td>Small</td> <td>IV</td> </tr> <tr> <td></td> <td>Large</td> <td>Large</td> <td>III</td> </tr> <tr> <td></td> <td>Large</td> <td>Small</td> <td>III</td> </tr> <tr> <td>Small</td> <td>Medium</td> <td>Large</td> <td>IV</td> </tr> <tr> <td></td> <td>Small</td> <td>Small</td> <td>IV</td> </tr> <tr> <td></td> <td>Small</td> <td>Small</td> <td>IV</td> </tr> </tbody> </table> <p>Damage was observed, but rehabilitation is not needed. Follow-up inspection must be executed.</p>	X	Y	Z	All member		Large	Large	II		Small	Small	II	Large	Medium	Large	II		Small	Small	III		Small	Small	IV		Large	Large	III		Large	Small	III	Small	Medium	Large	IV		Small	Small	IV		Small	Small	IV	III

X	Y	Z	All member																																												
	Large	Large	II																																														
	Small	Small	II																																														
Large	Medium	Large	II																																														
	Small	Small	III																																														
	Small	Small	IV																																														
	Large	Large	III																																														
	Large	Small	III																																														
Small	Medium	Large	IV																																														
	Small	Small	IV																																														
	Small	Small	IV																																														
	<p>Cracking</p> <p>Efflorescence</p> <p>Z: over 0.1m²</p> <p>X: one direction 0.3mm < Y < 0.2mm</p> <p>Z: less 50cm</p>	Efflorescence	<table border="1"> <thead> <tr> <th>Z</th> <th>Main Member</th> <th>Secondary Member</th> </tr> </thead> <tbody> <tr> <td>Large</td> <td></td> <td>II</td> </tr> <tr> <td>Small</td> <td></td> <td>IV</td> </tr> </tbody> </table> <p>Degree of damage was large so that rehabilitation must be needed.</p>	Z	Main Member	Secondary Member	Large		II	Small		IV	II

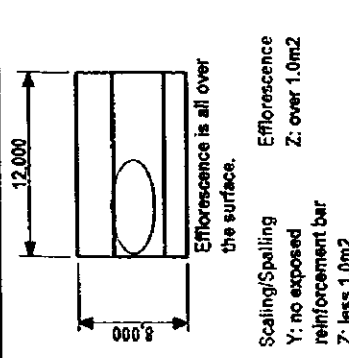
<p>12,000</p> <p>8,900</p> <p>Efflorescence</p> <p>Scaling/Spalling</p> <p>Efflorescence is all over the surface.</p> <p>Scaling/Spalling</p> <p>Efflorescence</p> <p>Z: over 1.0m²</p> <p>Y: no exposed reinforcement bar</p> <p>Z: less 1.0m²</p>	Scaling/Spalling Efflorescence	<table border="1"> <thead> <tr> <th>Y</th> <th>Z</th> <th>Main Member</th> <th>Secondary Member</th> </tr> </thead> <tbody> <tr> <td>Large</td> <td>Large</td> <td>I</td> <td>II</td> </tr> <tr> <td>Small</td> <td>Small</td> <td>I</td> <td>IV</td> </tr> <tr> <td></td> <td>Large</td> <td>III</td> <td>IV</td> </tr> <tr> <td></td> <td>Small</td> <td>III</td> <td>IV</td> </tr> </tbody> </table> <p>Damage was observed, the degree must be recorded.</p> <table border="1"> <thead> <tr> <th>Z</th> <th>Main Member</th> <th>Secondary Member</th> </tr> </thead> <tbody> <tr> <td>Large</td> <td></td> <td>II</td> </tr> <tr> <td>Small</td> <td></td> <td>IV</td> </tr> </tbody> </table> <p>Degree of damage is large, so that rehabilitation must be needed.</p>	Y	Z	Main Member	Secondary Member	Large	Large	I	II	Small	Small	I	IV		Large	III	IV		Small	III	IV	Z	Main Member	Secondary Member	Large		II	Small		IV	Scaling/Spalling IV Efflorescence II

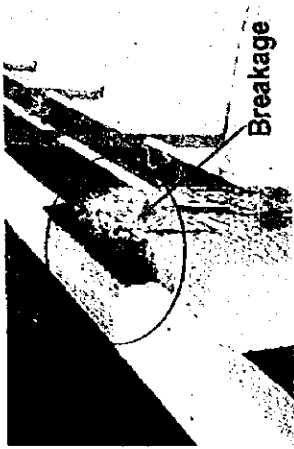
<p>Y: not remarkable damage (all concrete posts were damaged)</p>	Breakage	<table border="1" data-bbox="279 918 391 1131"> <tr><td>Y</td><td>All Members</td></tr> <tr><td>Large</td><td>II</td></tr> <tr><td>Small</td><td></td></tr> </table> <p>Damage is not remarkable, but rehabilitation must be needed from a point of the appearance.</p>	Y	All Members	Large	II	Small		IV*

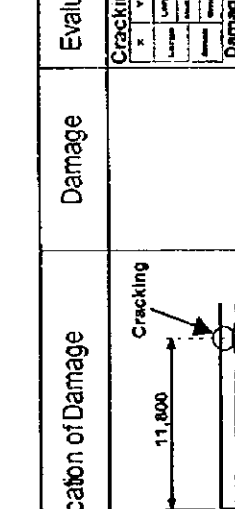
<p>13,850 P1 P2</p> <p>X: main part $0.3 > Y \geq 0.2 \text{ mm}$ Z: over 0.1 m²</p>	Cracking	<p>Cracking</p> <table border="1" data-bbox="639 1093 826 1272"> <thead> <tr> <th>X</th> <th>Y</th> <th>Z</th> <th>Main Member</th> <th>Secondary Member</th> </tr> </thead> <tbody> <tr> <td>Large</td> <td>Large</td> <td>Large</td> <td>III</td> <td>III</td> </tr> <tr> <td>Medium</td> <td>Medium</td> <td>Medium</td> <td>IV</td> <td>IV</td> </tr> <tr> <td>Small</td> <td>Small</td> <td>Small</td> <td>V</td> <td>V</td> </tr> </tbody> </table> <p>Damage was observed, but rehabilitation is not needed. Follow-up inspection must be executed.</p>	X	Y	Z	Main Member	Secondary Member	Large	Large	Large	III	III	Medium	Medium	Medium	IV	IV	Small	Small	Small	V	V	III

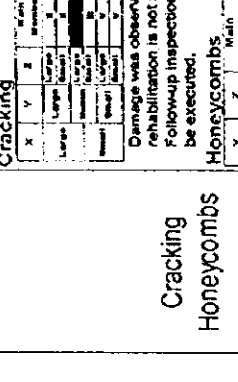
Cracking Honeycombs	Damage (cracking and honeycombs) were observed but damage rank was not justified because of inspection by distant view.	No rank

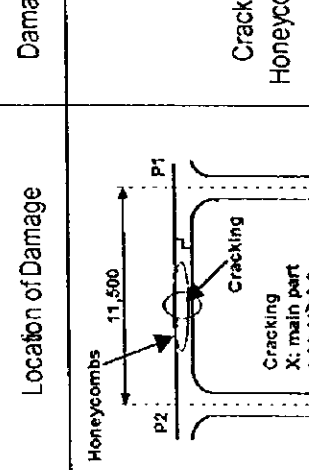
Cracking Honeycombs	Damage (cracking and honeycombs) were observed but damage rank was not justified because of inspection by distant view.	No rank

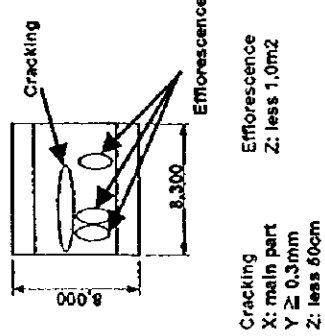
<p>Cracking X: main part Y \geq 0.3mm Z: less 60cm</p> <p>Efflorescence Z: less 1.0m²</p>	Cracking Efflorescence	<p>Cracking</p> <table border="1"> <tr><th>X</th><th>Y</th><th>Z</th><th>Main Member</th><th>Secondary Member</th></tr> <tr><td>Large</td><td>Large</td><td>Small</td><td>■</td><td>■</td></tr> <tr><td>Medium</td><td>Medium</td><td>Medium</td><td>■</td><td>■</td></tr> <tr><td>Small</td><td>Small</td><td>Large</td><td>■</td><td>■</td></tr> <tr><td>None</td><td>None</td><td>None</td><td>■</td><td>■</td></tr> </table> <p>Degree of damage is large, so that rehabilitation must be needed.</p> <p>Efflorescence</p> <table border="1"> <tr><th>Z</th><th>Main Member</th><th>Secondary Member</th></tr> <tr><td>Large</td><td>■</td><td>■</td></tr> <tr><td>Medium</td><td>■</td><td>■</td></tr> <tr><td>Small</td><td>■</td><td>■</td></tr> <tr><td>None</td><td>■</td><td>■</td></tr> </table> <p>Degree of damage is large, but rehabilitation is not needed. Follow-up inspection must be executed.</p>	X	Y	Z	Main Member	Secondary Member	Large	Large	Small	■	■	Medium	Medium	Medium	■	■	Small	Small	Large	■	■	None	None	None	■	■	Z	Main Member	Secondary Member	Large	■	■	Medium	■	■	Small	■	■	None	■	■	Cracking II Efflorescence III

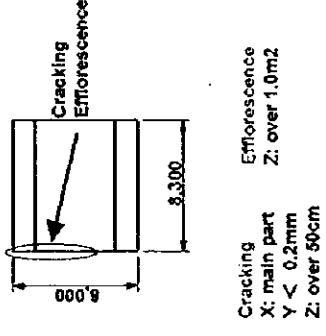
<p>Cracking X: main part Y < 0.2mm Z: over 50cm</p> <p>Efflorescence Z: over 1.0m²</p>	Cracking Efflorescence	<p>Cracking</p> <table border="1"> <tr><th>X</th><th>Y</th><th>Z</th><th>Main Member</th><th>Secondary Member</th></tr> <tr><td>Large</td><td>Large</td><td>Small</td><td>■</td><td>■</td></tr> <tr><td>Medium</td><td>Medium</td><td>Medium</td><td>■</td><td>■</td></tr> <tr><td>Small</td><td>Small</td><td>Large</td><td>■</td><td>■</td></tr> <tr><td>None</td><td>None</td><td>None</td><td>■</td><td>■</td></tr> </table> <p>Condition is sound</p> <p>Efflorescence</p> <table border="1"> <tr><th>Z</th><th>Main Member</th><th>Secondary Member</th></tr> <tr><td>Large</td><td>■</td><td>■</td></tr> <tr><td>Medium</td><td>■</td><td>■</td></tr> <tr><td>Small</td><td>■</td><td>■</td></tr> <tr><td>None</td><td>■</td><td>■</td></tr> </table> <p>Degree of damage is large, so that rehabilitation must be needed.</p>	X	Y	Z	Main Member	Secondary Member	Large	Large	Small	■	■	Medium	Medium	Medium	■	■	Small	Small	Large	■	■	None	None	None	■	■	Z	Main Member	Secondary Member	Large	■	■	Medium	■	■	Small	■	■	None	■	■	Cracking V Efflorescence II

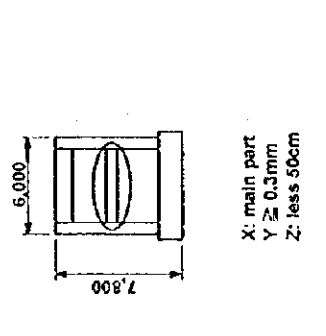
<p>X: main part Y \geq 0.3mm Z: less 50cm</p>	Cracking	<table border="1"> <tr><th>X</th><th>Y</th><th>Z</th><th>Main Member</th><th>Secondary Member</th></tr> <tr><td>Large</td><td>Large</td><td>Small</td><td>■</td><td>■</td></tr> <tr><td>Medium</td><td>Medium</td><td>Medium</td><td>■</td><td>■</td></tr> <tr><td>Small</td><td>Small</td><td>Large</td><td>■</td><td>■</td></tr> <tr><td>None</td><td>None</td><td>None</td><td>■</td><td>■</td></tr> </table> <p>Degree of damage is large, so that rehabilitation must be needed.</p>	X	Y	Z	Main Member	Secondary Member	Large	Large	Small	■	■	Medium	Medium	Medium	■	■	Small	Small	Large	■	■	None	None	None	■	■	II

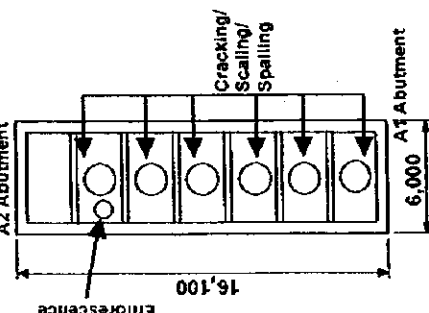
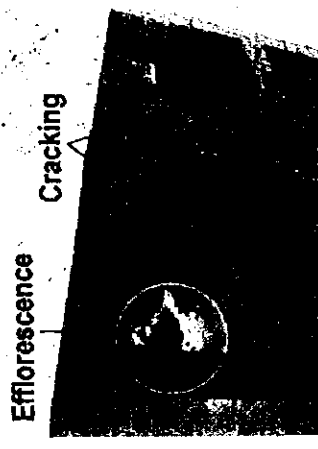
<p>Cracking X: main part 0.3 > Y ≥ 0.2mm Z: less 50cm</p> <p>Efflorescence Z: over 0.1m²</p> <p>Scaling/ Spalling Y: no exposed reinforcement bar but excessive Z: over 0.1m²</p>	Cracking Efflorescence	<p>Cracking</p> <table border="1"> <thead> <tr> <th>X</th> <th>Y</th> <th>Z</th> <th>Main Member</th> <th>Secondary Member</th> </tr> </thead> <tbody> <tr> <td>Large</td> <td>Small</td> <td>Small</td> <td>II</td> <td>II</td> </tr> <tr> <td>Small</td> <td>Small</td> <td>Small</td> <td>IV</td> <td>IV</td> </tr> </tbody> </table> <p>Degree of Damage is large so that rehabilitation must be needed.</p> <p>Efflorescence</p> <table border="1"> <thead> <tr> <th>Z</th> <th>Main Member</th> <th>Secondary Member</th> </tr> </thead> <tbody> <tr> <td>Large</td> <td>II</td> <td>II</td> </tr> <tr> <td>Small</td> <td>IV</td> <td>IV</td> </tr> </tbody> </table> <p>Degree of Damage is large so that rehabilitation must be needed.</p>	X	Y	Z	Main Member	Secondary Member	Large	Small	Small	II	II	Small	Small	Small	IV	IV	Z	Main Member	Secondary Member	Large	II	II	Small	IV	IV	Cracking II Efflorescence II

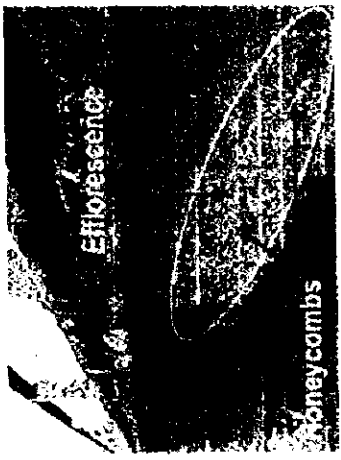
<p>4,800</p> <p>Efflorescence Z: less 1.0m²</p> <p>Honeycombs Y: no exposed reinforcement bar Z: less 1.0m²</p>	Efflorescence Honeycombs	<p>Efflorescence</p> <table border="1"> <tr> <td>Z</td> <td>Main Member</td> <td>Secondary Member</td> </tr> <tr> <td>Large</td> <td>II</td> <td>IV</td> </tr> <tr> <td>Small</td> <td></td> <td>IV</td> </tr> </table> <p>Damage was observed, but rehabilitation is not needed. Follow-up inspection must be executed.</p> <p>Honeycombs</p> <table border="1"> <tr> <td>Y</td> <td>Z</td> <td>Main Member</td> <td>Secondary Member</td> </tr> <tr> <td>Large</td> <td></td> <td>II</td> <td>IV</td> </tr> <tr> <td>Small</td> <td></td> <td>III</td> <td>IV</td> </tr> <tr> <td>Small</td> <td></td> <td>IV</td> <td>IV</td> </tr> </table> <p>Damage was observed, the degree must be recorded.</p>	Z	Main Member	Secondary Member	Large	II	IV	Small		IV	Y	Z	Main Member	Secondary Member	Large		II	IV	Small		III	IV	Small		IV	IV	Efflorescence III Honeycombs IV

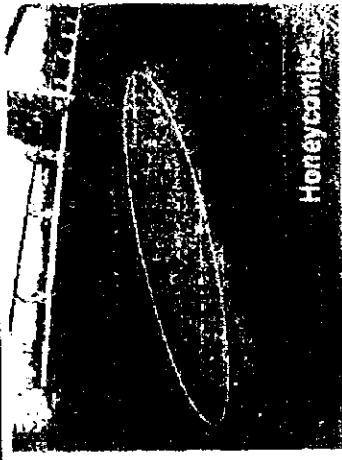
<p>4,800</p> <p>Y: no exposed reinforcement bar Z: less 1.0m²</p>	Honeycombs	<table border="1"> <tr> <td>Y</td> <td>Z</td> <td>Main Member</td> <td>Secondary Member</td> </tr> <tr> <td>Large</td> <td></td> <td>II</td> <td>IV</td> </tr> <tr> <td>Small</td> <td></td> <td>I</td> <td>IV</td> </tr> <tr> <td>Large</td> <td></td> <td>III</td> <td>IV</td> </tr> <tr> <td>Small</td> <td></td> <td>IV</td> <td>IV</td> </tr> </table> <p>Damage was observed, the degree must be recorded.</p>	Y	Z	Main Member	Secondary Member	Large		II	IV	Small		I	IV	Large		III	IV	Small		IV	IV	IV

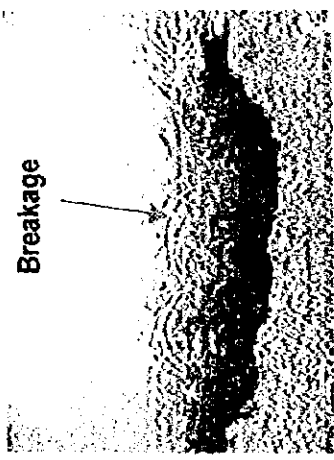
Y	Z	Main Member	Secondary Member																														
Large	Small	II	II																														
Small	Large	II	IV																														
	Small	III	IV																														
		IV	IV																														
Breakage	All Members																																
Y	Large																																
	Small																																
	IV																																
		Breakage	<table border="1"> <tr><td>Y</td><td>All Members</td></tr> <tr><td>Large</td><td>IV</td></tr> <tr><td>Small</td><td>IV</td></tr> </table> <p>Degree of damage is large, so that rehabilitation must be needed.</p>	Y	All Members	Large	IV	Small	IV	II

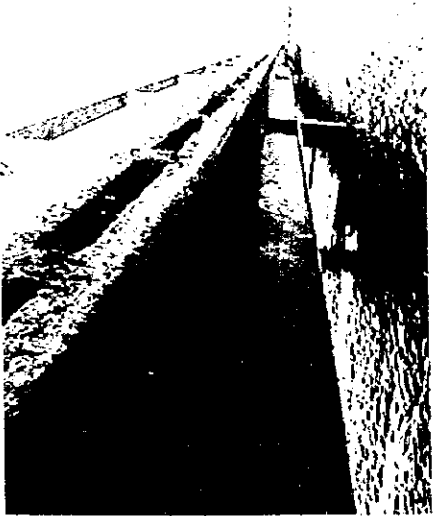
Bridge Component	Location of Damage	Damage	Evaluation of Damage	Damage Rank	Picture															
Beam		Aging of Coat

Y	Z	All Members	Large	Large	III	Small	Small	IV	Large	Large	IV	Small	Small	OK	IV

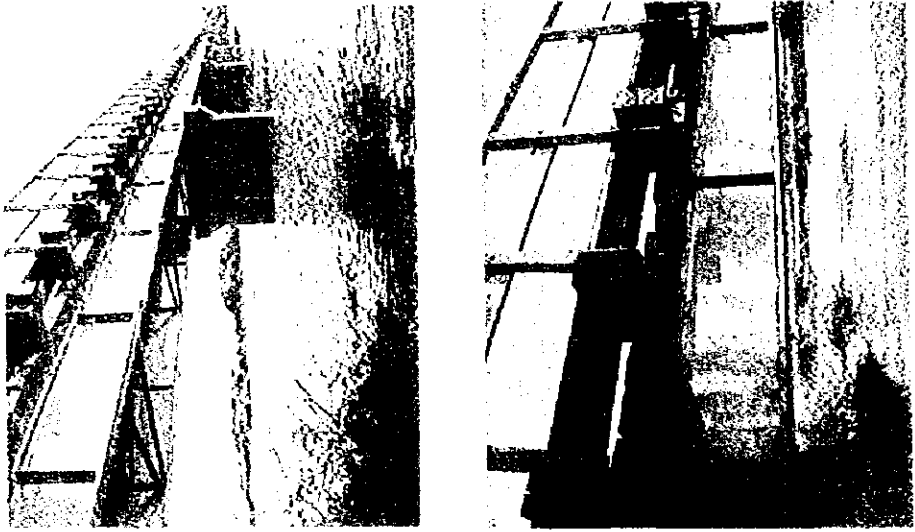
Los Cardos																		
(2) Steel Marerials	Location of Damage	Damage	Evaluation of Damage															
Bridge Compone Beam

<p>Y : Means Depth Z : Means Width No need repairing</p>	Y	Z	All Members	Large	Large	III	Small	Small	IV	Large	Large	IV	Small	Small	OK
Y	Z	All Members																
Large	Large	III																
Small	Small	IV																
Large	Large	IV																
Small	Small	OK																
		Damage Rank V	Picture

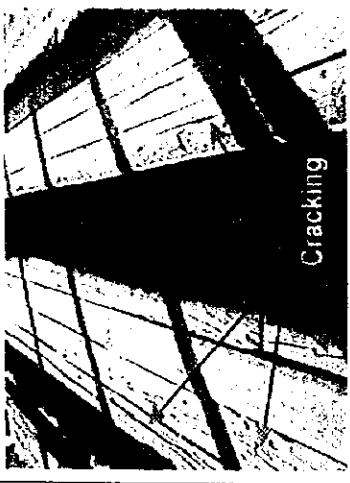
(3) Timber Materials		Bridge Component	Location of Damage	Damage	Evaluation of Damage	Damage Rank	Picture														
Slab1 ~ Slabe5

<p>X: main part Y: small (observed)</p>	Cracking	<table border="1" data-bbox="438 873 558 1131"> <tr> <td>X</td> <td>Y</td> <td>Main Member</td> <td>Secondary Member</td> </tr> <tr> <td>Large</td> <td>Large</td> <td>II</td> <td>III</td> </tr> <tr> <td>Small</td> <td>Large</td> <td>III</td> <td>IV</td> </tr> <tr> <td></td> <td>Small</td> <td>IV</td> <td>IV</td> </tr> </table> <p>Damage was observed, but rehabilitation is not needed. Follow-up inspection must be executed.</p>	X	Y	Main Member	Secondary Member	Large	Large	II	III	Small	Large	III	IV		Small	IV	IV	III

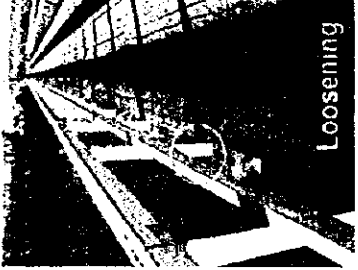
<p>Z: whole connections and excessive loosening</p>	Loosening	<table border="1" data-bbox="813 873 925 1131"> <tr> <td>Z</td> <td>All Members</td> </tr> <tr> <td>Large</td> <td></td> </tr> <tr> <td>Small</td> <td>IV</td> </tr> </table> <p>Damage was observed, the degree must be recorded.</p>	Z	All Members	Large		Small	IV	II
