BRIDGE NUMBER		YEAR OF BUILT	
BRIDGE NAME	CAUTIN	BRIDGE LENGTH	140.00m
REGION	X	BRIDGE WIDTH	7.00m
ROUTE NAME		TRAFFIC VOLUME

BRIDGE NO. C BRIDGE NAME : CAUTIN

B. DAMAGE RANK AND DECISION ON REHABILITATION

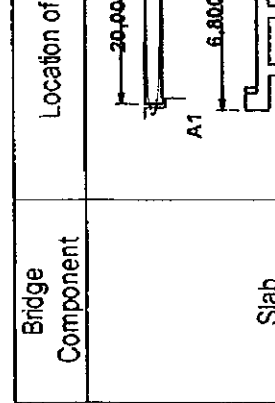
<p>Cracking (1) X: main part Y \geq 0.3mm Z: less 50cm</p> <p>Cracking (2) X: main part Y \geq 0.3mm Z: over 50cm</p>	<p>Damage</p> <p>Cracking</p>	<p>Evaluation of Damage</p> <p>Cracking</p> <table border="1" data-bbox="606 1500 790 1702"> <thead> <tr> <th>X</th> <th>Y</th> <th>Z</th> <th>Main Member</th> <th>Secondary Member</th> </tr> </thead> <tbody> <tr> <td>Large</td> <td>Small</td> <td>II</td> <td>II</td> <td>II</td> </tr> <tr> <td>Medium</td> <td>Small</td> <td>III</td> <td>III</td> <td>IV</td> </tr> <tr> <td>Small</td> <td>Small</td> <td>IV</td> <td>V</td> <td>V</td> </tr> </tbody> </table> <p>Degree of damage is large, so that rehabilitation must be needed.</p>	X	Y	Z	Main Member	Secondary Member	Large	Small	II	II	II	Medium	Small	III	III	IV	Small	Small	IV	V	V	<p>Damage Rank</p> <p>II</p>	<p>Picture</p>

<p>Cracking</p>

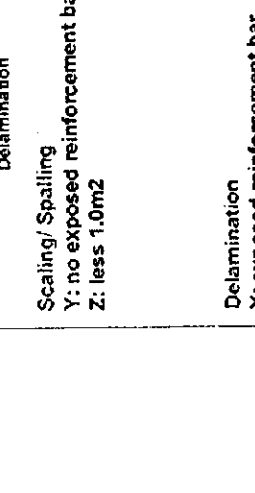
<p>Honeycombs</p>	Honeycombs	<table border="1" data-bbox="622 873 798 1075"> <tr> <td colspan="2">Honeycombs</td> <td colspan="2">Secondary Member</td> </tr> <tr> <td>Y</td> <td>Z</td> <td>Main Member</td> <td>Member</td> </tr> <tr> <td>Large</td> <td>Small</td> <td>II</td> <td>IV</td> </tr> <tr> <td>Large</td> <td>Small</td> <td>III</td> <td>IV</td> </tr> <tr> <td>Small</td> <td>Small</td> <td>IV</td> <td>IV</td> </tr> </table> <p>Damage was observed, the degree must be recorded.</p>	Honeycombs		Secondary Member		Y	Z	Main Member	Member	Large	Small	II	IV	Large	Small	III	IV	Small	Small	IV	IV	IV

<p>Honeycombs</p>
Honeycombs		Secondary Member																							
Y	Z	Main Member	Member																						
Large	Small	II	IV																						
Large	Small	III	IV

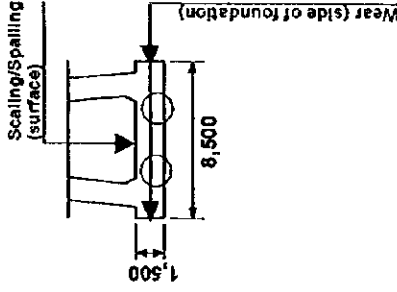
<p>Scaling/Spalling (surface)</p> <p>Wear (side of foundation)</p> <p>1,500</p> <p>8,500</p> <p>1,500</p>	Scaling/Spalling	<table border="1" data-bbox="343 869 486 1128"> <thead> <tr> <th colspan="2">Scaling/ Spalling</th> <th>Main Member</th> <th>Secondary Member</th> </tr> </thead> <tbody> <tr> <td>Y</td> <td>Z</td> <td>Large</td> <td>II</td> </tr> <tr> <td></td> <td></td> <td>Small</td> <td>IV</td> </tr> <tr> <td></td> <td></td> <td>Large</td> <td>IV</td> </tr> <tr> <td></td> <td></td> <td>Small</td> <td>IV</td> </tr> </tbody> </table> <p>Damage was observed, but rehabilitation is not needed. Follow-up inspection must be needed.</p>	Scaling/ Spalling		Main Member	Secondary Member	Y	Z	Large	II			Small	IV			Large	IV			Small	IV	III

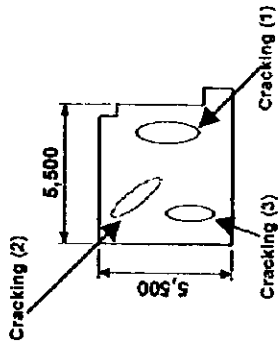
<p>Cracking (1) Cracking (2) Cracking (3)</p> <p>Cracking (1) X: main part Y \geq 0.3mm Z: less 50cm</p> <p>Cracking (2) X: main part Y \geq 0.3mm Z: less 50cm</p> <p>Cracking (3) X: main part Y \geq 0.3mm Z: less 50cm</p>	Cracking	<table border="1"> <thead> <tr> <th>X</th> <th>Y</th> <th>Z</th> <th>Main Member</th> <th>Secondary Member</th> </tr> </thead> <tbody> <tr> <td>Large</td> <td>Large</td> <td>Large</td> <td>II</td> <td>II</td> </tr> <tr> <td>Large</td> <td>Large</td> <td>Small</td> <td>III</td> <td>III</td> </tr> <tr> <td>Large</td> <td>Medium</td> <td>Large</td> <td>III</td> <td>IV</td> </tr> <tr> <td>Large</td> <td>Medium</td> <td>Small</td> <td>III</td> <td>IV</td> </tr> <tr> <td>Large</td> <td>Small</td> <td>Large</td> <td>V</td> <td>V</td> </tr> <tr> <td>Large</td> <td>Small</td> <td>Small</td> <td>V</td> <td>V</td> </tr> </tbody> </table> <p>Degree of damage is large, so that rehabilitation must be needed.</p>	X	Y	Z	Main Member	Secondary Member	Large	Large	Large	II	II	Large	Large	Small	III	III	Large	Medium	Large	III	IV	Large	Medium	Small	III	IV	Large	Small	Large	V	V	Large	Small	Small	V	V	II

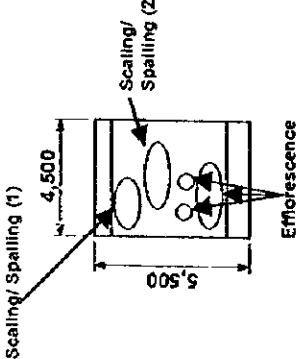
<p>Scaling/ Spalling (1) 4,500 Scaling/ Spalling (2) 5,500 Efflorescence</p> <p>Scaling/ Spalling (1) Y: no exposed reinforcement bar but deep Z: over 1.0m²</p> <p>Scaling/ Spalling (2) Y: no exposed reinforcement bar but deep Z: over 1.0m²</p> <p>Efflorescence Z: over 1.0m²</p>	Scaling/spalling Efflorescence	<table border="1" data-bbox="279 873 422 1120"> <thead> <tr> <th>Y</th> <th>Z</th> <th>Main Member</th> <th>Secondary Member</th> </tr> </thead> <tbody> <tr> <td>Large</td> <td>Large</td> <td>II</td> <td>II</td> </tr> <tr> <td>Small</td> <td>Small</td> <td>IV</td> <td>IV</td> </tr> </tbody> </table> <p>Although damage rank is III, the degree is large, so that rehabilitation must be needed.</p> <table border="1" data-bbox="662 873 805 1120"> <thead> <tr> <th>Y</th> <th>Z</th> <th>Main Member</th> <th>Secondary Member</th> </tr> </thead> <tbody> <tr> <td>Large</td> <td>Large</td> <td>II</td> <td>II</td> </tr> <tr> <td>Small</td> <td>Small</td> <td>IV</td> <td>IV</td> </tr> </tbody> </table> <p>Although damage rank is III, the degree is large, so that rehabilitation must be needed.</p> <table border="1" data-bbox="1021 873 1133 1120"> <thead> <tr> <th>Z</th> <th>Main Member</th> <th>Secondary Member</th> </tr> </thead> <tbody> <tr> <td>Large</td> <td>II</td> <td>II</td> </tr> <tr> <td>Small</td> <td>IV</td> <td>IV</td> </tr> </tbody> </table> <p>Degree of damage is large, so that rehabilitation must be needed.</p>	Y	Z	Main Member	Secondary Member	Large	Large	II	II	Small	Small	IV	IV	Y	Z	Main Member	Secondary Member	Large	Large	II	II	Small	Small	IV	IV	Z	Main Member	Secondary Member	Large	II	II	Small	IV	IV	* III

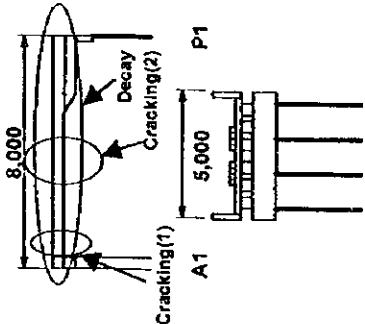
<p>Cracking (1) Cracking (2) Decay 8,000 A1 5,000 P1</p>	Decay	<table border="1" data-bbox="406 862 510 1120"> <thead> <tr> <th>Z</th> <th>Main Members</th> <th>Secondary Members</th> </tr> </thead> <tbody> <tr> <td>Large</td> <td>III</td> <td>IV</td> </tr> <tr> <td>Small</td> <td>II</td> <td>IV</td> </tr> </tbody> </table> <p>Degree of damage is large, so that rehabilitation must be needed.</p>	Z	Main Members	Secondary Members	Large	III	IV	Small	II	IV	II

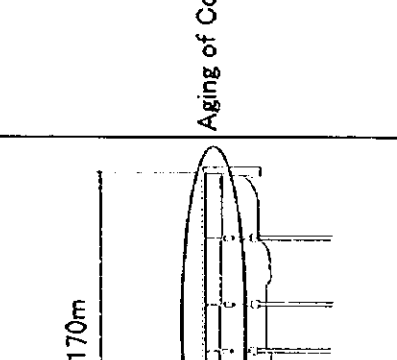
<p>170m</p>	Aging of Coat

<p>Y : Means Depth Z : Means Width</p>	Y	Z	All Members	Large	Large	III	Small	Small	IV	Large	Large	IV	Small	Small	OK	IV

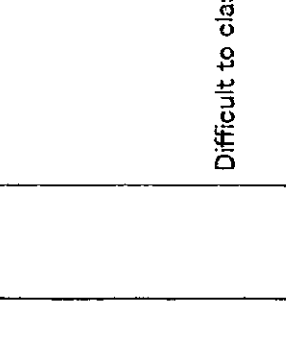
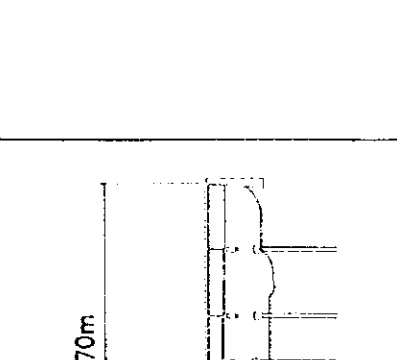
<p>Pile(Rail Steel)</p> <p>Difficult to classify what kind of damage it has.</p>

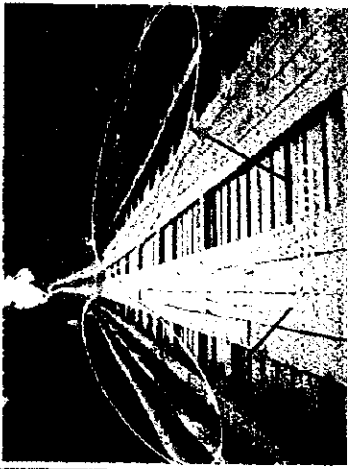
<p>Z: whole connections and not excessive loosening</p>	Loosening

Z	All Members	Large		Small	IV	II

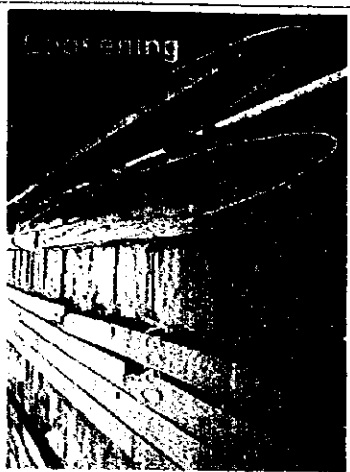
<p>5,000</p> <p>Decay Z: whole area and excessive damage</p> <p>Loosening Z: whole connections and excessive loosening</p>	Decay Loosening	<p>Decay</p> <table border="1" data-bbox="1109 884 1189 1131"> <tr> <td>Z</td> <td>Main Members</td> <td>Secondary Members</td> </tr> <tr> <td>Large</td> <td>II</td> <td>III</td> </tr> <tr> <td>Small</td> <td></td> <td>IV</td> </tr> </table> <p>Damage was observed, but rehabilitation is not needed. Follow-up inspection must be needed.</p> <p>Loosening</p> <table border="1" data-bbox="1292 884 1356 1131"> <tr> <td>Z</td> <td>All Members</td> </tr> <tr> <td>Large</td> <td></td> </tr> <tr> <td>Small</td> <td>IV</td> </tr> </table> <p>Degree of damage is large, so that rehabilitation must be needed.</p>	Z	Main Members	Secondary Members	Large	II	III	Small		IV	Z	All Members	Large		Small	IV	Decay III Loosening II

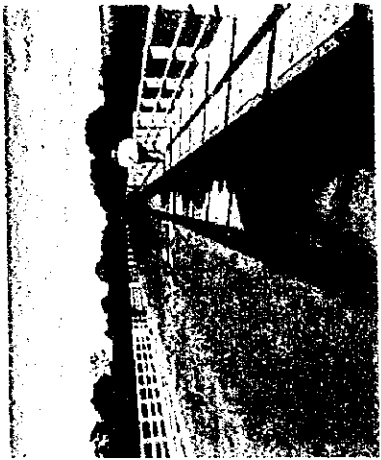
<p>Y : Means Depth Z : Means Width Keeping on inspection.</p>	Y	Z	All Members	Large	Small	III	Small	Small	IV			OK	IV

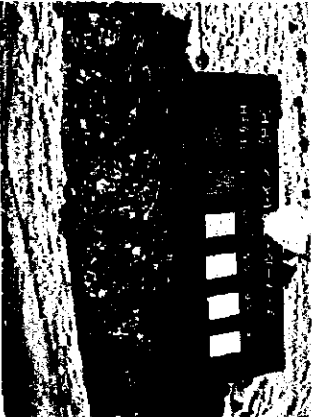
Cautin Abutment	pH=10.5 not neutralized
