**FEASIBILITY STUDY  
ON  
TAUNSA BARRAGE IRRIGATION SYSTEM REHABILITATION  
IN  
THE ISLAMIC REPUBLIC OF PAKISTAN**

***Annex A***  
***Gate Structure***

## ANNEX A GATE STRUCTURE

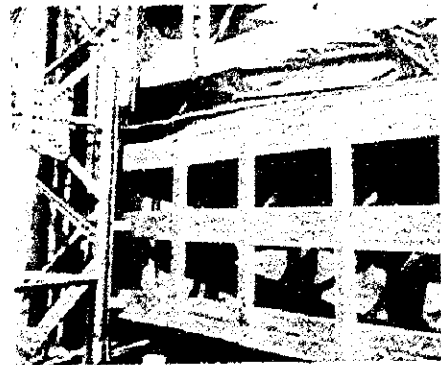
Gate No. USL (Lower Undersluice Gate)

Skin Plate	Thickness-Avg	Top - Mid - Low - Btm 8.3 (9.5mm)		N	Wire Rope	Main-Left	y: - Distortion: - Corrosion: - Oil: -		G	
	Corrosion	UIS-Bottom (L) M S		↑		Main-Right	y: - Distortion: - Corrosion: - Oil: -		G	
	Damage-Rivet	Corner-L 4 Corner-R 8				Roller Train-L	Broken		N	
				Roller Train-R		Broken		N		
Truss	Thickness-Avg	Bottom Flange 21.9, Bottom Web 21.0 (22.2mm)			Drum	Left	Damage: - Function: -		RS	
	Distortion					Right	Damage: - Function: -		RS	
End Girder	Thickness-Avg	L-Bottom 11.4, R-Bottom 10.8 (12.7mm)			Bearing	Drum	Damage: - Oil: -		RS	
	Remodeling	Left No Right No				Counter Shaft	Damage: - Oil: Center Gear Bearing Elbow Broken		C	
	Distortion	Left Small Bend Right -				Reduction Gear	Damage: - Oil: -		RS	
Bottom	Thickness-Avg	Flange 14.5 mm (16.0), Web 9.2 mm (9.7)			Gear	Drum Gear-L	Damage: - Fitting: - Backlash: - Oil: -		↑

Girder	Corrosion	L (M) S				Drum Pinion-L	Damage: -		
Rocker	Remodeling	Left No Right No				Drum Gear-R	Damage: - Fitting: - Backlash: - Oil: -			
	Assembly	Distortion	Left Heavy Ab. Right Heavy Ab.				Drum Pinion-R	Damage: -		
		Others	No Function				Gear-Middle	Damage: - Fitting: - Backlash: - Oil: -		
Roller Train	Missing	Left 0 Right 0				Pinion-Middle	Damage: -			
	Diameter-Roller	Average 152.2 mm			Basement	Drum-L	Damage: - Corrosion: L M (S)			
	Distortion	Left - Right -				Drum-R	Damage: - Corrosion: L M (S)		↓	
Seal	Left	Lost				Drive Device	Damage: - Corrosion: L (M) S		RS	
Seal	Bottom	Lost			Drive Chain	Damage: - Looseness: - Oil: -		C		
	Right	Lost				Chain Sprocket	Damage: - Corrosion: L (M) S		↑	
	Inclination	Top Level Difference - mm		↓	Reduction Gear	Damage: - Corrosion: L (M) S		↑		
Leakage	(L) M S		N	Cover	Drum-L	Damage: - Corrosion: L M (S)				
Sill	Side Seal	Abrasion-Max	Left: - mm, Right: - mm		RS	Drum-R	Damage: - Corrosion: L M (S)		↓

Roller Truck	Abrasion-Max		Left: - mm, Right: - mm		RL	Gear-Middle	Damage: - Corrosion: L (M) S	
	Roller Guard	Missing	Left 0 Right 0		N	Counter Shaft	Damage: Touching Corrosion: L M (S)		RS	
		Defect	Left 0 Right 0		N	Counter Weight	Damage: - Corrosion: L M S		RS	
	Sill Beam	Abrasion	L M S		-	Hoisting	Wet Condition	- kg·m		-
Concrete	Damage-Left	L M S		-	Torque		Dry Condition	2.0 kg·m		RS
	Damage-Right	L M S		-	Superstructure	Damage: - Corrosion: L M (S)		RS		
	Damage-Bottom	L M S		-

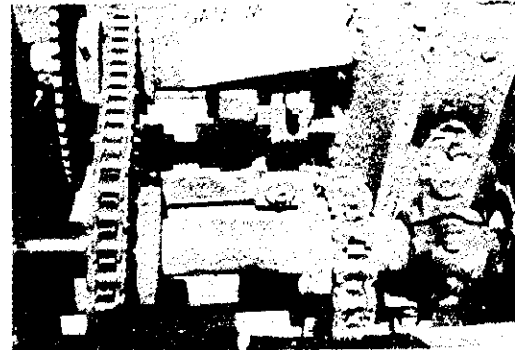
Gate No. U6L (Lower Undersluice Gate)

Skin Plate	Thickness-Avg	Top - Mid - Low - Btm 8.5 (9.5mm)			N	Wire Rope	Main-Left	Y: - Distortion: - Corrosion: - Oil: -			G			
	Corrosion	UIS-Bottom L (M) S			↑		Main-Right	Y: - Distortion: - Corrosion: - Oil: -			G			
Truss	Damage-Rivet	Corner-L 7 Corner-R 7					Roller Train-L	Y: - Distortion: - Corrosion: - Oil: -			N			
	Thickness-Avg	Bottom Flange 20.8, Bottom Web 21.3 (22.2mm)					Roller Train-R	Y: - Distortion: - Corrosion: - Oil: -			N			
End Girder	Distortion					Drum	Left	Damage: - Function: Touching Frame			RS			
	Thickness-Avg	L-Bottom 12.1, R-Bottom 11.9 (12.7mm)					Right	Damage: - Function: -			↑			
	Remodeling	Left No Right Re				Bearing	Drum	Damage: - Oil: -			↓			
Distortion	Left Bend Right Band				Counter Shaft		Damage: - Oil: -			RS				
Bottom Girder	Thickness-Avg	Flange 14.5 mm (16.0), Web 9.0 mm (9.7)				Reduction Gear	Damage: Broken Oil: -			C

Corrosion	L (M) S				Gear	Drum Gear-L	Damage: - Fitting: 90% Backlash: 3mm Oil: -			RS			
Rocker Assembly	Remodeling	Left No Right Re.					Drum Pinion-L	Damage: Miss Alignment			↑			
	Distortion	Left - Right Broken					Drum Gear-R	Damage: - Fitting: - Backlash: - Oil: -			↑			
Roller Train	Others						Drum Pinion-R	Damage: -			↑			
	Missing	Left 2 Right 1					Gear-Middle	Damage: - Fitting: - Backlash: - Oil: -			↑			
	Diameter-Roller	Average - mm				Pinion-Middle	Damage: Miss Alignment			↑				
Seal	Distortion	Left - Right -				Basement	Drum-L	Damage: - Corrosion: L M (S)			↑			
	Left	Lost					Drum-R	Damage: - Corrosion: L M (S)			↓			
	Bottom	Lost					Drive Device	Damage: - Corrosion: L (M) S			RS			
Inclination	Right	Lost				Drive Chain	Damage: - Looseness: - Oil: -			C				
	Top Level Difference	- mm			↓	Chain Sprocket	Damage: - Corrosion: L (M) S			↑				
Leakage						(L) M S	N	Reduction Gear	Damage: - Corrosion: L (M) S			↑

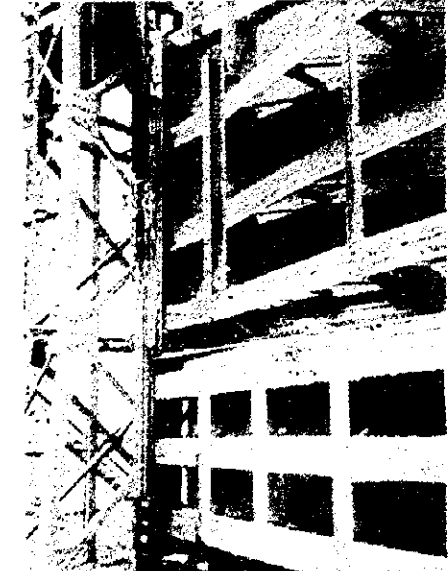
Gate No. U7U (Upper Undersluice Gate)

Skin Plate	Thickness-Avg	Top - Mid - Low - Blm 10.0 (9.5mm)	N	Wire Rope	Main-Left	y: - Distortion: - Corrosion: - Oil: -	G	
	Corrosion	U/S-Bottom L M (S)	↑		Main-Right	y: - Distortion: - Corrosion: - Oil: -	G	
	Damage-Rivet	Corner-L - Corner-R -			Roller Train-L	y: - Distortion: - Corrosion: - Oil: -	N	
			Roller Train-R		y: - Distortion: - Corrosion: - Oil: -	N		
Truss	Thickness-Avg	Bottom Flange 19.1, Bottom Web 18.7 (19.1mm)		Drum	Left	Damage: - Function: Miss Alignment	RS	
	Distortion				Right	Damage: - Function: -	↑	
End Girder	Thickness-Avg	L-Bottom 12.7, R-Bottom 12.6 (12.7mm)		Bearing	Drum	Damage: - Oil: -	↓	
	Remodeling	Left No Right No			Counter Shaft	Damage: - Oil: -	RS	
	Distortion	Left - Right -			Reduction Gear	Damage: - Oil: -	C	
Bottom	Thickness-Avg	Flange 11.4 mm (16.3), Web 9.2 mm (9.4)		Gear	Drum Gear-L	Damage: - Fitting: - Backlash: - Oil: -	RS

Corrosion	(L) M S			Drum Pinion-L	Damage: -	↑	
Rocker	Remodeling	Left No Right No			Drum Gear-R	Damage: - Fitting: - Backlash: - Oil: -		
	Distortion	Left - Right -			Drum Pinion-R	Damage: -		
Assembly	Others	No Function			Gear-Middle	Damage: - Fitting: - Backlash: - Oil: -		
	Roller Train	Missing Left 0 Right 0			Pinion-Middle	Damage: -		
	Diameter-Roller	Average - mm		Basement	Drum-L	Damage: - Corrosion: L M (S)		
Distortion	Left - Right -		Drum-R		Damage: - Corrosion: L M (S)	↓		
Seal	Left 4 m Broken		Drive Device		Damage: - Corrosion: L (M) S	RS		
Seal	Bottom	Good		Drive Chain	Damage: - Looseness: - Oil: -	C		
	Right 3 m Broken			Chain Sprocket	Damage: - Corrosion: L (M) S	↑		
Inclination	Top Level Difference - mm		Reduction Gear	Damage: - Corrosion: L (M) S	↑			
Leakage	(L) M S		Cover	Drum-L	Damage: - Corrosion: L M (S)			
Sill	Side Seal	Abrasion-Max Left: - mm, Right: - mm		RS	Drum-R	Damage: - Corrosion: L M (S)	↓

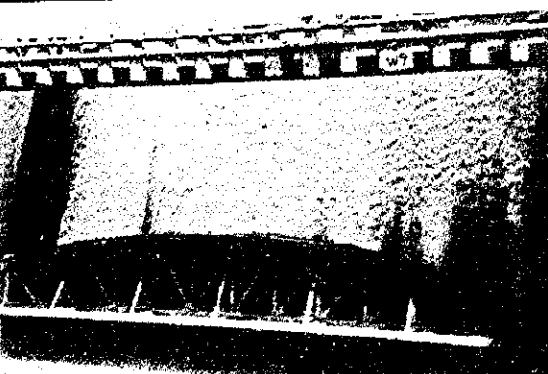
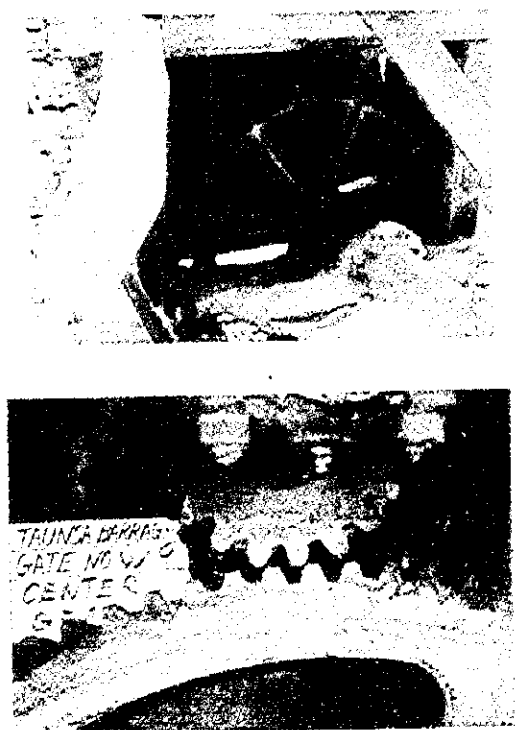
Gate No. W9 (Main Weir Gate)

Skin Plate	Thickness-Avg	Top 10.2 Mid 9.9 Low 9.9 Blm - (9.5mm)	G	Wire Rope	Main-Left	y: - Distortion: - Corrosion: - Oil: -		G
	Corrosion	U/S-Bottom L M S	-		Main-Right	y: - Distortion: - Corrosion: - Oil: -		G
	Damage-Rivet	Corner-L - Corner-R -	-		Roller Train-L	y: - Distortion: - Corrosion: - Oil: -		C
Truss	Thickness-Avg	Bottom Flange - Bottom Web - (19.1mm)	-		Roller Train-R	y: - Distortion: - Corrosion: - Oil: -		C
	Distortion		G	Drum	Left	Damage: - Function: -		RS
End Girder	Thickness-Avg	L-Bottom - R-Bottom - (11.1mm)	C		Right	Damage: - Function: -		↑
	Remodeling	Left No Right No	↑	Bearing	Drum	Damage: - Oil: -		
	Distortion	Left - Right -			Counter Shaft	Damage: - Oil: -		
Bottom	Thickness-Avg	Flange - mm (16.3), Web - mm (9.4)			Reduction Gear	Damage: - Oil: -		
	Corrosion	L M S		Gear	Drum Gear-L	Damage: - Fitting: - Backlash: - Oil: -

Girder	Remodeling	Left No Right No			Drum Pinion-L	Damage: -		
	Distortion	Left - Right -			Drum Gear-R	Damage: - Fitting: - Backlash: - Oil: -		
Rocker	Remodeling	Left No Right No			Drum Pinion-R	Damage: -		
	Distortion	Left - Right -			Gear-Middle	Damage: - Fitting: - Backlash: 10 mm Oil: -		
Assembly	Others	No Function		Pinion-Middle	Damage: Dangerous to Operation			
	Roller Train	Missing	Left - Right -		Basement	Drum-L		Damage: - Corrosion: L M (S)
Diameter-Roller		Average - mm		Drum-R		Damage: - Corrosion: L M (S)		RS
Distortion		Left - Right -		Drive Device		Damage: - Corrosion: (L) M S		C
Seal	Left	-		Drive Chain	Damage: - Looseness: - Oil: -	↑		
	Bottom	-		Chain Sprocket	Damage: - Corrosion: L (M) S			
	Right	-		Reduction Gear	Damage: - Corrosion: L (M) S			
	Inclination	Top Level Difference 140 mm	↓	Cover	Drum-L	Damage: - Corrosion: L M (S)		
Leakage	L (M) S	C	Drum-R		Damage: - Corrosion: L M (S)	↓

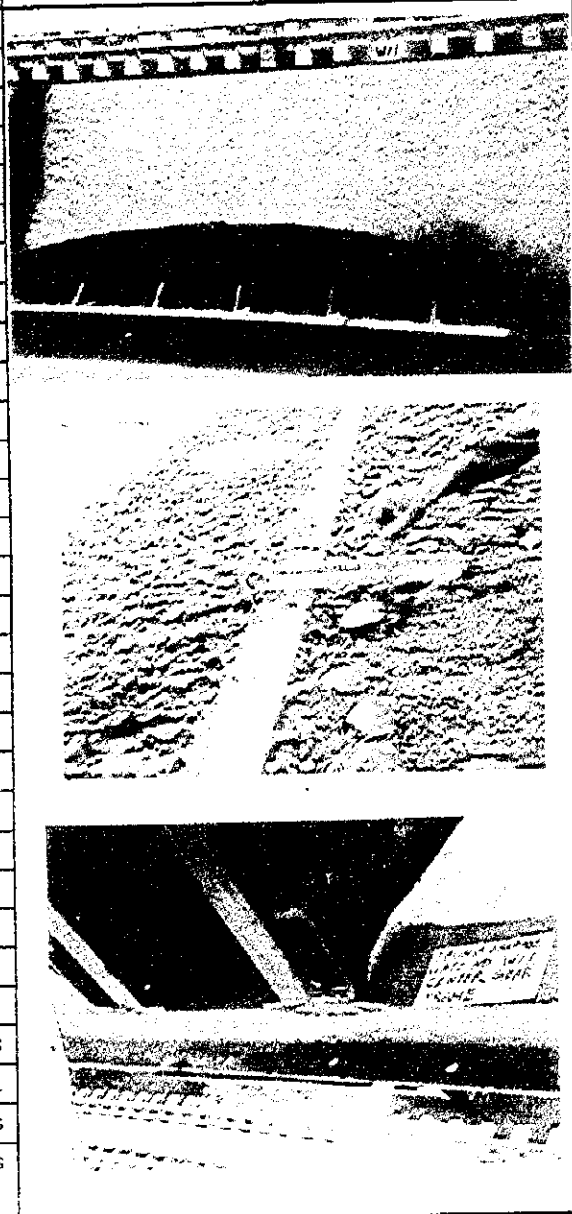
Gate No. W11 (Main Weir Gate)

Skin Plate	Thickness-Avg	Top 10.2 Mid 10.0 Low 9.9 Btm 9.1 (9.5mm)	G	Wire Rope	Main-Left	γ: - Distortion: - Corrosion: - Oil: -		G	
	Corrosion	U/S-Bottom L M S	-		Main-Right	γ: - Distortion: - Corrosion: - Oil: -		G	
	Damage-Rivet	Corner-L - Corner-R -	-		Roller Train-L	γ: - Distortion: - Corrosion: - Oil: -		C	
Truss	Thickness-Avg	Bottom Flange 18.4, Bottom Web 18.5 (19.1mm)	G		Roller Train-R	γ: - Distortion: - Corrosion: - Oil: -		C	
	Distortion		-	Drum	Left	Damage: - Function: -		RS	
End Girder	Thickness-Avg	L-Bottom 9.6, R-Bottom 9.7 (11.1mm)	C		Right	Damage: - Function: -		↑	
	Remodeling	Left No Right No	↑	Bearing	Drum	Damage: - Oil: -		↓	
	Distortion	Left - Right -			Counter Shaft	Damage: - Oil: -		RS	
Bottom	Thickness-Avg	Flange 15.0 mm (16.3), Web 8.3 mm (9.4)			Reduction Gear	Damage: - Oil: -		C

Girder	Corrosion L M S		Gear	Drum Gear-L	Damage: - Fitting: - Backlash: - Oil: -		RS	
Rocker	Remodeling	Left No Right No			Drum Pinion-L	Damage: -		↑	
	Assembly	Distortion	Left - Right -			Drum Gear-R		Damage: - Fitting: - Backlash: - Oil: -	
Roller Train		Missing	Left - Right -			Drum Pinion-R		Damage: -	
		Diameter-Roller	Average - mm			Gear-Middle		Damage: - Fitting: - Backlash: 10 mm Oil: -	
Seal	Distortion	Left - Right -		Pinion-Middle	Damage: -				
	Left	-		Basement	Drum-L	Damage: - Corrosion: L M (S)		↓	
	Bottom	-			Drum-R	Damage: - Corrosion: L M (S)		RS	
Right	-		Drive Device		Damage: - Corrosion: L (M) S	C			
Inclination		Top Level Difference 30 mm	↓	Drive Chain	Damage: - Looseness: - Oil: -	↑			
				Chain Sprocket	Damage: - Corrosion: L (M) S				
Leakage		(L) M S	C	Reduction Gear	Damage: - Corrosion: L (M) S				
Sill	Side Seal	Abrasion-Max Left: - mm, Right: - mm	RS	Cover	Drum-L	Damage: - Corrosion: L M (S)

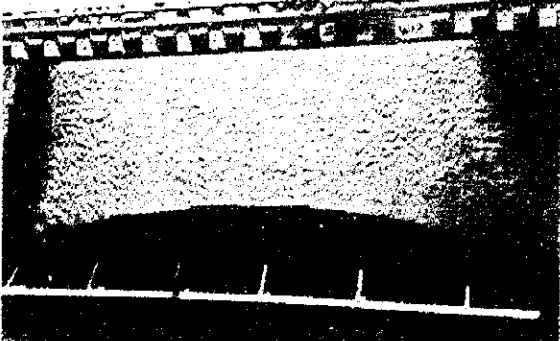
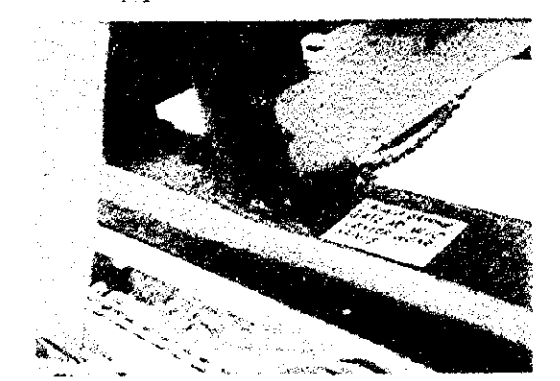
Gate No. W12 (Main Weir Gate)

Skin Plate	Thickness-Avg	Top 10.1 Mid 10.0 Low 10.0 Btm 9.2 (9.5mm)	G	Wire Rope	Main-Left	γ: - Distortion: - Corrosion: - Oil: -		G
	Corrosion	U/S-Bottom L M S	-		Main-Right	γ: - Distortion: - Corrosion: - Oil: -		G
Damage-Rivet	Corner-L	-	-		Roller Train-L	γ: - Distortion: - Corrosion: - Oil: -		C
	Corner-R	-	-		Roller Train-R	γ: - Distortion: - Corrosion: - Oil: -		C
Truss	Thickness-Avg	Bottom Flange 18.6, Bottom Web 18.6 (19.1mm)	G	Drum	Left	Damage: - Function: -		RS
	Distortion	-	-		Right	Damage: - Function: -		↑
End Girder	Thickness-Avg	L-Bottom 9.2, R-Bottom 9.8 (11.1mm)	C	Bearing	Drum	Damage: - Oil: -		↓
	Remodeling	Left No Right No	↑		Counter Shaft	Damage: - Oil: -		RS
	Distortion	Left - Right -	-		Reduction Gear	Damage: - Oil: -		C
Bottom Girder	Thickness-Avg	Flange 15.1 mm (16.3), Web 9.5 mm (9.4)	-	Gear	Drum Gear-L	Damage: - Fitting: - Backlash: - Oil: -		RS

Corrosion	L (M) S	-		Drum Pinion-L	Damage: -		↑
Rocker Assembly	Remodeling	Left No Right No	-		Drum Gear-R	Damage: - Fitting: - Backlash: - Oil: -		↑
	Distortion	Left - Right -	-		Drum Pinion-R	Damage: -		↓
Roller Train	Missing	Left - Right -	-		Gear-Middle	Damage: - Fitting: - Backlash: - Oil: -		↑
	Diameter-Roller	Average - mm	-		Pinion-Middle	Damage: -		↓
	Distortion	Left - Right -	-	Basement	Drum-L	Damage: - Corrosion: L M (S)		↓
Seal	Left	-	-		Drum-R	Damage: - Corrosion: L M (S)		↓
	Bottom	-	-		Drive Device	Damage: - Corrosion: L (M) S		RS
	Right	-	-	Drive Chain	Damage: - Looseness: - Oil: -	C		
Inclination	Top Level Difference 5 mm	↓	Chain Sprocket	Damage: - Corrosion: L (M) S	↑			
Leakage	(L) M S	C	Reduction Gear	Damage: - Corrosion: L (M) S	↑			
Sill				Cover	Drum-L	Damage: - Corrosion: L M (S)	↑	
Side Seal	Abrasion-Max	Left: - mm, Right: - mm	RS		Drum-R	Damage: - Corrosion: L M (S)	↓	
	Roller Truck	Abrasion-Max	Left: - mm, Right: - mm		RL	Gear-Middle	Damage: - Corrosion: L (M) S	C

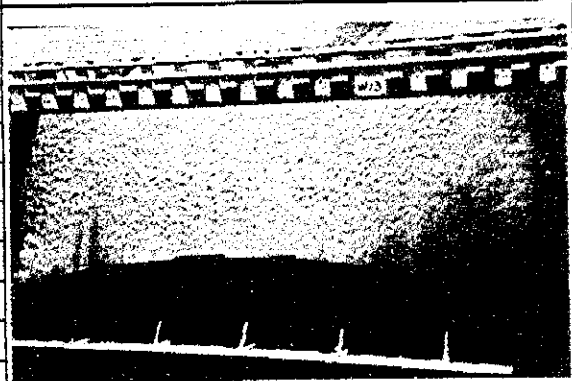
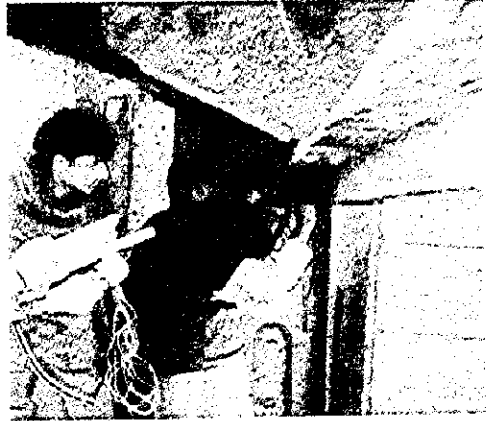
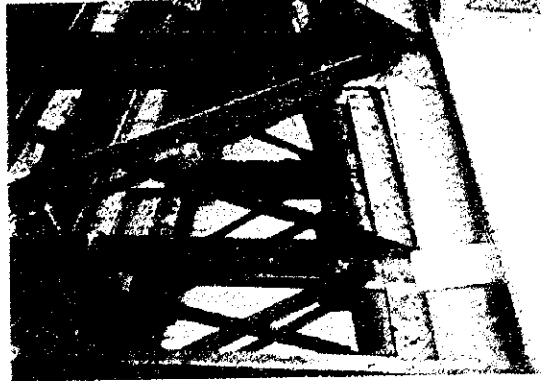
Gate No. W13 (Main Weir Gate)

Skin Plate	Thickness-Avg	Top 10.0 Mid 10.1 Low 9.9 Blm 9.0 (9.5mm)	G	Wire Rope	Main-Left	y: - Distortion: - Corrosion: - Oil: -		G	
	Corrosion	U/S-Bottom L M S	-		Main-Right	y: - Distortion: - Corrosion: - Oil: -		G	
Damage-Rivet	Corner-L	-	-		Roller Train-L	y: - Distortion: - Corrosion: - Oil: -		C	
	Corner-R	-	-		Roller Train-R	y: - Distortion: - Corrosion: - Oil: -		C	
Truss	Thickness-Avg	Bottom Flange 18.5, Bottom Web 18.5 (19.1mm)	G	Drum	Left	Damage: - Function: -		RS	
	Distortion		-		Right	Damage: - Function: -		↑	
End Girder	Thickness-Avg	L-Bottom 9.8, R-Bottom 10.1 (11.1mm)	C	Beaning	Drum	Damage: - Oil: -		↓	
	Remodeling	Left No Right No	↑		Counter Shaft	Damage: - Oil: -		RS	
	Distortion	Left - Right -			Reduction Gear	Damage: - Oil: -		C	
Bottom	Thickness-Avg	Flange 14.7 mm (16.3), Web 9.1 mm (9.4)		Gear	Drum Gear-L	Damage: - Fitting: - Backlash: - Oil: -		RS

Corrosion	L (M) S			Drum Pinion-L	Damage: -		↑	
Rocker	Remodeling	Left No Right No			Drum Gear-R	Damage: - Fitting: - Backlash: - Oil: -		↑	
	Distortion	Left - Right -			Drum Pinion-R	Damage: -		↑	
Others		No Function			Gear-Middle	Damage: - Fitting: - Backlash: - Oil: -		↑	
Roller Train	Missing	Left - Right -		Pinion-Middle	Damage: -	↓			
	Diameter-Roller	Average - mm		Basement	Drum-L	Damage: - Corrosion: L M (S)		↓	
	Distortion	Left - Right -			Drum-R	Damage: - Corrosion: L M (S)		↓	
Seal	Left	-	Drive Device		Damage: - Corrosion: L (M) S	RS			
Seal	Bottom	-		Drive Chain	Damage: - Looseness: - Oil: -	C			
	Right	-			Chain Sprocket	Damage: - Corrosion: L (M) S		↑	
	Inclination	Top Level Difference 30 mm	↓	Reduction Gear	Damage: - Corrosion: L (M) S	↑			
Leakage	(L) M S	C	Cover	Drum-L	Damage: - Corrosion: L M (S)	↓			
Sill	Side Seal	Abrasion-Max		Left: - mm, Right: - mm	RS	Drum-R		Damage: - Corrosion: L M (S)	↓

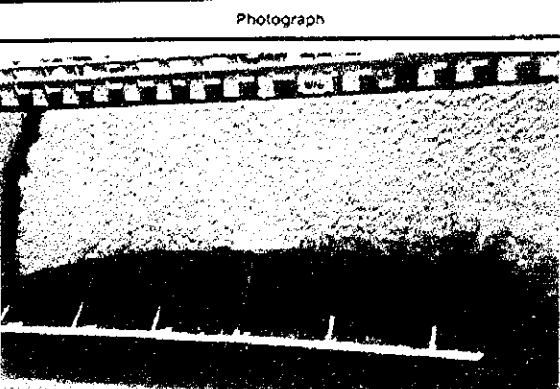
Gate No. W16 (Main Weir Gate)

Skin Plate	Thickness-Avg	Top - Mid - Low - Btm 8.8 (9.5mm)		G	Wire Rope	Main-Left	Y: - Distortion: - Corrosion: - Oil: -		G	
	Corrosion	U/S-Bottom L M S		--		Main-Right	Y: - Distortion: - Corrosion: - Oil: -		G	
Truss	Thickness-Avg	Bottom Flange 18.8, Bottom Web 18.5 (19.1mm)		G	Roller Train-L	Broken		C		
	Distortion			--	Roller Train-R	Y: - Distortion: - Corrosion: - Oil: -		C		
End Girder	Thickness-Avg	L-Bottom 10.2, R-Bottom 10.3 (11.1mm)		C	Drum	Left	Damage: - Function: -		RS	
	Remodeling	Left No Right No		↑		Right	Damage: - Function: -		↑	
	Distortion	Left - Right -			Bearing	Drum	Damage: - Oil: -		↓	
Bottom	Thickness-Avg	Flange 14.4 mm (16.3), Web 8.6 mm (9.4)				Counter Shaft	Damage: - Oil: -		RS	
	Corrosion	L (M) S				Reduction Gear	Damage: - Oil: -		C	
Rocker Assembly	Remodeling	Left No Right No			Gear	Drum Gear-L	Damage: - Fitting: 100% Backlash: 1.0 mm		RS

Distortion	Left 0.5 m Broken Right 1.5 m Heavy Ab.				Drum Pinion-L	Damage: -		↑	
Roller Train	Others	No Function				Drum Gear-R	Damage: - Fitting: - Backlash: - Oil: -			
	Missing	Left 1 Right 2				Drum Pinion-R	Damage: -			
	Diameter-Roller	Average - mm				Gear-Middle	Damage: - Fitting: - Backlash: - Oil: -			
Seal	Distortion	Left - Right -				Pinion-Middle	Damage: -			
	Left	-			Basement	Drum-L	Damage: - Corrosion: L M (S)			
	Bottom	-				Drum-R	Damage: - Corrosion: L M (S)		↓	
Right	-			Drive Device		Damage: - Corrosion: L (M) S		RS		
Inclination		Top Level Difference 10 mm		↓	Drive Chain	Damage: - Looseness: - Oil: -		C		
	Leakage	(L) M S		C	Chain Sprocket	Damage: - Corrosion: L (M) S		↑		
Sill					Reduction Gear	Damage: - Corrosion: L (M) S				
Side Seal	Abrasion-Max	Left: - mm, Right: - mm		RS	Cover	Drum-L	Damage: - Corrosion: L M (S)			
	Roller Truck	Left: - mm, Right: - mm		RL		Drum-R	Damage: - Corrosion: L M (S)		↓
