# Survey Results of Gate Structure

Gate No. W55 (Main Weir Gate)

Gate No. W56 (Main Weir Gate)		Survey Item	Survey Result	Judge	Survey Item	Survey Result	Judge	Photograph
Gate Leaf					Hoisting Device			
Sun Plate	Thickness-Avg	Top - Mid - Low - Btm - (9.5mm)	—		Wire Rope	Main-Left	Y - Distortion: - Corrosion: - Oil: -

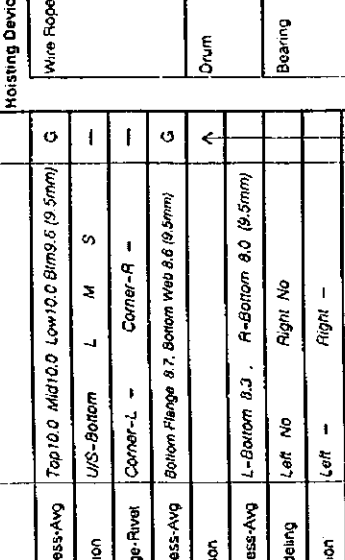
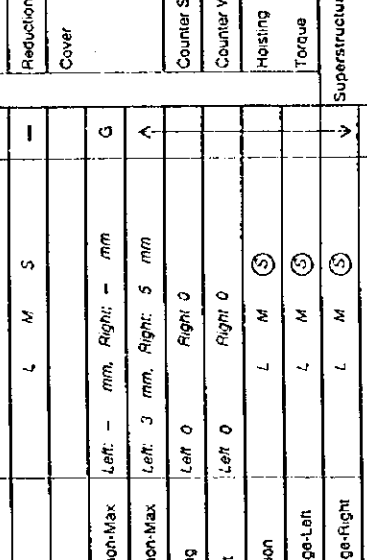
Side Seal	Abrasion-Max	Left: - mm, Right: - mm	G		Drum-L	Damage: - Corrosion: L M (S)	
	Abrasion-Max	Left: 3 mm, Right: 5 mm	↑		Drum-R	Damage: - Corrosion: L M (S)

Roller Guard Missing	Left 0 Right 0		Gear-Middle	Damage: - Corrosion: L M (S)		
Sill Beam	Defect	Left 0 Right 0		Counter Shaft	Damage: - Corrosion: L M (S)

Abrasion	L M (S)			Counter Weight		Damage: - Corrosion: L M S
	Damage-Left	L M (S)			Wet Condition		11.1 kg-m
Concrete	Damage-Right	L M (S)		Torque	Dry Condition	0 kg-m

Damage-Bottom	L M (S)	↓		Damage: - Corrosion: L M (S)		
			G				
Superstructure							
Remarks: Judgement = N: Totally Replace, C: Partly Replace, RL: Large Repair, RM: Medium Repair, RS: Small Repair, G: No Repair, -: No Data.
