## **6.6 Results of Detailed Inspection**

# PRELIMINARY DESIGN OF REPAIR WORK

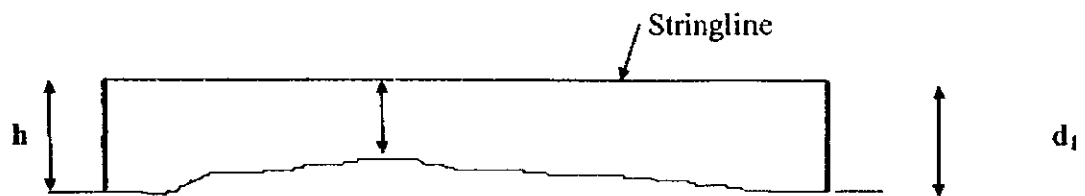
**Fig. 6.6.2 Alternative Measurement of Rutting Depth On Some Surface Treated Roads Where Transverse Road Section Bows Upwards**

In determining rut depth there are some instances, especially on surface treated roads, where the road surface bows out between the wheel tracks. Where the measurement of rutting depth cannot be obtained by the method described in section 6.3.1. In these instances the rut depth is measured as shown below

$$\text{Rut depth } D_1 = h - d_1$$

Rut depth is the greatest value of  $D_1$  for each section

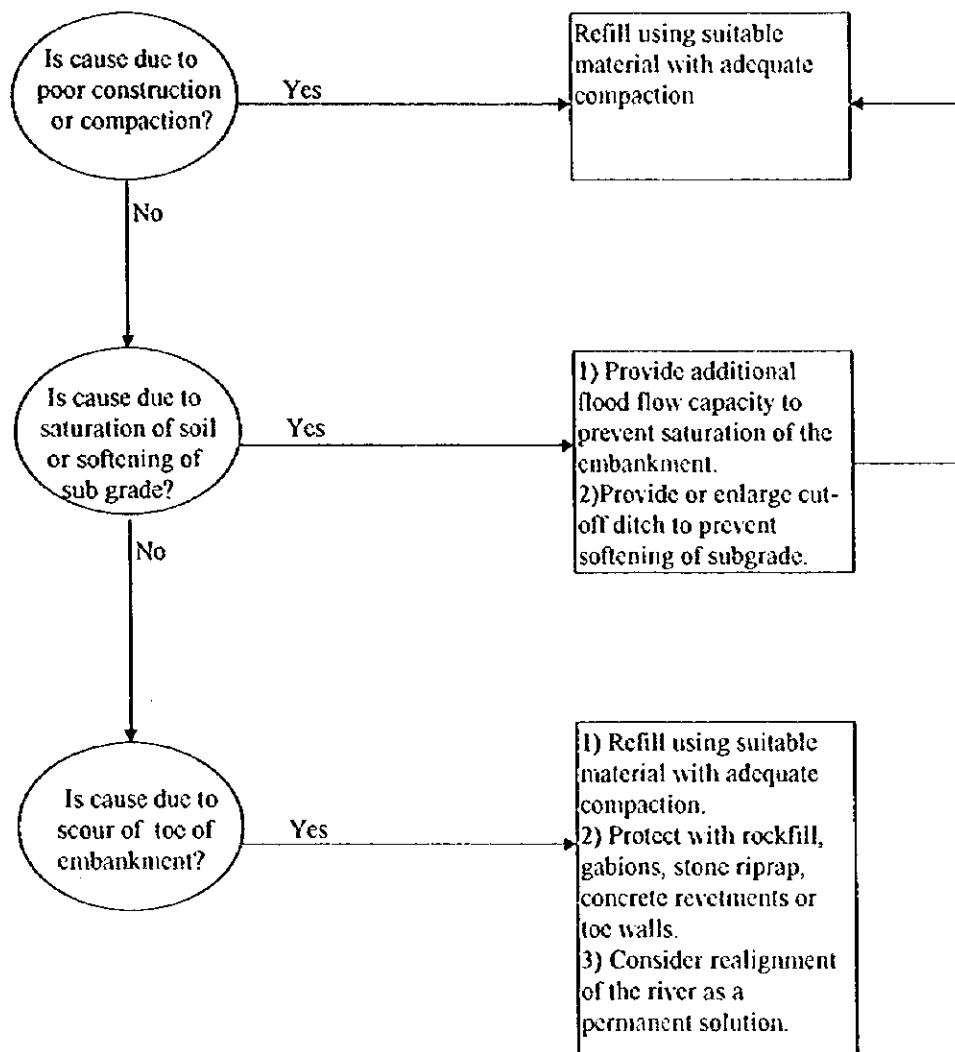
**Fig. 7.4.2 Selection of Repair Method for a Collapsed Embankment**

Where the collapse has been caused by river scouring, the cost of the permanent solution to realigning the river should be compared with the other alternatives to decide on the optimum solution. This will depend on the budget availability.

Drainage options may be considered both to avoid flooding, preventing saturation of the embankment and also to lower the ground water level to maintain a dry subgrade under the embankment.
