**THE AFTERCARE STUDY ON
THE NATIONAL WATER MASTER PLAN
JAPAN INTERNATIONAL COOPERATION AGENCY**

**Figure -
Existing Water Supply Schemes
(630 SIAYA District)**

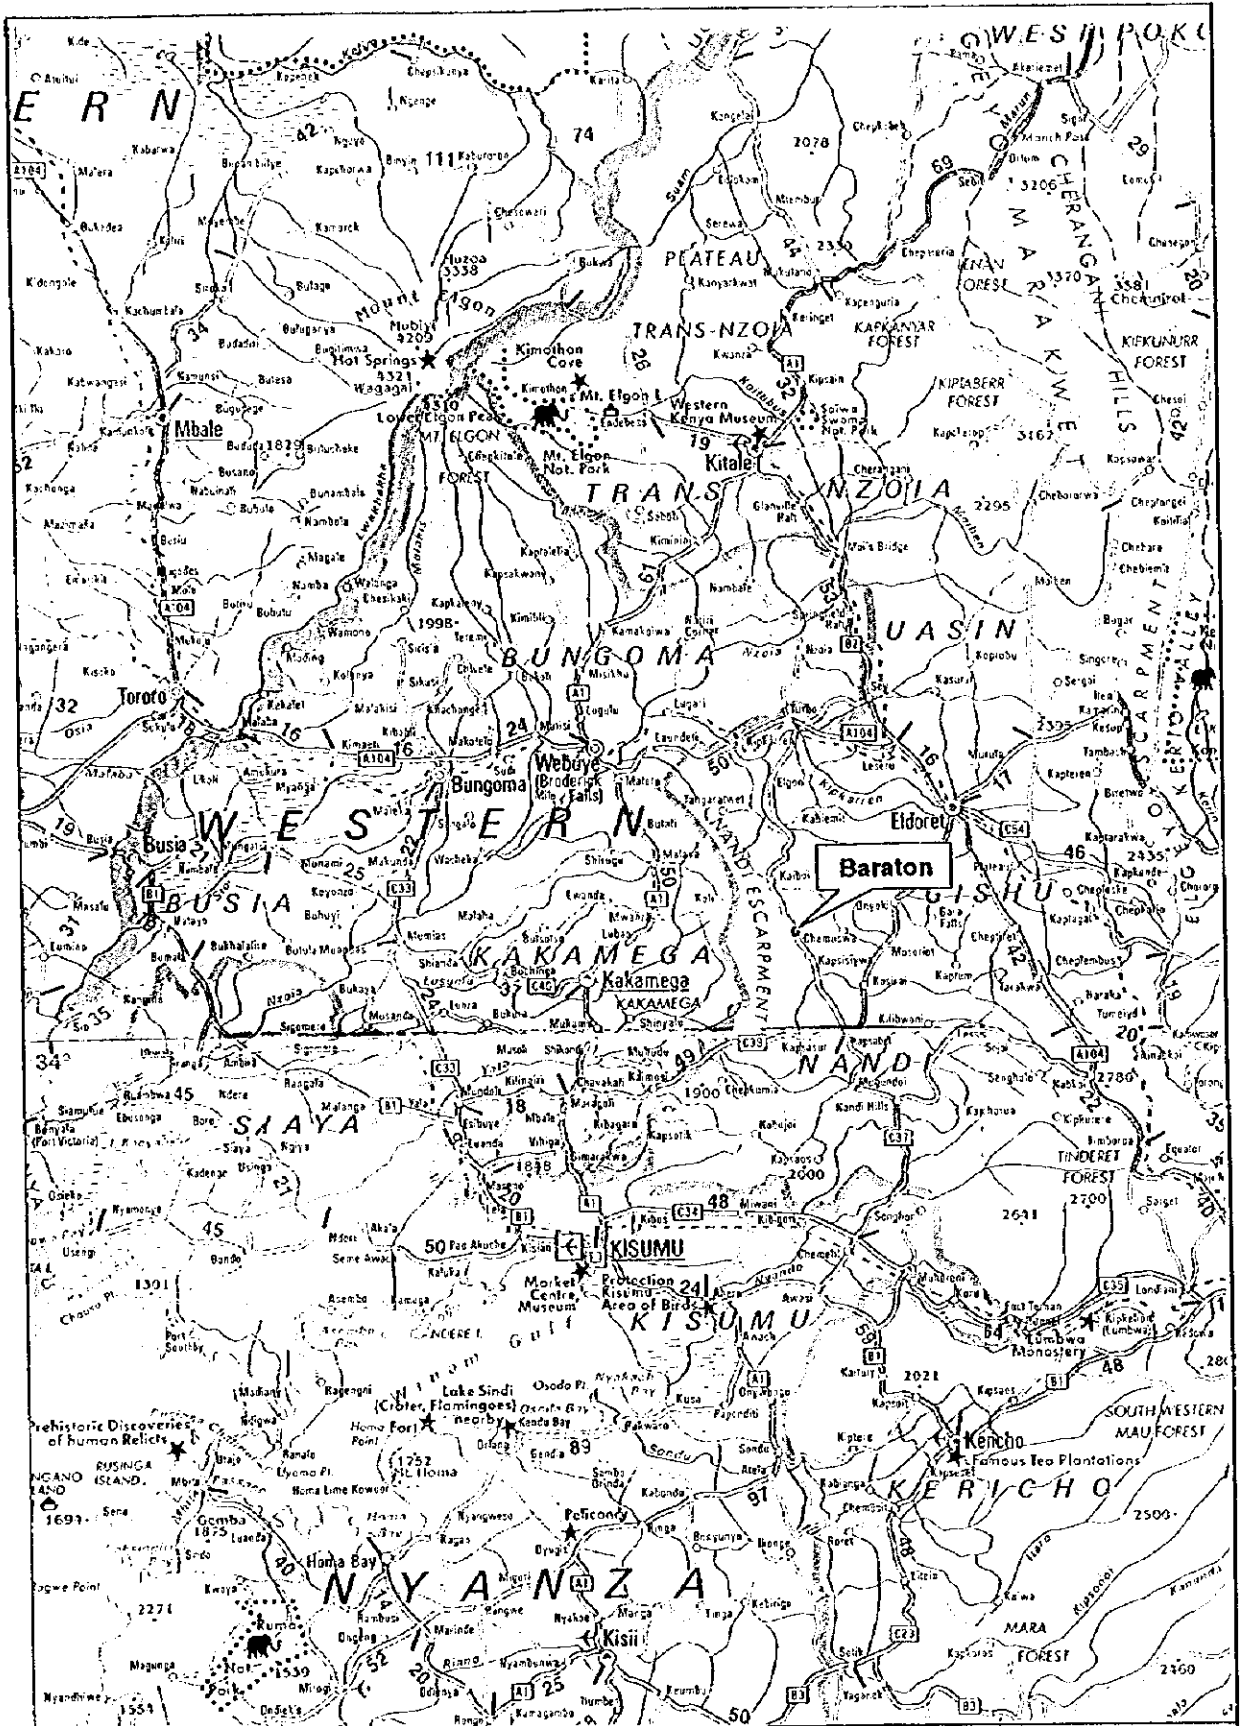
- This is a University of East Africa, Baraton institutional scheme, but it serves the surrounding communities also*
- 1. Borehole source is not operational due to financial constraints*
 - 2. Alum and Chlorine dosing is not being properly done as dosers are not working*
 - 3. The scheme was adversely affected by the El-Nino floods*

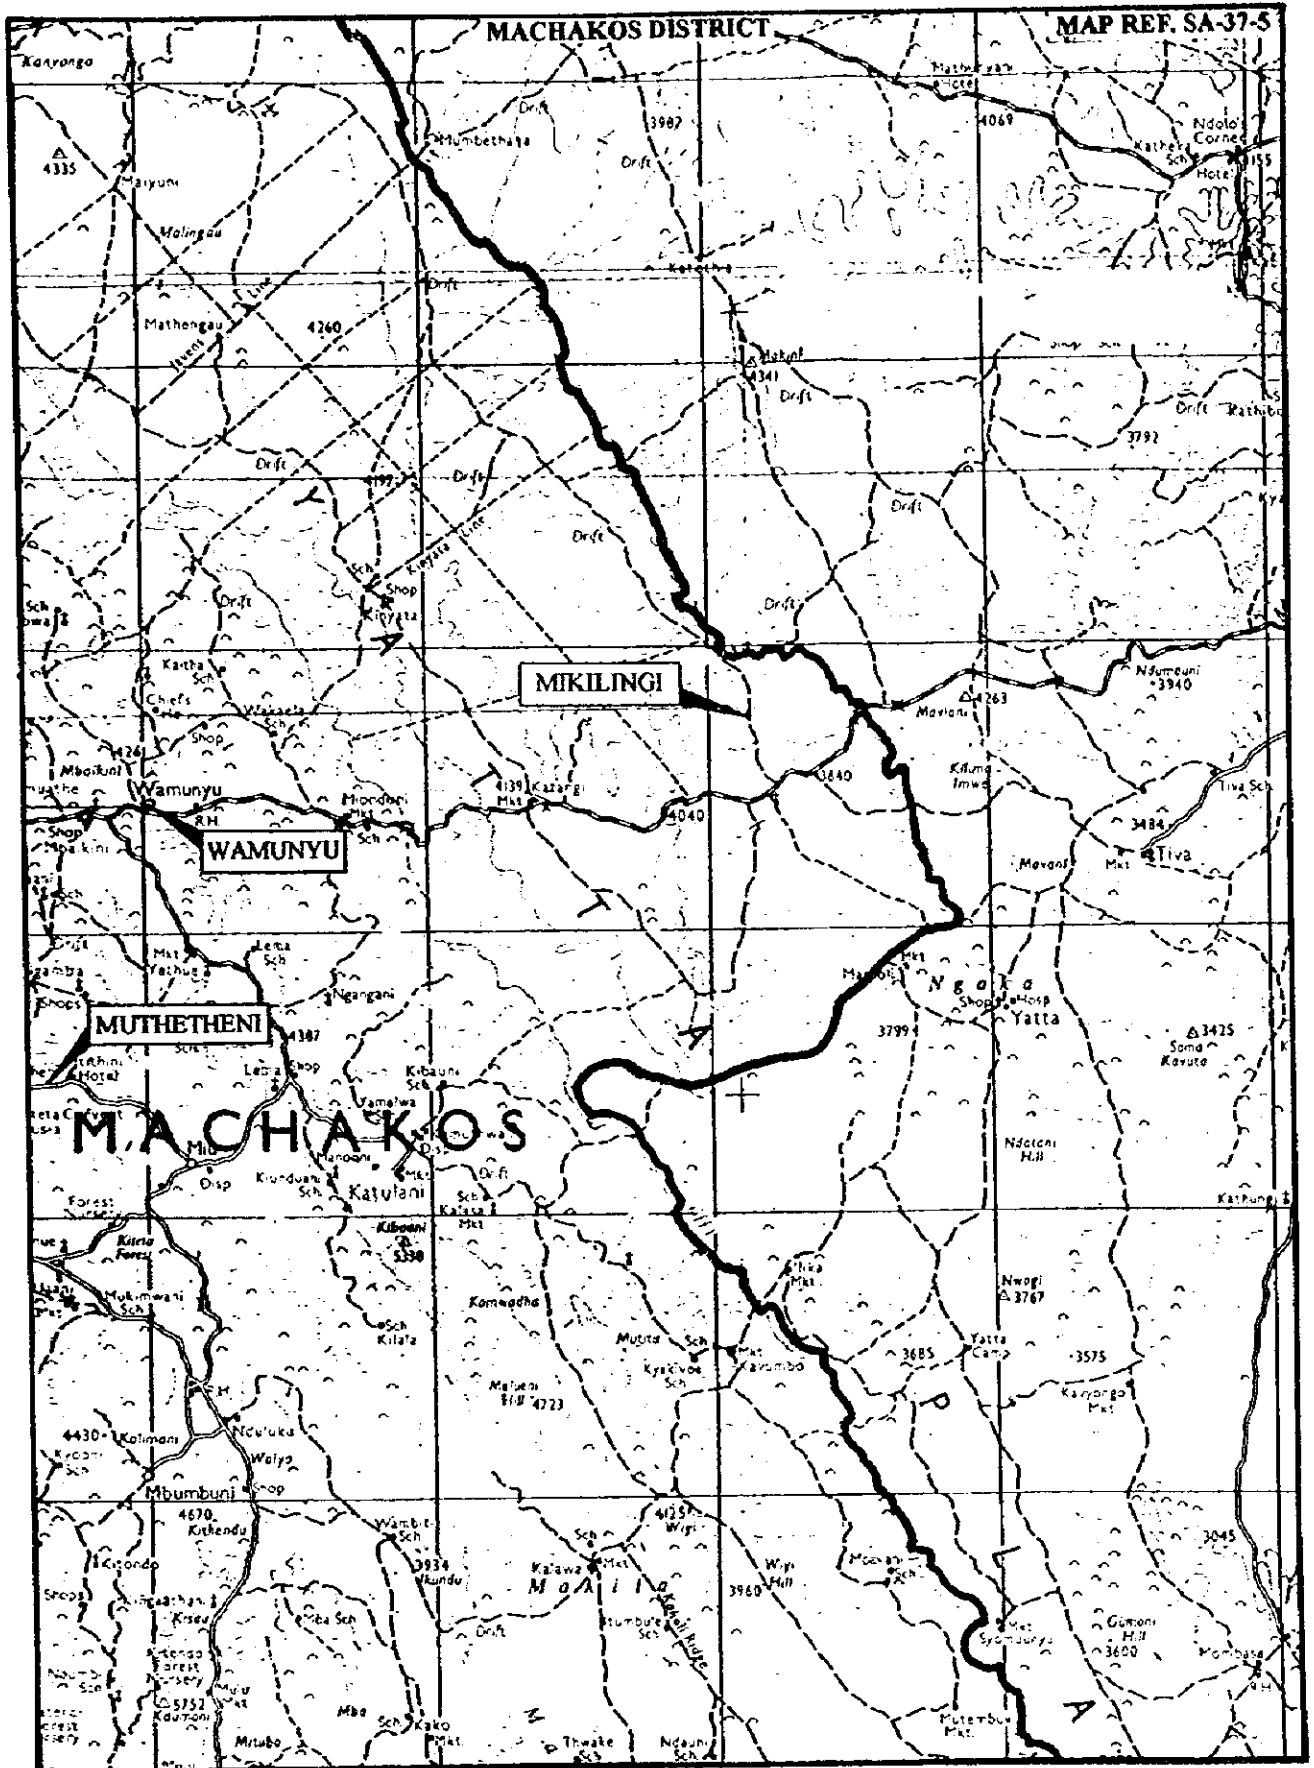
- Problems include:
1. Frequent bursts in rising main
 2. Old pumps require frequent repairs. This affects the continuity of supply
 3. Poor payments by consumers Large numbers of consumers are disconnected
 4. Intake, backwash tank, sedimentation chambers and sluice valves need repairs. Treatment units need augmentation
