CHAPTER 4. ASSESSMENT OF SARAJEVO WWTP

CHAPTER 4 ASSESSMENT OF SARAJEVO WWTP

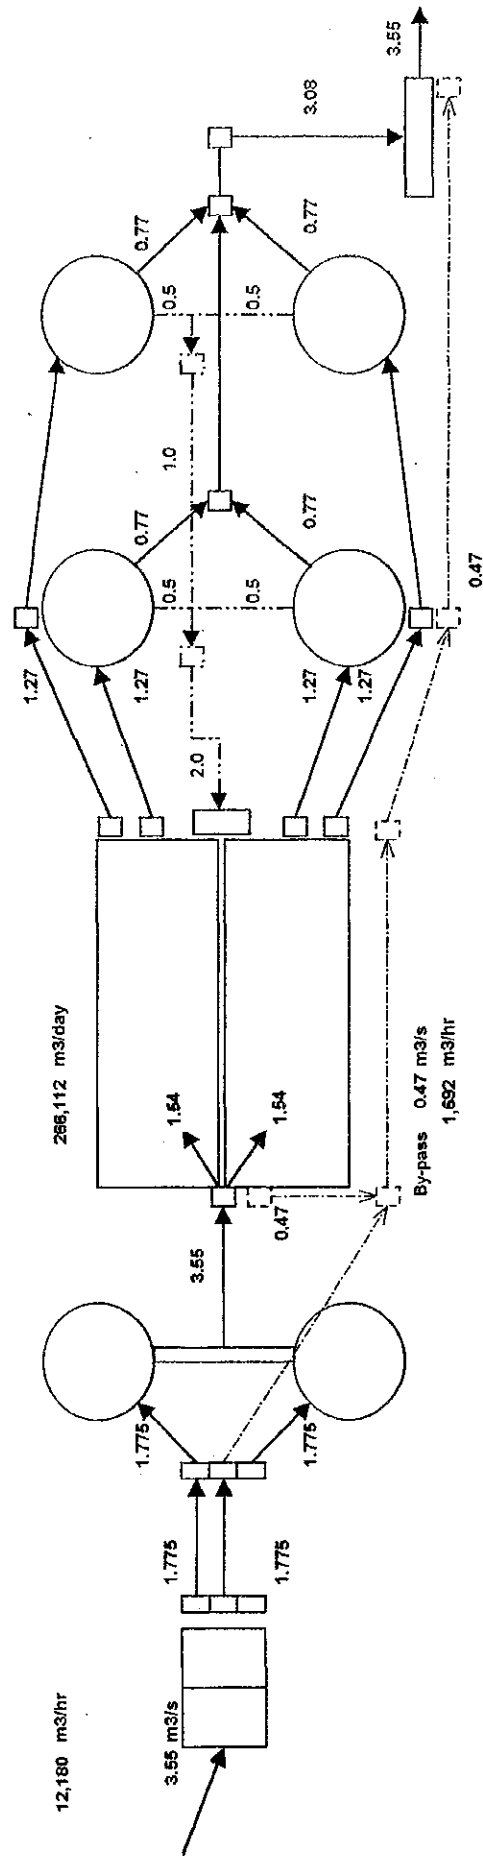
Figure 4.1 (2/3) HYDRAULIC CAPACITY OF EXISTING TREATMENT PLANT

Table 4.2 indicates that flows and loads forecast for the year 2000 loads are less than those used for the design of the plant. For year 2015 the BOD load exceeds original design criteria by 5%. Process calculations prepared for the purpose of preliminary design indicate that the biological aeration process has sufficient capacity for the year 2015 BOD loading conditions. However, secondary sedimentation tanks will be slightly overloaded at peak wet weather flow. Therefore it will be necessary to add two more sedimentation tanks 52m in diameter.

Schematic diagrams showing the flow regime of the existing WTP are shown in **Figure 4.1**. Hydraulic grade lines for the original plant are illustrated on **Drawing C1**.
