**THE FEASIBILITY STUDY  
ON  
THE WASTEWATER TREATMENT PLANT  
OF  
SARAJEVO CITY  
IN  
BOSNIA AND HERZEGOVINA**

**VOLUME III : ASSESSMENT WORK REPORT**

**NOVEMBER 1999**

**TOKYO ENGINEERING CONSULTANTS CO., LTD.  
NIHON SUIDO CONSULTANTS CO., LTD.**

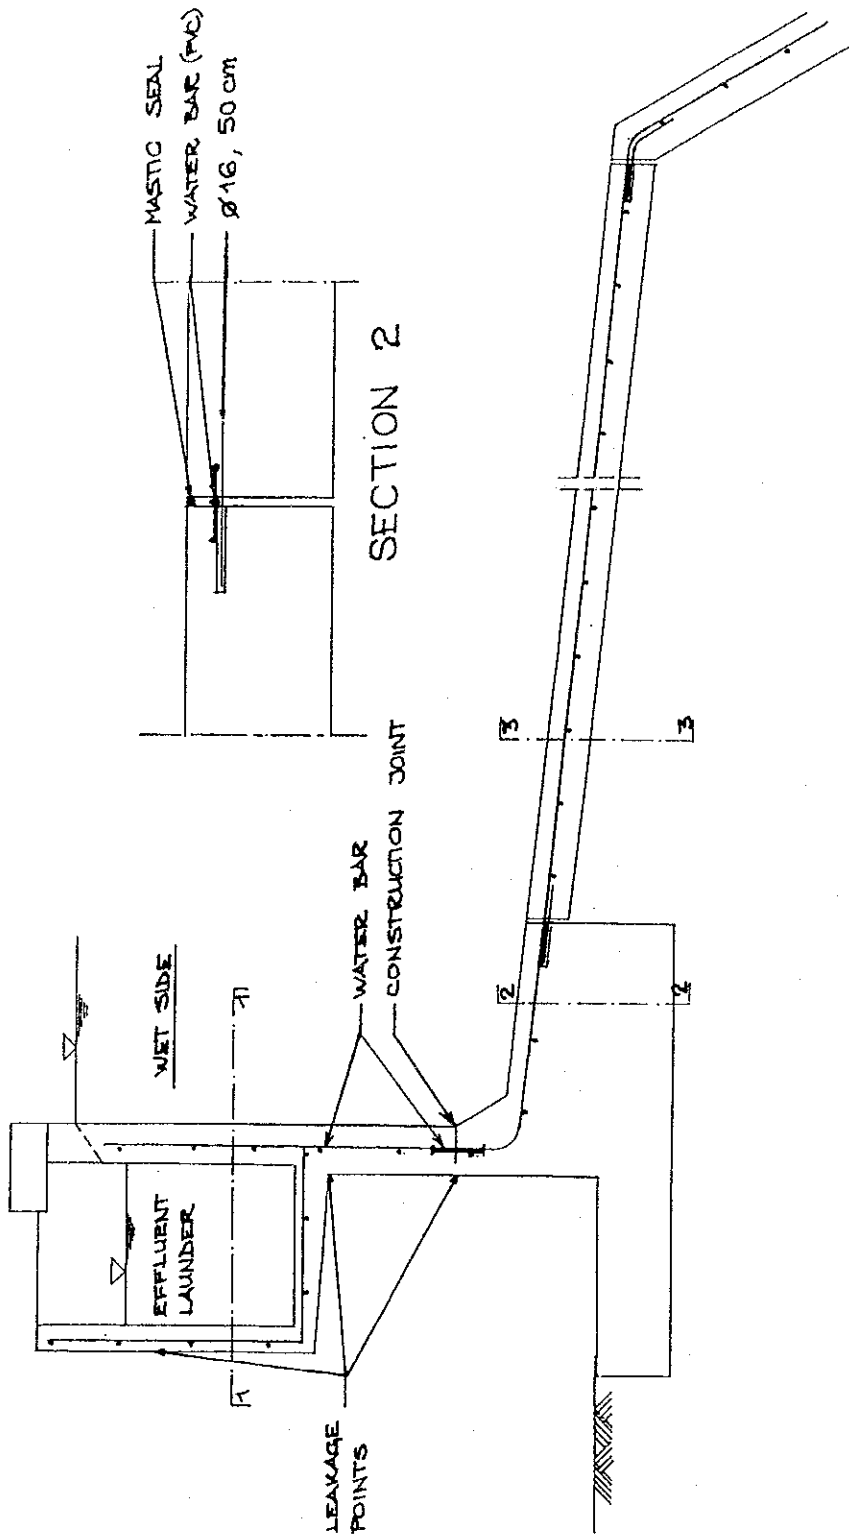
Figure  
2.5.2

Water bars used in the construction of all water retaining structures on site appear to be polyvinyl chloride strips 250mm wide with a central bulb. In walls the water bar is located centrally following common construction practice. Typical water stop details for the structures on site are shown in **Figure 2.5.2** and **Figure 2.5.3**. It is important for walls to be sufficiently thick to allow proper compaction of the concrete around the water bar. Wall thickness wherever practical should be at least 250mm thick. The walls on main structures appear to be sufficiently thick to ensure good compaction. Effluent launder wall thickness varies from 150 to 200 and it is likely that good compaction could not be achieved which might explain why all joints in effluent launders leak.

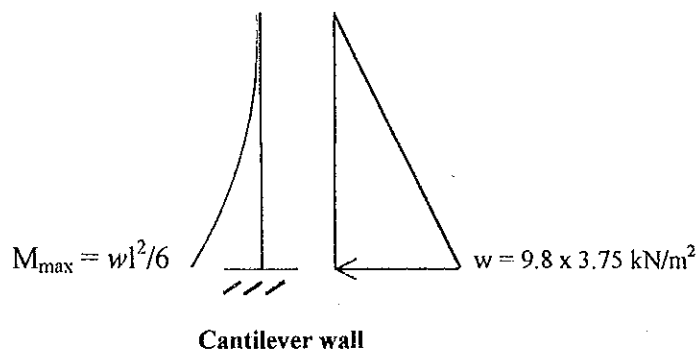
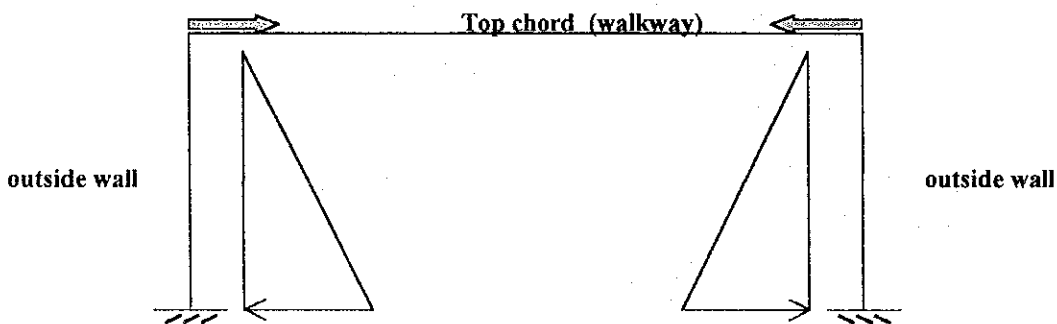
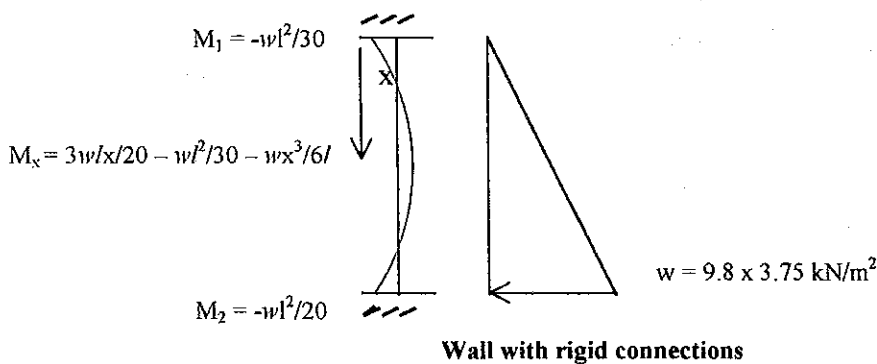
A review of design calculations shows that the walls were designed, as is common practice, for cantilever action with primary bending in the vertical plane.

Maximum bending moment under this assumed condition is 93 kN.m and occurs at the base of the wall on the wet side of the tank. Vertical steel indicated on the drawings is  $\square 18$  at 200 mm spacing and is adequate for resisting moments under this condition.

The cantilever model is not valid where the concrete walkway is attached to the top of the wall. The observed cracking can be explained by a simplified model assuming the concrete walkway acts as a top chord tying the two outside walls together as illustrated below.

The top chord prevents the walls from bending out at the top as they were designed for and the rigid connection between wall and walkway induces positive bending moments on the outside face in two locations:

- Bending in the horizontal plane with a maximum in the middle span
- Bending in the vertical plane with negative moments at the top and bottom of the wall and positive moments approximately 2 m from the top.

Bending moment  $M_1$  and  $M_2$  are smaller than in the simple cantilever model therefore reinforcement on the inside face of the wall is adequate to resist bending. However reinforcing steel on the outside face is insufficient to resist positive bending moments. Reinforcing steel on the outside face is  $\square 8$  at 100mm centres in the vertical direction and  $\square 8$  at 200mm centres in the horizontal direction. The maximum positive bending moment occurs at 2.05 m from the top and is 11.08 kN.m. The reinforcement is insufficient to resist bending moments resulting in tension cracks under load.

These two models are simple assumptions and neither one accurately describes the actual stress and shear patterns in the wall. Precise analysis would require finite element modelling of the walls to determine how the wall plates actually behave under load. Nevertheless, for the purposes of finding an appropriate repair strategy the simplified assumptions are sufficient to confirm that filling these cracks with epoxy grout will not solve the problem. It is important to remove the restraint provided by the walkway and allow the wall to function as it was intended (i.e. as a cantilever wall). The change can easily be made by cutting out the existing slab and replacing it with an open-grate galvanised metal walkway freely supported at the wall.

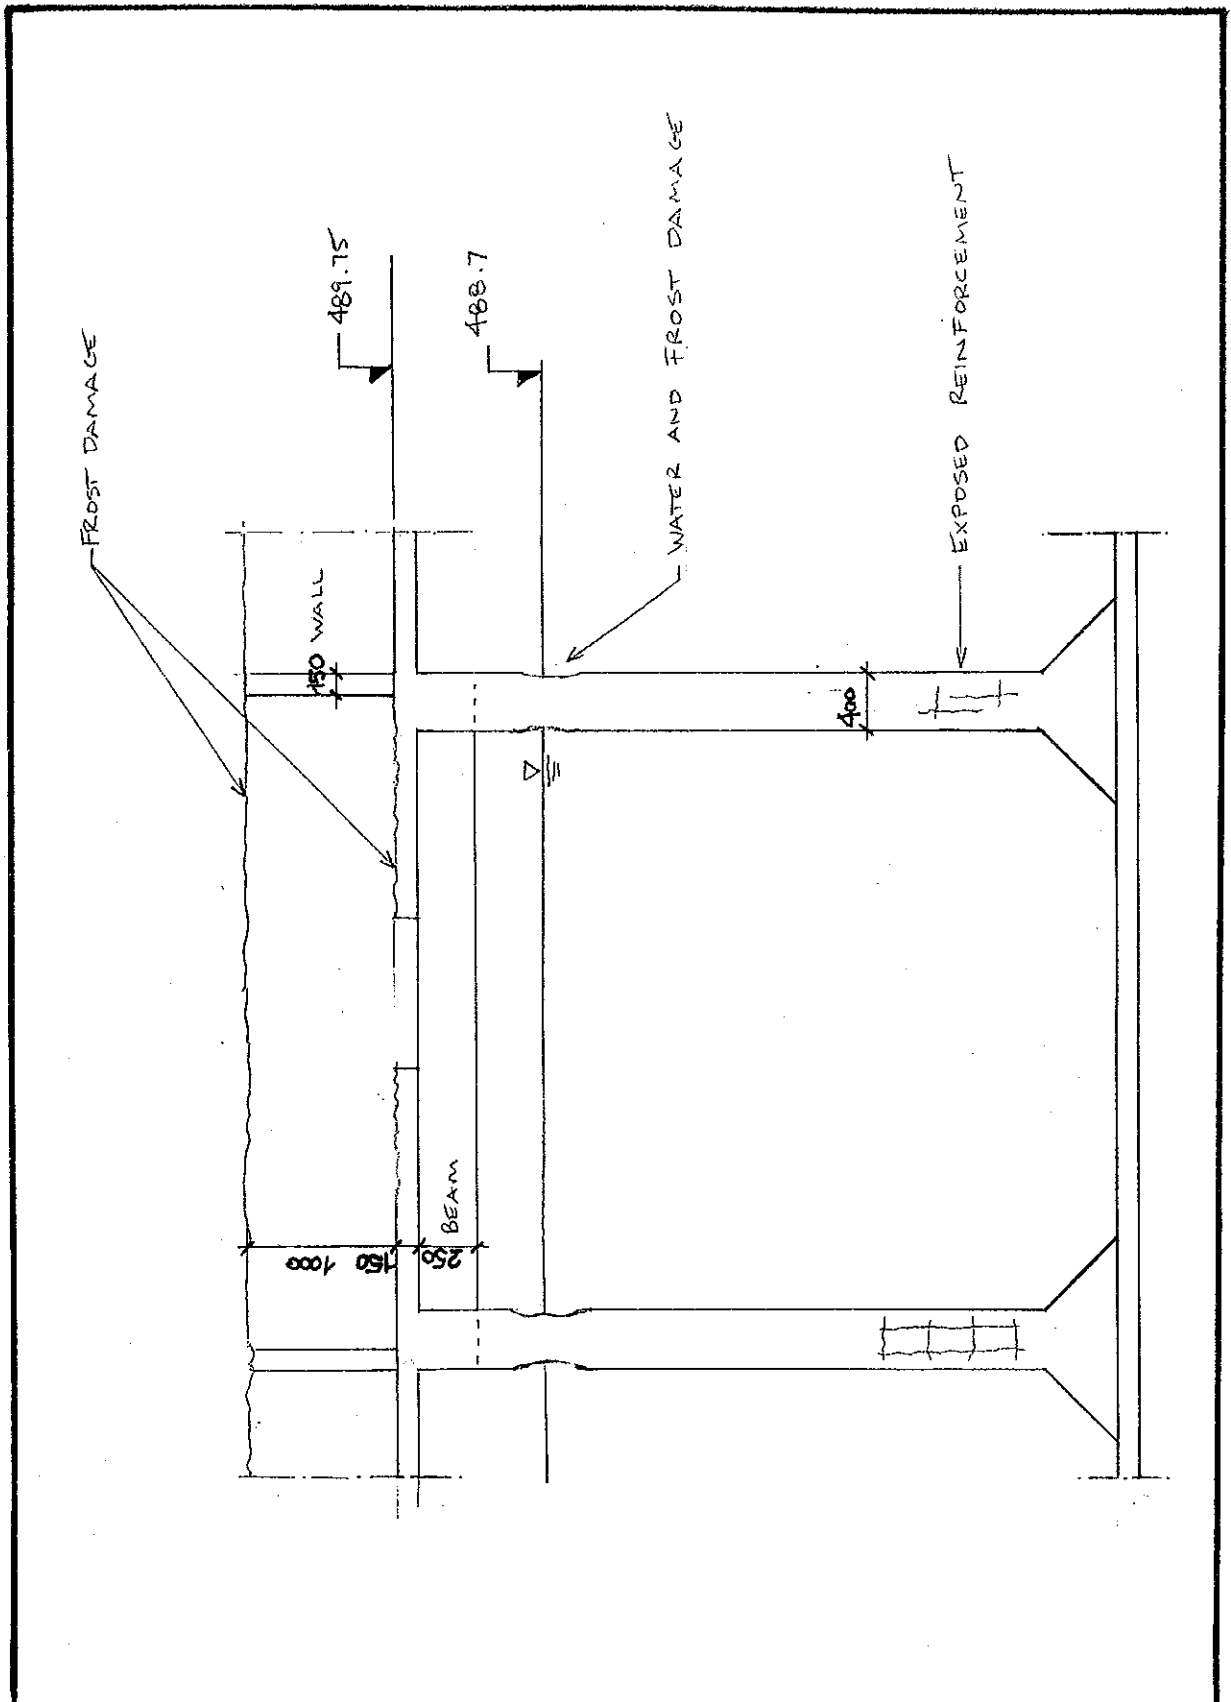
Date : Nov. 99 Scale: Not to scale	THE FEASIBILITY STUDY ON THE WASTEWATER TREATMENT PLANT OF SARAJEVO	Figure 2.5.5
	SURFACE AERATORS - EXISTING SECTIONAL VIEW

Plan and sectional views of the existing aerators are presented in **Figure 2.5.4** and **2.5.5**. Slabs and columns will need extensive reconstruction if the decision is made to keep the present surface aeration system. There are several problems observed:
