PHOTODOKUMENTATION

APPENDIX 6

VISUAL SURVEY

Liquid Retaining Structures

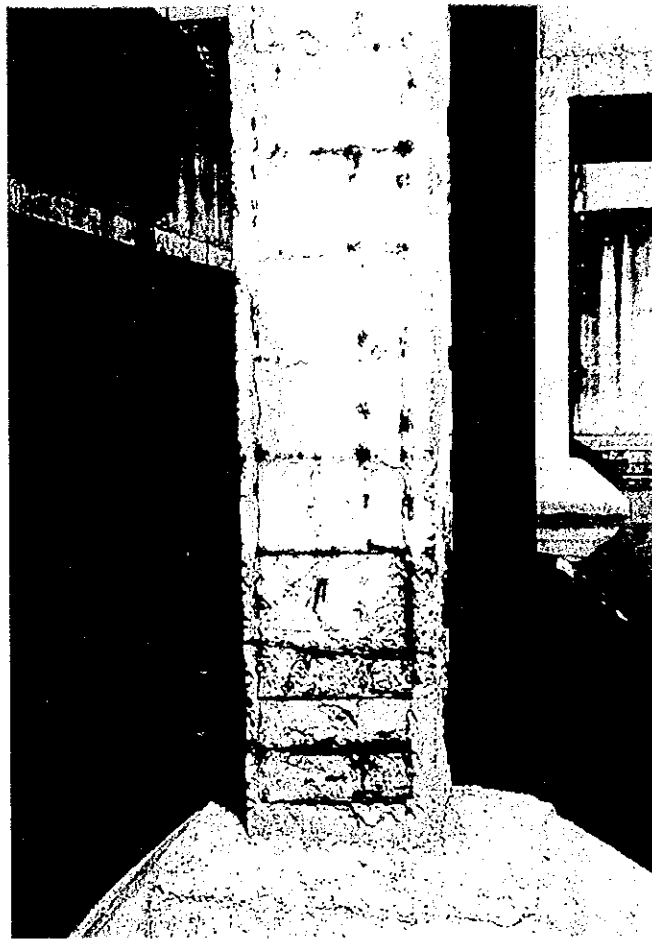
Photo 17. View on the column F16, structure N° 5
