APPENDIX

VISUAL SURVEY ARCHITECTURAL ASPECTS

ARCHITECTURAL
INSPECTION SHEET AND PHOTO

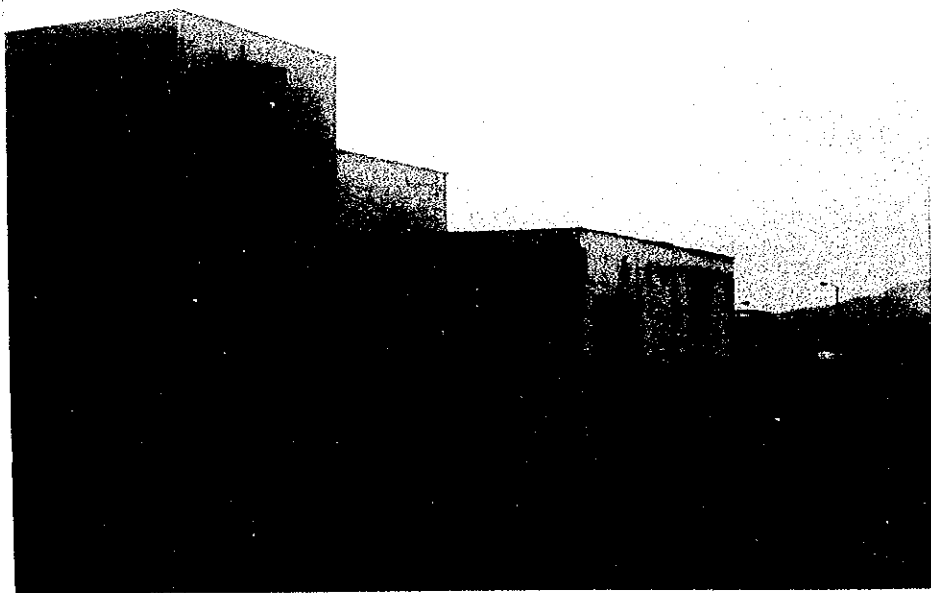
PHOTO NUMBER	1,2-3
--------------	-------

1.2	RAW WATER PUMPING STATION SCREENING STATION	REINFORCED CONCRETE COLUMN/BEAM/WALL BRICK	1984	323.84m ²	323.84m ²	300KG/cm ²	458KG/cm ²		
EXTERIOR NORTH	COLUMN BEAM	WALL(BRICK)	Δ	DOOR	X WINDOW	METAL	EXTERIOR FINISH	X COPING	X CAULKING
EVALUATION ITEM	NORMAL	NORMAL	✓	NORMAL	NORMAL	NORMAL	NORMAL	NORMAL	NORMAL
	DAMAGE	DAMAGE	✓	RUSTY	RUSTY	RUSTY	DIRTY	RUSTY	BROKEN
		BROKEN		CORROSION	CORROSION	CORROSION	WORN OUT	CORROSION	NONE
		BULLET MARKS		MISSING	MISSING	NONE		NONE	
INVESTIGATION METHOD	VISUAL INSPECTION	VISUAL INSPECTION		VISUAL INSPECTION	VISUAL INSPECTION	VISUAL INSPECTION	VISUAL INSPECTION	VISUAL INSPECTION	VISUAL INSPECTION
PHOTO NUMBERS		1.2-1		1.2-2	1.2-2	1.2-2	1.2-13		
RECOMMENDATION	C	C		A	A	A	A	A	A
EXTERIOR EAST	COLUMN BEAM	WALL(BRICK)	Δ	DOOR	X WINDOW	METAL	EXTERIOR FINISH	X COPING	X CAULKING
EVALUATION ITEM	NORMAL	NORMAL	✓	NORMAL	NORMAL	NORMAL	NORMAL	NORMAL	NORMAL
	DAMAGE	DAMAGE	✓	RUSTY	RUSTY	RUSTY	DIRTY	RUSTY	BROKEN

BROKEN		CORROSION	CORROSION	CORROSION	WORN OUT	CORROSION	NONE
		BULLET MARKS		MISSING	MISSING	NONE		NONE	
INVESTIGATION METHOD	VISUAL INSPECTION	VISUAL INSPECTION		VISUAL INSPECTION	VISUAL INSPECTION	VISUAL INSPECTION	VISUAL INSPECTION	VISUAL INSPECTION	VISUAL INSPECTION
PHOTO NUMBERS		1.2-3		1.2-3	1.2-3	1.2-3			
RECOMMENDATION	C	C		A	A	A	A	A	A
EXTERIOR SOUTH	COLUMN BEAM	WALL(BRICK)	Δ	DOOR	X WINDOW	METAL	EXTERIOR FINISH	X COPING	X CAULKING
EVALUATION ITEM	NORMAL	NORMAL	✓	NORMAL	NORMAL	NORMAL	NORMAL	NORMAL	NORMAL
	DAMAGE	DAMAGE	✓	RUSTY	RUSTY	RUSTY	DIRTY	RUSTY	BROKEN
		BROKEN		CORROSION	CORROSION	CORROSION	WORN OUT	CORROSION	NONE
		BULLET MARKS		MISSING	MISSING	NONE		NONE	
INVESTIGATION METHOD	VISUAL INSPECTION	VISUAL INSPECTION		VISUAL INSPECTION	VISUAL INSPECTION	VISUAL INSPECTION	VISUAL INSPECTION	VISUAL INSPECTION	VISUAL INSPECTION
PHOTO NUMBERS		1.2-4		1.2-4	1.2-4	1.2-4			
RECOMMENDATION	C	C		A	A	A	A	A	A
