BUILDING SURVEY DETAILS

BUILDING NUMBER-23B
ADMINISTRATION BUILDING B-BLOCK

INSPECTION SHEETS MECHANICAL ASPECTS

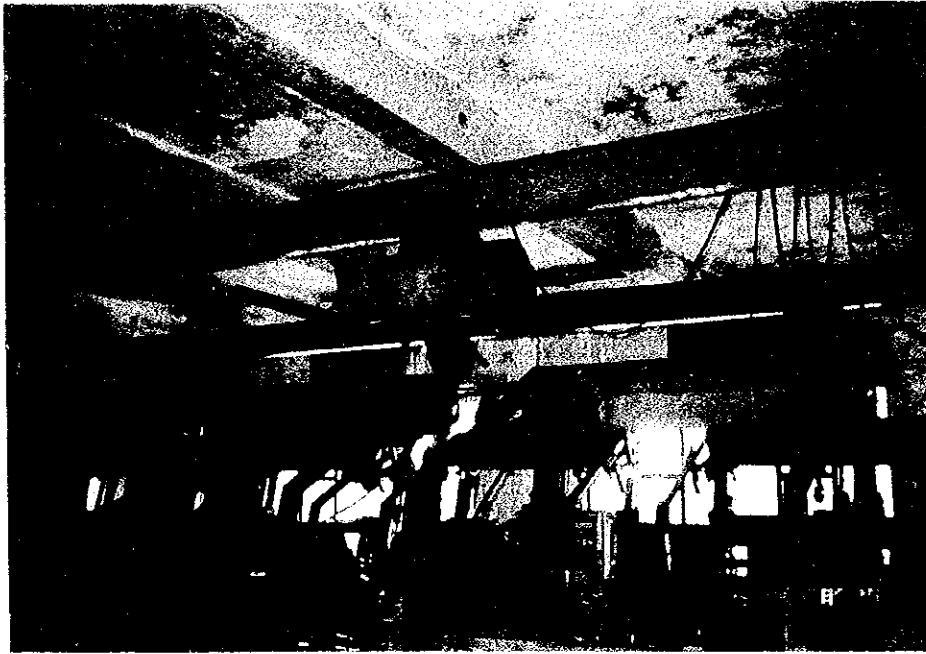
PHOTO No. 2.2 AUTOMATIC COARSE SCREEN No.1 No.4

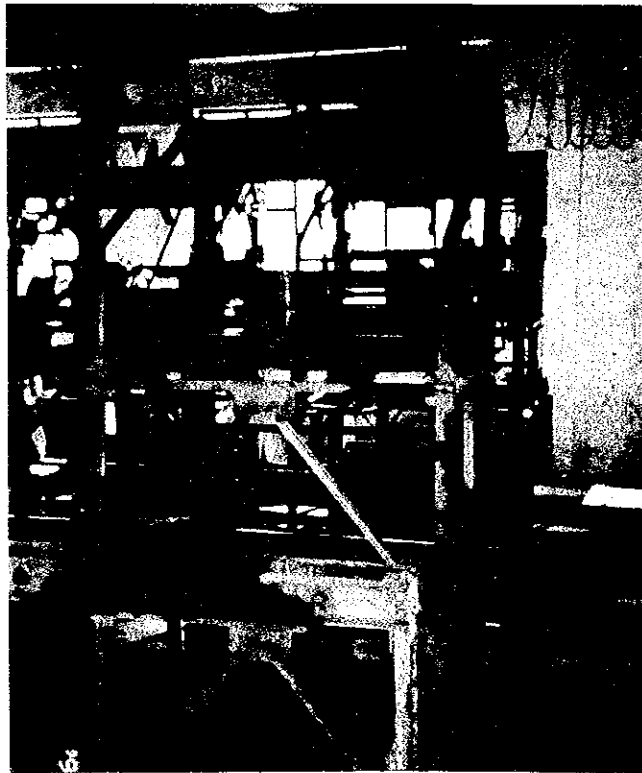
PHOTO No. 2.3 AUTOMATIC FINE SCREEN No. 1 No.4

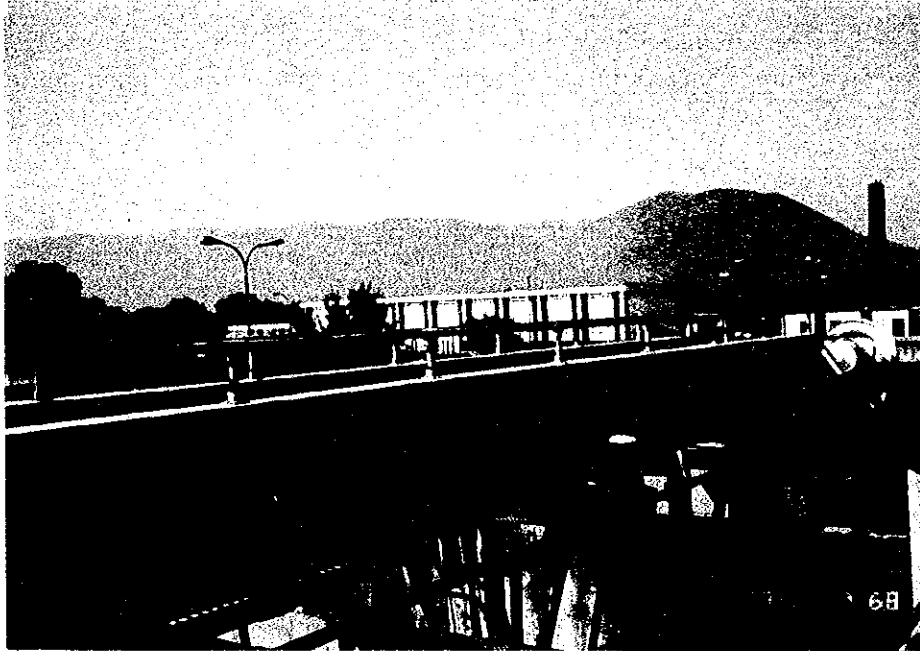
PHOTO No. 3-M 3 SAND TRAP BRIDGE

All bolts and nuts as well as retainers are needed to be replaced with new ones and readjusted .

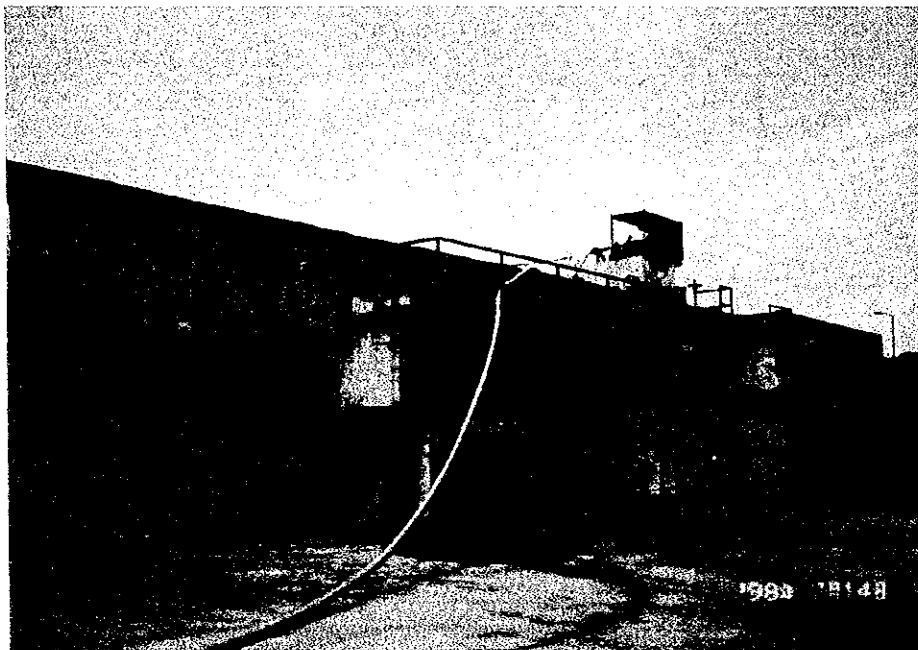
PHOTO No. 3-4 SAND TRAP BRIDGE
