EXISTING WATER SUPPLY SYSTEM

**THE STUDY ON WATER SUPPLY SYSTEM
FOR SIEM REAP REGION IN CAMBODIA**

**FINAL REPORT
Vol. III SUPPORTING REPORT**

ANNEX 4.4.1 EXISTING WATER SUPPLY SYSTEM

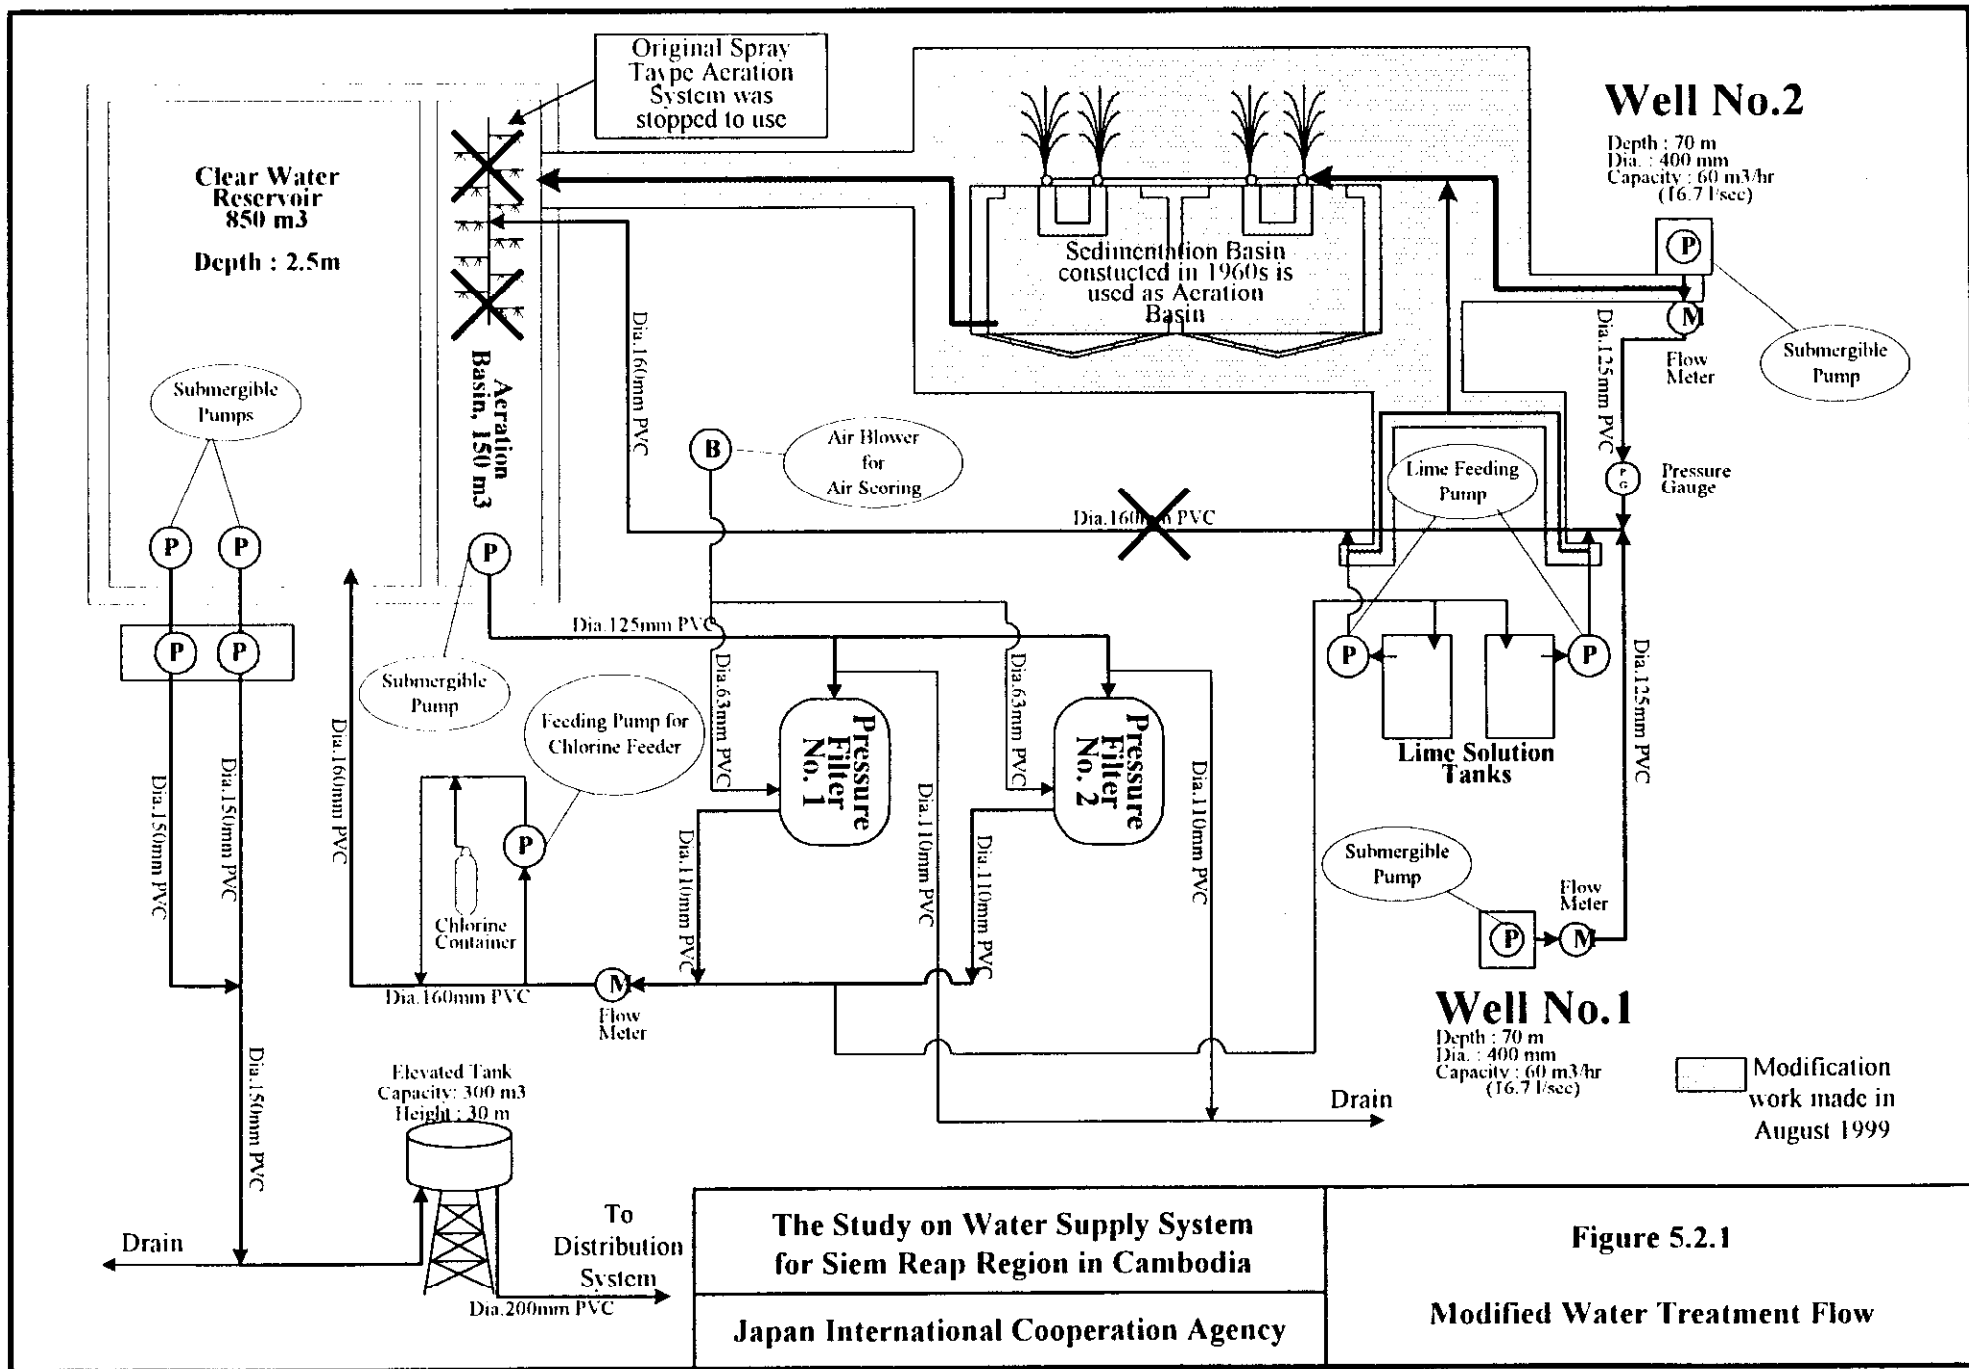
This modified treatment flow is shown on Figure 5.2.1. As shown on this Figure, in addition to the modification of aeration system, the Waterworks installed two distribution pumps to save energy costs. Original two submersible pumps have

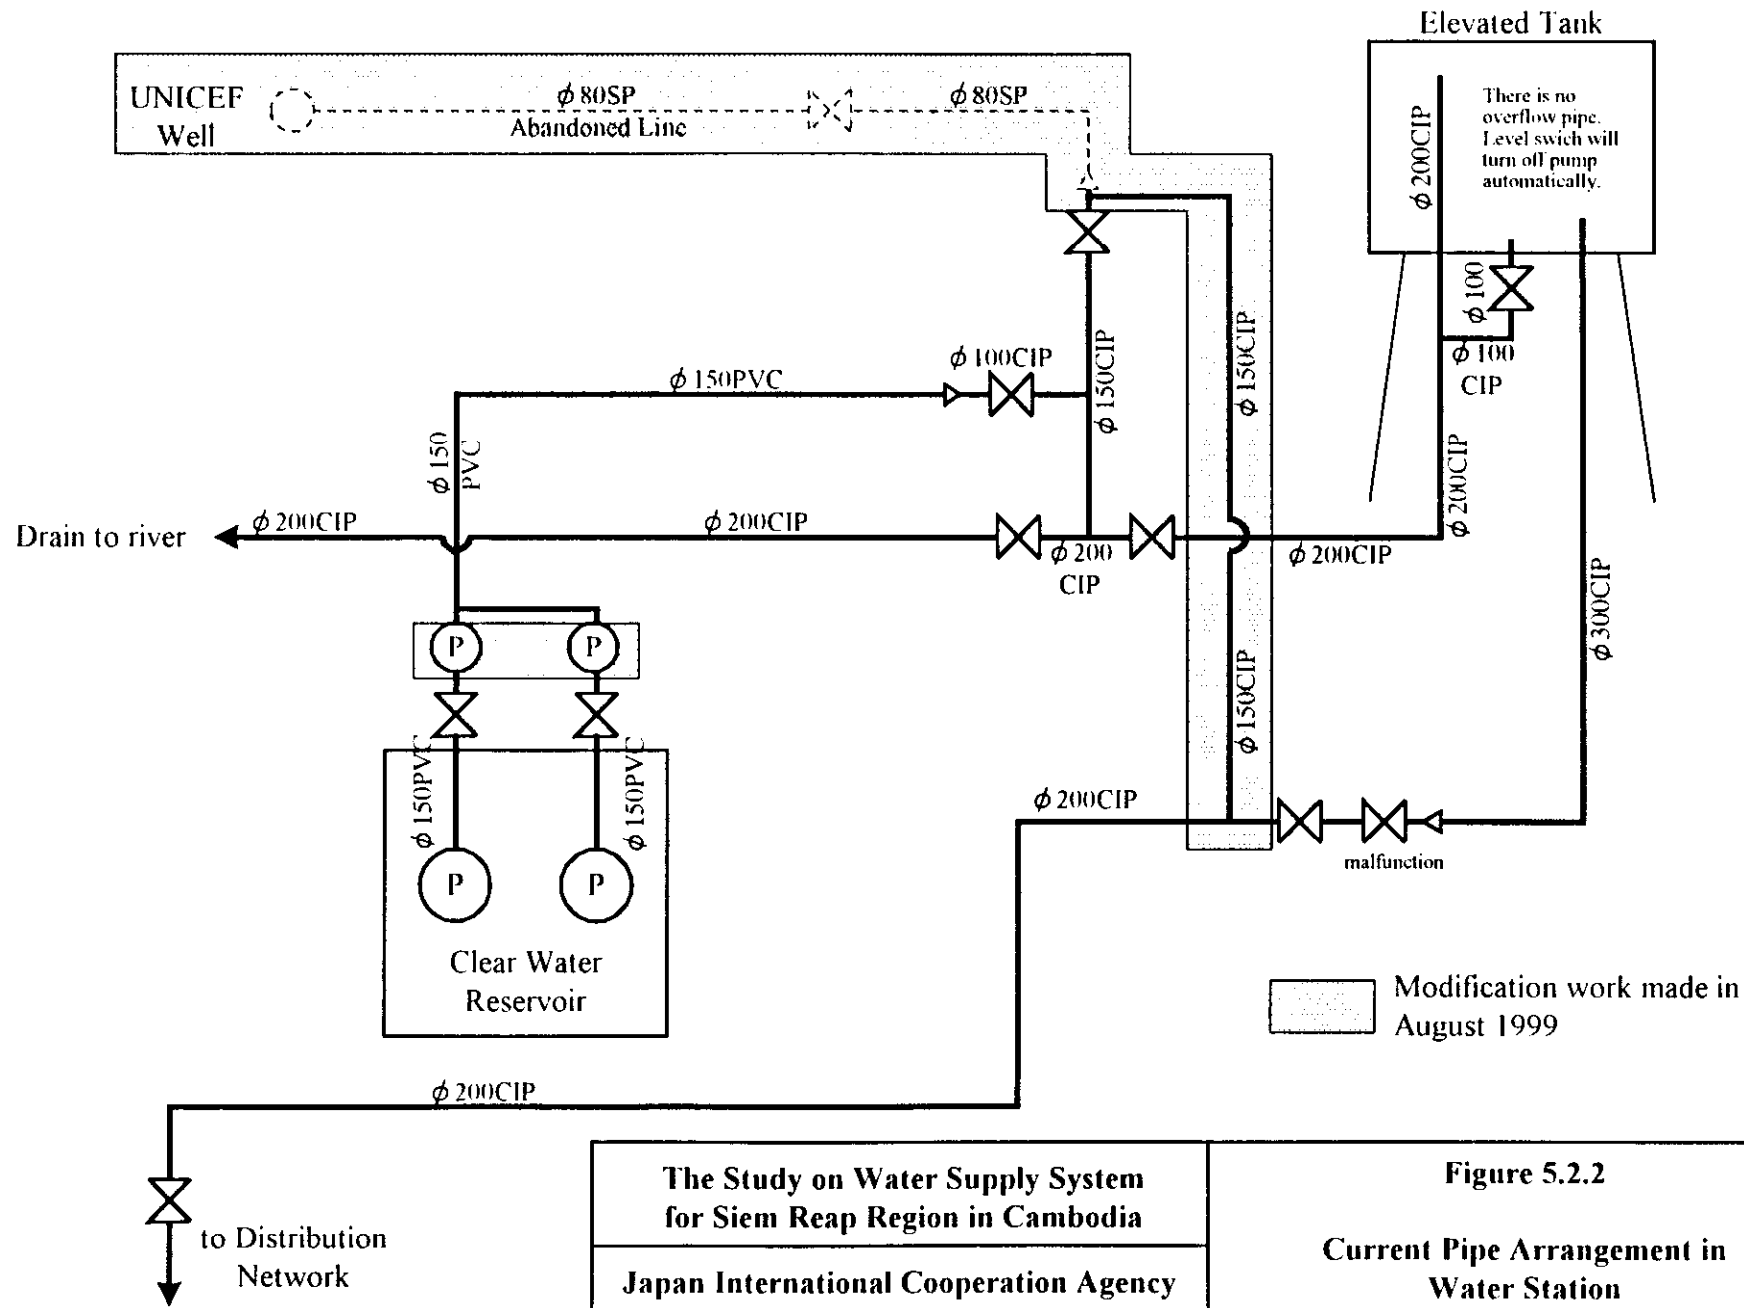
Figure 5.2.2
Current Pipe Arrangement in
Water Station

During these new pump installations, the Waterworks modified pipe arrangement within the Water Station in order to distribute water by direct pumping without using the elevated tank in case it is required. This modification was made to achieve continuous water supply even during the maintenance of the elevated tank. Current pipe arrangement in the Water Station is shown on Figure 5.2.2.

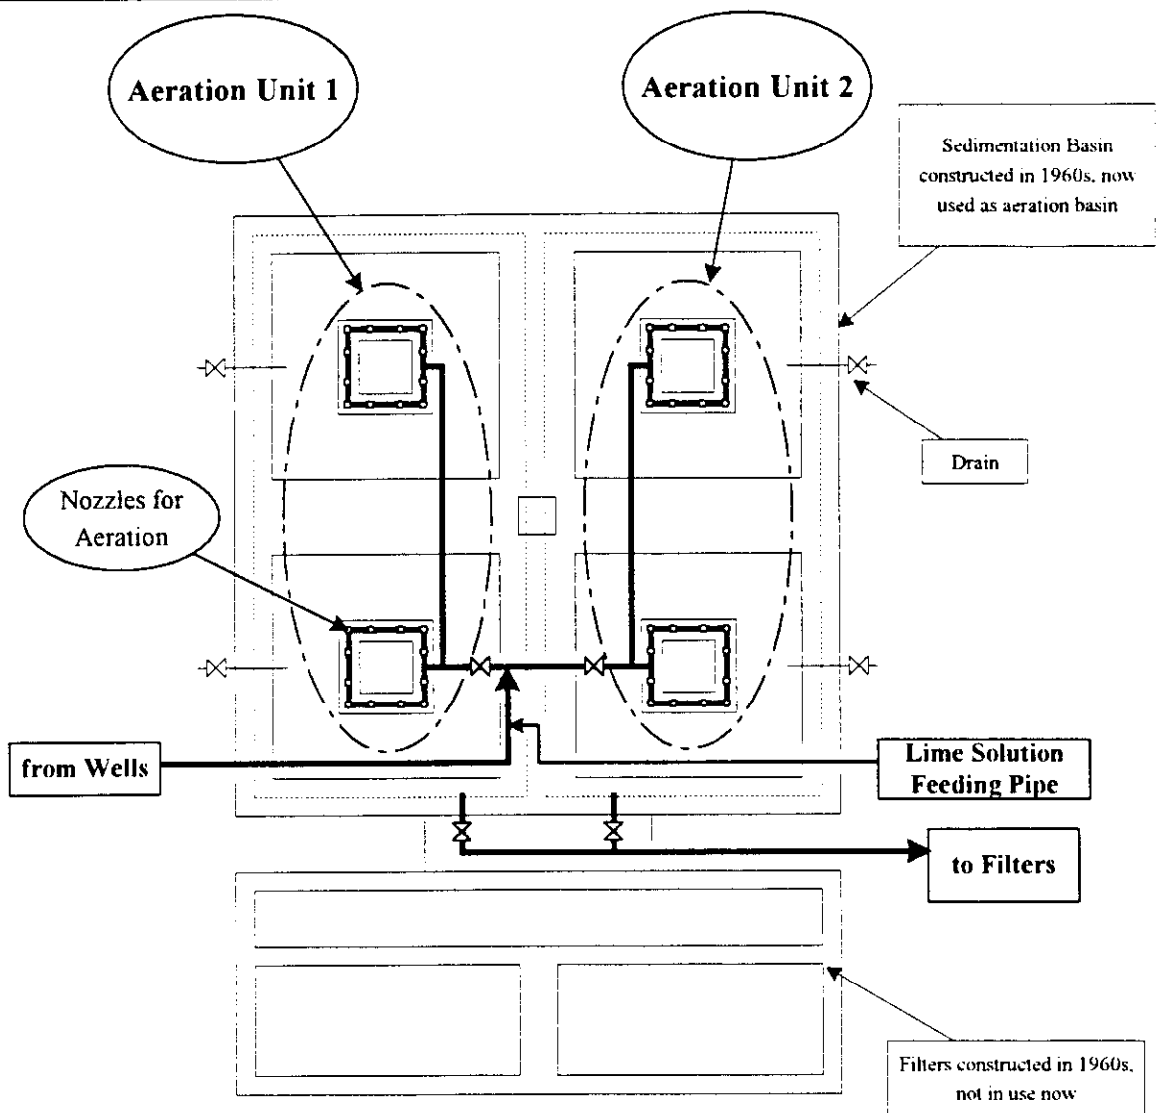
Figure 5.2.3
Current Aeration System

Figure 5.2.3 shows the new aeration system that is installed on the previous sedimentation basin. It should be noted that operation of the new aeration system is not continuous and operated in batch system. The new aeration system is consisted of two units and these two units are operated alternately. Groundwater is sprayed upward like fountain to have contact with air. When the half section of the previous sedimentation basin becomes full, aeration in the unit is stopped and aeration in the another unit starts. Aerated water in the sedimentation basin is kept for about 3 hours for sedimentation of oxidized iron. After sedimentation, water is transferred to the pressure filters through the original aeration basin.

Concentration of iron in treated water after these process modifications is 0.1 to 0.3 mg/l and the quality is acceptable for the customers. Although the quality of treated water is much improved by this modification; plant capacity becomes low to 500 m³/day against design capacity of 1,440 m³/day because of the batch operation.

To increase treatment capacity, the Waterworks has a plan to expand its aeration system occupying previous filter basin. According to the estimation of the Waterworks, capacity will be increased up to 800 m³/day by the expansion.

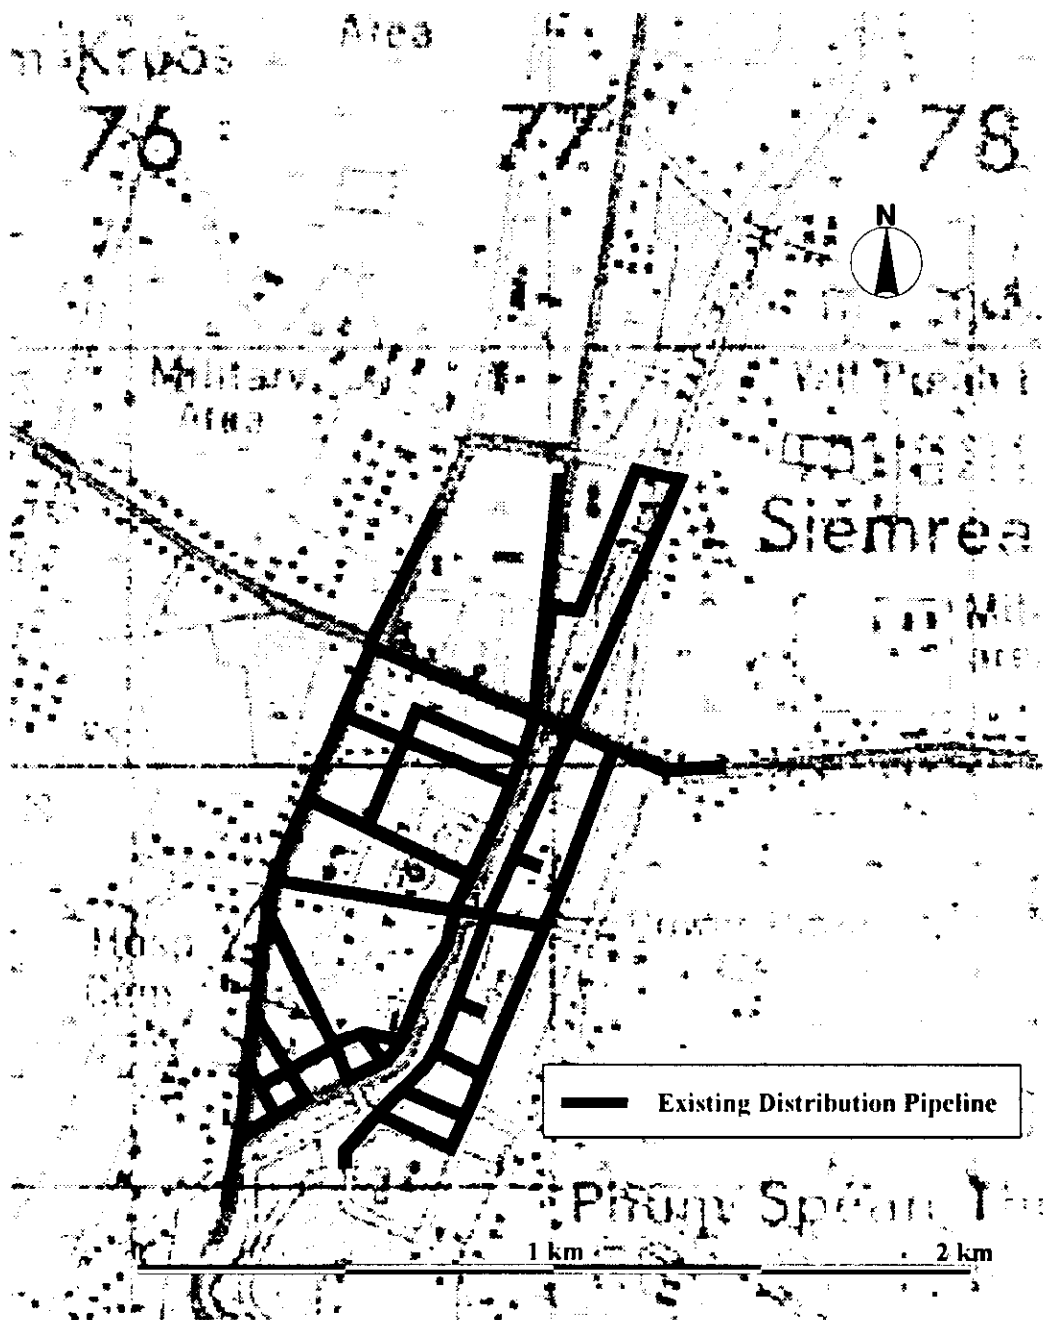
Range of diameter of the existing distribution network, which was constructed in 1960's, is 100 mm to 250 mm and the dominant material of the distribution pipeline is ACP. PVC material was used in very limited pipeline which was recently installed by AFD in 1995. Breakdown of the network by its diameter and material is shown on Table 1.1. Alignment of the existing distribution network is shown on Figure 1.1 and diameter and length of each pipeline is shown on network diagram, Figure 1.2.

When the New French System was constructed, AFD checked all distribution network pipeline, and in case they found broken pipe, they repaired the pipe. Although AFD repaired some pipelines, but the condition of distribution network is still not good according to the staff of Waterworks. After the AFD's repairing work, many construction activities have been taken place such as electric cable installation along the distribution pipelines. These construction works must damage water pipeline according to the staff of the Waterworks.
