BASIC DESIGN STUDY REPORT

THE NEW NYALI BRIDGE AND THE NEW MTWAPA BRIDGE

THE REPUBLIC OF KENYA

August 2000

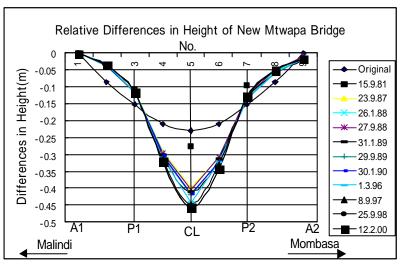
Fig. 2.3.2 Deflection of span center girder

Deflection along the time-course of span center portion

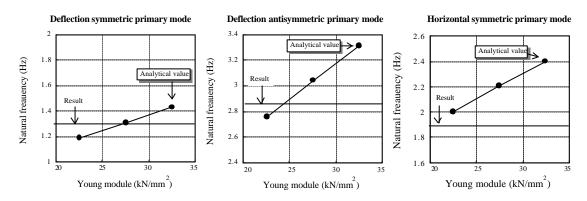
Fig. 1-2 Relationships between test and analytical values

Table 1-1 shows the result of analysis using as parameters the natural frequency determined from a vibration test and the concrete elastic modulus (Ec). The analysis assumed that the entire section is effective and used the elastic modulus value $(Ec=23kN/mm^2)$ determined from the elastic modulus test with concrete cores, the design value $(Ec=28kN/mm^2)$, and the value $(Ec=33kN/mm^2)$ estimated from the concrete strength of 51N/mm². The relationships between tests and analytical values are shown in Fig. 1-2. It is evident that the natural frequency in the deflection direction falls between the analytical value using the elastic modulus test value and that using the design value. It may be surmised from the above that no remarkable decrease in rigidity occurred within the range estimated from the vibration test result.

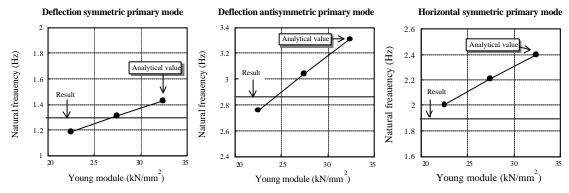
Fig. 1-15 Comparison between test and analysis values

From Fig. 1-15, it is evident that the natural frequency of torsion vibration falls between the analysis value based on the elastic modulus test value and the design value. As regards the natural frequency of horizontal vibration, the analysis value was higher than the test value in all cases. This may be attributed to the fact that the analysis model did not consider the substructure, resulting in evaluation of the structure more rigid.
