*The Study on Comprehensive Disaster Prevention
around Mayon Volcano*

SUPPORTING REPORT (1)

(Part I : Master Plan)

**SUPPORTING REPORT (1)-III
FACILITY DESIGN**

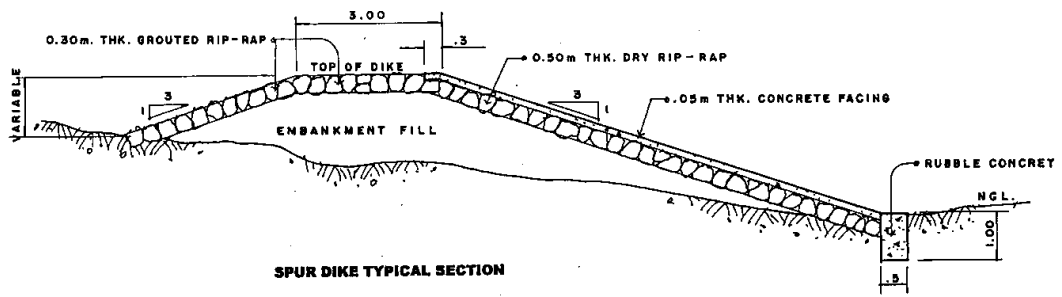
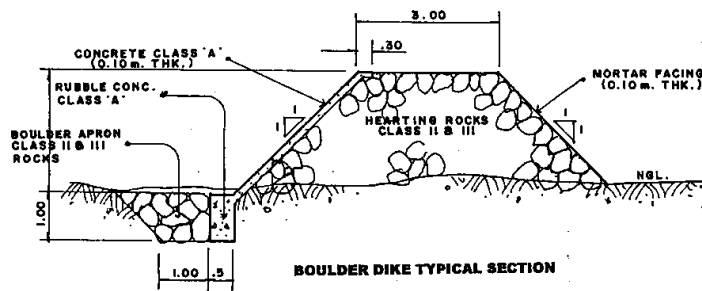
Situation of Failure of Spur Dike in Bulawan River

- The main cause of failure of the spur dike in the Bulawan River is considered to be from being bumped by boulders.
- The main cause of failure of the spur dike in the Anolin River is considered to be from both the erosion of the basement and being bumped by boulders.
- The cause of failure of the spur dike in the Padang River is considered that a part of the foundation of the dam eroded away and was mainly destroyed, so fill material in dike was washed away, and the broken portion was expanded more by impact of boulders.

BULAWAN RIVER = DIKE

1. DAMAGE CONDITION OF LEFT SIDE DIKE (UPSTREAM FROM N.R.)

2. PROCESS OF DAMAGED DIKE

- Fill material in dike must not be setting and flowing away.
- Facing wall and inside material must strengthen to be protected from impact of boulder.
- If the foundation of dike is eroded, whole dike body must be strong enough to prevent the failure spreading to the main body.

- Easy construction work, low cost, and high local content
- The foundation depth of the existing spur dike is 1m. These foundations have been scoured by debris flow in some location. The foundation will be the depth of 2m, which is commonly used on sand and gravel area in Japan.

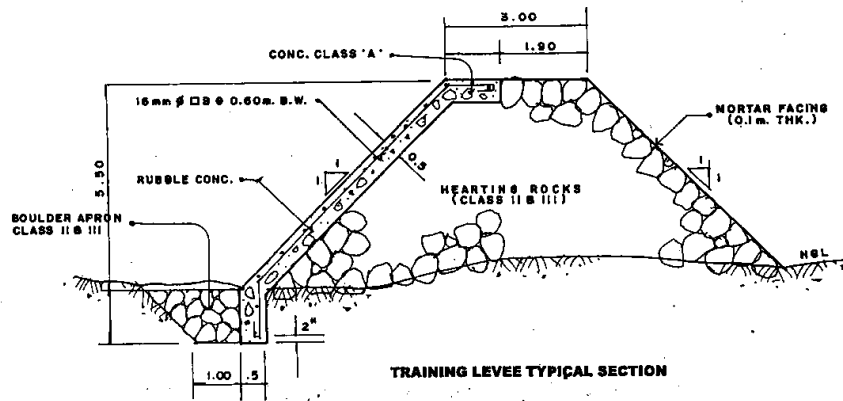
Situation of Failure of Spur Dike in Anoling River

ANOLING RIVER (1) BROKEN CONDITION OF DIKE

(2) PROCESS OF BROKEN DIKE

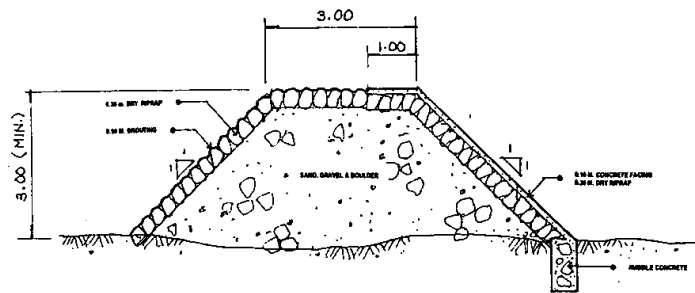
Situation of Failure of Spur Dike in Padang River

1. DAMAGE CONDITION OF LEFT SIDE DIKE

2. PROCESS OF DAMAGED DIKE

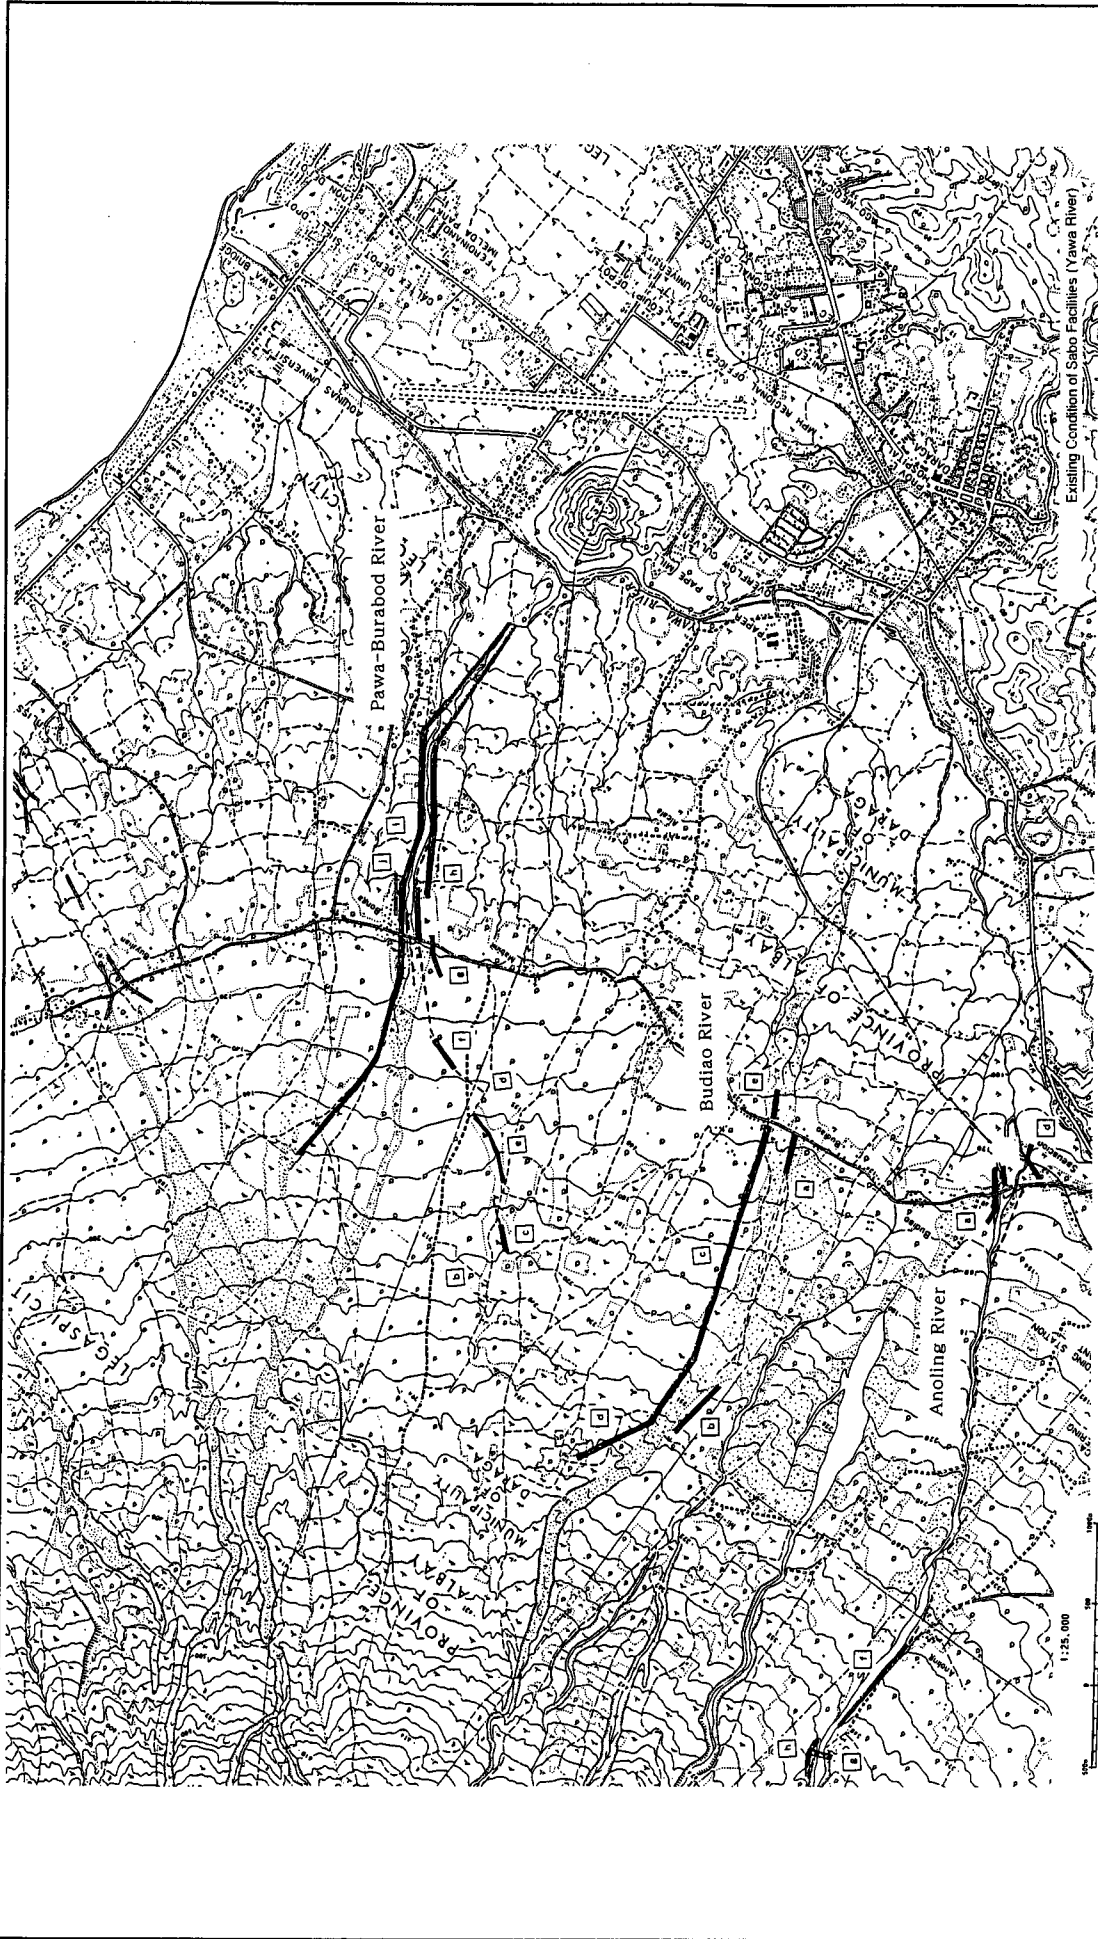
Figure III 1.1
Existing Condition of Sabo Facilities (Yawa River)

River System	River Name & Location	Facility Name	Facility Size		Date Constructed	Expected Effect	Existing Condition	Cause of Failure
			Height(m)	Length(m)				
YAWA River system	1.YAWA Legaspi city	a.Boulder dike	(4.00)	320	2-14-89	Fix flood flows course		
		b.Boulder dike	(4.00)	1,200	6-02-91	-do-		
		c.Concreting of boulder dike	(4.00)	1,250	11-01-89	-do-		
		d.Dike No.1,2,3,4	4.00	308	ongoing	-do-	Broken part of structure damaged (about 50m)	Erosion on foundation of dike
		Dredging	45000cu.m		1991
