## **6-5: Soundness of Bridges**

### Table-A Bridge Soundness Sheet (Sheet No.1)

NAME OF BRIDGE: Dood Selbe River B Trunk Road		CROSSING: Selbe River		INSPECTION BY		INSPECTION: 2000, June 9		INSPECTION BY			
Design Information		* Yes No		Construction By China		Date of Construction: 1963		Maintenance by			
Superstructure		Reinforced Concrete T-Girder		Reinforced Concrete		Russian 22 ton		Load limitation *No			
Substructure		Reinforced Concrete		Reinforced Concrete		Reversed		Design Loading			
Substructure		Reinforced Concrete		Reinforced Concrete		Tetrapole column		Design Standard			
Pier		45.6m		Span		4@11.4m		Skew of Bridge			
Overall		9.0m		Carriage: 7.0m		Pedestrian: 2@1m		Condition of Crossing			
Kind: communication		Number		4		Ratio of Heavy Veh. 2.3 (0veh./day)		Others			
Traffic Volume		19,500veh./day		Ratio of Heavy Veh. 2.3 (0veh./day)		Others		Others			
Pavement		Deck Slab		Main Beam		Painting		Expansion Joint			
Others		Others		Others		Others		Others			
Component		Conditions Of Damage		Rating		Component		Conditions of Damage		Rating

Table-B Photo for Existing Conditions of Bridge (No.1-1)

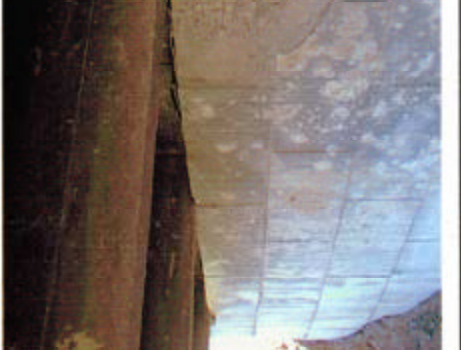
<p>Comments</p> <p>General view of beam, sub-structure:                      Poor conditions, scaling of beam &amp; slab                      Scouring at piers</p>	<p>Location</p>
