APPENDIX 5B

RESULTS OF LEAKAGE SURVEY

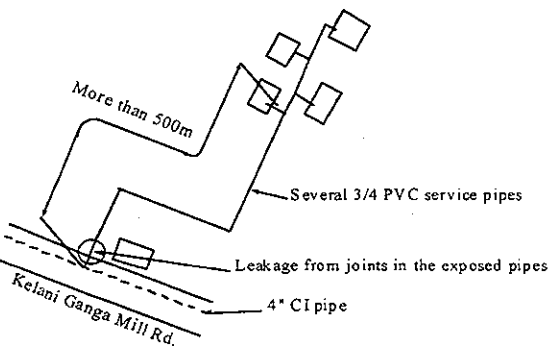
Photo No.2

Pipe Material	PVC (Service Pipe)
Nominal Internal Dia. (inch)	3/4
Age Group	unknown
Pipe Location	see Notes
Detected by:	Visual Inspection on the Ground
Leakage from:	Joint
Leakage Volume	Medium

- Many small leaks were observed near the joint
- Some part of service pipe were exposed on the ground and leaking from joint
- Service pipe shown in photo No.1 and No.2 was connected to the house 500m away from distribution main drawn as below

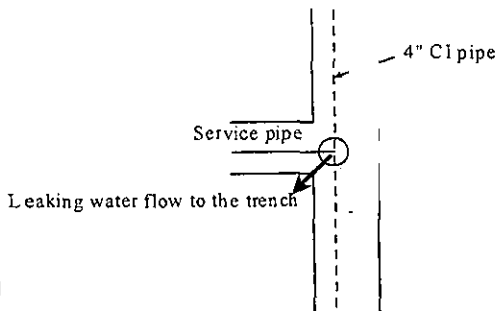
Pipe Material	unknown
Nominal Internal Dia. (inch)	unknown
Age Group	unknown
Pipe Location	under Roadway (paved)
Detected by:	Visual Inspection on the Ground
Leakage from:	Unknown
Leakage Volume	Medium

- There was leaking water flowing in the trench shown in photos
- It could be leakage from service pipe
- It was very difficult to hear the leakage sound because water pressure was extremely low

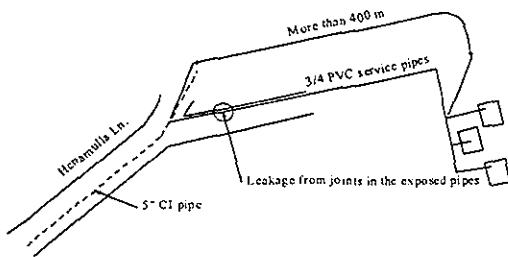
Photo No. 2

Pipe Material	PVC (Service Pipe)
Nominal Internal Dia. (inch)	3/4
Age Group	unknown
Pipe Location	see Notes
Detected by:	Visual Inspection on the Ground
Leakage from:	Joint
Leakage Volume	Small

- Some part of service pipe were exposed on the ground and leaking from joint
- Service pipe show in photos was connected to the house 400 m away from distribution drawn as below

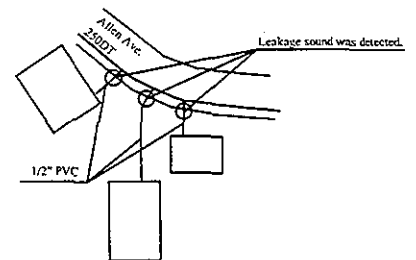
Pipe Material	Unknown
Nominal Internal Dia. (inch)	Unknown
Age Group	20 to 50 years
Pipe Location	under Roadway (paved)
Detected by:	Sounding Bar
Leakage from:	Unknown
Leakage Volume	Medium
