BASIC DESIGN STUDY REPORT
ON
THE PROJECT
FOR
IMPROVEMENT OF COASTAL FISHERIES DEVELOPMENT
IN
THE COMMONWEALTH OF DOMINICA

January 2001

JAPAN INTERNATIONAL COOPERATION AGENCY
ECOH CORPORATION

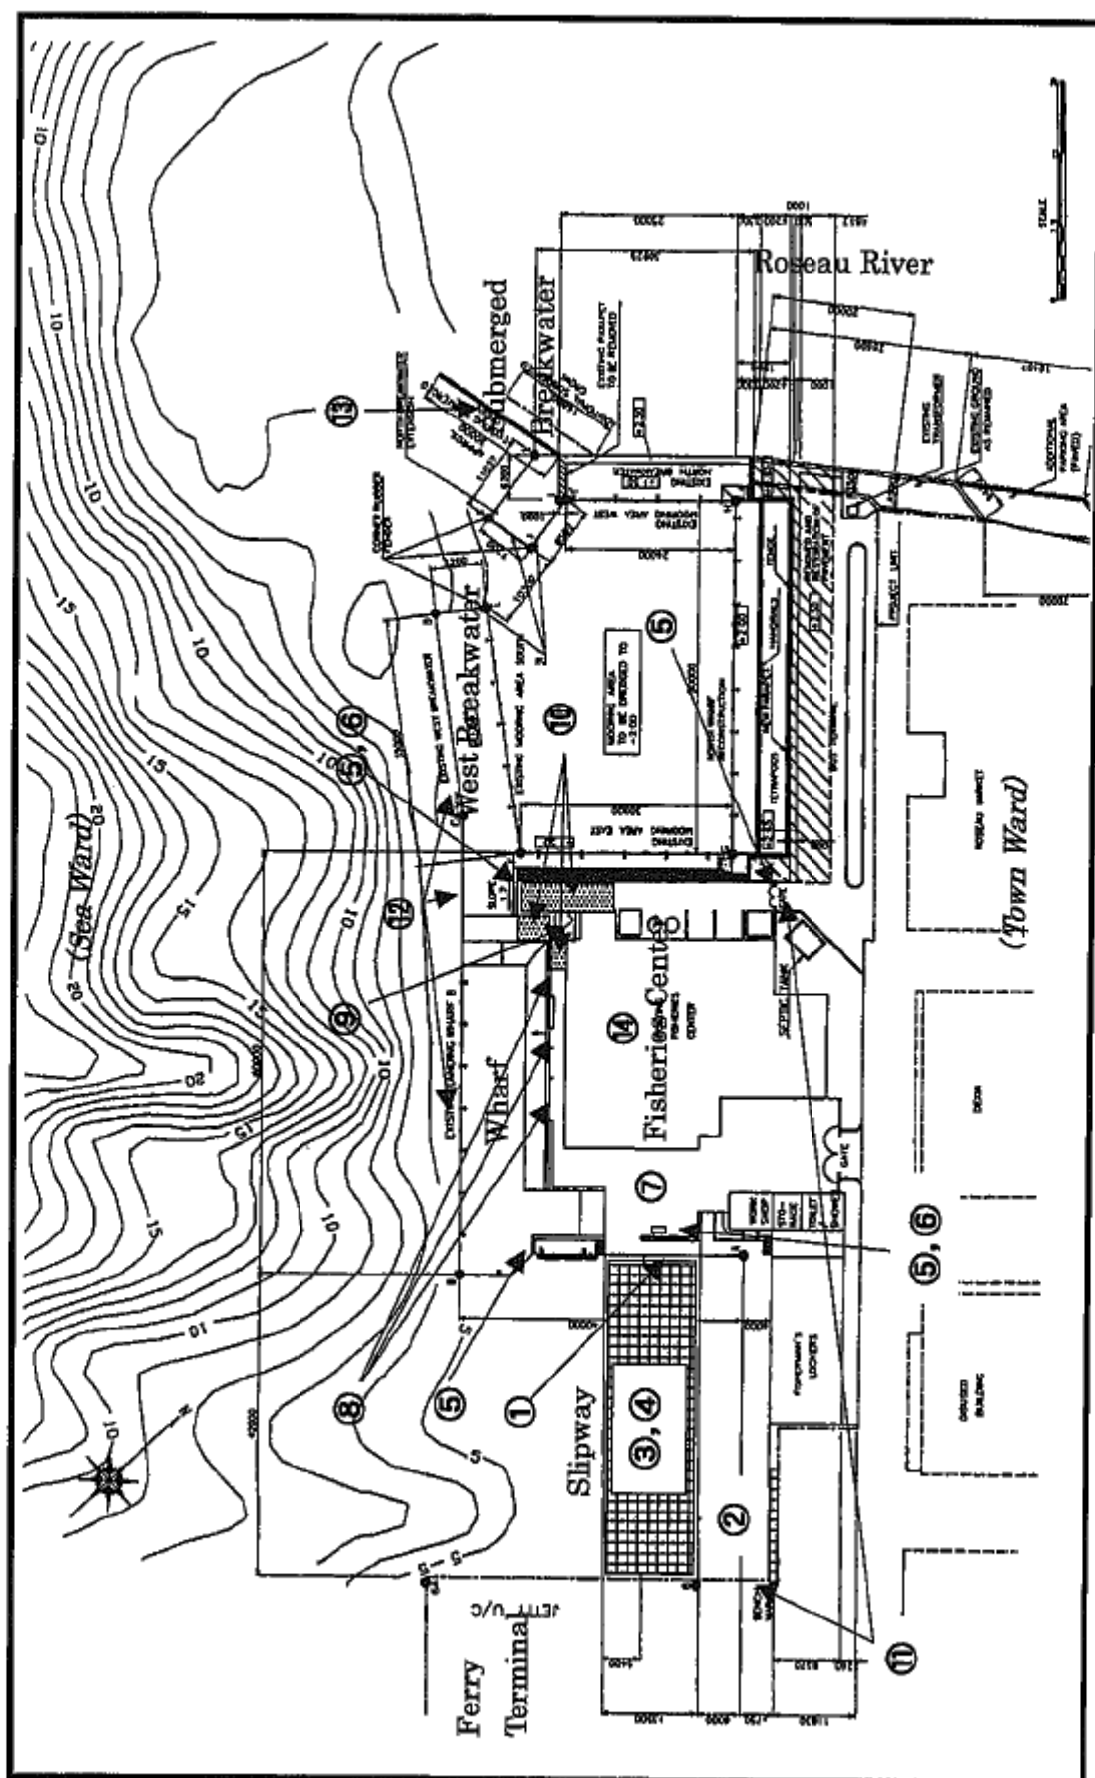
Damages at Project Site are described in Table-1-3-1 (1), and locations and points of damaged facilities are indicated in Figure-1-3-1 (1), then photographs of damaged facilities are shown in Figure-1-3-1 (2), (3) and (4).

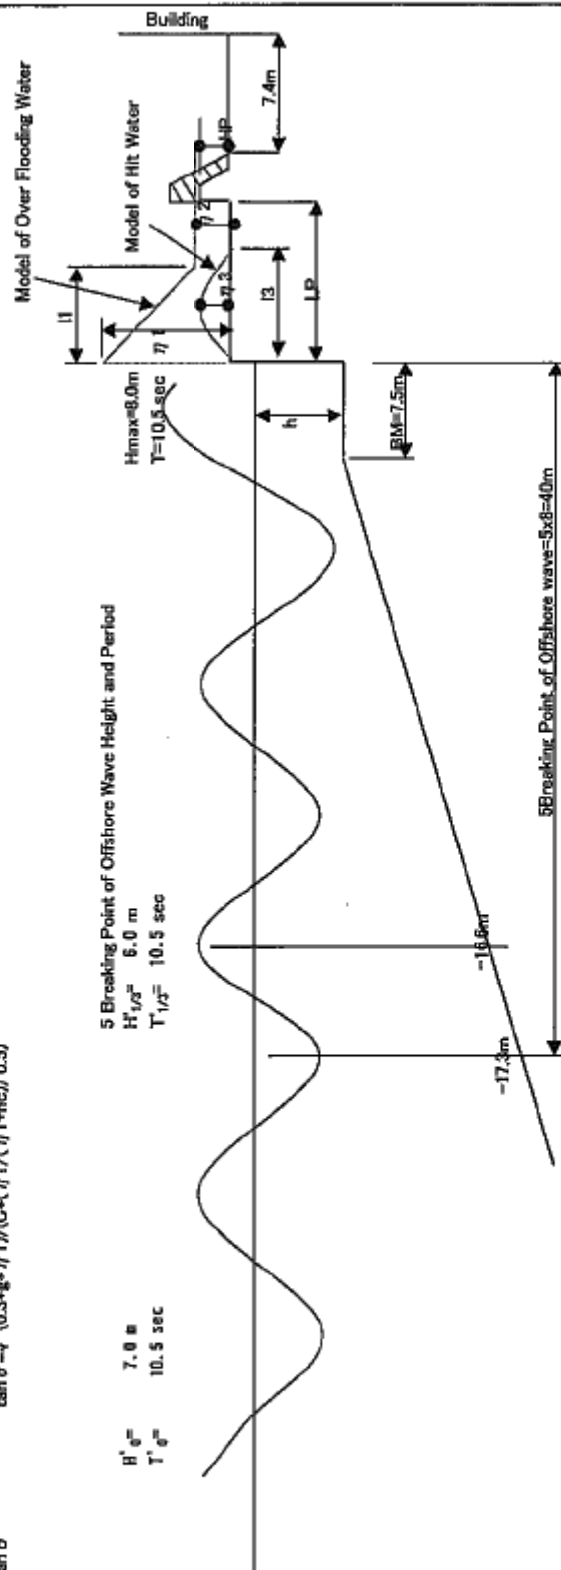
Figure-2-2-3 (1) Calculation Measure of Over Flooding Wave

Based on the thesis, " Experimental research of motion of overtopping wave on the breakwater without the parapet", Takahashi, et. al. Collection Volume 38(1) 1991, the height of over flooding wave at the point of striking on the landing wharf is estimated 4.29m for a 30-year probable wave. The height of existing parapet wall is 1.50m. The effect of depression for over flooding wave is $4.29\text{m} - 1.50\text{m} = 2.79\text{m}$. The part of water of 2.79m will over flood. The effect of depression for the over flooding wave of existing parapet wall is 1.50m. Consideration of over flooding wave is described in Figure-2-2-3 (1).

wall. However, the existing parapet wall is not sufficiently effective for reducing the water pressure to the building of Fisheries Center. Therefore, it is necessary to move the location of placement that the basin is able to increase for catching volume and size up of height of the parapet wall without gates.

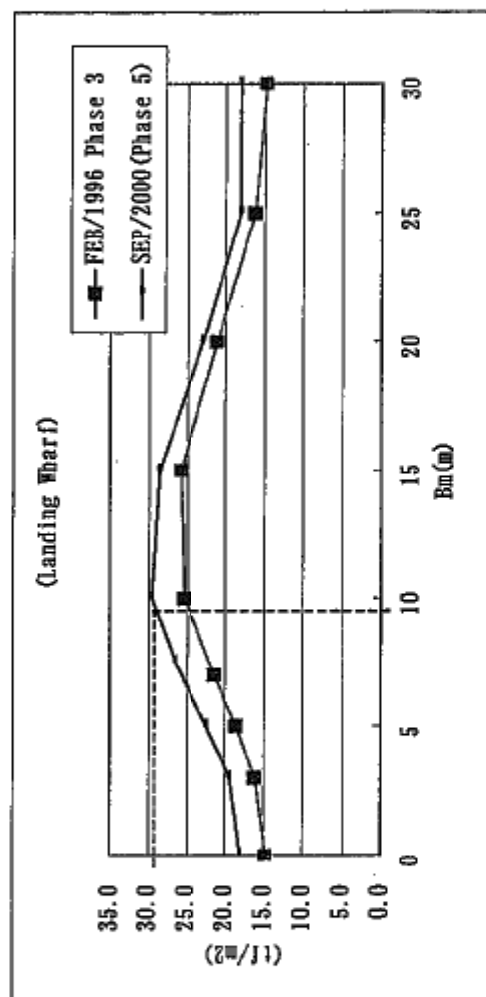
Figure 2-3-1 (4) Pressure of Shock Waves at Landing Wharf

This area is steeper than the forward area of west breakwater. The sea bottom Topographical profile changes to steeper than the result of sounding survey in 1998. This area is in shock wave. The shock wave pressure is estimated to 27tf/m^2 using the above mentioned method of Takahashi's thesis. In this case, the maximum wave height is 10.8m of same of west breakwater. Calculation results of pressure of shock waves in the vicinity of landing slipway are described in Figure-2-3-1 (4).
