**THE STUDY  
ON  
CRITICAL LAND  
AND  
PROTECTION FOREST REHABILITATION  
AT TONDANO WATERSHED  
IN  
THE REPUBLIC OF INDONESIA**

**APPENDIX-H**

**SOIL EROSION AND SEDIMENTATION**

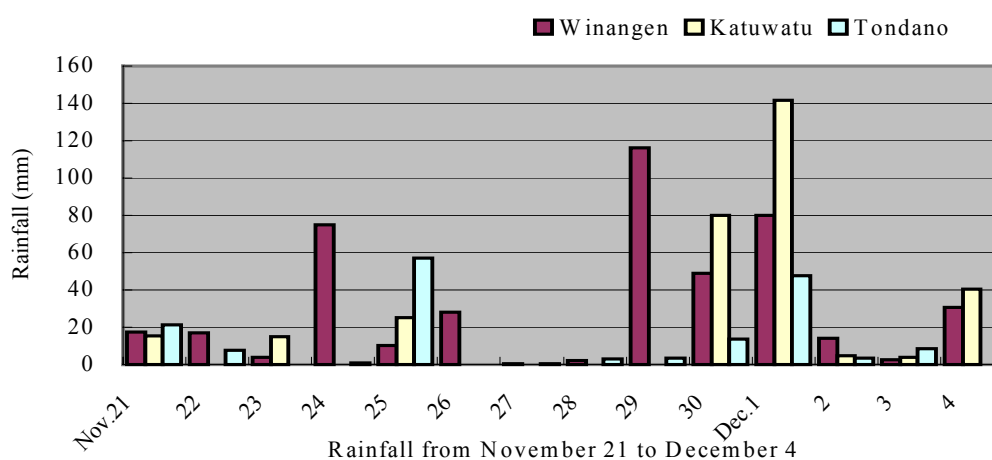
According to the report of 'North Sulawesi Water Resources Management Plan' by CIDA, extensive flooding was reported in Manado city in 1996; the depth of flooding was over two meters in some areas. Flood water receded after about three days. Flooding caused considerable damage to property and disrupted life in the city. Three kotamadya Manado were subject to flooding: Malalayang, Wenang, and Sario.

During the phase-II study period, serious flood attacked over the Minahasa district, where huge flood damages were reported. Manado city was attacked by flood again, and the area along Tondano River, especially in Kotamadga Wenang, inundated a few days with 2 m deep water.

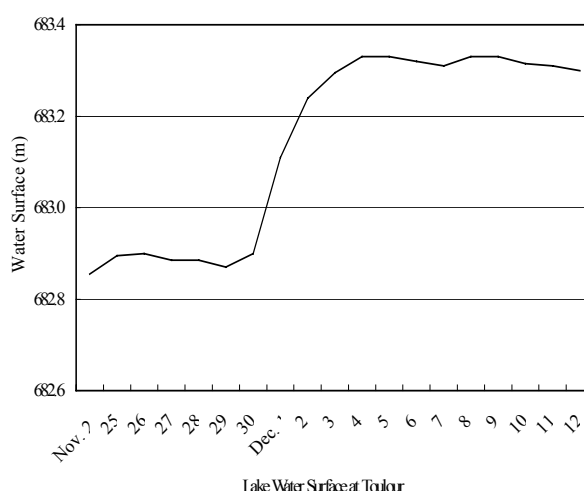
During the flooding period, water surface of Tondano Lake rose about 40 cm within 3 days as shown in right figure.

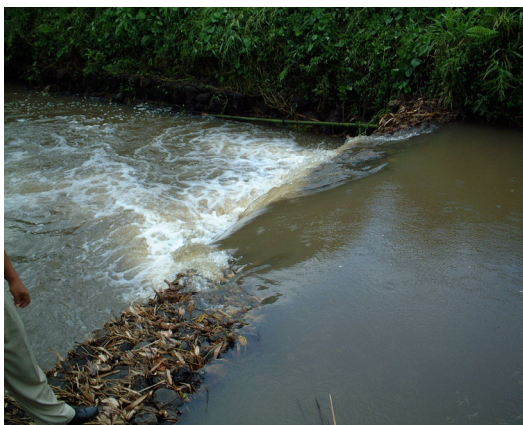
**Gabion Box Check Dam at Tontimomor**

| Code No. | Name of the Dam | Dam Type | Identified Problem |
|---|---|---|---|
| CD-11 | Tontimomor | Gabion box check dam | Gabion dam body has been damaged. |
