Inventory Survey of Check Dams in the Intensive Area

CD - 5

**The Study on Critical Land and Protection Forest
Rehabilitation at Tondano Watershed
in the Republic of Indonesia**

**Inventory Survey of Existing Check Dam
(CD-5) (1/2)**

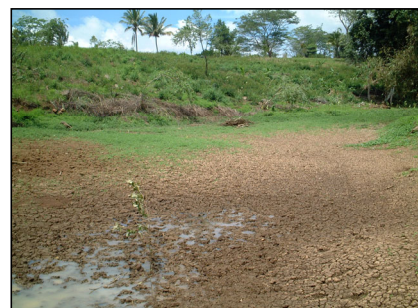
General View of Dam Lake

Status of Sediment Control **Functioning**
Deposition Gradient **1.8** %
Sedimentation Yield **3,000** m³
3.6 ton/ha/year
