## Inventory Survey of Check Dams in the Intensive Area

CD - 6

The Study on Critical Land and Protection Forest  
Rehabilitation at Tondano Watershed  
in the Republic of Indonesia

Inventory Survey of Existing Check Dam  
(CD-6) (1/2)

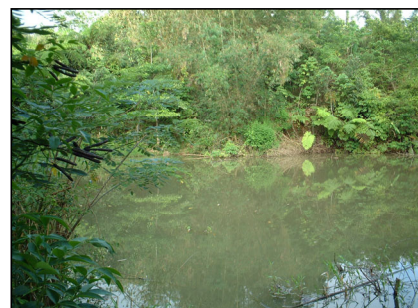
Status of Sediment Control	Functioning
Deposition Gradient	N/A %
Sedimentation Yield	N/A m <sup>3</sup>
	N/A ton/ha/year
