## Inventory Survey of Check Dams in the Intensive Area

CD - 16

Touliang Oki

Inventory Survey of Existing Check Dam (CD-16) (1/2)

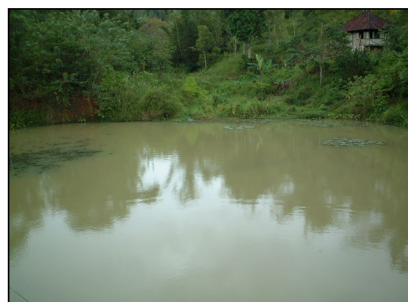
General View of Dam Lake

Status of Sediment Control	Functioning	
Deposition Gradient	N/A	%
Sedimentation Yield	N/A	m <sup>3</sup>
	N/A	m <sup>3</sup> /ha/year
