Table S.2.4.1.3 General Characteristics of Proposed Dam and Intake Site (4/18)

Table S.2.4.1.3 General Characteristics of Proposed Dam and Intake Site (5/18)

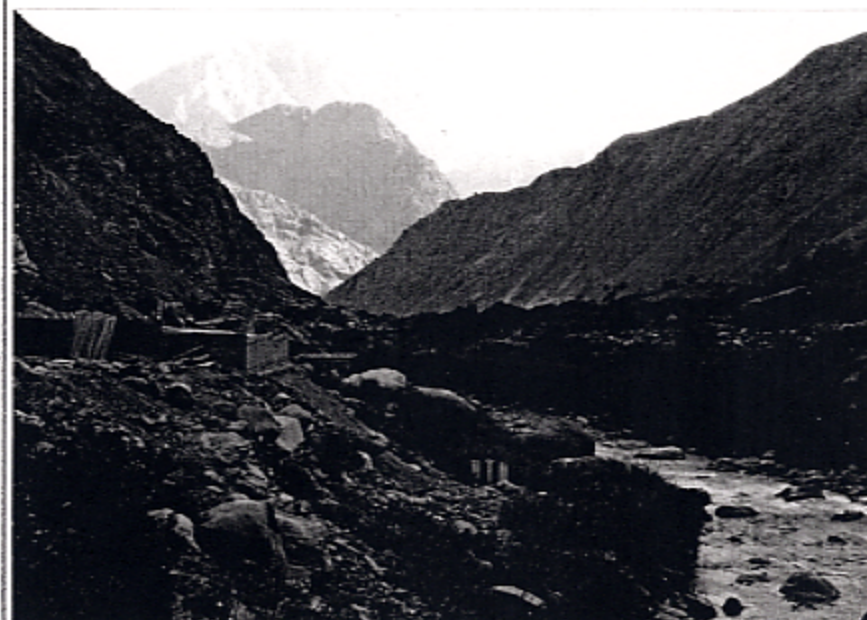
Negative No.1-29

Fractures in parallel with flow structure.		Massive		Fracturing								
			No present		No present		No present								
			Slight rusty-weathering along the fracture.		No present		Slight rusty-weathering along the fracture.								
	Overlying Sediment		Some rock fragments		Present fluvial deposit in small scale		Terrace deposit and talus deposit on the slope in large scale.								
	Landslide and/or Failure		No present		No present		Slide of unstable talus deposit								
	Remarks		Terrace and talus deposits are distributed widely in the right abutment. The later deposit shows unstable aspect.
