2.6 Current Status of Countermeasure Works

2.6.1 Present Condition of Countermeasure Against Slope Failure

2.6.2 Present Condition of River Crossing Drainage in Malaysia

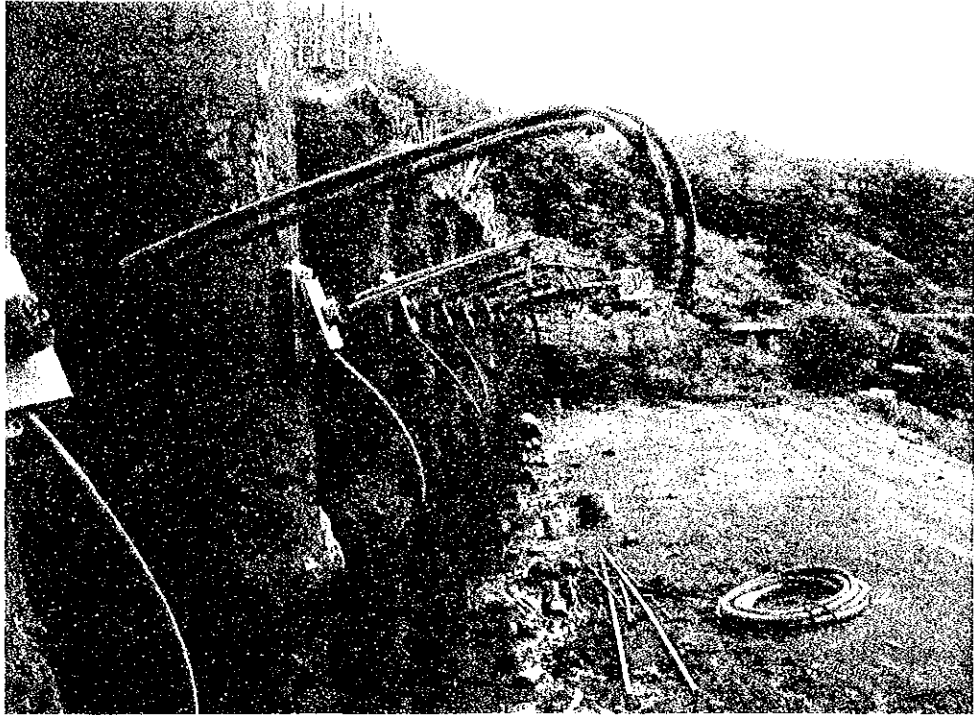
Figure 2.6.16 Reinforced Concrete pile with Ground Anchor

- 3) Reinforced concrete pile is used for countermeasure against landslide, but against landslide, reinforced concrete pile is not effective to protect landslide because the prevention work of landslide is need the strength of shearing strength of slip surface of landslide.

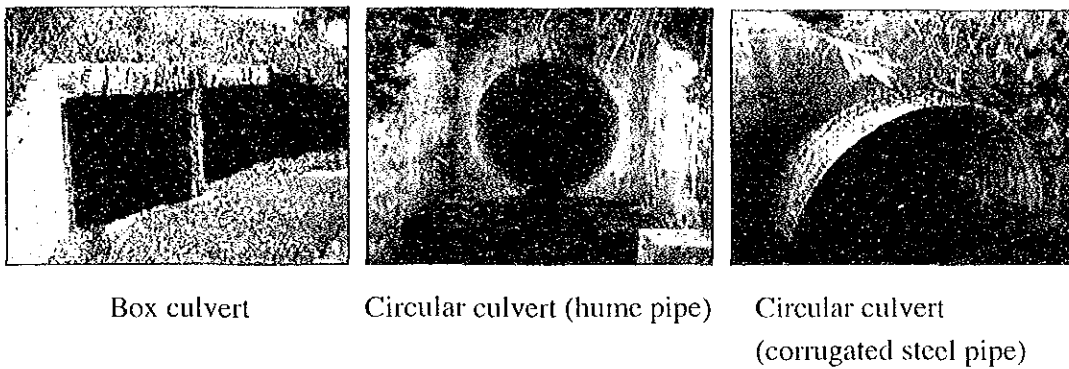
Figure 2.6.21 Three Type of Culvert at East-West Highway

Adopted types at East-West Highway are three (3) types of facilities which are box culvert, circular culvert (hume pipe) and circular culvert (corrugated steel pipe) as shown in the following photos.
