3.4 Geological Investigation

Suitable methods and procedures were used onsite for the geological investigation and instrumentation of the road slope in Malaysia. The study team selected three representative sites to study the stability of the EW highway. The objectives of the study are as follows.

The EW Highway is about 117km long and crosses mountainous terrain with difference of elevation (relief) exceeding 1000m. Most of the routes lie adjacent to rock slopes.

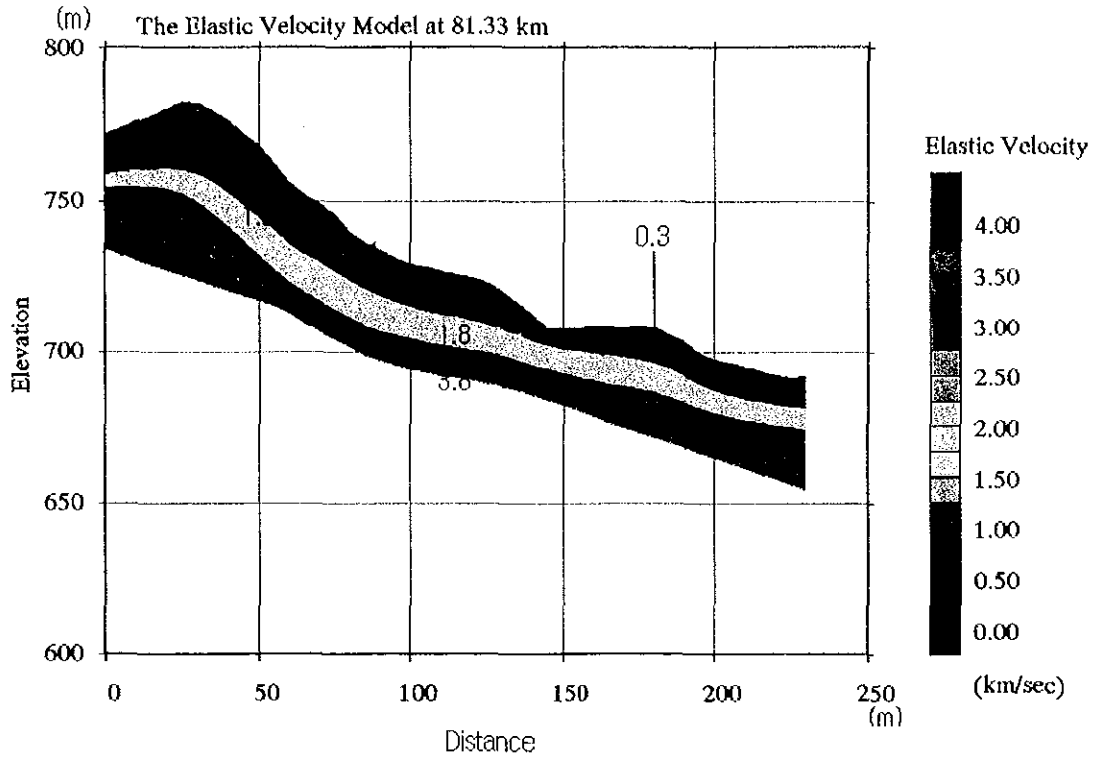
Figure 3.4.6 Elastic Velocity Model Section A-A': 81.33km

- 2) The landslide surface is estimated as line A-A' in Figure 3.4.4 and as line B-B' in Figure 3.4.5. Estimated sliding surface A-A' and b-e-b' is occurring the zone of shearing failure in the rock, that zone is classified highly weathered class-V, the movement and velocity is small, since lowering of the groundwater level now.

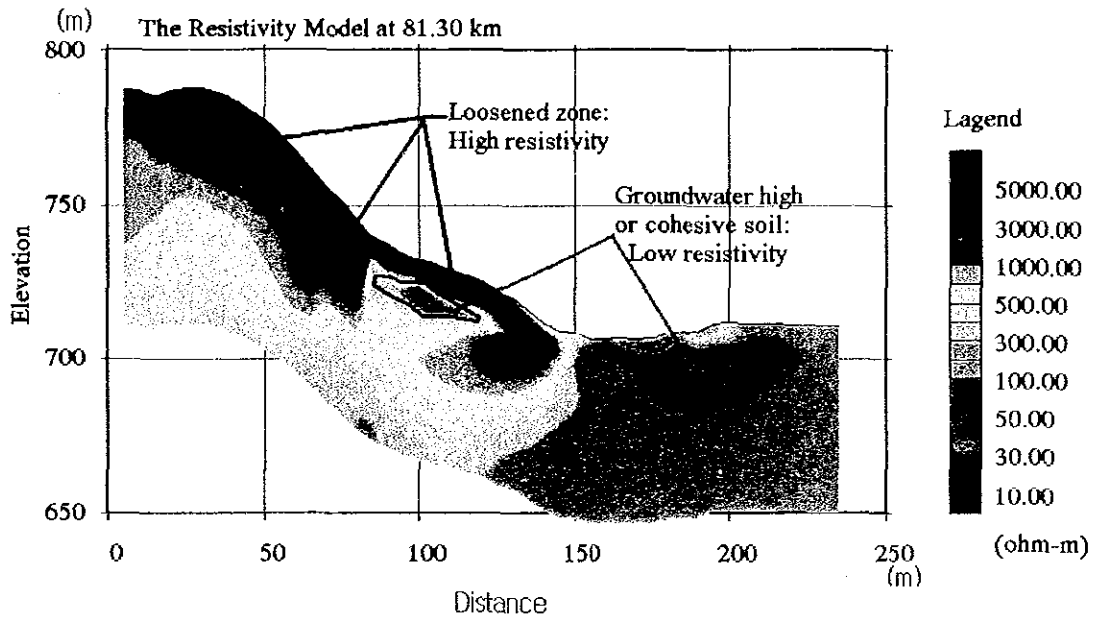
Figure 3.4.7 Resistivity Imaging Model Section A-A': 81.33km

In this case study three sites, mainly sedimentary rocks as mudstone or metamorphic rocks as schist laid, low resistivity means high consolidation or concretion, high resistivity means high void and loosened ground. Low resistivity often shows clayed ground or high groundwater level.

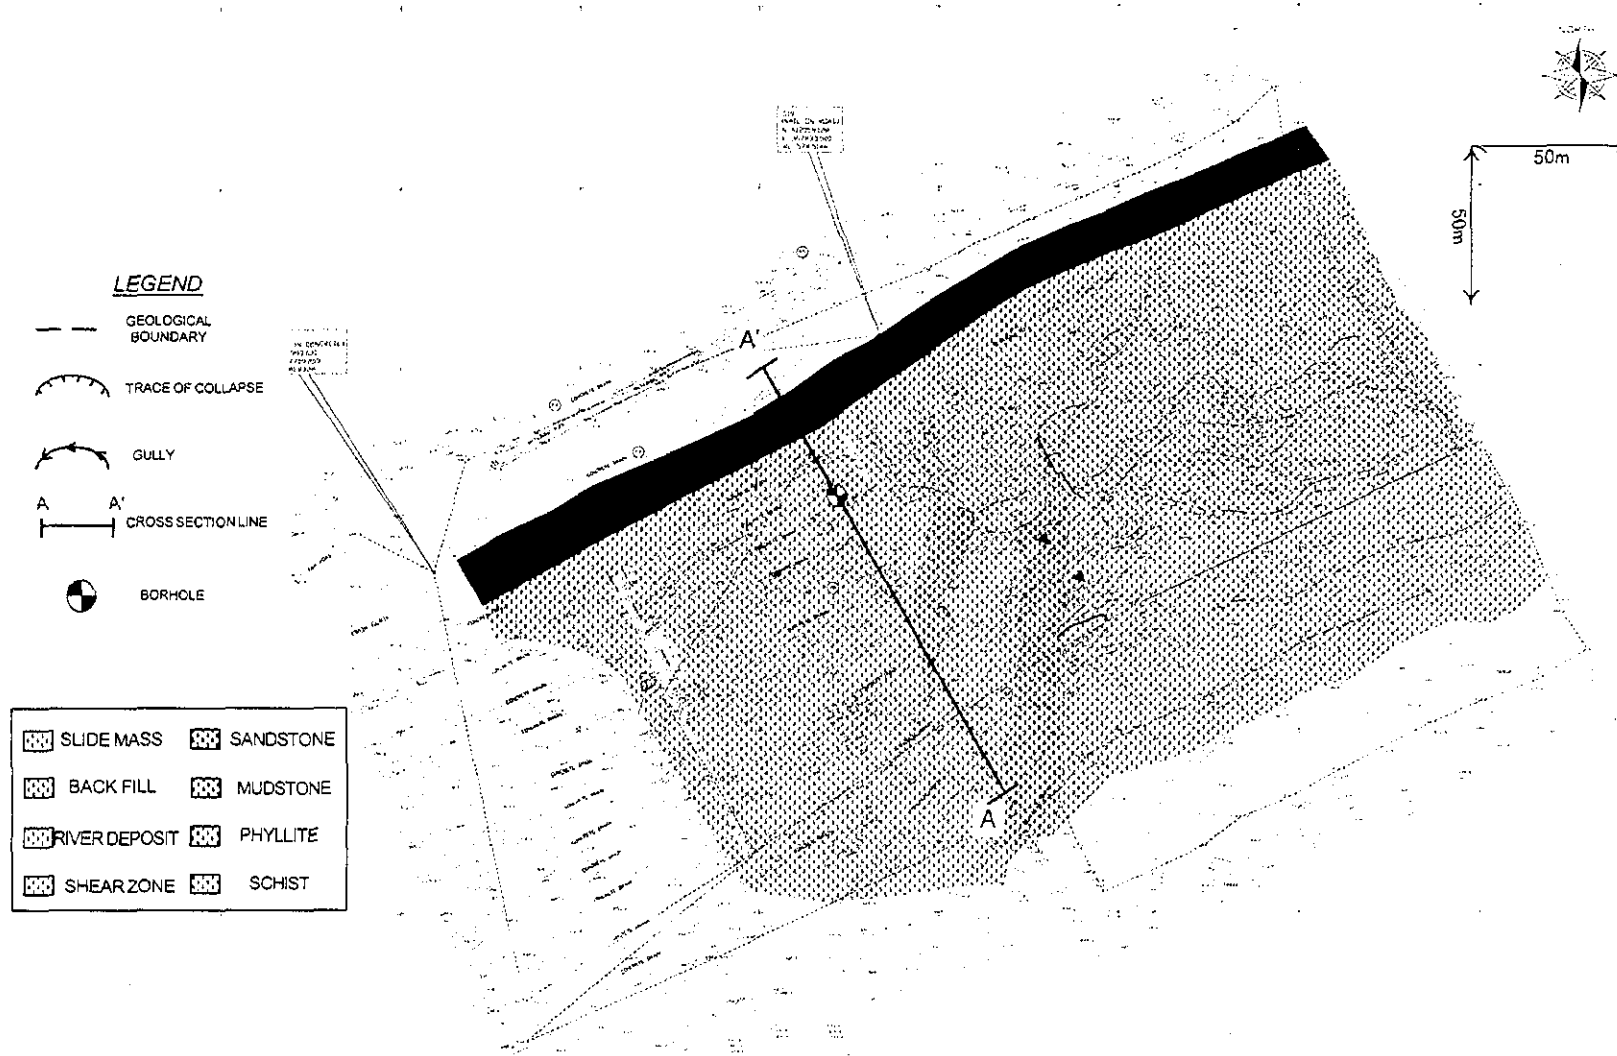
Figure 3.4.10 Geological Map at: CH27.00km

The studied area locates at the end of high cut slope of road toward Jeli, and it also locates the slide of large landslide area. The feature of this slope failure has both feature of collapse and landslide. In this case, the countermeasure of slope failure should be selected against landslide for the safety of traffic. The boring investigation results show that the rock-type consists of interstratified sandstone and shale. The Standard Penetration Test (SPT) N-value generally shows a relatively high ranging from 22 to more than 100. The materials generally consist of heavy weathered sandstone and shale.

The countermeasure of this slope failure can be selected crib work and ground anchors because of steep grade of slope and slip surface. It is also available the diversion of route, because of existence of open space at opposite of road, and counterweight embankment can be done at open space of shifted old road. So we will study the countermeasure of this slope at two cases, 1) counterweight embankment and road diversion, 2) crib work and ground anchors.

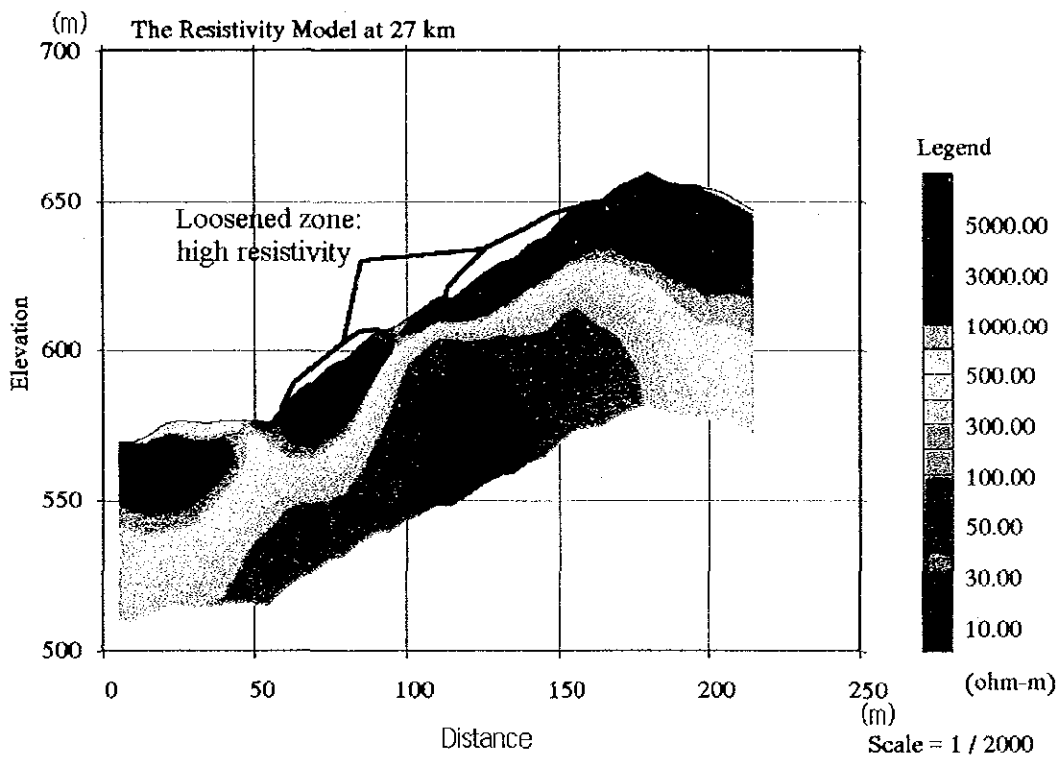
Figure 3.4.13 Resistivity Imaging Model Section A-A': 26.95km

The results of resistivity survey show that high resistivity zone develop at cut slope of roadside and high part of cut slope. It is considered that these high resistivity zones developed loosened rock zone.

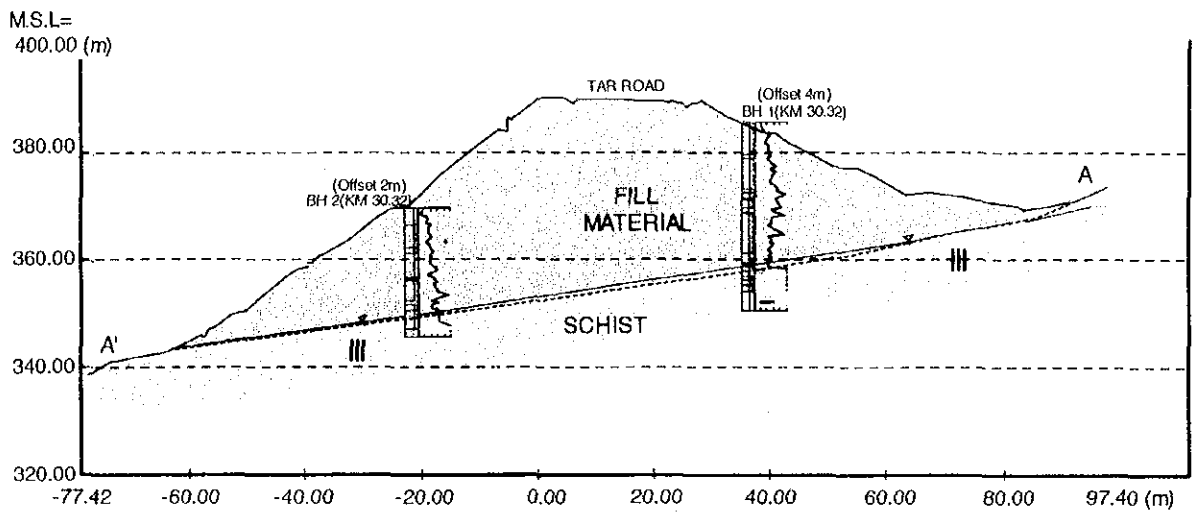
Figure 3.4.15 Geological cross section A-A': CH30.32km

The results of slope investigation show that maximum height of fill is 35 m and the groundwater level stayed almost original ground surface. Materials of fill are mainly silt and contain small amount of sand and gravel. Most part of fill was compacted more than 20 N-Value. The estimated collapse pattern is a progressive failure from lower erosion to upper part. So countermeasure of this site is complete drainage of berm and boundary of ground and fill.

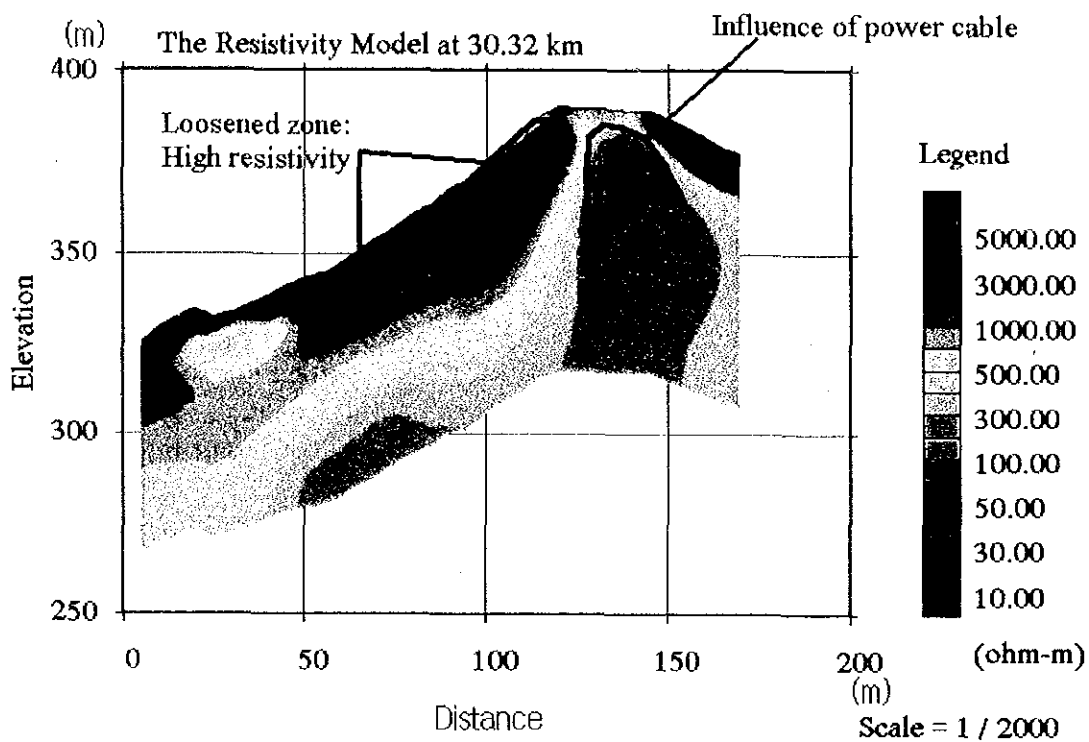
Figure 3.4.17 Resistivity Imaging Model Section A-A': CH30.32km

- (1) The countermeasure has been executed by JKR since 1999 to January 2001 to the top parts of the embankment that was employed the retaining wall with piling and the fill's re-compaction with geo-textile method, because the road surface had settled around 1998. The purpose of this case study is to grasp the possibilities of further failure, which may be seepage failure, presence of weak zone in the lower part of the embankment, etc.
- (2) No significant weak zone in the embankment that most of fill was compacted more than 20 N-value encountered through this boring investigation. Result of resistivity imaging profile means that the slope surface (reddish zone) is very dry, loose or

low density. Based on the instrumentation records during July to August 2001, the groundwater stayed low level in the small rain. The behaviour of inclinometer shows a small lateral displacement downward. The estimated collapsible mechanism is a progressive failure from lower erosion to upper part during rain.

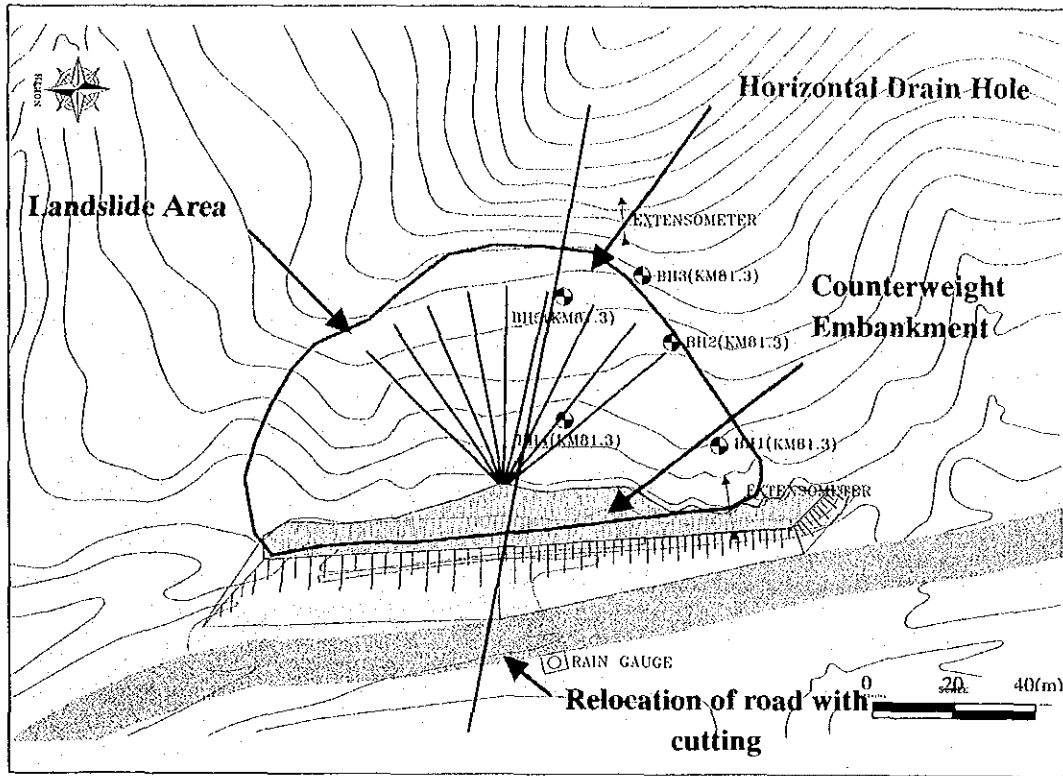
Figure 3.6.7 Plan of counterweight embankment in CH 81.30 km

Disaster occurred as subsidence of road, and the pavement has been broken by landslide, and now sinkage reached more than 2 m. The cause of landslide is assumed that the fill of road added the normal force of landslide, the stability of landslide decreased a little, and ground water level rose in the landslide mass, and then landslide moved toward down slope.

The stability factor of this landslide is estimated almost $F_s = 1.00$ on actual condition, and filled condition of first construction of road is less than 1.00.

- Horizontal drain holes
 - Length : 50 m
 - Nos. : 9
 - Total length : $50 \text{ m} * 9 = 450 \text{ m}$
- Steel Pipe Piles
 - ϕ ; 400 mm
 - t ; 24 mm
 - τ_{sa} ; 490 N/mm² (SKK 490)
 - Pitch : 2.0m (Horizontal)
 - Length : L = 17.5 m
 - Nos. : $n = 150/2 = 75$
 - Total length : $17.5 \text{ m} * 75 = 1,312.5 \text{ m}$

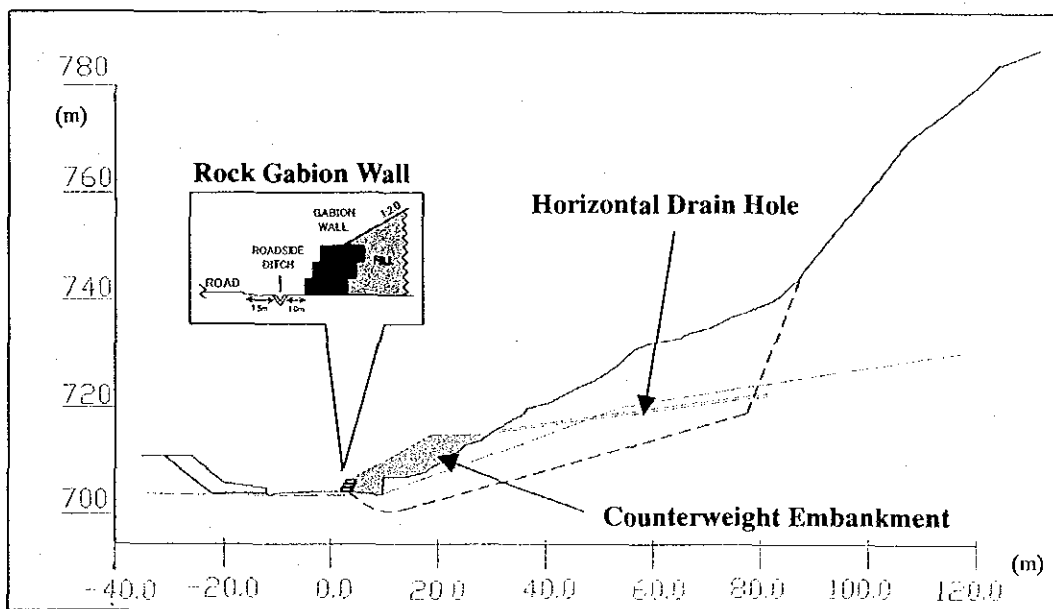
Figure 3.6.8 Cross section of counterweight embankment in CH 81.30 km

The results of slope investigation and shape of deformation of slope, slip surface is assumed like Figures 3.6.8 and 3.6.10.

The stability factor of this slope is determined $F_s=1.00$ because of this slope is stable on normal condition, except heavy rain situation.

CH 81.30 km	Unit weight γ_1 (kN/m ³)	Cohesion C (kN/m ²)	Internal friction angle ϕ (degree)	After Drain Holes Fs	Required Shearing Resistance for Fs=1.20 (kN/m)
	18	20	17.352 ($\tan \phi = 0.3125$)	1.086	630.36
