## 5. REPORTS on site observations to Hospital Buildings of Kathmandu Valley

Site-visit Team Members: Hideo Kagawa, JICA and Ramesh Guragain, NSET- Nepal

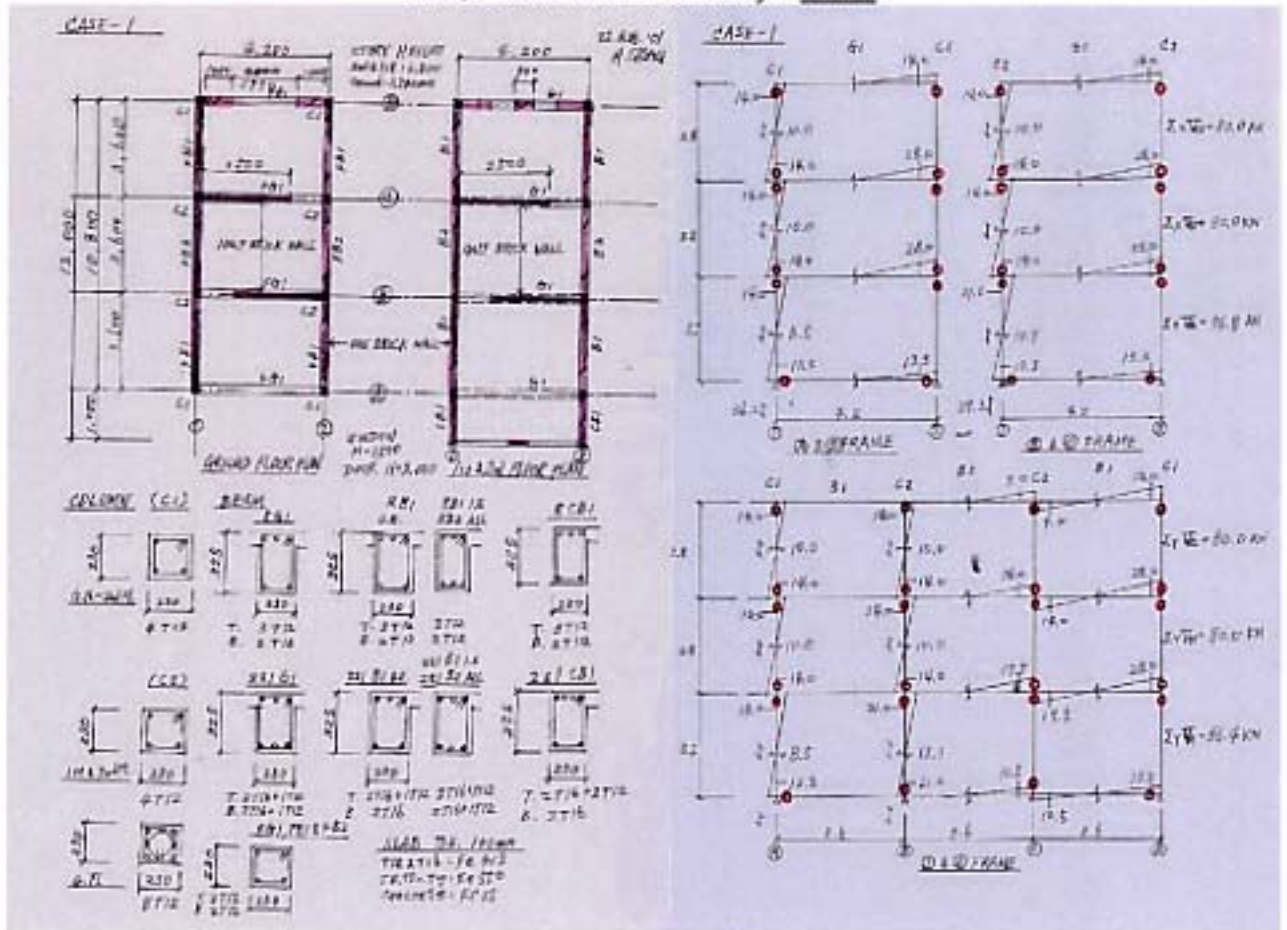
**Plan, Member List and Results for Case-1**

G. Fl. X-Direction	0.61	0.87	220.5/398.0=0.55	0.62
Y-Direction	0.69	0.96	187.2/398.0=0.47	0.62
<b>JUDGMENT</b>	<b>NO</b>	<b>NO</b>	<b>NO</b>	<b>NO</b>
