GEOLOGICAL LOG OF CORE DRILL

Project: JICA Study Team: Landslide Protection Page: 1 / 2
 Core Drill #: Y-7 Site Location: Colonia 14 de Febrero Ref. #: B-8
 Elevation: 939.70 Inclination (Angle with respect to Horizontal): Vertical (90°)
 Log Elaborated by: Ing. Raul Flores Peñalba Date: November 3, 2001

Project: JICA Study Team: Landslide Protection **Page:** 1 / 2
Core Drill #: A-1 **Site Location:** Col. El Porvenir Facing IHSS **Ref. #:** B-9
Elevation: 940.60 **Inclination (Angle with respect to Horizontal):** Vertical (90°)
Log Elaborated by: Ing. Raul Flores Peñalba **Date:** November 6, 2001

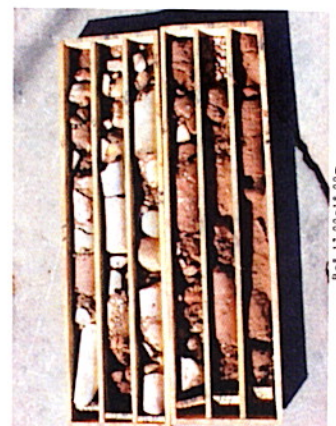
11.00~19.65m
Detritus (sand, boulder)

WATER CONTENT END OF DRILLING	ELEVATION (m)	DRILL DEPTH (m)	GRAPHIC LOG	CLASSIFICATION AND PHYSICAL CONDITION (COLOR)
	939.70	0.00		
	938.70	1.00		Topsoil, with organic contamination, brown color
	937.70	2.00	
	936.70	3.00		
	935.70	4.00		
	934.70	5.00		
	933.70	6.00		Organic contamination with boulders maybe detritus
	932.70	7.00		
	931.70	8.00		
NOV.1 9.25	930.70	9.00		
	929.70	10.00		Clayey soil, red color with small pebbles
	928.70	11.00		
	927.70	12.00		
	926.70	13.00		
	925.70	14.00		Sand and boulder lens, clayey material with gravels
	924.70	15.00

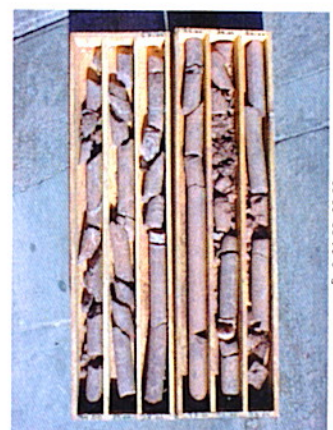
19.00m~
Sound Rock

Rock composed of lutite (shale) or sandstone due to small particles of quartz present on core, red color with white bands of gypsum
