CHAPTER 5

PRESENT CONDITIONS, PROBLEMS, AND PROPOSED REHABILITATION OF TRANSMISSION, SUBSTATION, AND DISTRIBUTION FACILITIES

5.1 Dar es Salaam

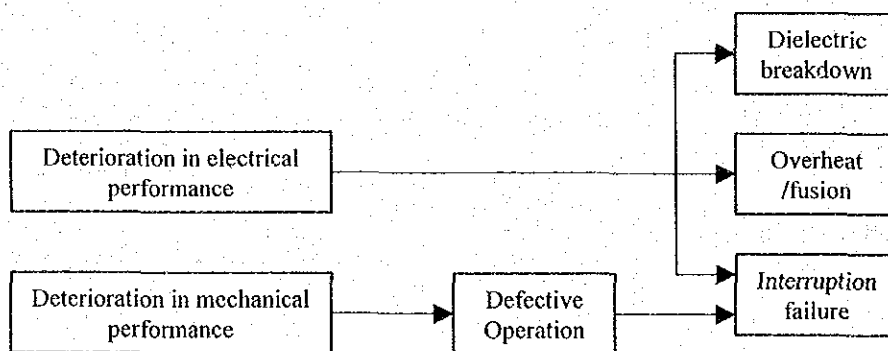
Fig. 5.1.2 Deterioration of circuit breaker

The mechanical deterioration of a circuit breaker may be a decline in operating speed due to insufficient mechanical force of the operating mechanism, a decrease in operating stroke, etc. In this case, the mechanical force required to operate the interrupting contact properly cannot be obtained. As a result, like the electrical deterioration, the mechanical deterioration can cause a very serious accident.

The phenomena that indicate electrical or mechanical deterioration of a circuit breaker are shown in Fig. 5.1.2.

Therefore, it is necessary to routinely check the circuit breakers for abnormal conditions (appearance inspection) so as to maintain their performance. To diagnose their functions, including the function of the interrupting part, it is necessary to carry out internal inspection and operation tests every 6 years or so. Based on the results of inspections and tests, defective components must be replaced to ensure that the circuit breakers always function properly.

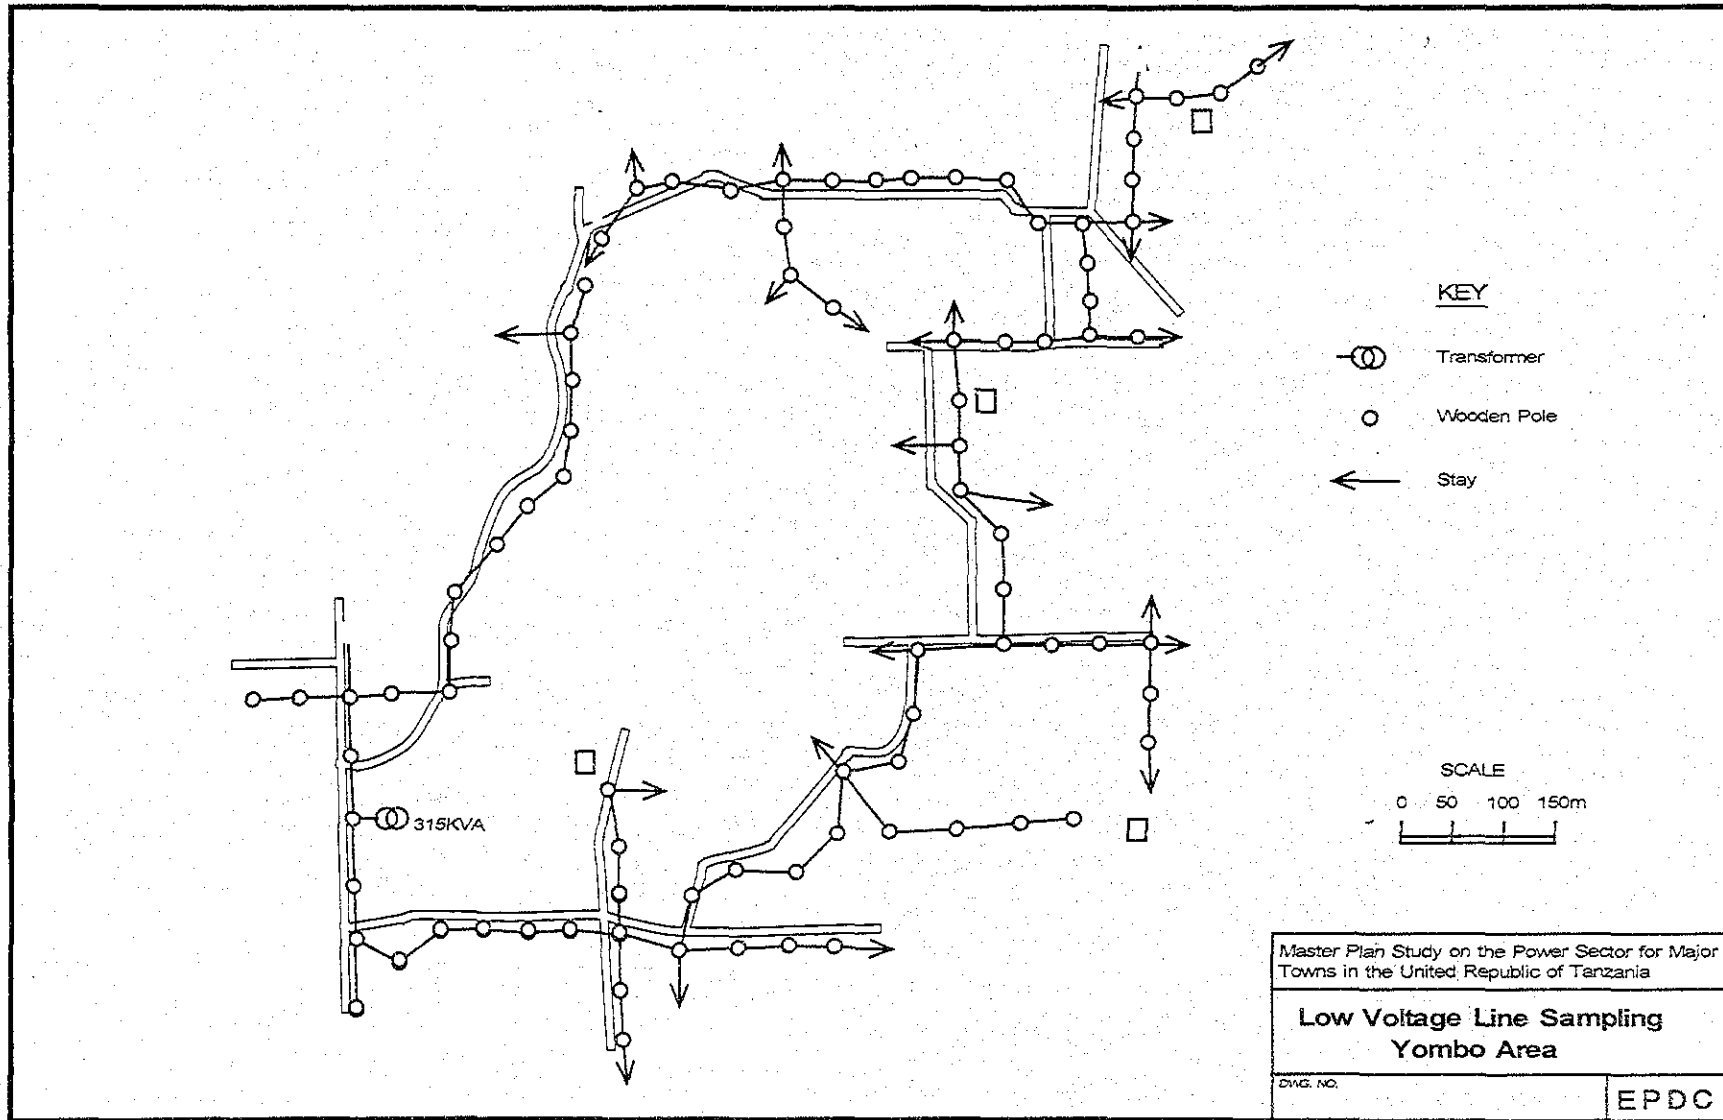
Fig.5.1.4 Mesuring point (Yombo Area Low Tension Line)

In the Yombo area, the problem of voltage drops has arisen. The main reason for this is that the 11 kV distribution lines from the distribution substation have not been fully extended to the load center and that the number of pole transformers is insufficient for the number of consumer. As a result, TANESCO has received many complaints from the consumer. The Study Team measured voltages in this area and found that the voltage can drop below 150 V during the peak time at night. The results of the voltage measurement are shown in Fig. 5.1.3. A typical example of a low-voltage circuit which causes the low-voltage problem in the area is shown in Fig. 5.1.4
