FEASIBILITY STUDY

CHAPTER 1
INVENTORY SURVEY FOR
PROJECT ROADS

1.2 Road Inventory Survey

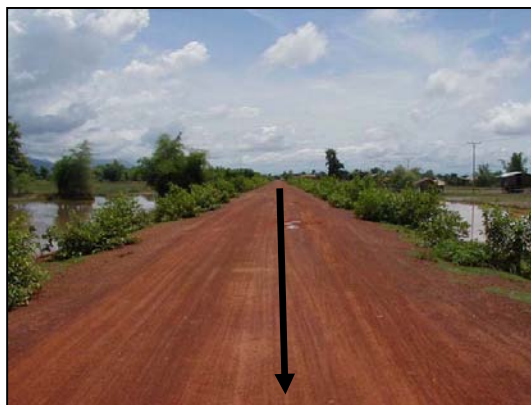
Figure 1.2.14 Typical Cross Section (at 40.3km)

The width of this section is more than 4.5m (i.e., two-way traffic is possible at present) and the earth road surface is generally well maintained. On the other hand, only 4.2% of the section is equipped with a side ditch. As for road surface roughness, it was evaluated as 'A' (60km/h<V). Roadside land-use is mainly paddy field (92% of section length). The route also passes through 4 villages (see Table 1.2.6). A typical cross section is shown in Figure 1.2.14. When there have been heavy rains in the past, water has come up to the road surface due to improperly functioning drainage facilities (e.g., side ditch, pipe culvert) and shortage of their facilities.

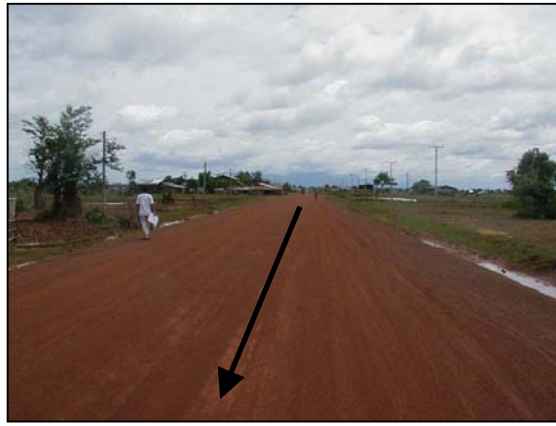
Figure 1.2.19 Present Status of Flat Paddy Field Section (at 58.4km)

The road surface is earth and generally well maintained. Surface roughness for the entire section is evaluated as ‘A’, which is due to effective drainage system, e.g., the large number of side ditches (76% of section length). On sub-sections with no side ditches, surface water flows into the roadside paddy fields; thereby, avoiding any serious damage to the road.

Regarding flooding, when there are heavy rains, water has come up to road surface due to improperly functioning drainage facilities (e.g., side ditch, pipe culverts). Therefore, plans for the improvement and/or adequate maintenance of these facilities will be necessary.

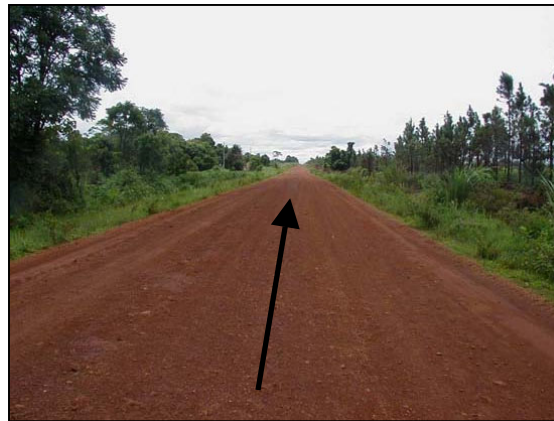
Figure 1.2.22 Present Status of Large-Scale Afforestation Section (at 3.4km)

The survey route starts at the junction with Route 16 located at the 1.0 km post east of Paksong town. Based on the Road Design Manual of MCTPC, the terrain is designated as level. There are no villages on this section, and 94% of the section length has no side ditches. Road width is more than 4.5 m, and the present status of this section is as shown in Figure 1.2.22.

Surface roughness is evaluated as B (i.e. $40\text{km/h} < V$), in spite of there being no side ditches and rutting on both sides of the road. This condition is due to surface water flows that have eroded the surface (see Figure 1.2.24).

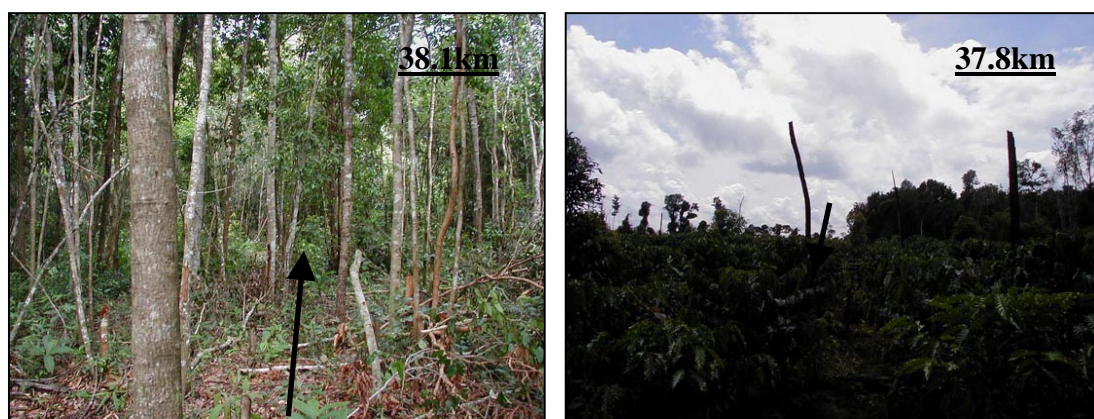
Figure 1.2.29 Present Status of Shortcut Section (Forest & Coffee Plantation)

Eighty percent of this section does not have a road structure and the other 20% is a very narrow road (less than 2.0m in width). Land-use consists namely of forest (88%) and coffee plantations (12%). Typical views of this section are shown in Figure 1.2.29. The survey route crosses 1 river (possibly a bridge is required) and 3 streams (possible culverts are required) on this section. The shortcut section joins up with existing road at the 42.2 km point. The present status of this junction is as shown in Figure 1.2.30.

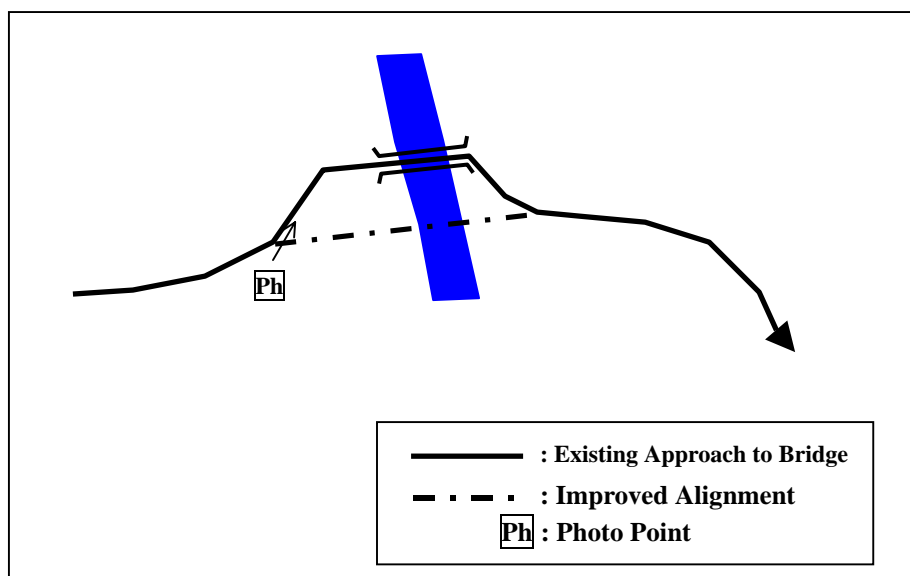
Figure 1.2.33 Layout of Bridge Approach

Regarding the existing bridge between the 10.3 – 10.7 km mark, improvement to the vertical and horizontal alignments should be considered. Figure 1.2.33 shows the layout of the existing bridge approach and improved alignment. A photograph indicating the present status of the bridge approach is shown in Figure 1.2.34.

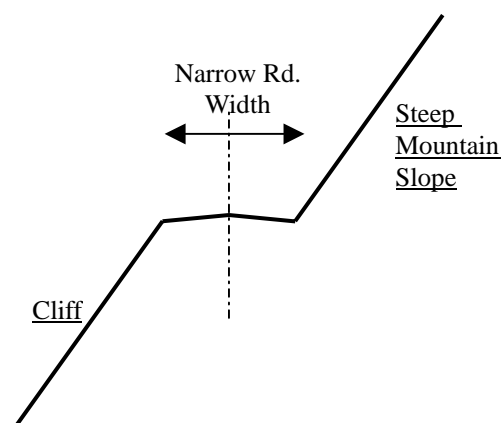
**Figure 1.2.37 Sketch of Typical Cross Section**

The present road structure of this section is inadequate for heavy traffic or high-speed travel. Road width is less than 4.5m over 88% of the section, and the horizontal and vertical alignment does not ensure proper sight distance. A typical cross section of this section is shown in Figure 1.2.36.

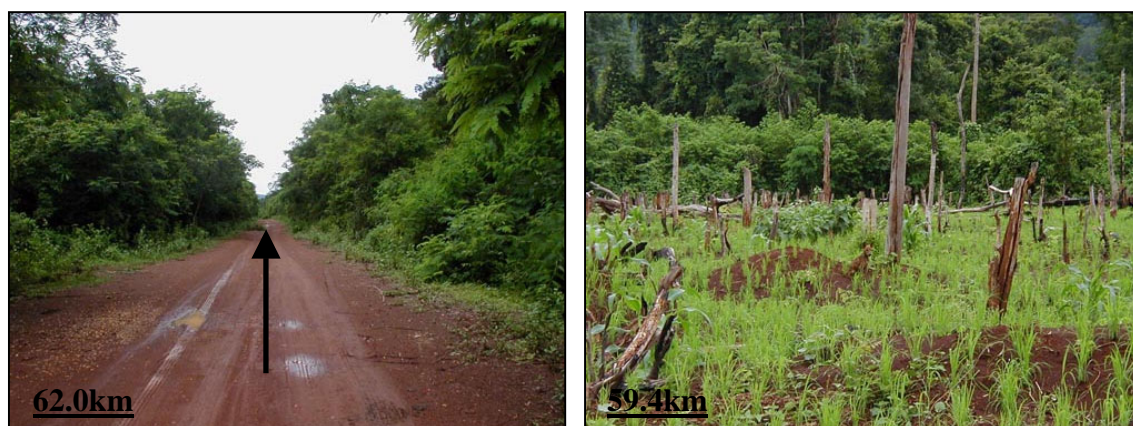
Figure 1.2.39 Typical Cross Section & Rice Plantation

Road width is less than 4.5m over 76% of this section, and surface roughness has been evaluated as C ($40 < V < 20 \text{ km/h}$) for 82% of the section. As for the terrain, it is designated as flat.

There are 2 major land-uses along the section and they are forestry (59%) and rice plantations (41%). The latter land-use is different than that of the paddy fields seen along Route 14A(i). It is called dry-land rice. A typical cross section and photograph of a rice farm is shown in Figure 1.2.39. No villages were found on this section except for Ban Lak 52 village at the end point. An access to the proposed road should be considered for the transport of crops.
