CHAPTER 5
SURVEY RESULT AND IDENTIFICATION OF
POTENTIAL SPOTS

5.1 NIC.1

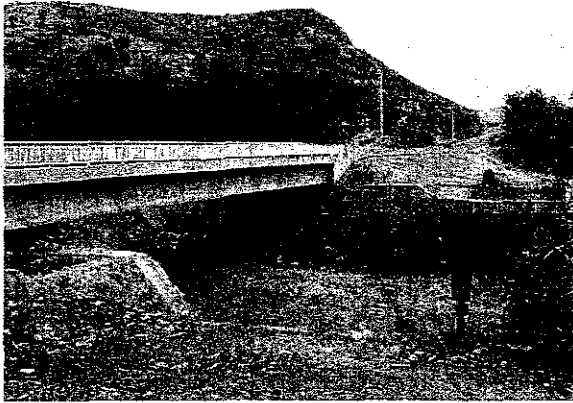
Photo 5.3.1 Las Maderas Bridge

Las Maderas Bridge and Sebaco Bridge were completed one year before Hurricane Mitch and survived the vent without damage. The other major disaster that affected NIC.1 was the Managua Earthquake of December 23rd 1972. A report of this earthquake, by American Iron and Steel Institute, recorded that the only observed earthquake effect on these bridges was a minor settling of approach fills.

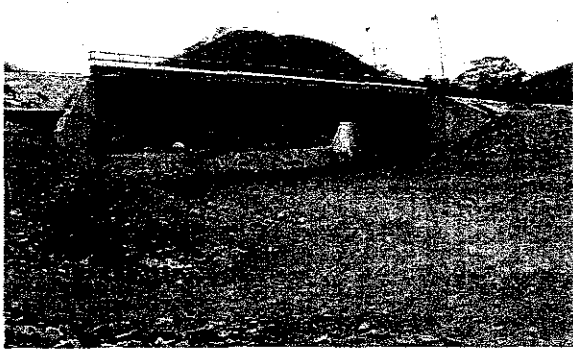
Photo 5.1.3 Ducuali Bridge

Many of the bridges between Esteli and El Espino suffered serious damage from Hurricane Mitch. Ducuali Bridge and Los Encuentros Bridge were destroyed, and these were reconstructed in 2000. The main damage to the other bridges was to river-banks in front of abutments, and to piers and approach roads.

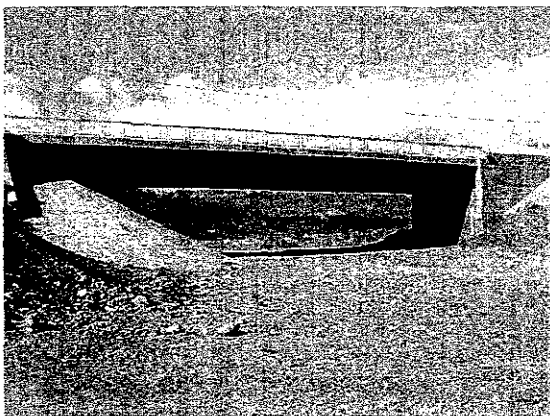
Photo 5.2.1 Waswali Bridge

Waswali Bridge was reconstructed in 2001 with aid of the Government of Japan. It is shown in Photo 5.2.1. The other bridges were constructed in 1940's.

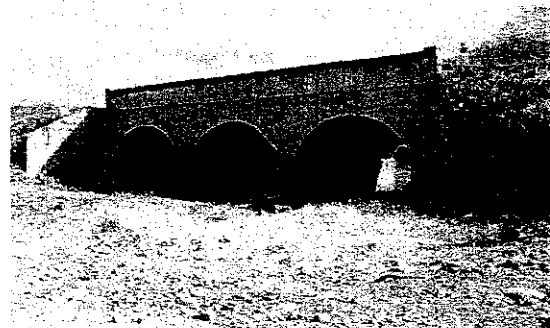
Photo 5.2.2 El Guayacan Bridge
(Up stream side)

El Guayacan Bridge is a 20 meter arched bridge with three spans each about five meters, with small wingwalls. It has a blockage ratio of more than 7%, and the free height underneath the girder is less than four meters. A wingwall and embankment was destroyed by A2 abutment differential settlement (Photos 5.2.2 and 5.2.3).

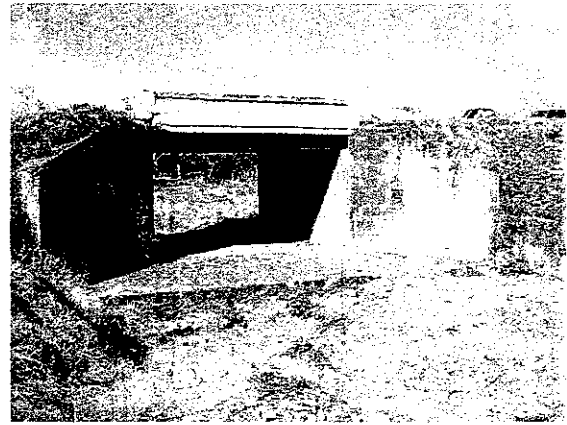
**Photo 5.2.4 Los Cocos Bridge
(Down stream side)**

Los Cocos Bridge is a seven meters single span with protection of the riverbed. (Photo 5.2.4) There were no traces of scouring, but many problems regarding the river profile and river grade.

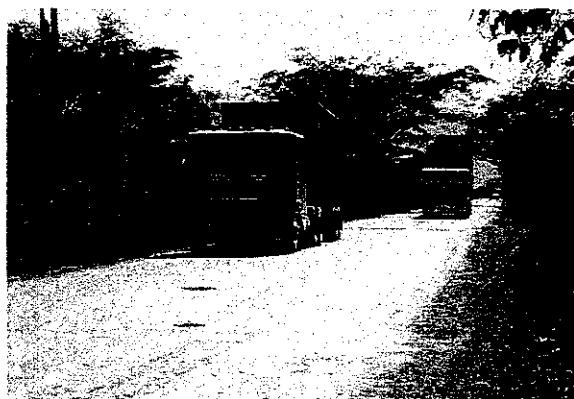
Photo 5.5.2 Articulated trucks

third largest port on the Pacific Ocean coast of central America. NIC.24 carries large traffic volumes with a high proportion of heavy goods vehicles (Photo 5.5.1).

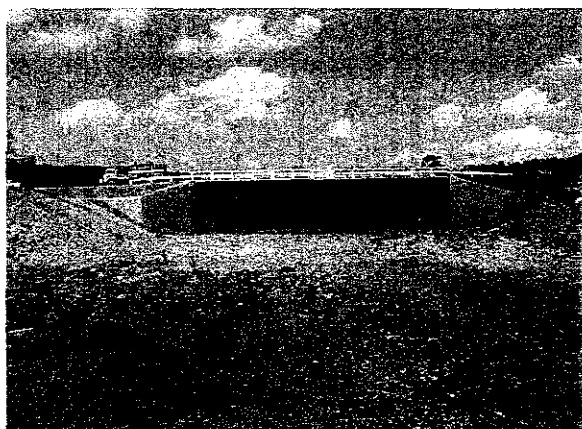
Photo 5.6.1 La Manga Bridge No.2

La Manga Bridge No.2 and El Jicaral Bridge were reconstructed by the help of Denmark in 2001 (Photo 5.6.1, 5.6.2), Other bridges were constructed 1960's. Almost half number of bridge's length is less than 10m.

La Manga Bridge No.2, that was constructed same time El Jicaral Bridge, is single span bridge and catchment area size of this bridge at site is 52 km^2 , design discharge is $360\text{m}^3/\text{s}$ (50 years Hurricane event).

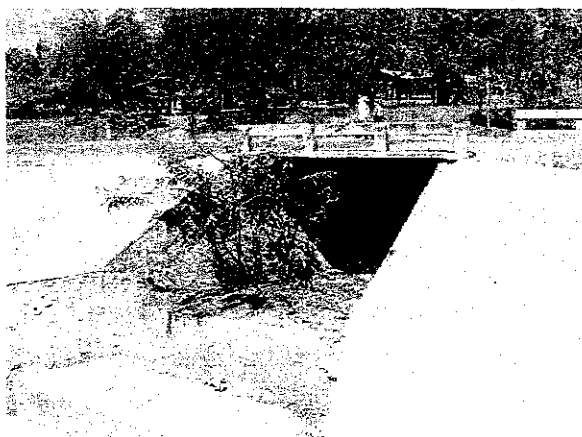
Photo 5.6.3 Los Pedrones

There a lot of short span bridges that length is less than 10m in lowland area, and we confirmed that abutment protrude into the river at some bridges. Quimera Bridge and La Milagrosa bridge already repaired, existing approach road replaced new arched bridge with three (3) spans. Furthermore in Los Pedrones Bridge, there is new barrage in downstream side for improvement riverbed grade. But some bridges haven't repaired as shown in Photo 5.6.4 and 5.6.5
