**BASIC DESIGN STUDY REPORT
ON
THE PROJECT
FOR
URGENT REHABILITATION OF
SINDHULI ROAD (SECTION IV)
IN
THE KINGDOM OF NEPAL**

FEBRUARY 2003

JAPAN INTERNATIONAL COOPERATION AGENCY

NIPPON KOEI CO., LTD.

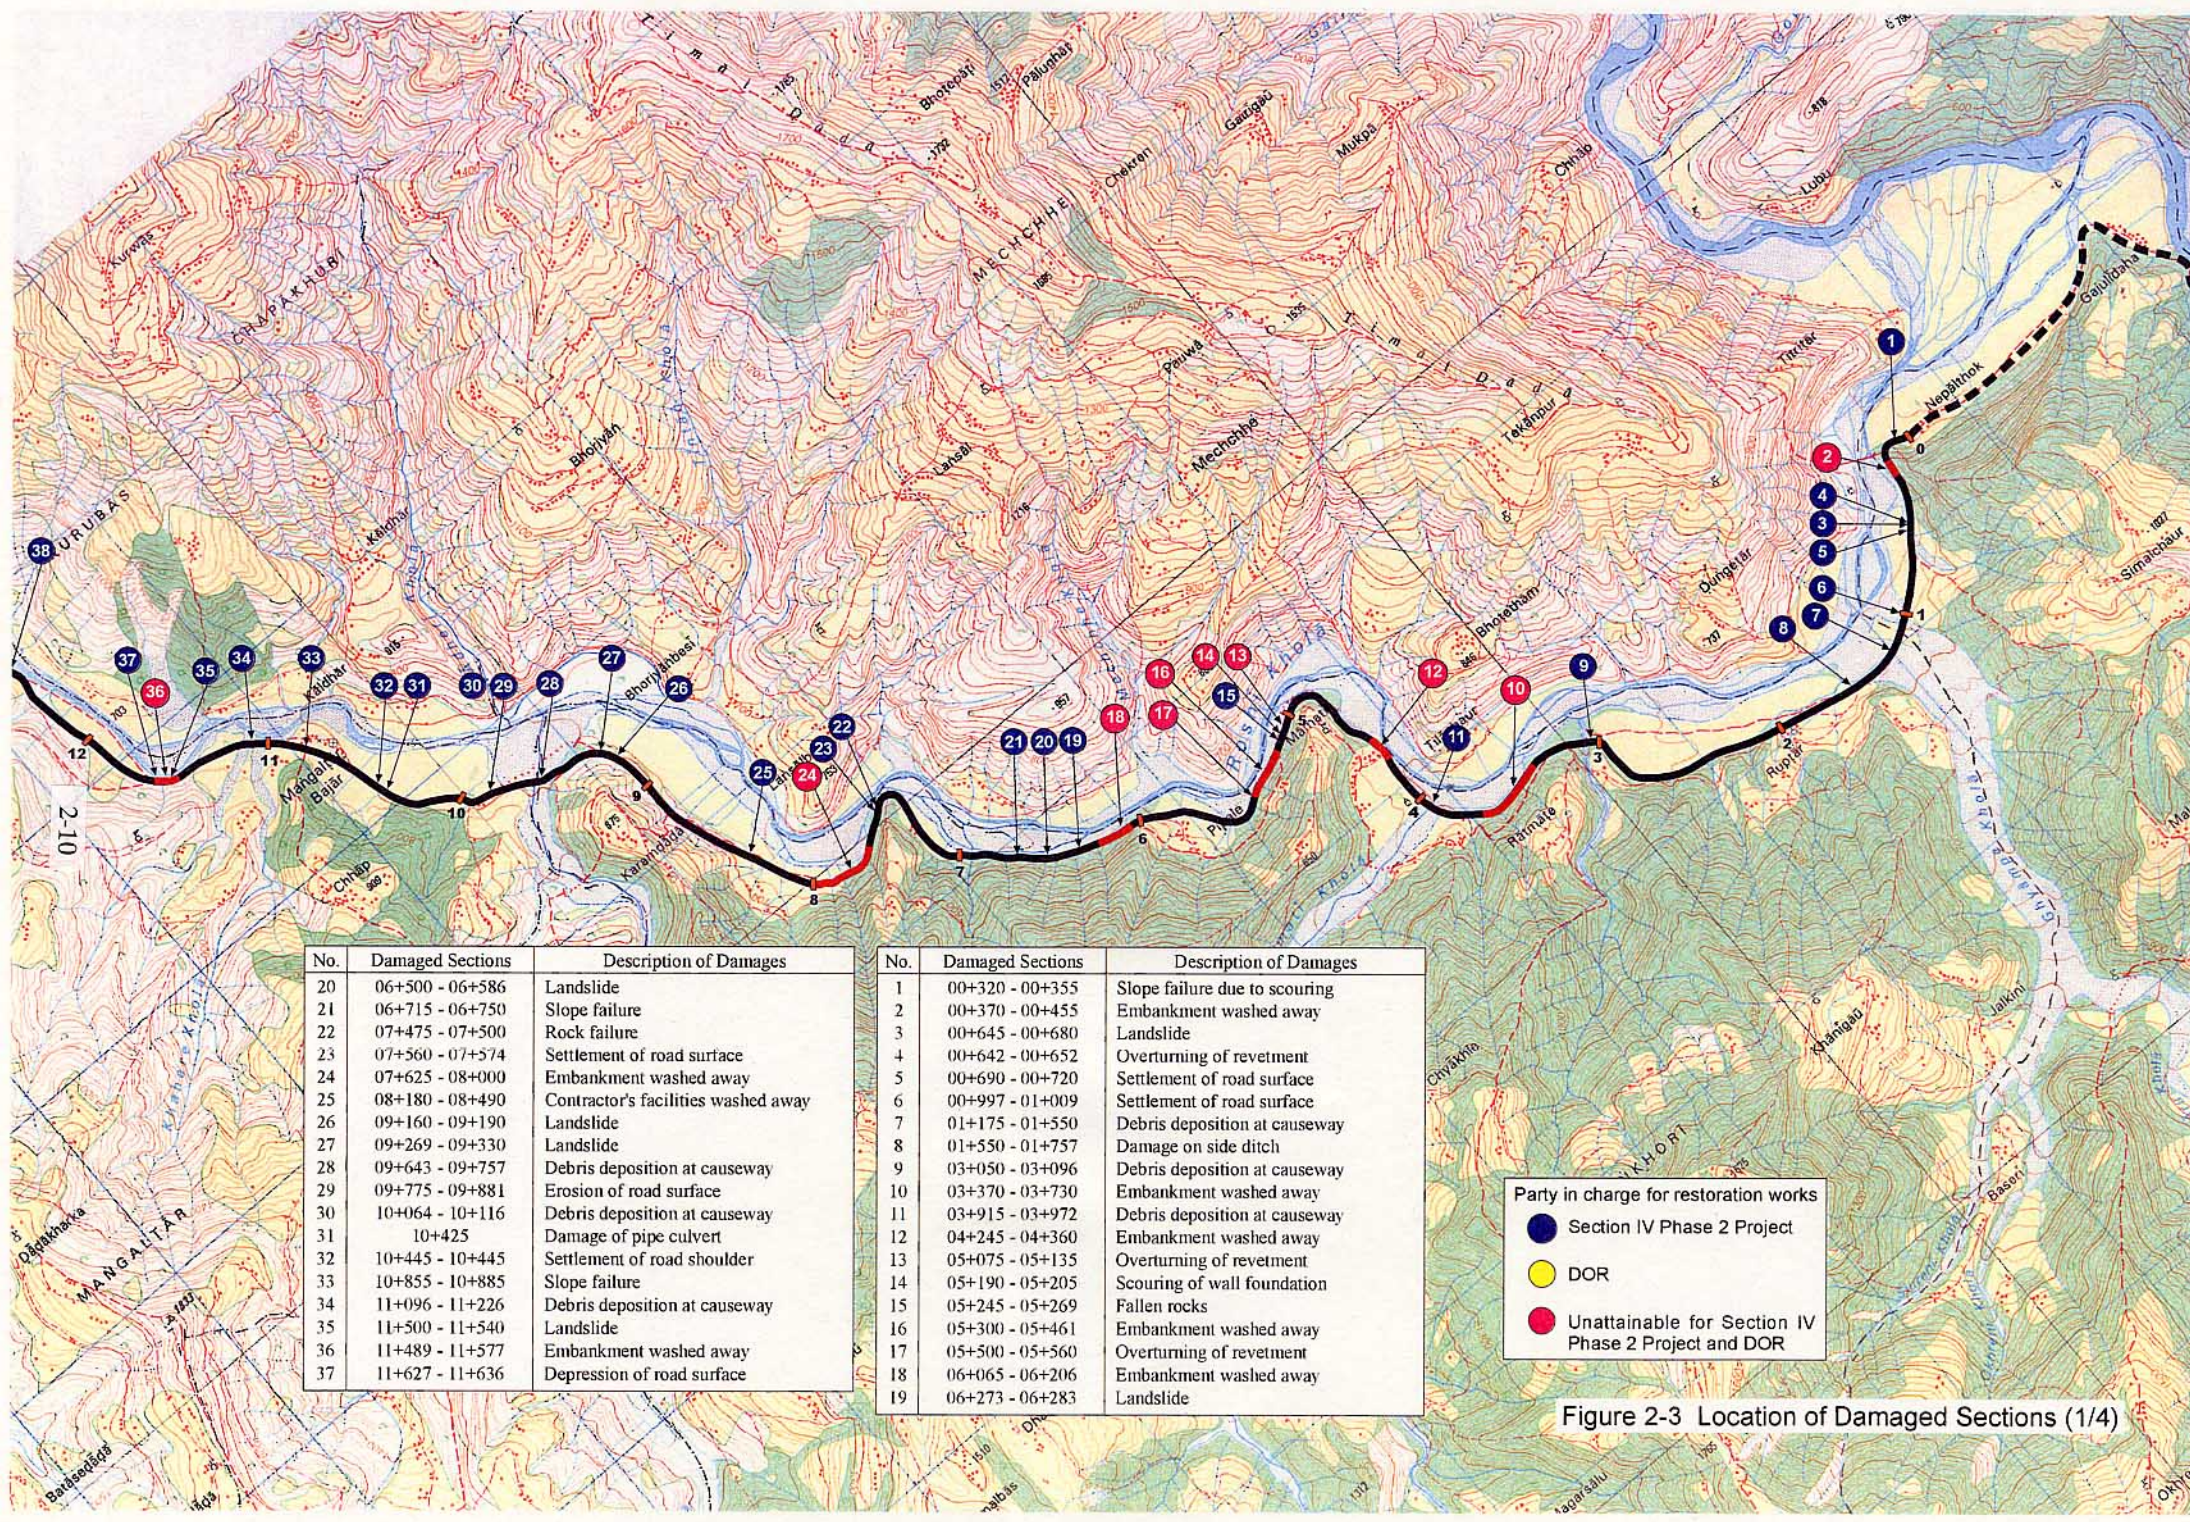
Figure 2-3 Location of Damaged Sections (1/4)

| No. | Damaged Sections | Description of Damages |
| 20 | 06+500 - 06+586 | Landslide |

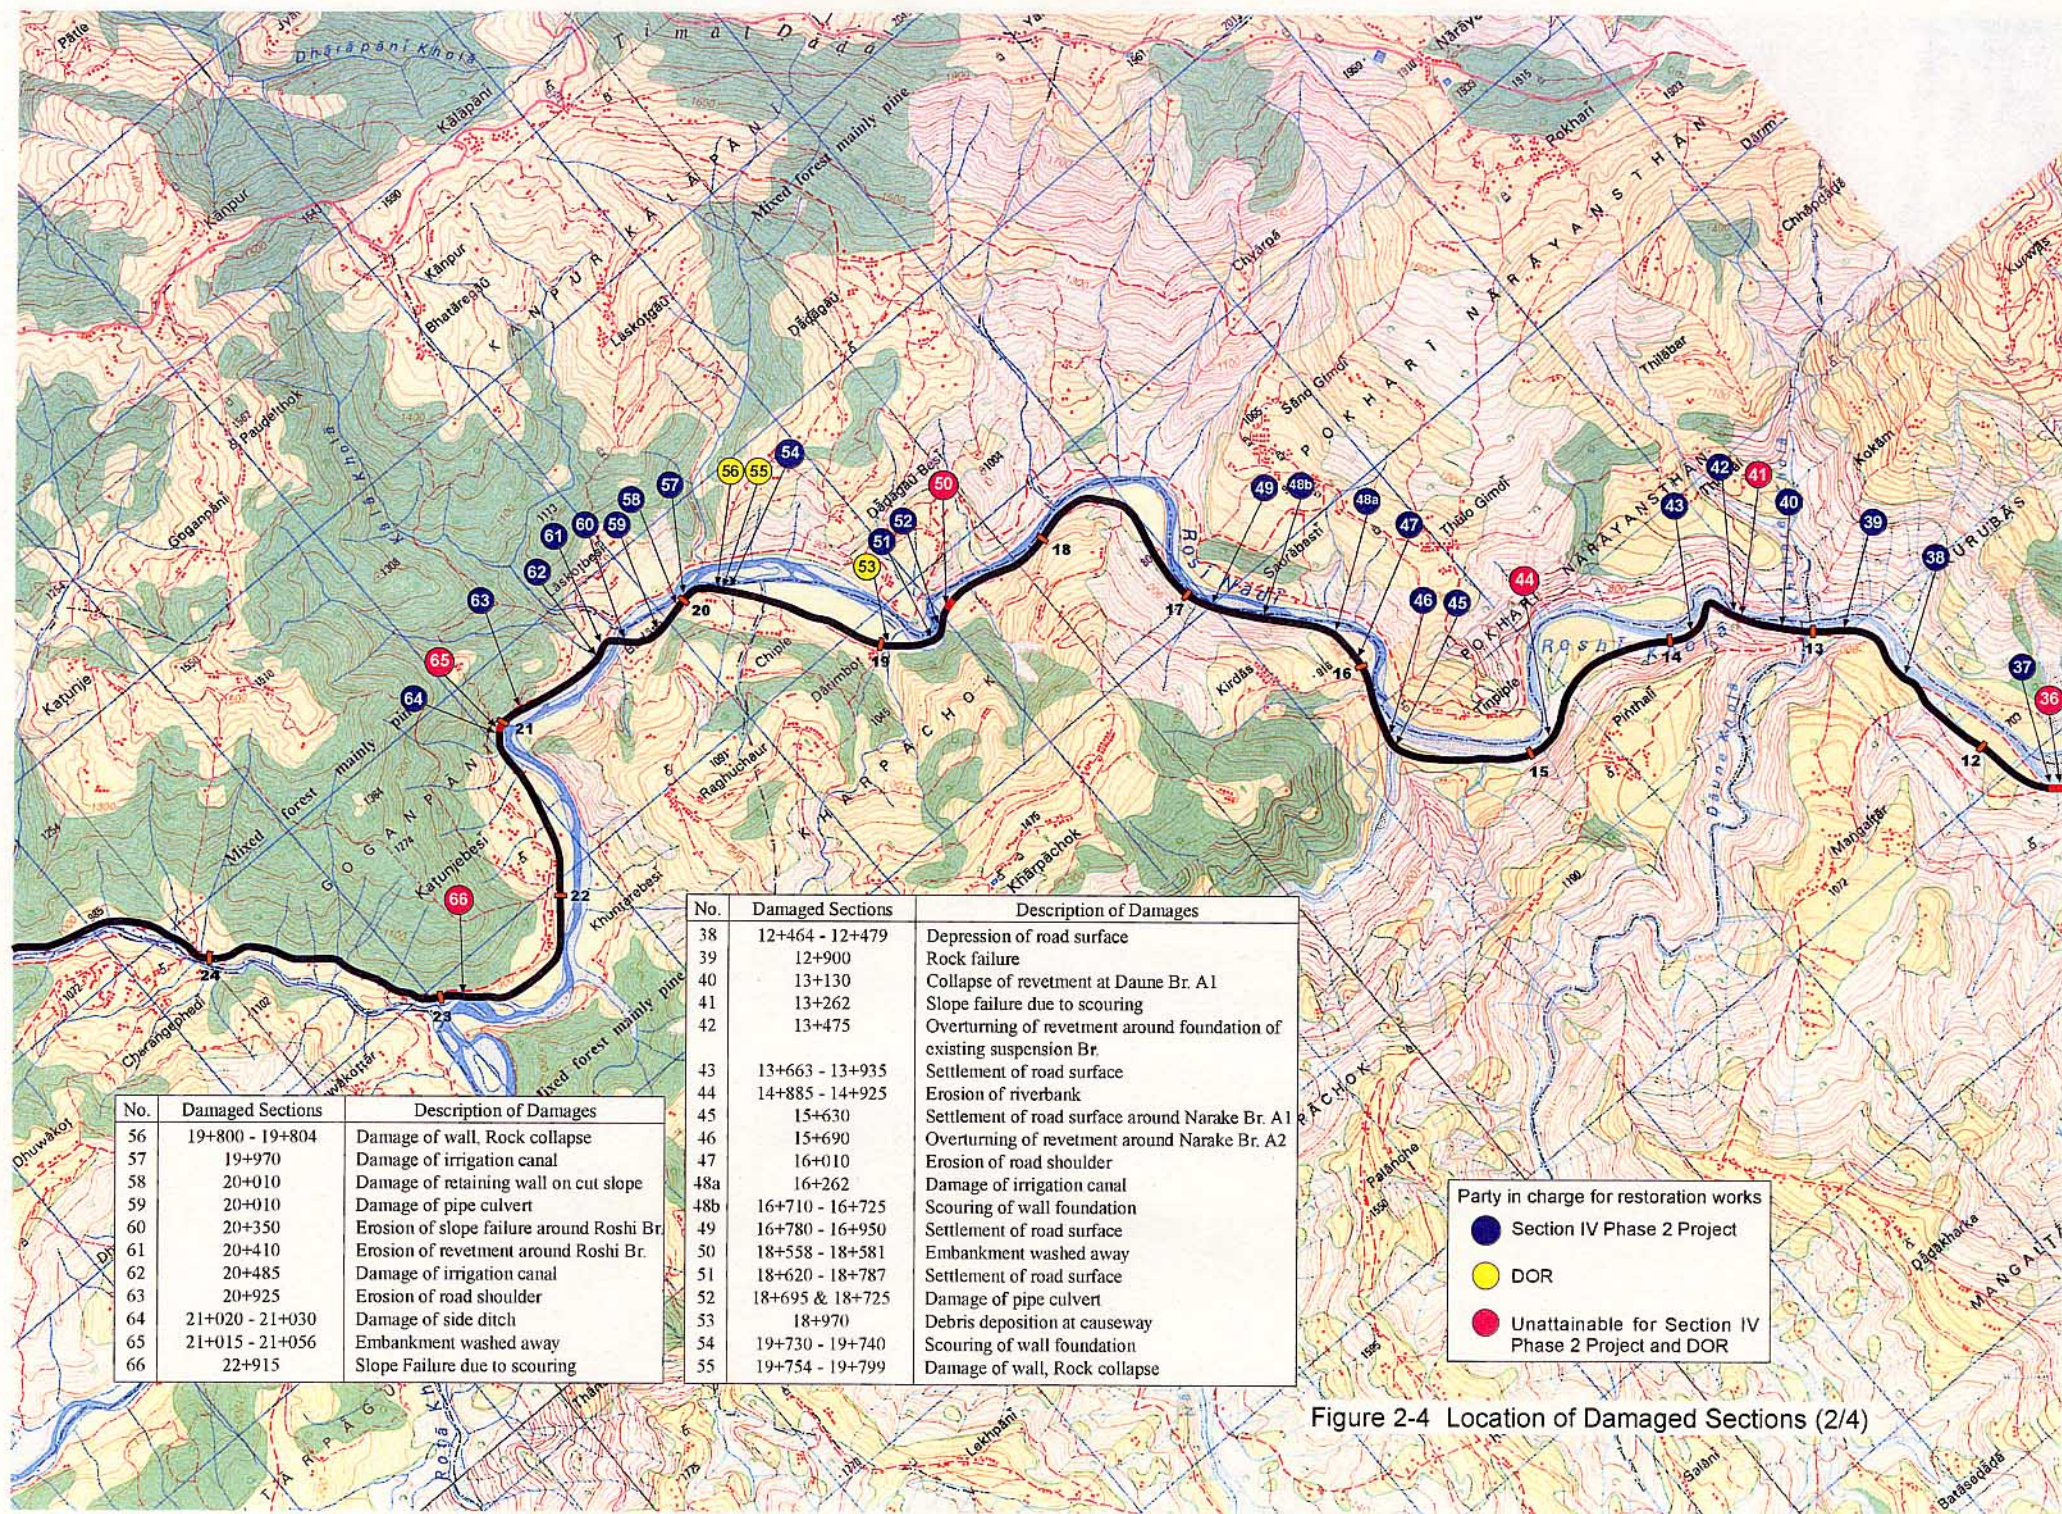
Figure 2-4 Location of Damaged Sections (2/4)

| No. | Damaged Sections | Description of Damages |
| 56 | 19+800 - 19+804 | Damage of wall, Rock collapse |

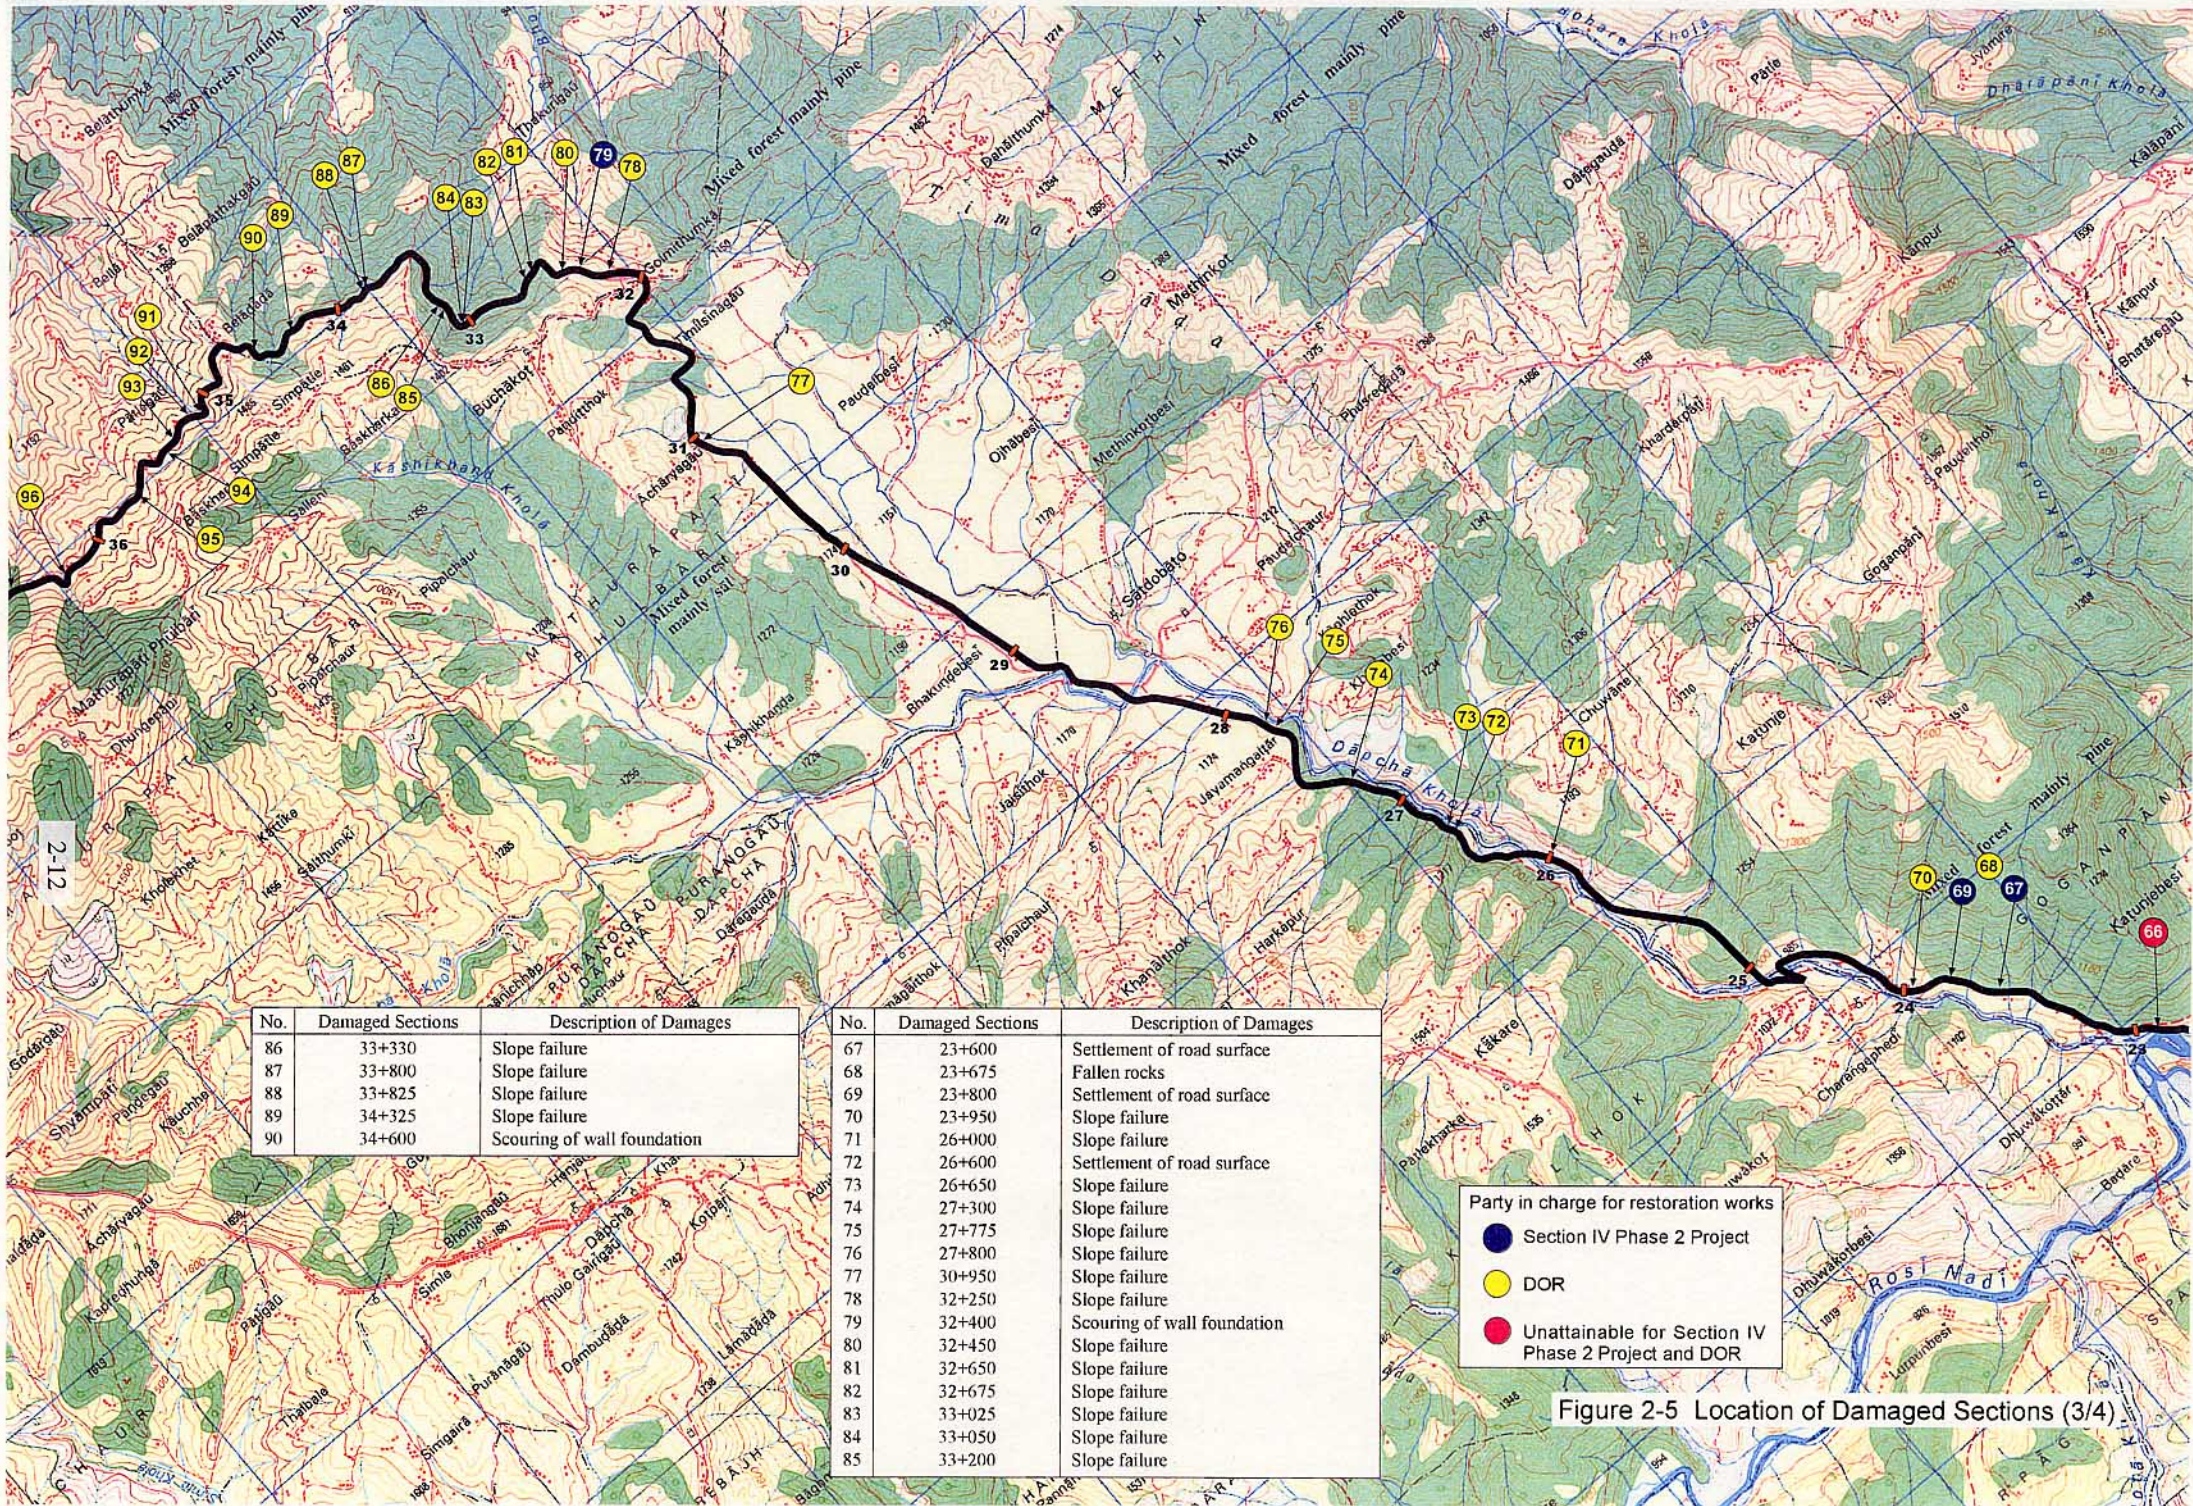
Figure 2-5 Location of Damaged Sections (3/4)

| No. | Damaged Sections | Description of Damages | No. | Damaged Sections | Description of Damages |
| | | | 114 | 40+000 | Slope failure |
| | | | 115 | 40+975 | Erosion of road shoulder |
