CHAPTER 3

CONTENTS OF THE PROJECT

3.1. Basic Concept of the Project

The Project (Urgent Rehabilitation of the Sindhuli Road Section IV) aims to restore the damage of the Project Road caused by the heavy rain during July 2002 to achieve the objectives of the Sindhuli Road Construction Project stated in Chapter 3.1.1.

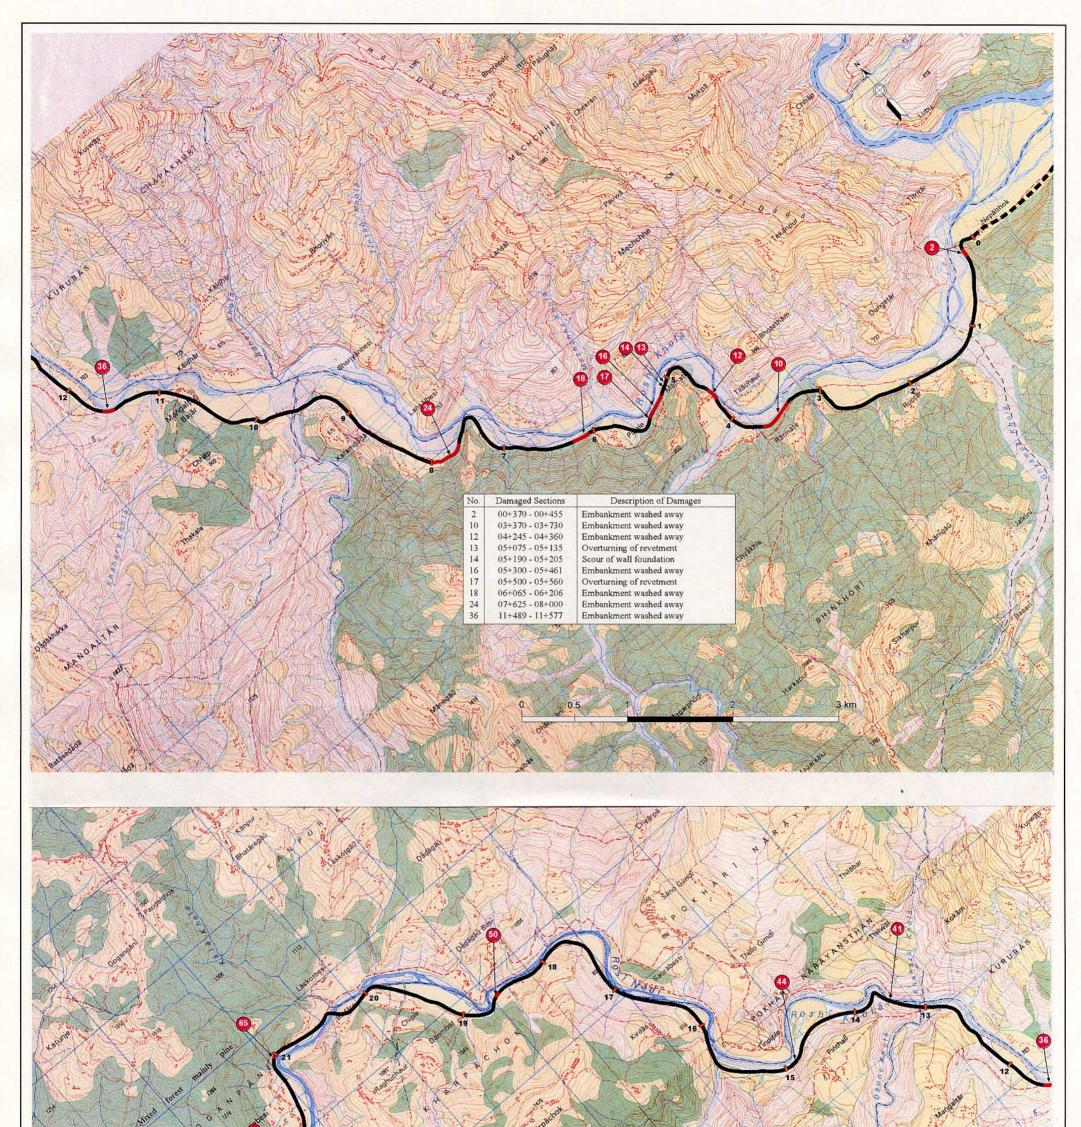
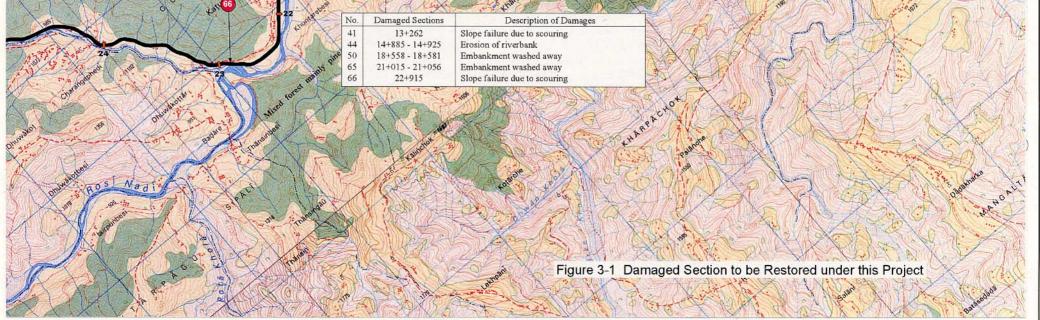
Table 3-1 Damaged sections to be restored under this project

Tuste of Tournaged Sections to be restored under time project				
Damaged section	Length(m)	Description		
00+370 - 00+455	85	Embankment washed away		
03+370 - 03+730	360	Embankment washed away		
04+245 - 04+360	115	Embankment washed away		
05+075 - 05+135	60	Overturning of revetment		
05+190 - 05+205	15	Scour of wall foundation		
05+300 - 05+461	161	Embankment washed away		
05+500 - 05+560	60	Overturning of revetment		
06+065 - 06+206	141	Embankment washed away		
07+625 - 08+000	375	Embankment washed away		
11+489 - 11+577	88	Embankment washed away		
13+262	-	Slope failure due to scouring		
14+885 - 14+925	-	Erosion of riverbank		
18+558 - 18+581	23	Embankment washed away		
21+015 - 21+056	41	Embankment washed away		
22+915		Slope failure due to scouring		
	$\begin{array}{c} 00+370-00+455\\ 03+370-03+730\\ 04+245-04+360\\ 05+075-05+135\\ 05+190-05+205\\ 05+300-05+461\\ 05+500-05+560\\ 06+065-06+206\\ 07+625-08+000\\ 11+489-11+577\\ 13+262\\ 14+885-14+925\\ 18+558-18+581\\ 21+015-21+056\\ \end{array}$	00+370 - 00+45585 $03+370 - 03+730$ 360 $04+245 - 04+360$ 115 $05+075 - 05+135$ 60 $05+190 - 05+205$ 15 $05+300 - 05+461$ 161 $05+500 - 05+560$ 60 $06+065 - 06+206$ 141 $07+625 - 08+000$ 375 $11+489 - 11+577$ 88 $13+262$ - $14+885 - 14+925$ - $18+558 - 18+581$ 23 $21+015 - 21+056$ 41

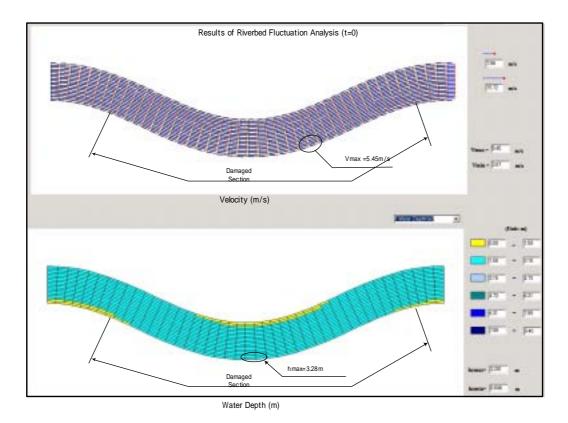
A typical example of the simulated sequences of failure process of revetment based on a preliminary 2.5 dimension riverbed fluctuation analysis at the section between STA. 3+370 and STA. 3+730 as shown in Figure 3-5 through to Figure 3-8 and described below. The foundation of the revetment was set at 3 meter below the riverbed with foot protection blocks. The structures were designed for a 5.5 m/s of flow velocity.

- Just after the occurrence of the flood, the velocity and water depths are within the design conditions.
- After 24 hours of the continuous flood, maximum velocity is 5.7m/sec and maximum water depth is 5.0m almost equivalent to design level.
- After 48 hours of the continuous flood, maximum velocity and maximum water depth reached 6m/sec and 6.9m respectively. At this point, the revetment is very vulnerable to being washed away. It was observed that the actual failure of structures at the site only started after 48 hours from the beginning of the flood event justifying the results of the analysis.
- After 72 hours from the beginning of the flood, maximum velocity reaches 6.9m/sec and maximum water depth is 8.8m.

The preliminary 2.5 dimension riverbed fluctuation thus justifies the assumption that the July 2002 event was a hydrologically unforeseen case, caused by the heavy rainfall lasting over a three day period.

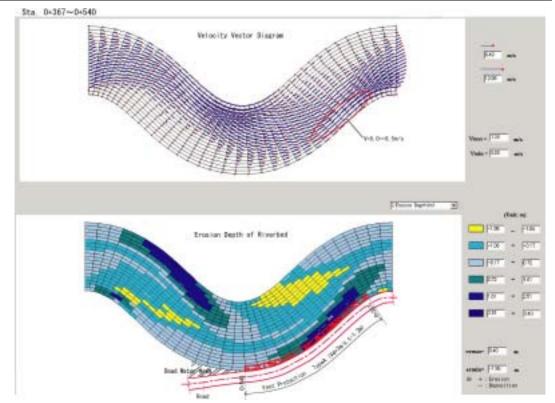
Figure 3-10 Calculation result of 2.5-dimension riverbed fluctuation analysis

Sample results from 2.5-dimension riverbed fluctuation analysis are shown in Figure 2-1. Details of the result for each damaged section are shown in Appendix-6.

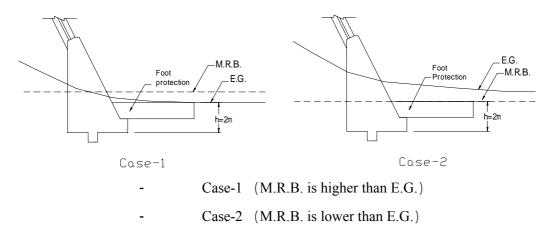
Figure 3-11 Design policy for Embedment level with foot protection

The embedment level of wall foundation is usually set at a maximum scour depth measured below the lowest level between mean riverbed level and existing ground. Since the assumed maximum scouring depths for all cases exceed 2 m. And it is difficult excavate more than 2 m, the design embedment level is thus set as 2 m in conjunction with foot protection works.

The two cases of embedment level with respect to the relationship between the Mean River Bed level (MRB) and the existing ground level (EG) are illustrated in Figure 3-11.
