## **C. STRUCTURE**

C-2. Inventory Sheet for the Structures

**NATIONAL ROAD NO.1**

**Structure Inventory**

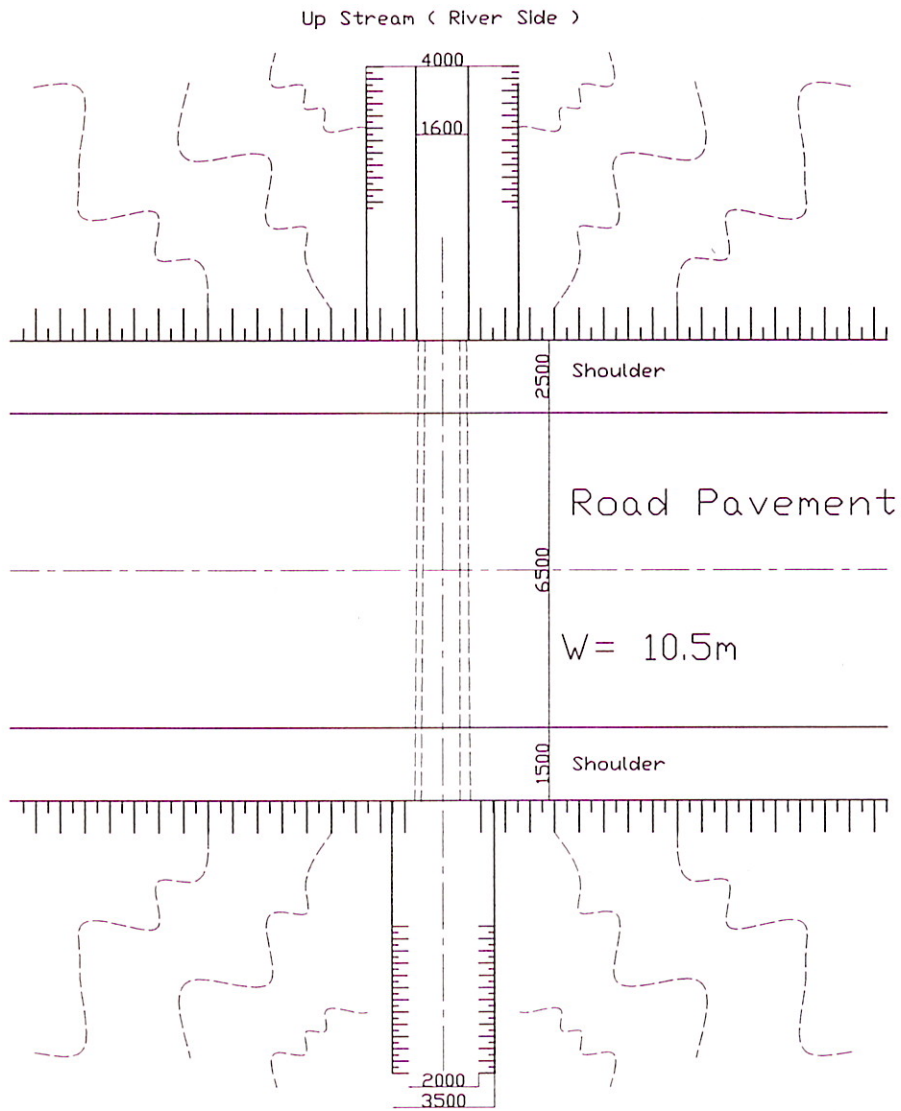
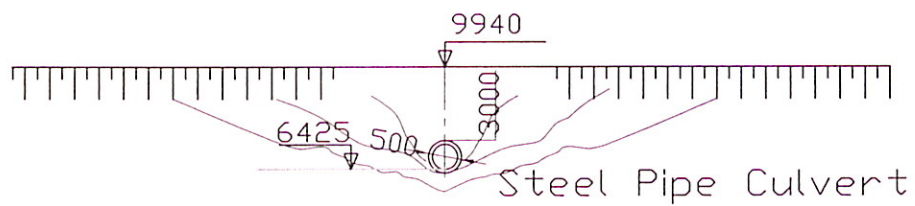
Pk 24+000

(21)	Foundation Type	Stone compaction for base of steel pipe only							
(22)	Foundation Condition	Settled							
	Comment	S=Settled, E=PILE EXPOSED - Height in meters, F=Foundation Scoured						Pavement cracking and settled. Shoulder both side settled	Evaluation

(35)	River Bank Condition	D and C		
		D=Damaged, S=Scoured, C=Corroded, E=Enchroachment on Stream		
	Comment	River bank is the natural soil, so easy to damaged by rain	Evaluation	C

Comment	The water can not flow easy and not do direction way to channel	Evaluation	D
(38)	Approach condition	None		
		S= Sinking (height in cm), AS=Scour Behind Abutment (length in meters)

Comment	Damaged by water flow	Evaluation	C
<b>G. OVERALL EVLUATION</b>		Can serviceability, but need to rehabilitation		
H. OVERALL COMMENT				
	<p>1- This Pipe Culvert for drainage system in the raining season and protection of emergency flood.</p> <p>2- Position of steel pipe culvert is settled, because according to the appearance which pavement have cracking, base of steel pipe by crushed stone compaction only and it was scoured. Slope protection both side also scoured. So need to rehabilitation for availability.</p>

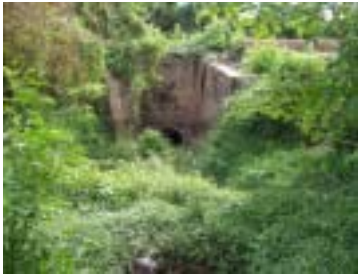
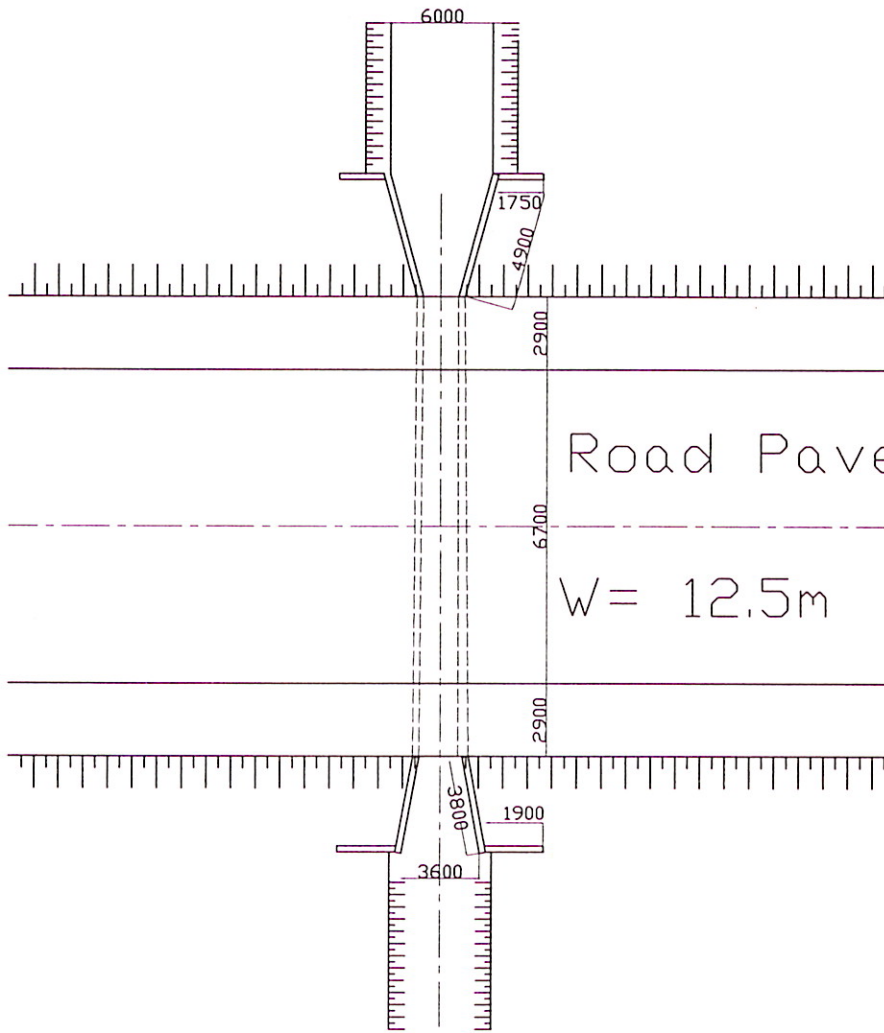
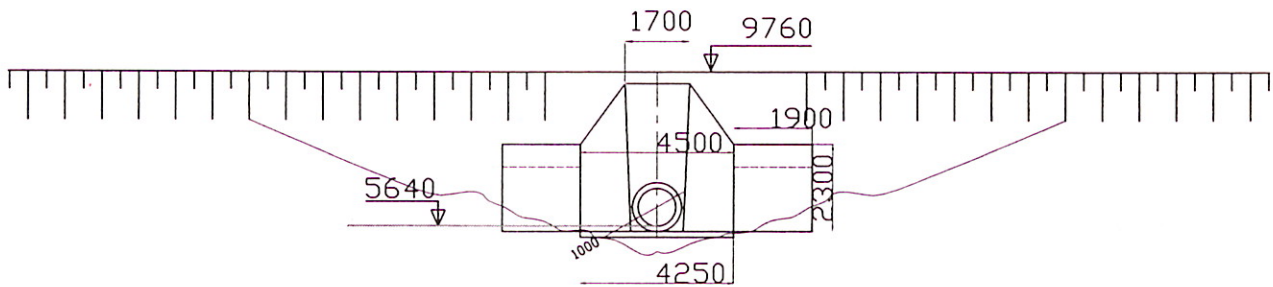
Sketch of Old Pipe Culvert ( Lou Rohatkchal )

Comment	Base of pavement no good compaction		Evaluation	C
(17)	Top Slab Condition	Good			
		C=Cracking, X=Repaired	R=Rebar Exposed,	S=Spalling,	SC=Scale

Comment	None		Evaluation	
(29)	Wing Wall Condition	W and honeycomb			
		C=Cracked,	W=Wing Wall Scoured		
	Comment	Concrete no vibration and strenght of plastering fair		Evaluation	C

Comment	No prevention in raining season	Evaluation C
<b>G. OVERALL EVLUATION</b>		Can use for irrigation and traffic, but need to rehabilitation	
H. OVERALL COMMENT			
<p>1- For structure need to repair (reconstruction), but the river condition must be new construction both river bank, bed and slope protection.</p> <p>2- Local people said that: this culvert constructed by Chinese Company (Sub-constructor) of government, not Japanese Company. So it is Chinese Standard.</p> <p>3- Top of water level (TWL)</p>

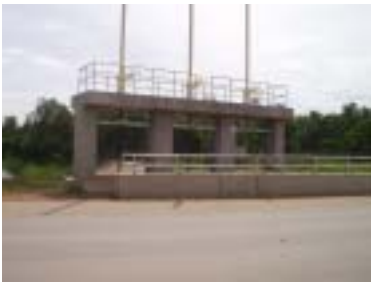
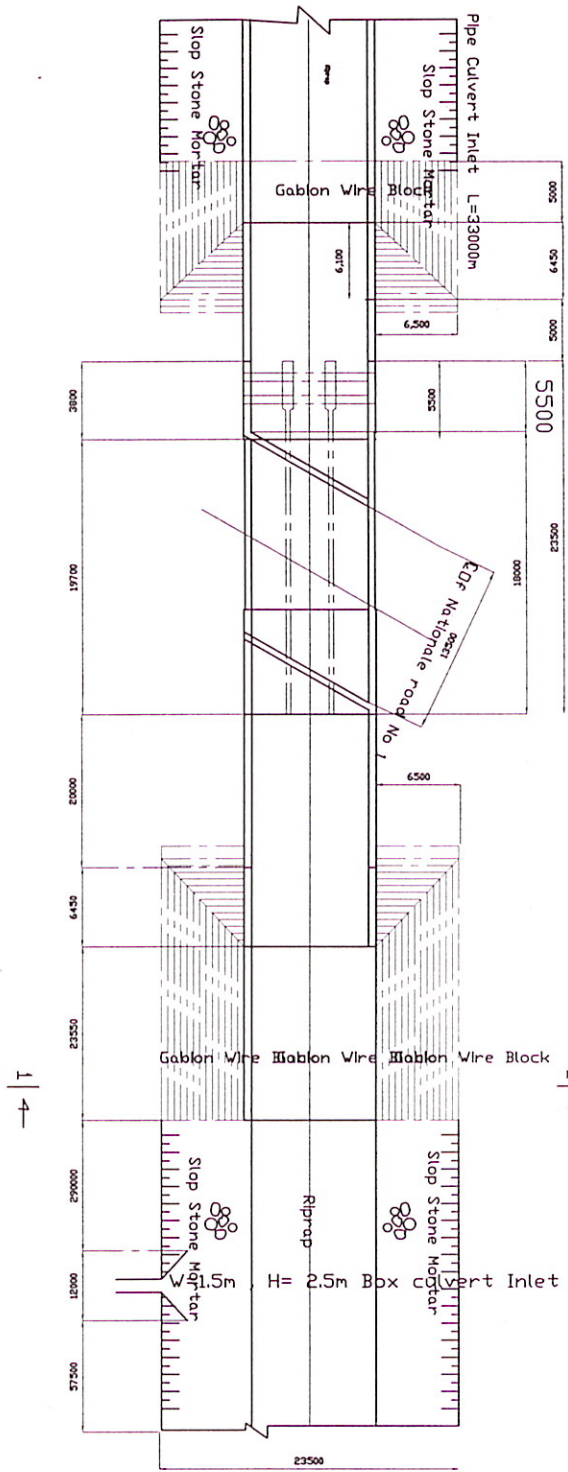
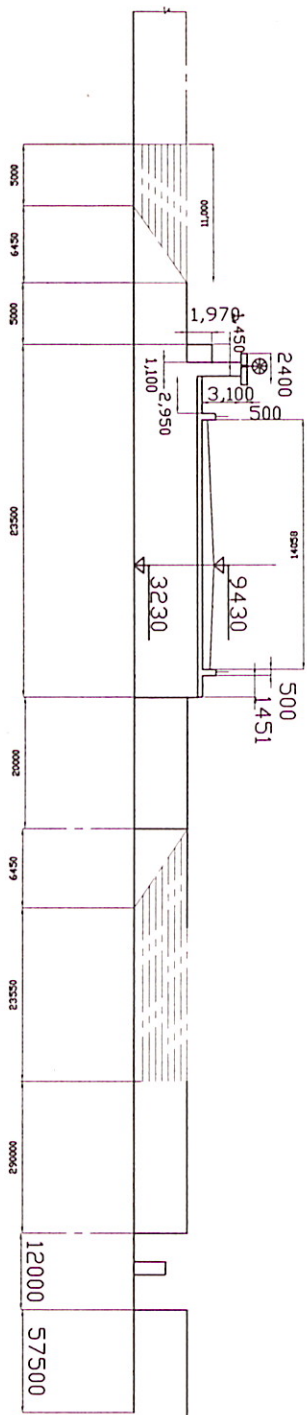
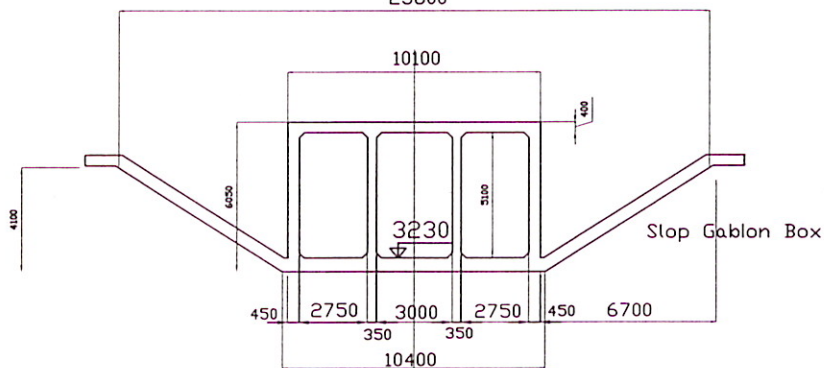
Water Gate Prek YDURN ( Prek Takao ) New  
 PK31+120  
 PLAN

(41)	Slope Protection Condition	Some cracks occur at the joint with Riprap.		
	D=Damaged, S=Scoured, C=Corroded, E=Enchroachment on Stream			
	Comment	Need following inspection	Evaluation	B
<b>G. OVERALL EVLUATION</b>		A (Good durability, Serviceability)

H. OVERALL COMMENT				
<p>1 - This Water Gate is very important for regular water flow in the rainy season and flood protection for NR1.                  2 - This plays an important role in the dry season to keep the water in low-lying area with the gate shut down.                  3 - Road width is enough for future traffic volume.                  4 - As to gabion box for slope protection and river bank protection, wire mesh were corroded. Repair is required.</p>

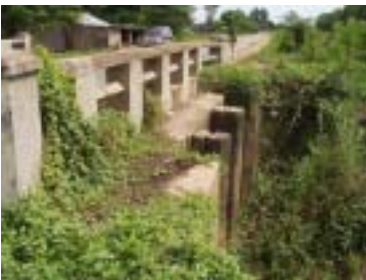
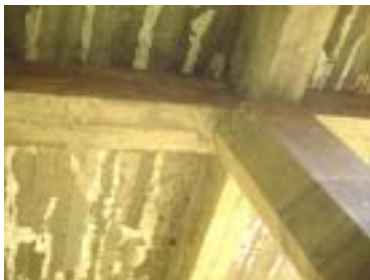
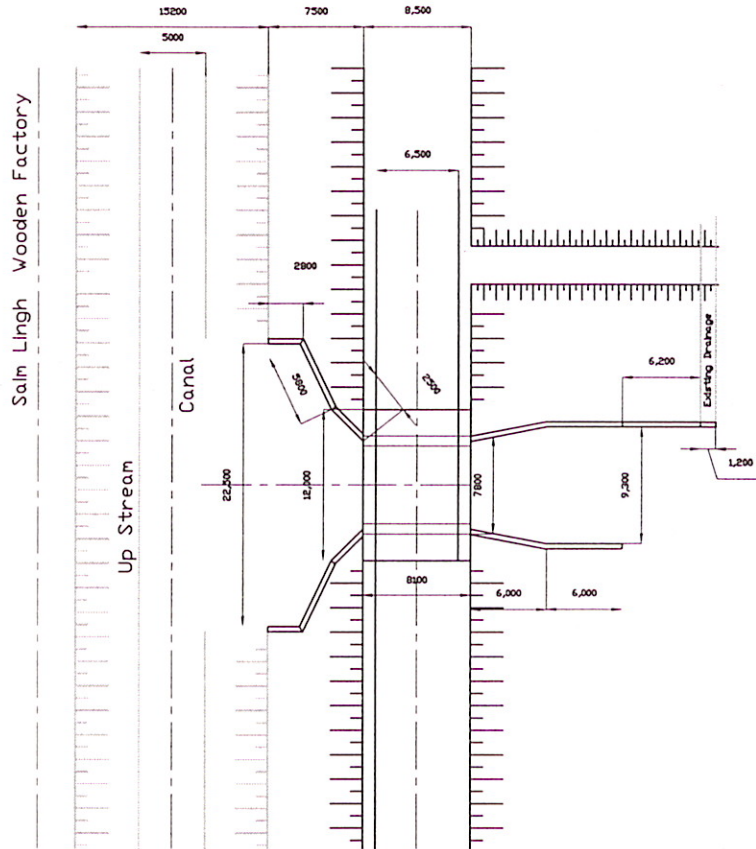
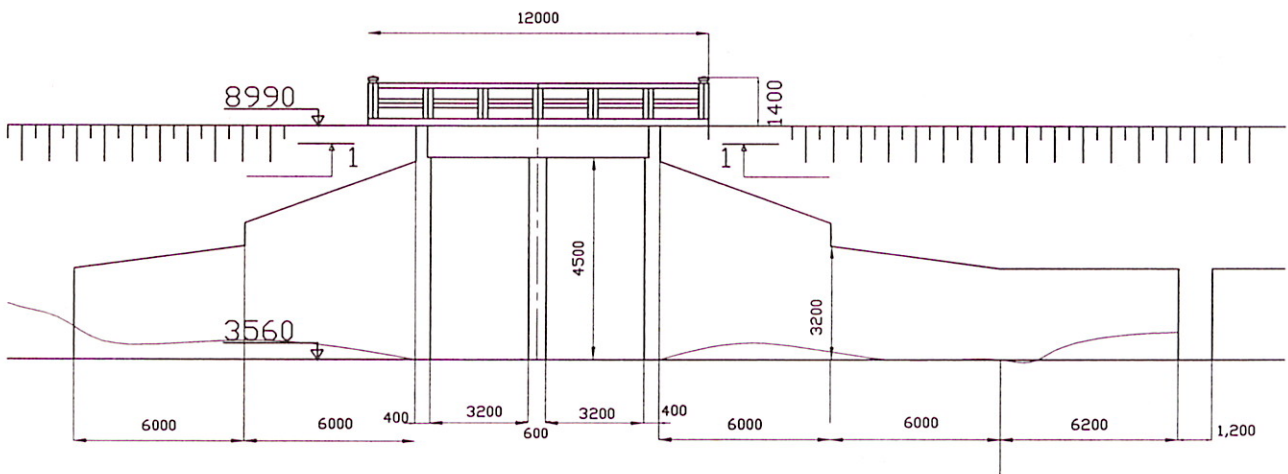
Sketch of Old Water gate ( Prek Samrong Thom)  
Pk 41+040

(40)	No.	A1	A2	
	Slope Protection Type	None		None
		N=None, R=Riprap, G=Gabion, C=Concrete, P=Piled Walls		
(41)	Slope Condition	Damaged and Scoured		
		D=Damaged, S=Scoured, C=Corroded, E=Encroachment on Stream

Comment	Protection required	Evaluation	B
G. OVERALL EVALUATION		D (Not enough on durability and serviceability)		
H. OVERALL COMMENT				
<p>1- This structure was built in 1977 in Pol Pot Regime, so everything became damaged</p> <p>2- There are some problem with local people, because downstream rice field can not job (Late job of farmer in the rainy season) 意味不明</p> <p>3- On the left bank (upstream), channel was filled for the factory. No flow.</p> <p>4- Downstream telephone cable on the slab.</p>

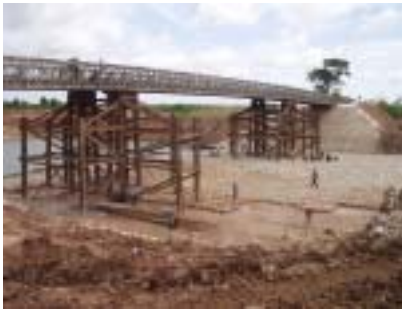
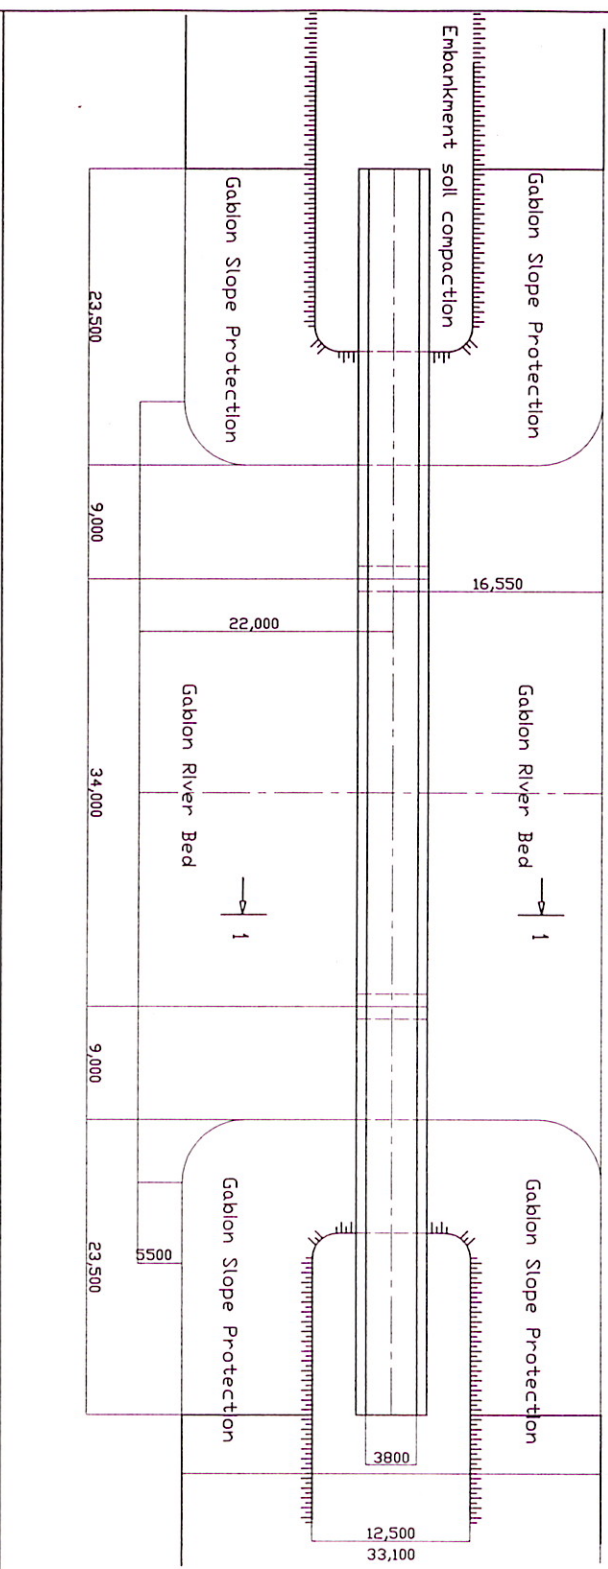
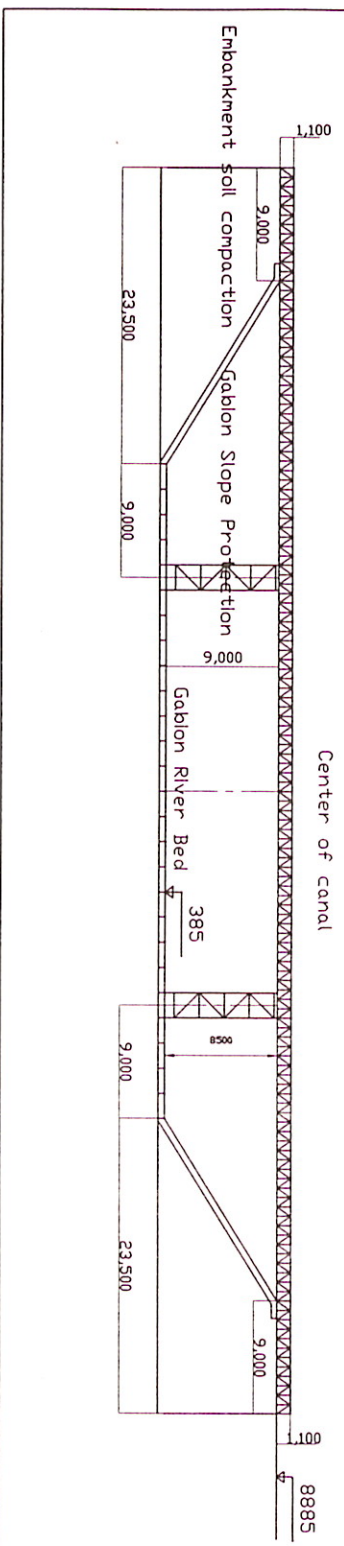
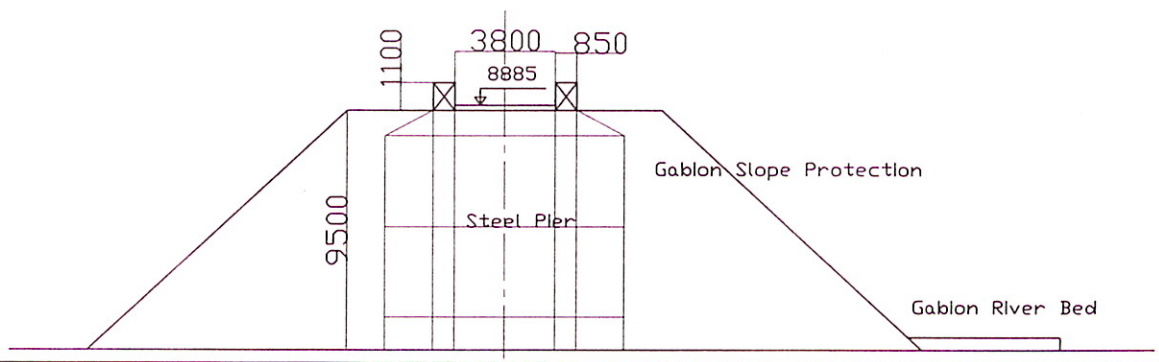
BALEY BRIDGE Pk 42+850  
PLAN

(46)	Slope Protection Condition	Eroded, Scoured	
		D=Damaged, S=Scoured, C=Corroded, E=Encroachment on Stream	
	Comment		Evaluation
			D
G. OVERALL EVALUATION			
		D (This bridge is subject to load limit. Road width is not enough for future traffic. This structure type is not appropriate against flood effect.)

H. OVERALL COMMENT			
	<p>1 - There was a box culvert before. However, due to serious flood damage, the Government cut the embankment here and constructed a Bailey Bridge.</p> <p>2 - Load capacity 16 ton and speed limit of 5km/h</p> <p>3 - Serious flood damages around this bridge every year.</p> <p>4 - This bridge is reconstructed by Ministry of Public Work and Transport (MPWT)</p>

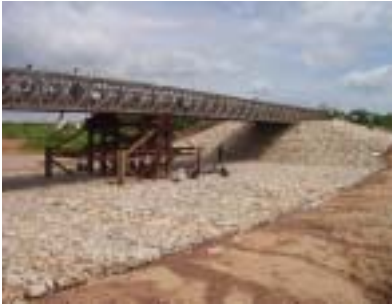
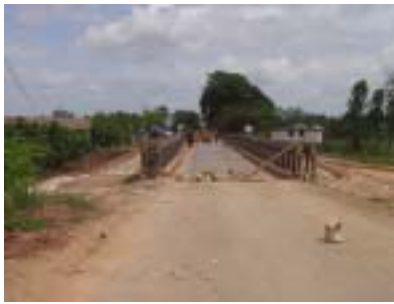
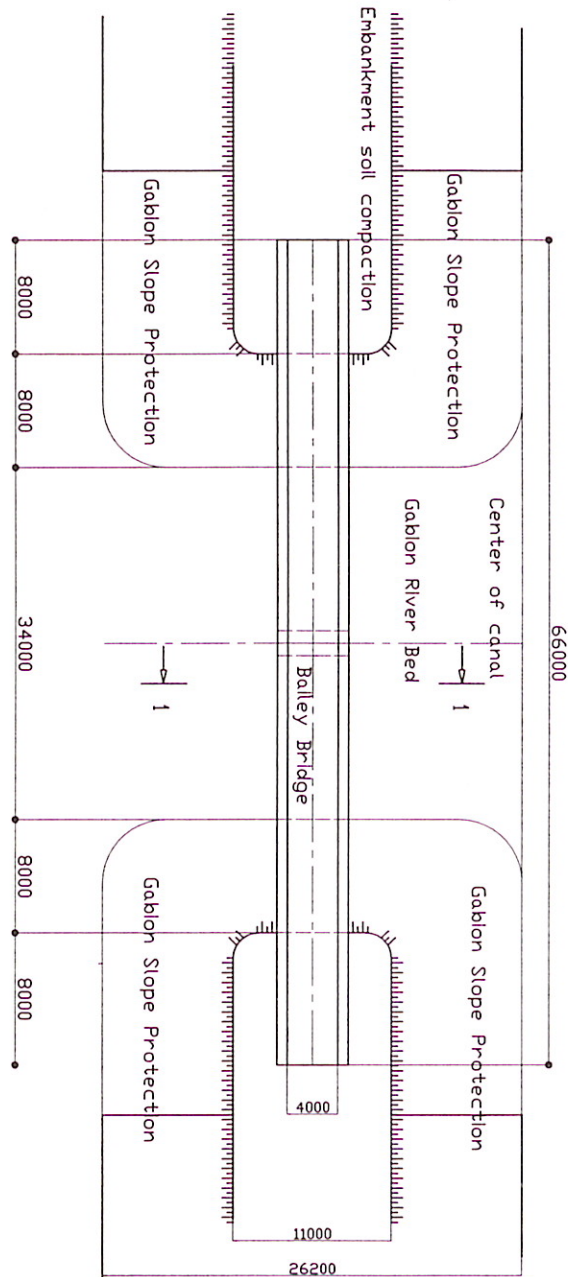
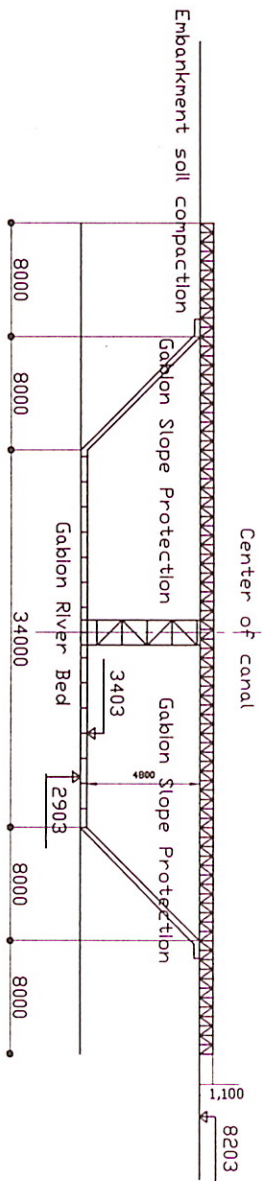
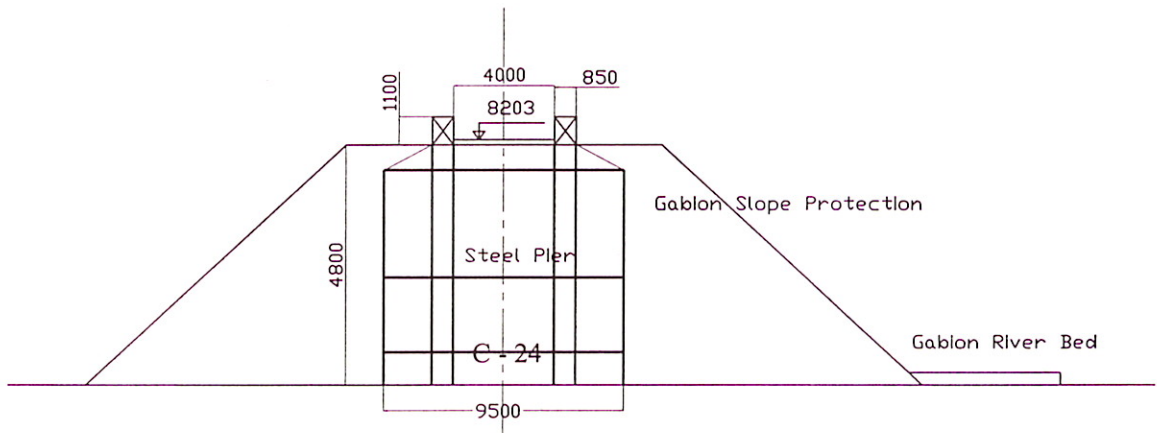
BAILEY BRIDGE Pk 47+967 ( D Chouk )  
PLAN

(46)	Slope Protection Condition	Eroded, Scoured	
		D=Damaged, S=Scoured, C=Corroded, E=Encroachment on Stream	
	Comment		Evaluation D
G. OVERALL EVALUATION		D (This bridge is subject to load limit. Road width is not enough for future traffic. This structure type is not appropriate against flood effect.)

H. OVERALL COMMENT			
<p>1 - There was a box culvert before. However, due to serious flood damage, the Government cut the embankment here and constructed a Bailey Bridge.</p> <p>2 - Load capacity 16 ton and speed limit of 5km/h</p> <p>3 - Serious flood damages around this bridge every year.</p>

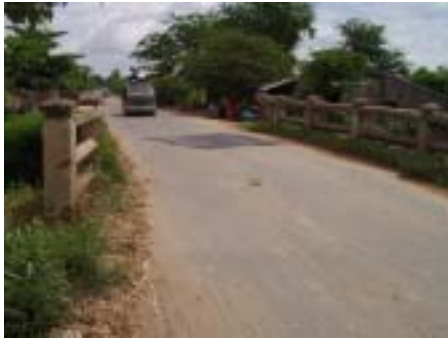
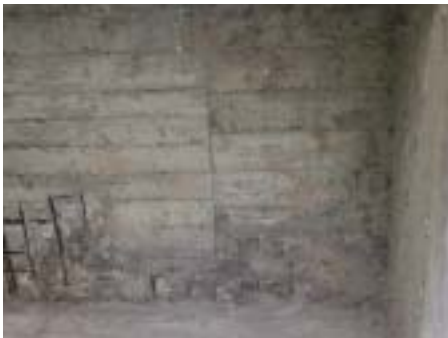
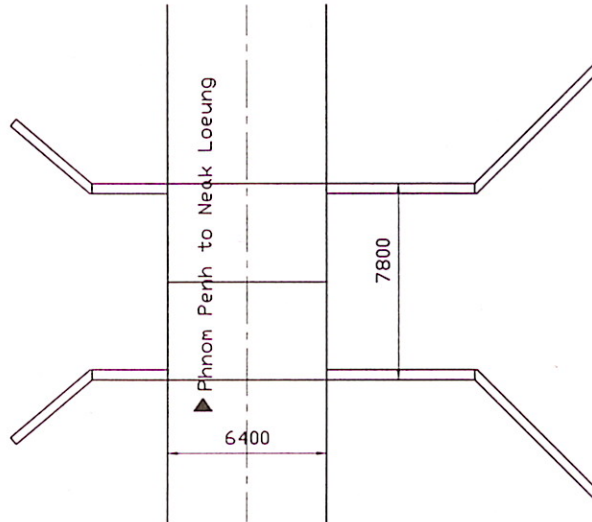
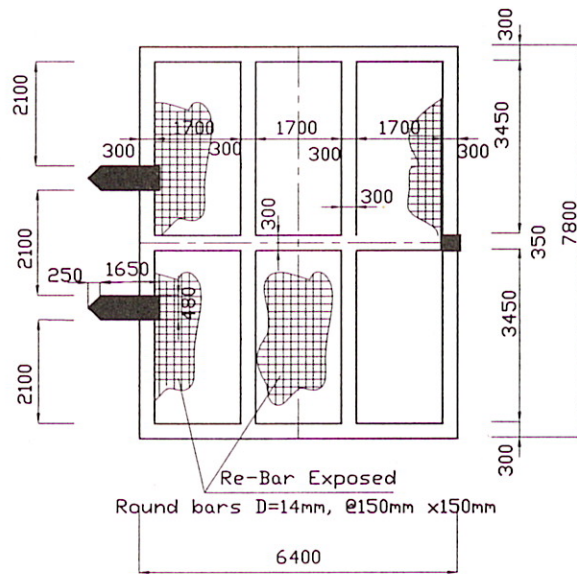
Sketch of Old Water gate ( Kampong Phnom )

(40)	No.	A1	A2	
	Slope Protection Type	None		None
		N=None, R=Riprap, G=Gabion, C=Concrete, P=Piled Walls		
(41)	Slope Condition	Damaged		
		D=Damaged, S=Scoured, C=Corroded, E=Encroachment on Stream

Comment	Protection required	Evaluation	B
G. OVERALL EVALUATION		D (Not enough on durability and serviceability)		
H. OVERALL COMMENT				
<p>1- This Water Gate is an old structure which was constructed in the Pol Pot Regime for irrigation drainage to the rice field and also flood emergency protection in the rainy season.</p> <p>2- Slab of structure was gun shoting hole, now close by steel plate.</p> <p>3- Upstream small canal presents only in flood seasons.</p>

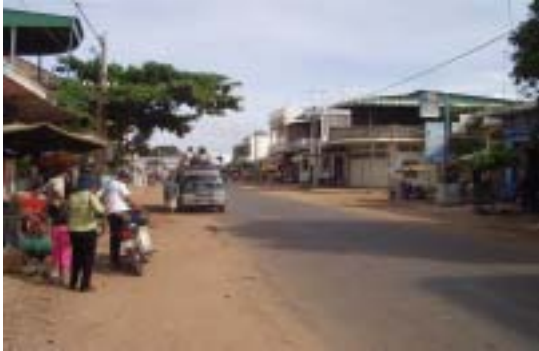
<p>Pk 9+100</p> <p>Damaged Pavement at Shoulder</p>

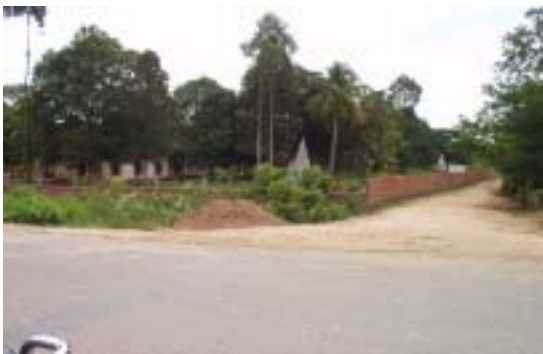
<p>Pk 52+100 Spean Wat</p> <p>Culvert Location from Interview Result (Not Found)</p> <p>There was steel bridge (10-15m) in 1986. After demolished bridge, pipe culverts (1.0m*4) were installed in 1986. Finally, pipe culverts were demolished due to constructed housing land in 1999. (No function at up-stream side)</p>

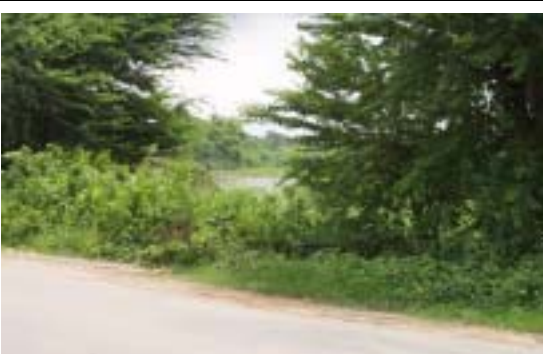
<p>Pk 53+700</p> <p>Canal at Both Side of Road Candidate Location for Culvert</p>

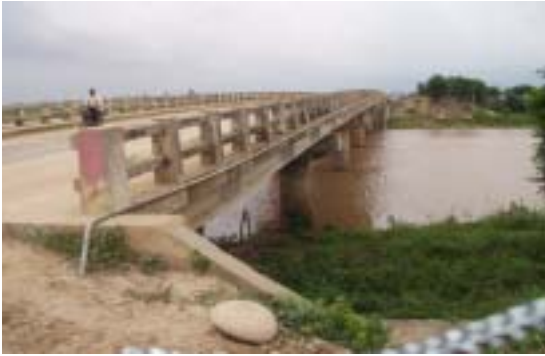
NR1 (C-2) Stoeng Slot Br.

Constructed 1986  
Pre-stressed Concrete Girder  
for 2 lanes

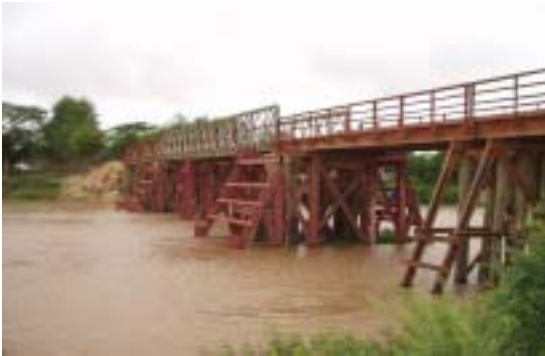
Secondary Road from NR1(C-2)

Steel Bridge  
Narrow width

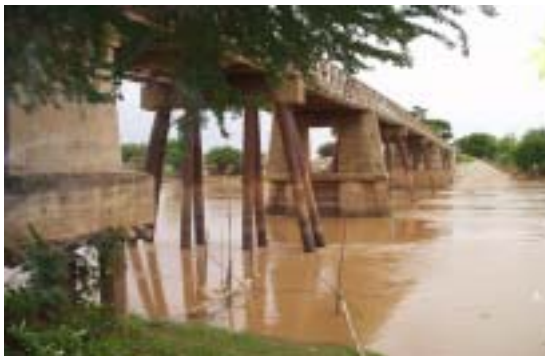
NR 11

Steel Bridge  
Narrow width

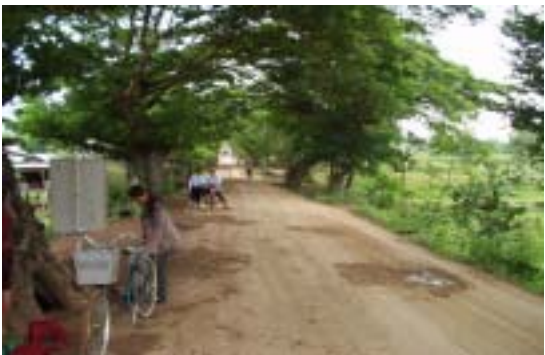
NR 11

Road Conditions  
Not paved

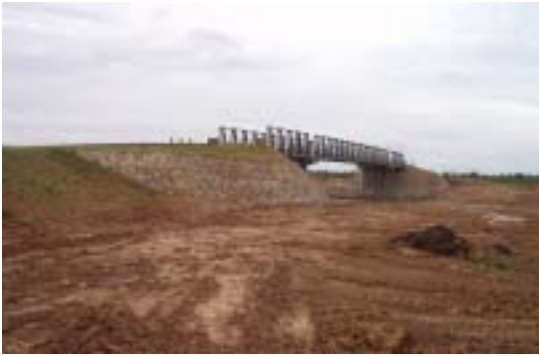
NR 11

Improved Steel Bridge & Approach

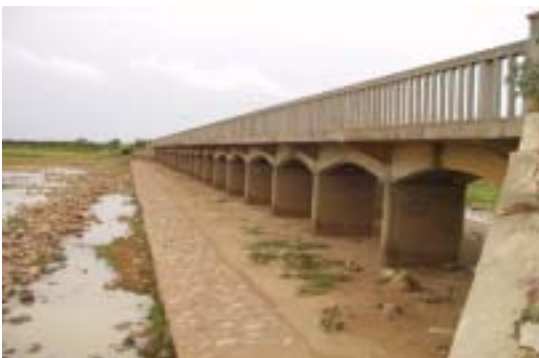
Branch Road of NR 11

Reinforced Concrete Bridge  
Submerged Bridge Type
