Inspection Memo 3 Inspection of Hopin Small Hydropower Station in Hopin, Kachin

26.11.2002

Inspection Memo 4 Inspection of Zi Chaung Power Station during De-Watering

23 to 29 May 2003

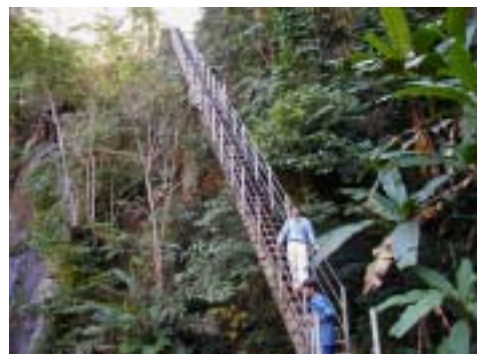
Steps on Siphon Pipes

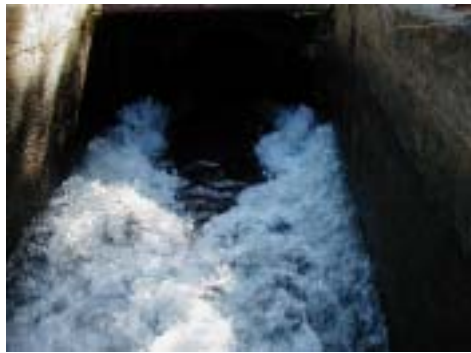
Outlet of Siphon

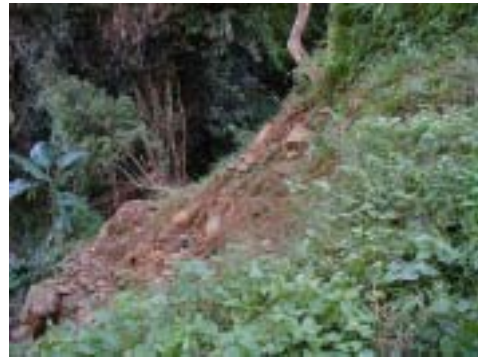
Downside slope much eroded by water

- It was observed at the open canal that slope sliding above the waterway entered the canal once and dammed off the flow, of which overflow induced the slope failure below the canal.
- It appears that the Head Tank was designed to supply the maximum design discharge for just 1.0 hour only ($0.85 \text{ m}^3/\text{s} \times 3,600 = 3,060 \text{ m}^3$)
- The water leakage was observed at 2 locations of expansion joints of Penstock.

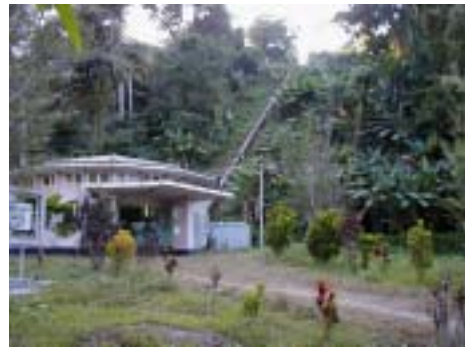
Hopin Power Station & penstock

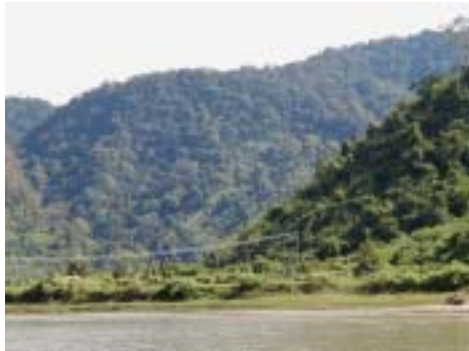
A distant view of penstock

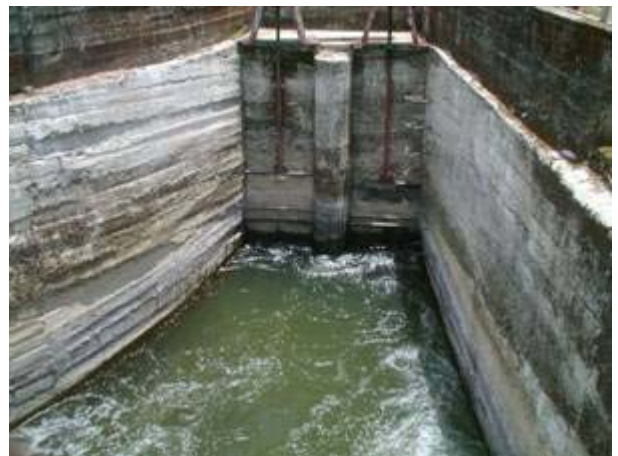
Intake gates looked from upstream

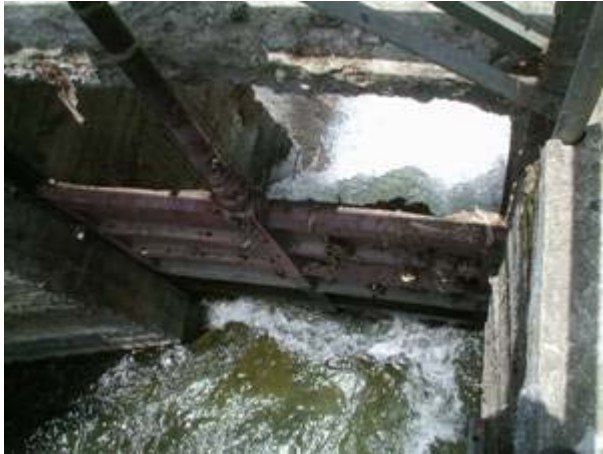
Sand flushing gate

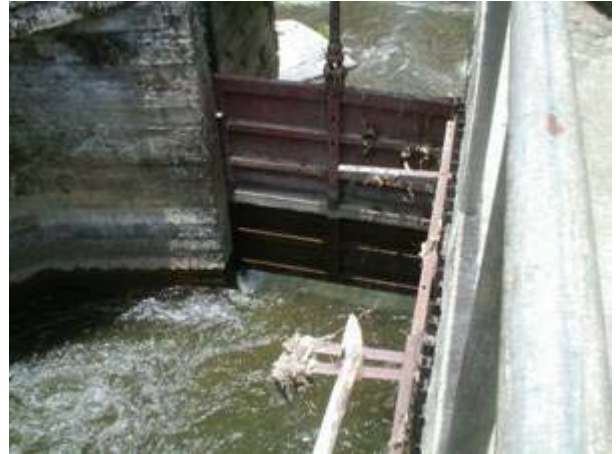
Sand flushing gate fully opened

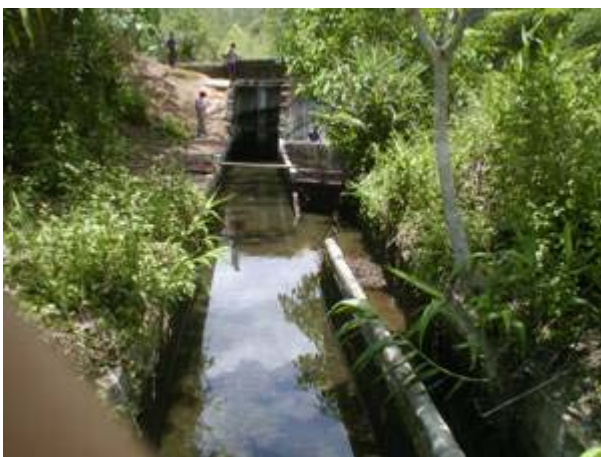
Side spillway section after intake gates fully closed.

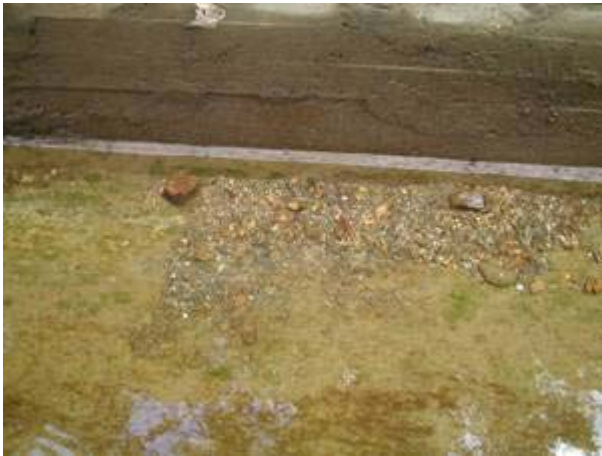
Joint between floor slab and side wall

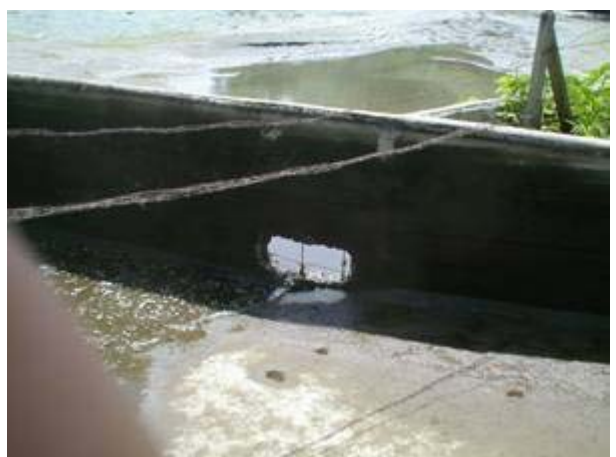
A hole is made on side wall to divert water flushing works in the Regulating Pond

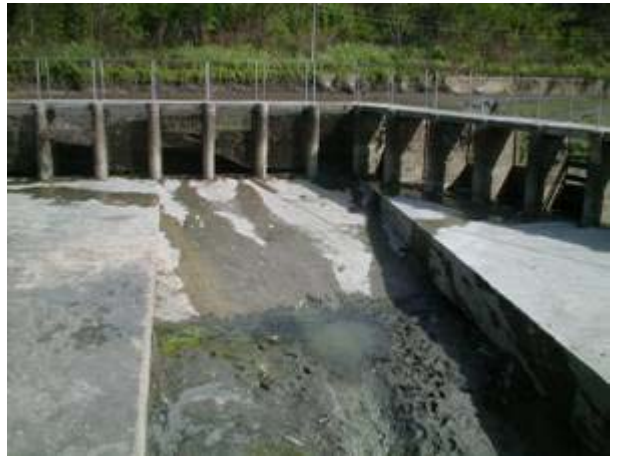
Sloped pond floor towards penstock inlet looking upstream

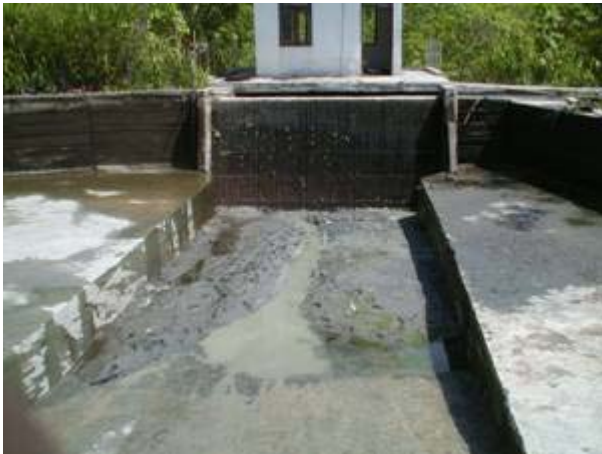
Looking penstock inlet. Sediments were flushed in mid-May 2003
